OSHA Fatal Facts: Fatalities Caused by Improper Work Practices

Course No: C04-026

Mark Rossow, PhD, PE, Retired

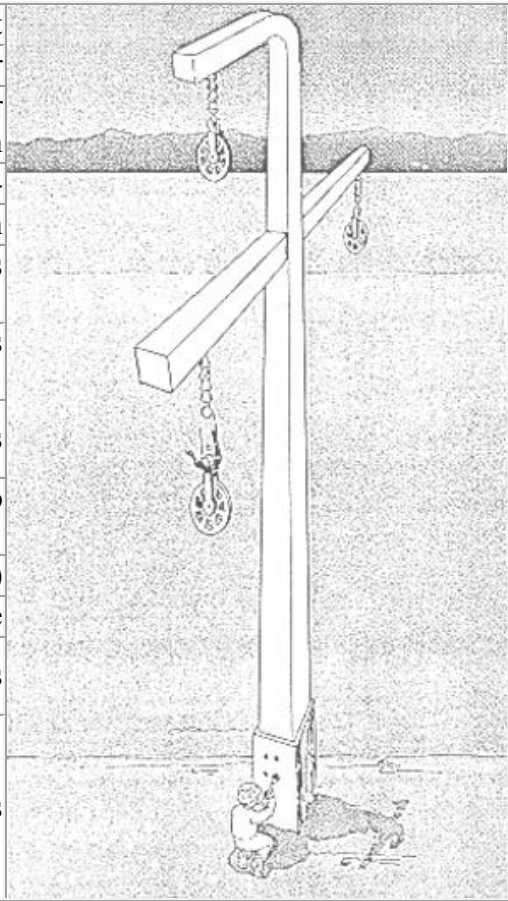
ACCIDENT SUMMARY No. 8

Accident Type:	Struck by Falling Object
Weather Conditions:	Clear
Type of Operation:	Transmission Tower Construction
Size of Work Crew:	4
Union or Non-union	Union
Competent Safety Monitor on Site:	Yes
Safety and Health Program in Effect:	Yes
Was the Worksite Inspected Regularly:	Yes
Training and Education Provided:	No
Employee Job Title:	Groundman (Framer)
Age & Sex:	24-Male
Experience at this Type of Work:	2 Years
Time on Project:	3 Days

Ball and socket connectors are used to attach conductor stringing blocks to insulators on the arms of 90 foot metal towers of electrical transmission lines. Normally stainless steel cotter keys secure the ball and socket connector in place. In this case, however, black electrical tape was wrapped around the socket to keep the ball in place rather than a cotter key. The tape apparently stretched and the ball came loose, dropping the stringing block approximately 90 feet onto the head of an employee below, one of a four-man erection crew.

1. Rigging and equipment must be inspected regularly and maintained in safe operating condition as required by general provisions of OSHA's construction (29 CFR 1926.995).
2. Employees must be instructed to recognize and avoid unsafe conditions and be made aware of regulations which apply to the work and the work area to eliminate safety and health hazards as required in the safety training and education section of OSHA's construction safety standards (29 CFR 1926.21(b)(2)).

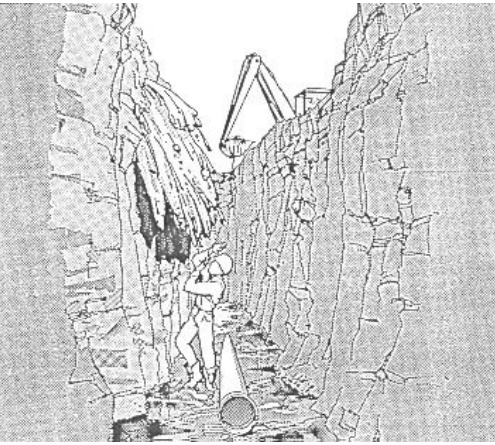
ACCIDENT SUMMARY No. 9

Accident Type:	Trench Cave-in

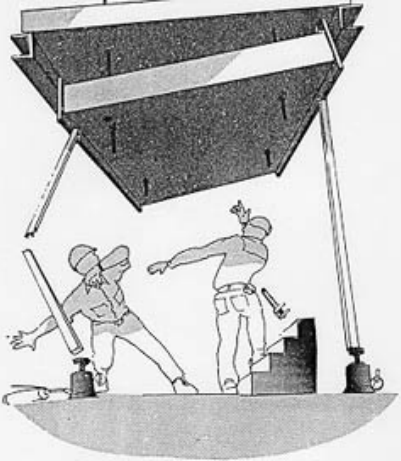
ACCIDENT SUMMARY No. 10

Accident Type:	Crushed by Falling Machinery

2. Train employees in the proper inspection techniques for hydraulic jacks and the procedures to be used during the installation of the equipment (1926.21(b)(2)).
3. Crib or block the load after raising to secure it against movement (1910.244(a)(2)(iii)).
4. Inspect hydraulic jacks at least every 6 months for deteriorated lines, leaks, mushroomed heads, etc. (1910.244(a)(2)(vi)(a)).
5. Inspect rigging equipment prior to each shift use (1926.251 (a)(1)).

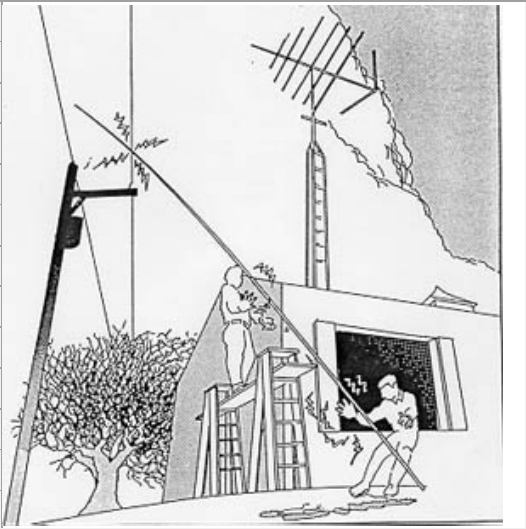
ACCIDENT SUMMARY No. 11

Accident Type:	Electrocution
Weather Conditions:	Wet Ground
Type of Operation:	Remodeling
Size of Work Crew:	2
Collective Bargaining	No
Competent Safety Monitor on Site:	Yes
Safety and Health Program in Effect:	No
Was the Worksite Inspected Regularly:	Yes
Training and Education Provided:	No
Employee Job Title:	Carpenter
Age & Sex:	33-Male
Experience at this Type of Work:	30 Days
Time on Project:	3 Days

Two employees were installing aluminum siding on a farmhouse when it became necessary to remove a 36-foot high metal pole CB antenna. One employee stood on a metal pick board between two ladders and unfastened the antenna at the top of the house. The other employee, who was standing on the ground, took the antenna to lay it down in the yard. The antenna made electrical contact with a 7200-volt power transmission line 30 feet 10 inches from the house and 23 feet 9 inches above the ground. The employee handling the antenna received a fatal shock and the other employee a minor shock.

1. Note the presence of power lines and be extremely cautious when working near them. Train employees to recognize and avoid electrical hazards (29CFR 1926.21(b)(2)).
2. Do not permit employees to work near any part of an electrical power circuit which might be contacted in the course of the work. Guard all electrical power circuits against accidental contact by insulating the circuit or deenergizing it or by other effective means that would protect the employee (29CFR 1926.400(C)(1)).

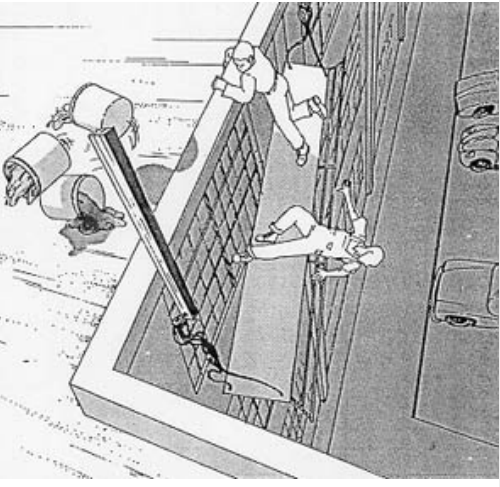
ACCIDENT SUMMARY No. 14

Accident Type:	Fall, Different Level

Two employees were painting the exterior of a three-story building when one of the two outriggers on their two-point suspension scaffold failed. One painter safely climbed back onto the roof while the other fell approximately 35 feet to his death. The outriggers were inadequately counterweighted with three 5-gallon buckets containing sand and were not secured to a structurally sound portion of the building. Neither painter was wearing an approved safety belt and lanyard attached to an independent lifeline.

1. Develop and maintain a safety and health program to provide guidance for safe operations (29 CFR 1926.20(b)(1)).
2. Institute, a program for frequent and regular inspections of the job site, as well as materials and equipment by a competent person(s) (29 CFR 1926.20(b)(2)).
3. Instruct each employee on how to recognize and avoid unsafe conditions which apply to the work and work areas (29 CFR 1926.21(b)(2)).
4. Construct scaffolds and their components so that they can support at least four times the maximum intended load (29 CFR 1926.451(a)(7)).

5. Install outrigger tiebacks of $\frac{3}{4}$ inch rope, or equivalent, to a structurally sound portion of the building to provide a secondary means of anchorage (29 CFR 1926.451(i)(4)).
6. Require employees to wear approved safety belt and lanyard equipment attached to an independent lifeline that is attached to a substantial structural member (29 CFR 1926.451(i)(8)).

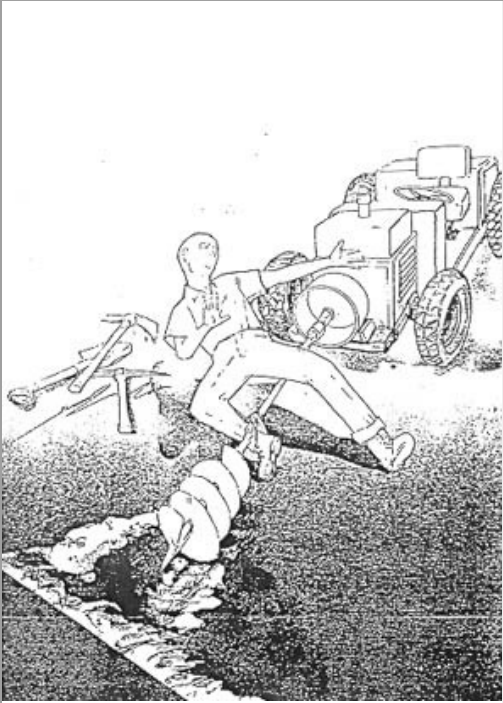
ACCIDENT SUMMARY No. 18

Accident Type:	Caught by Rotating Part

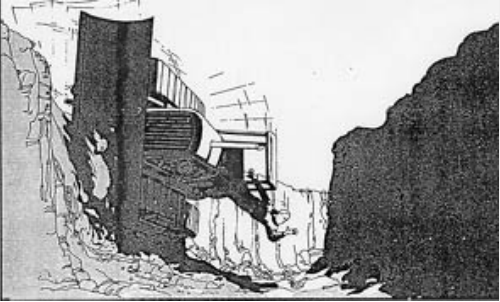
ACCIDENT SUMMARY No. 19

Accident Type:	Crushing

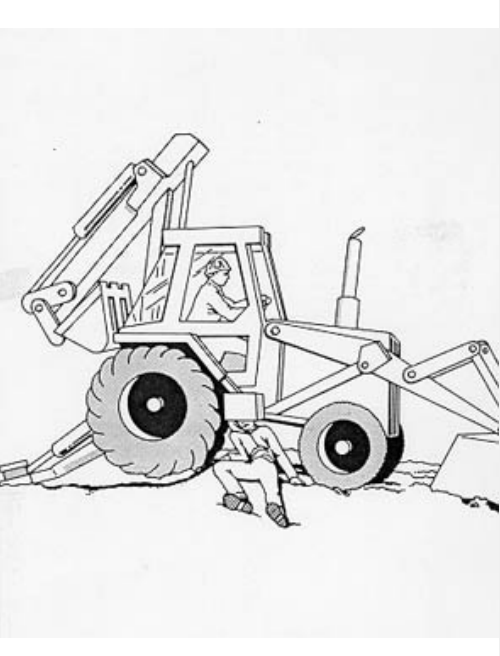
ACCIDENT SUMMARY No. 34

Accident Type:	Caught in Machinery

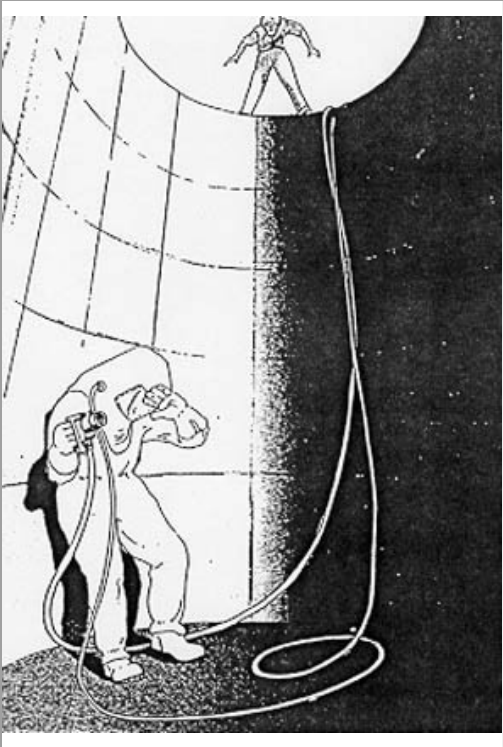
ACCIDENT SUMMARY No. 36

Accident Type:	Asphyxiation
Weather Conditions:	Warm, partly cloudy
Type of Operation:	Sandblasting/painting contractor
Size of Work Crew:	4
Collective Bargaining:	No
Competent Safety Monitor on Site:	Yes
Safety and Health Program in Effect:	Limited
Was the Worksite Inspected Regularly:	Yes
Training and Education Provided:	Inadequate
Employee Job Title:	Sandblaster/Painter
Age & Sex:	56-Male
Experience at this Type of Work:	5 years on a permanently assigned crew
Time on Project:	45 minutes

A contract employee was assigned to sandblast the inside of a reactor vessel during turnaround activities at a petrochemical refinery. Instead of relying on the contract company's own air compressors in accordance with the contractor's policy, the contract foreman connected the employee's supplied air respirator to a hose containing what he thought was plant air. Instead it was nitrogen. Both hoses were identical except for markings at the shutoff valve. The sandblaster entered the vessel, descended to the bottom, placed the respirator hood on his head and was overcome.

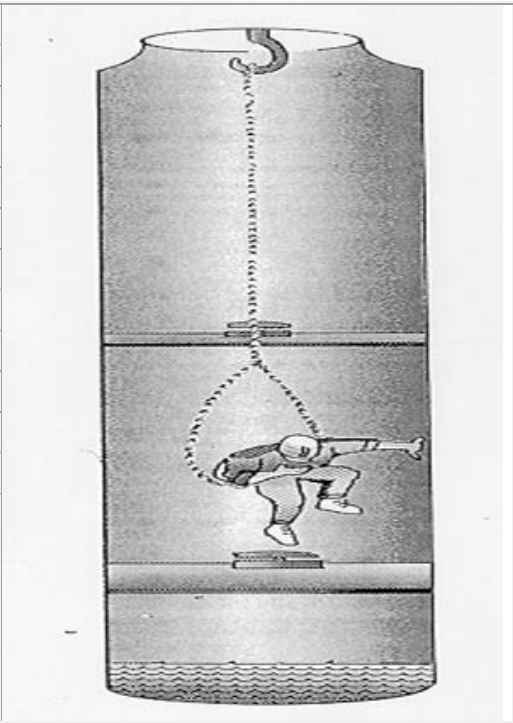
ACCIDENT SUMMARY No. 39

Accident Type:	Asphyxiation
Weather Conditions:	Warm
Type of Operation:	Boring, Jacking
Size of Work Crew:	6
Collective Bargaining	No
Competent Safety Monitor on Site:	No
Safety and Health Program in Effect:	No
Was the Worksite Inspected Regularly:	No
Training and Education Provided:	No
Employee Job Title:	Laborer
Age & Sex:	23-Male
Experience at this Type of Work:	1 Day
Time on Project:	1 Hour

An employee sitting in a looped chain was lowered approximately 17 feet into a 21-foot deep manhole. Twenty seconds later he started gasping for air and fell from the chain seat face down into the accumulated water at the bottom of the manhole. An autopsy determined oxygen deficiency as the cause of death.

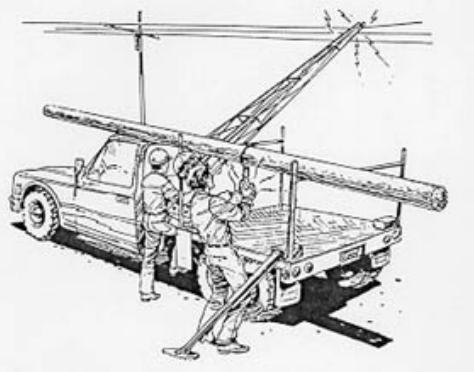
ACCIDENT SUMMARY No. 44

Accident Type:	Electrocution

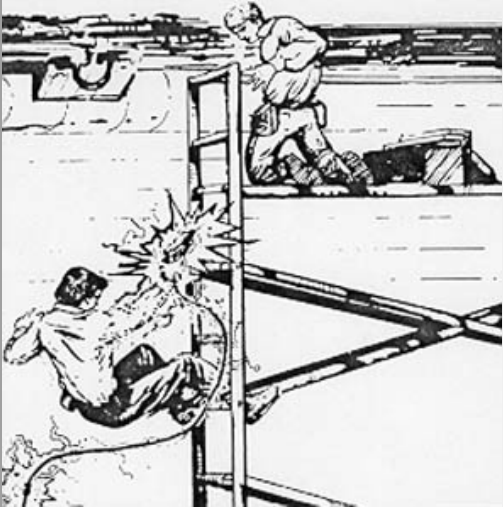
ACCIDENT SUMMARY No. 57

Accident Type:	Electrocution

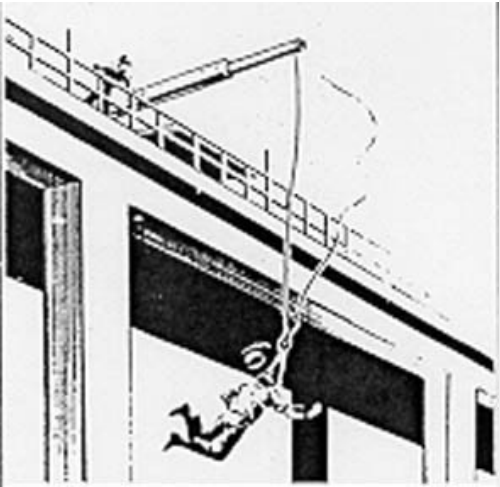
ACCIDENT SUMMARY No. 58

Accident Type:	Fall and Drowning

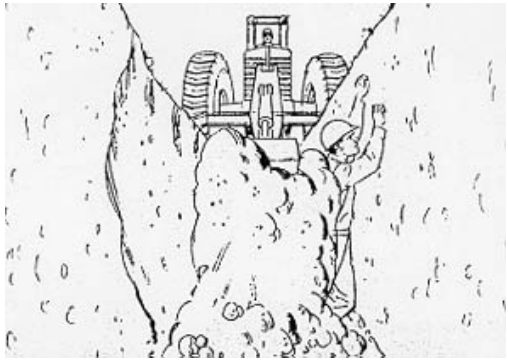
ACCIDENT SUMMARY No. 61

Accident Type:	Trench Collapse

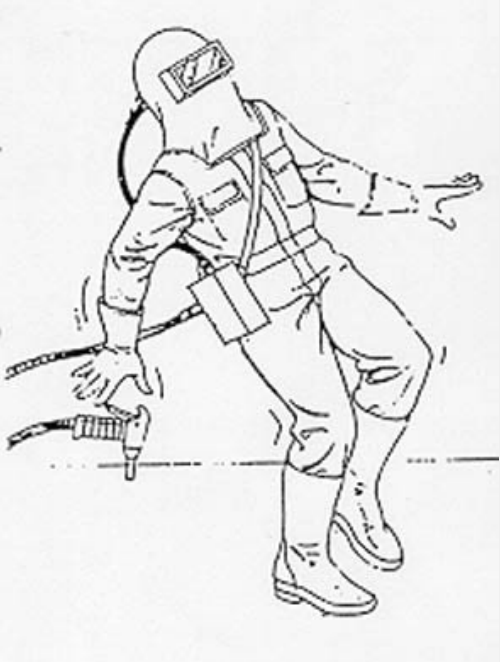
ACCIDENT SUMMARY No. 67

Accident Type:	Asphyxiation
