Taum Sauk Upper Dam Breach FERC No. P-2277

Technical Reasons for the Breach
of December 14, 2005

FERC Independent Panel of Consultants (IPOC)

May 24, 2006

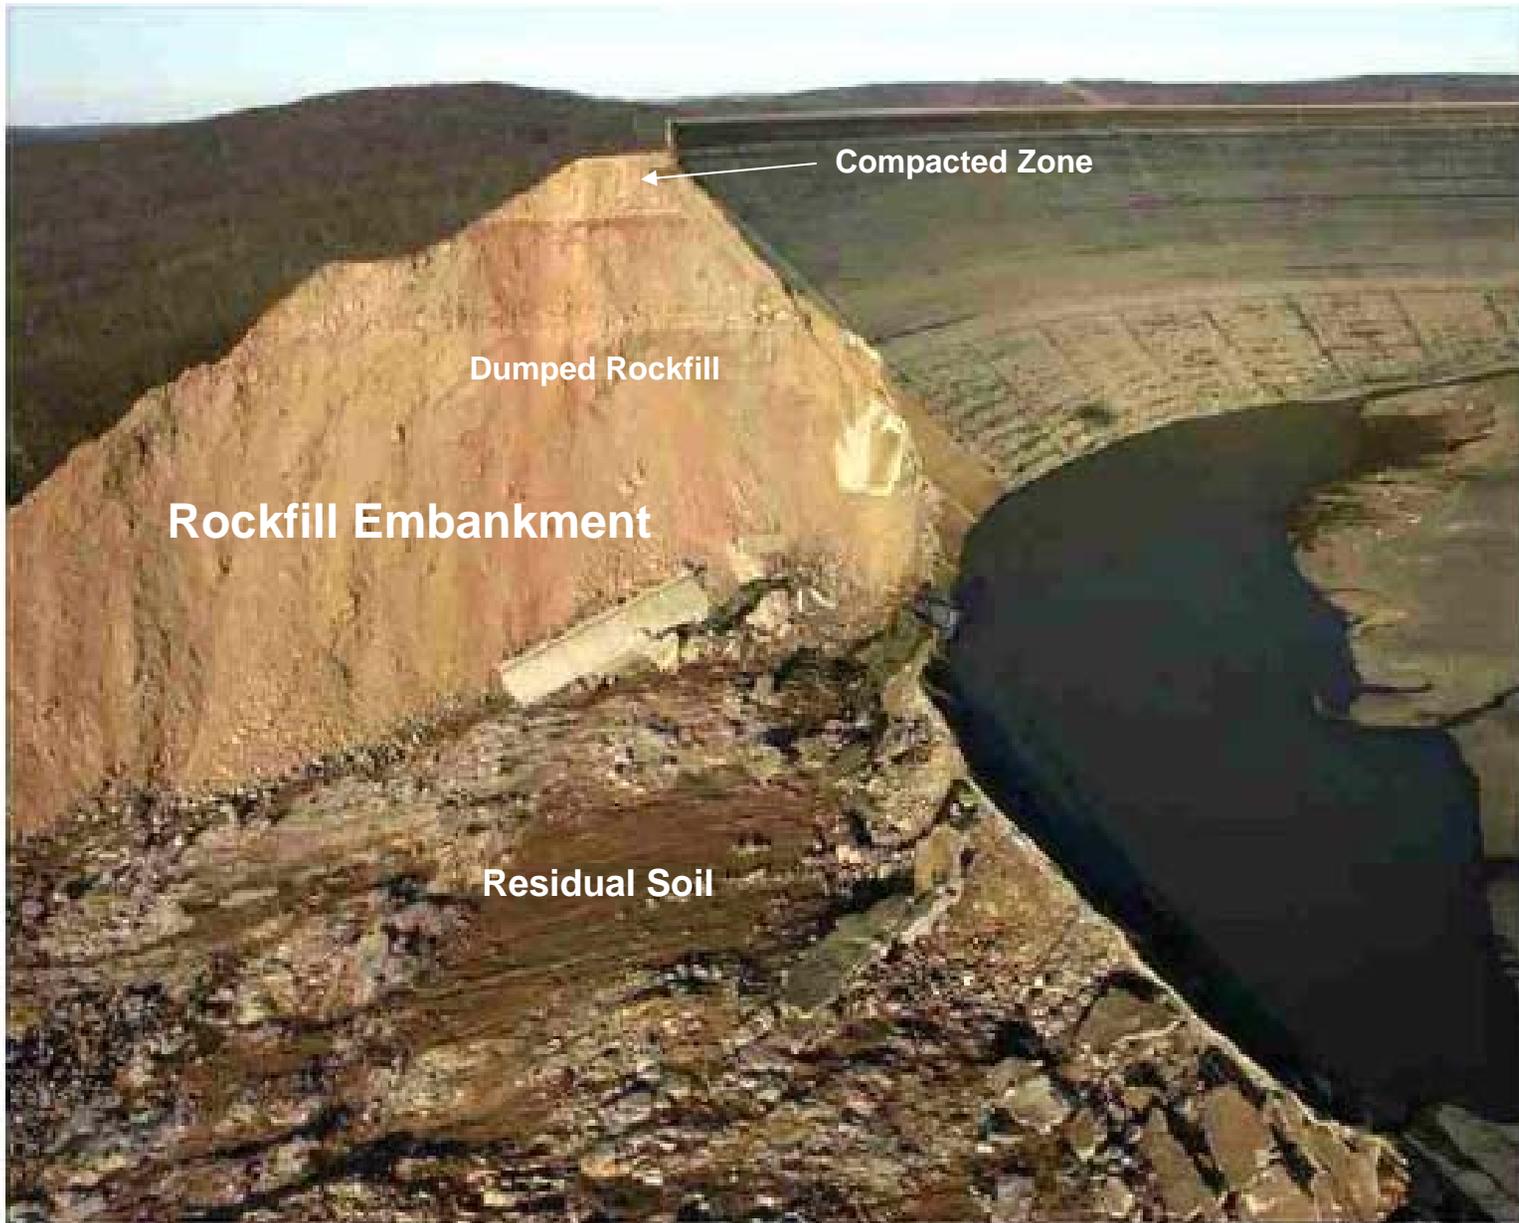
During IPOC inspections at the site, a good cross-section of the embankment could be observed on the north side of the breach as shown in Figure 6-4. In Figure 6-4 the dumped rockfill can be observed below the upper 20 ft of compacted rockfill. The rockfill exposed in this section is dirtier than a normal rockfill and as such would be more erodible and would be less free draining than a normal rockfill. In fact Dr. Frank Nickell (one of the original consultants during design) mentioned in one of his reports that the rockfill with the most fines could be used in the upper 20 ft of compacted rockfill for the roadway on the outside of the parapet wall.

A residual soil zone of weathered rhyolite could also be observed in the breach area; and one location is shown in Figure 6-4. The residual soil was observed to

be clayey and it was judged to have an effective shear strength almost dictated by the clay portion of the soil. Exposed rhyolite bedrock is also observed in Figure 6-4 as well as the remnants of the lower face slab and plinth.

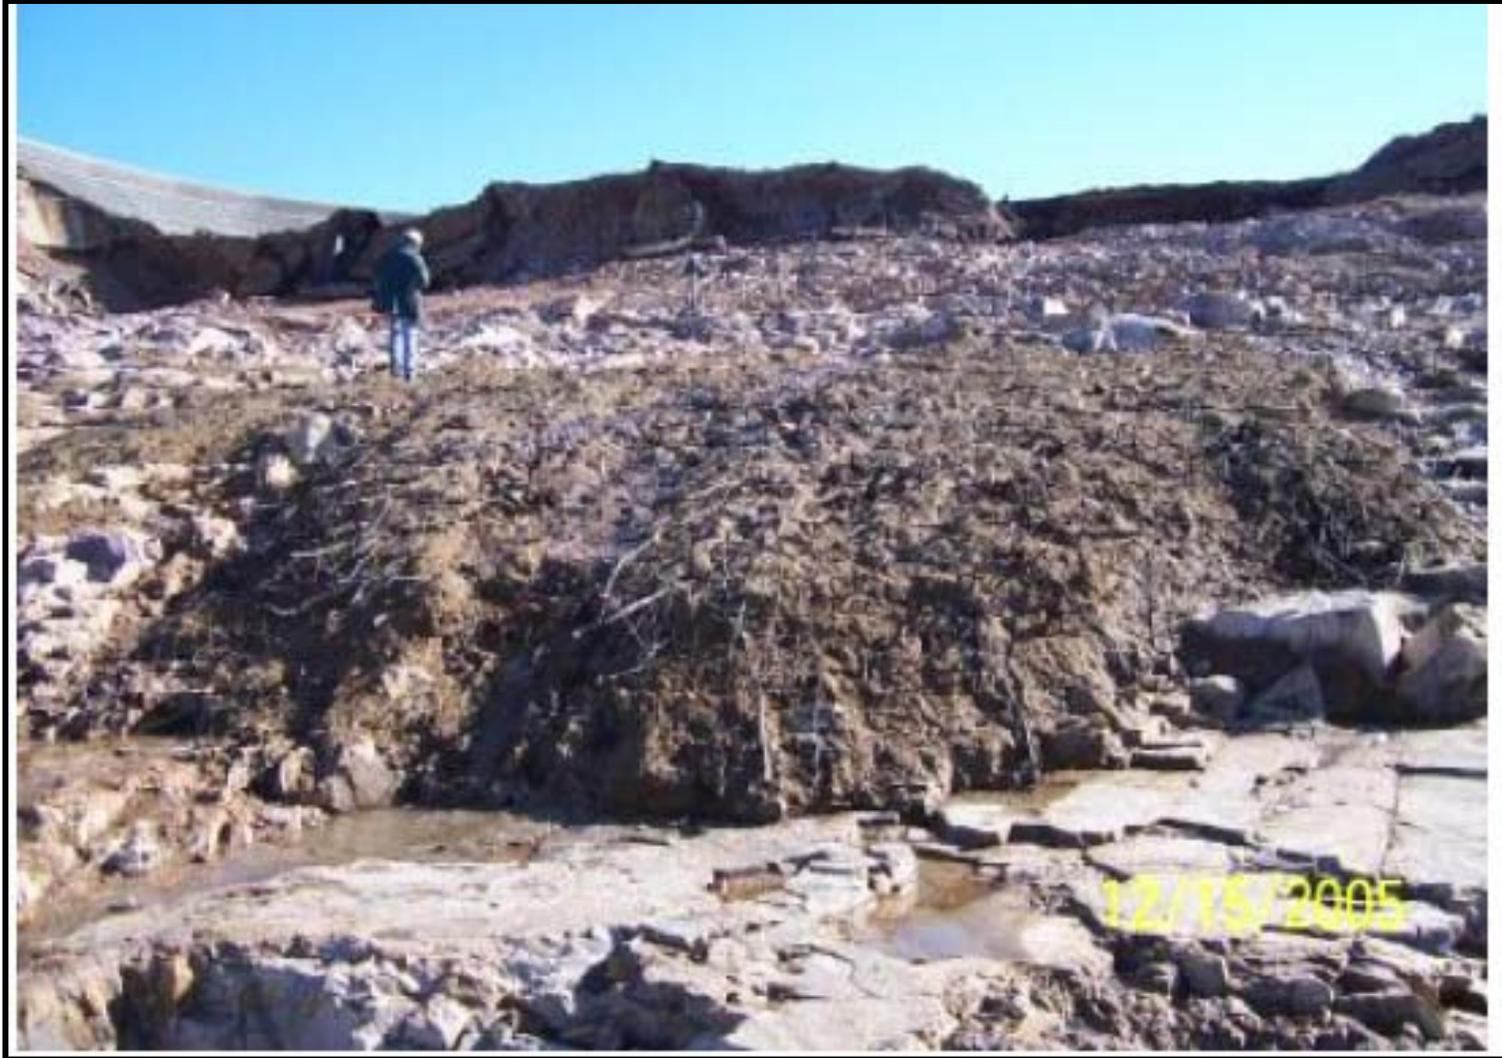
Figure 6-5

A closer view of the exposed rhyolite bedrock and residual soil is shown in Figure 6-5. This photo is taken looking east and the rather flat looking joint surface in the rhyolite dips toward the camera in a westerly direction. This discontinuity was observed in the field to dip nearly west at a dip of about 10° . This discontinuity is described as Fracture Set 8 (FS-8) in the Rizzo Report and is reported to have a dip of 8° and a dip azimuth of 270° . As a result of the observation of the residual soil, the IPOC requested that samples of the residual soil be taken for direct shear testing.

Eroded foundation, note rock jointing and overlying clay materials

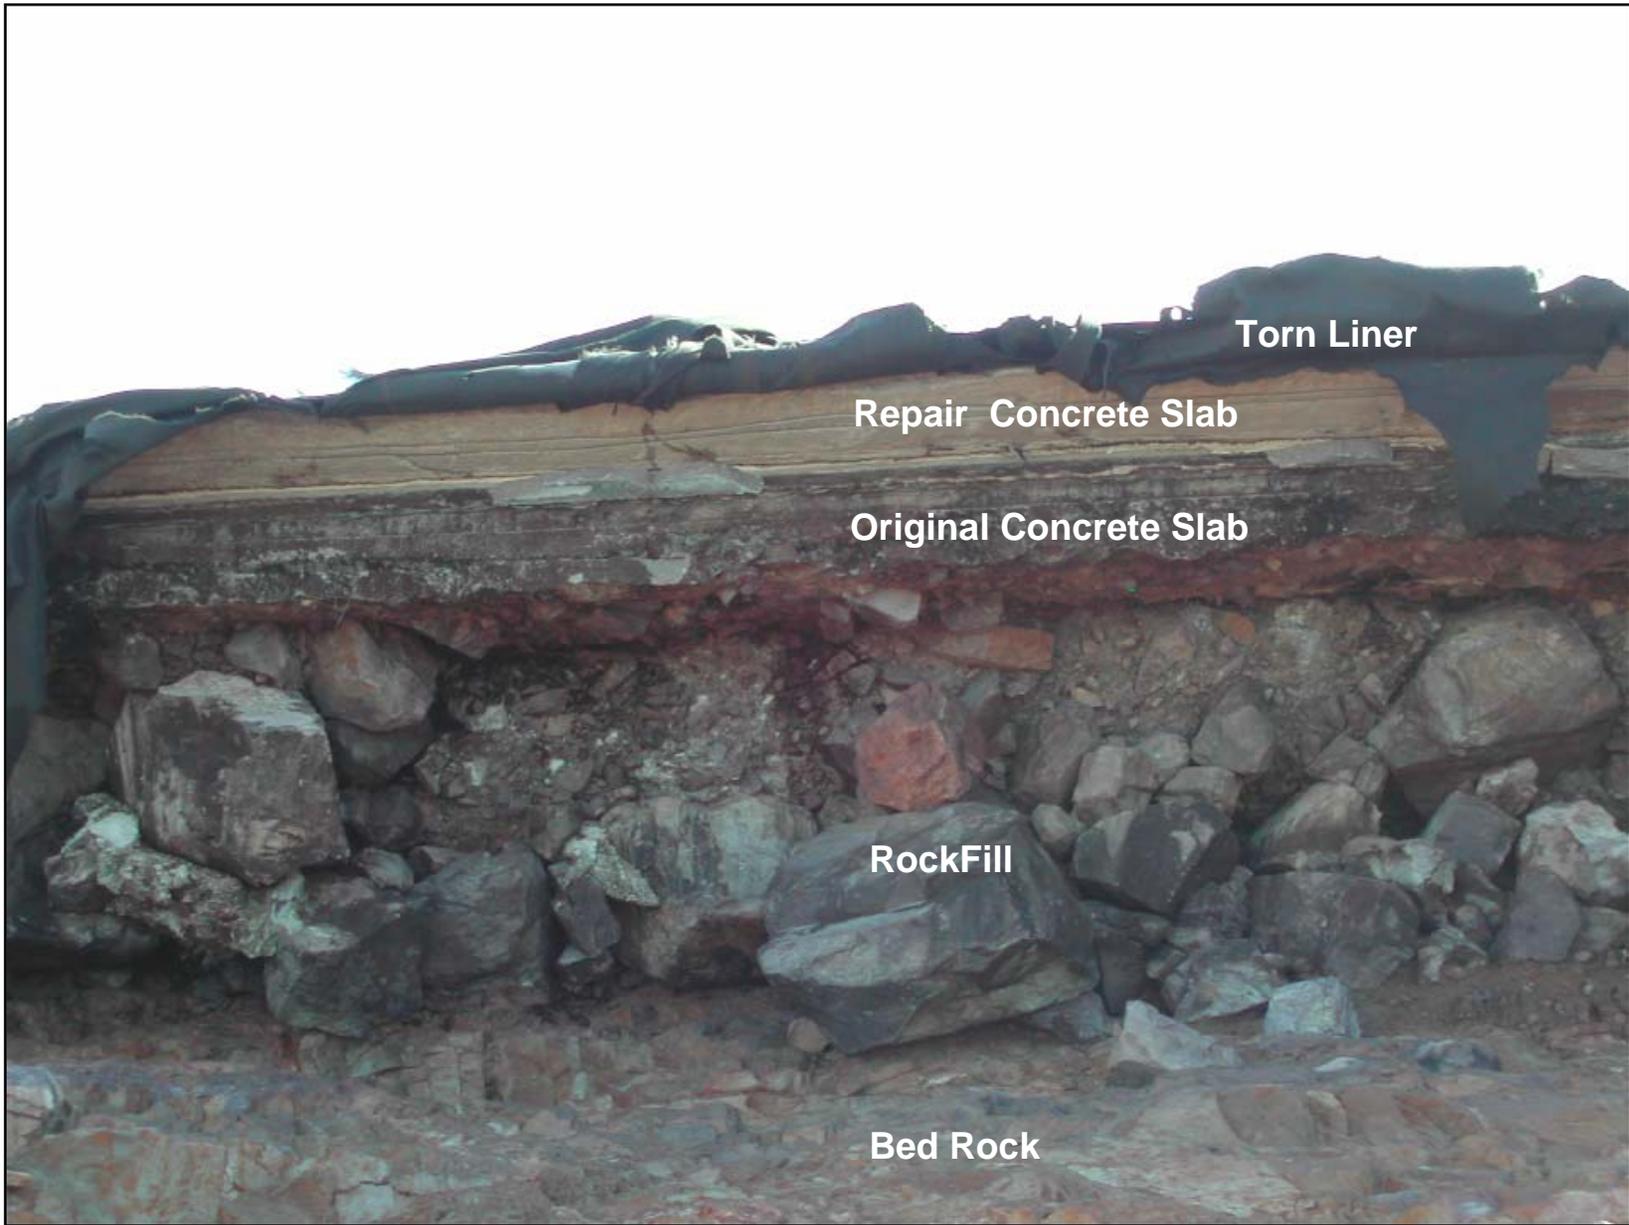
Figures 6-6, 6-7, and 6-8 show three views of the area under the base of the bottom of the face slab and plinth. The most glaring issue revealed by Figure 6-6 for example is that it appears that the plinth was not taken down to the rhyolite bedrock shown at the bottom of the photo. This is not considered good practice today and it was not good practice in 1963. Figures 6-7 and 6-8 show similar construction along the plinth area. This observation makes it consistent to rationalize the blow outs and holes that had to be repaired upstream of Panels 90-95 in 1963 and 1964. It definitely appears from these inspections that the plinth was not extended to bedrock for this dam, at least in the breach area.

Rockfill between top of rock and base of plinth

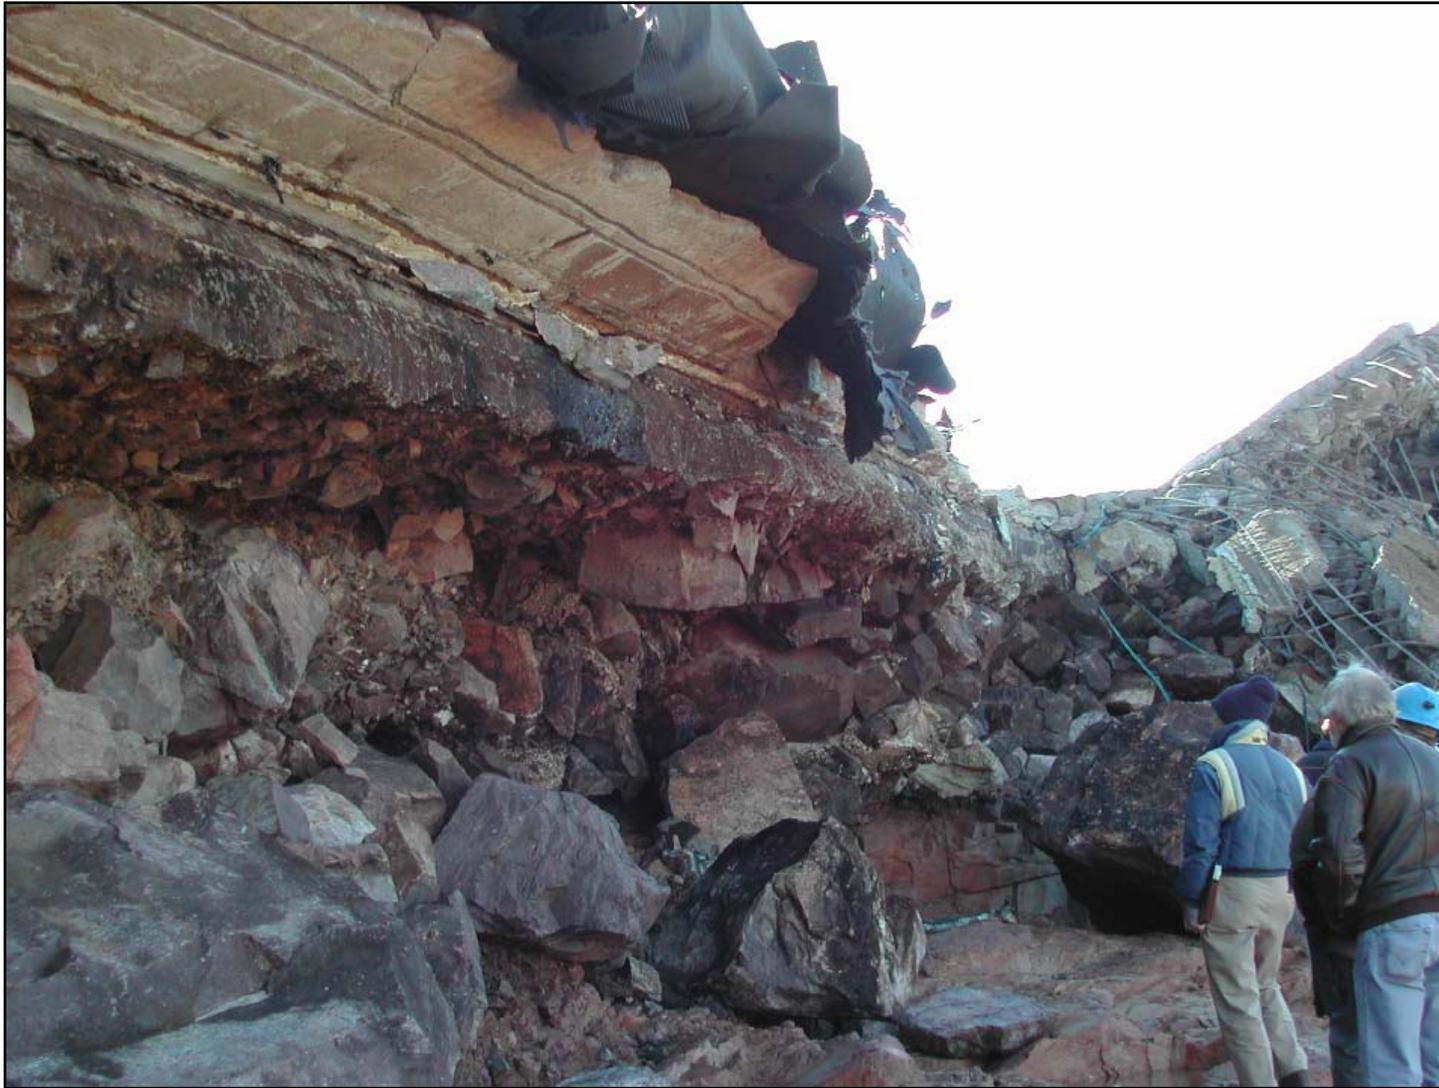
Figure 6-7

Rockfill between top of rock and base of plinth,
note reddish grout in rockfill beneath the plinth

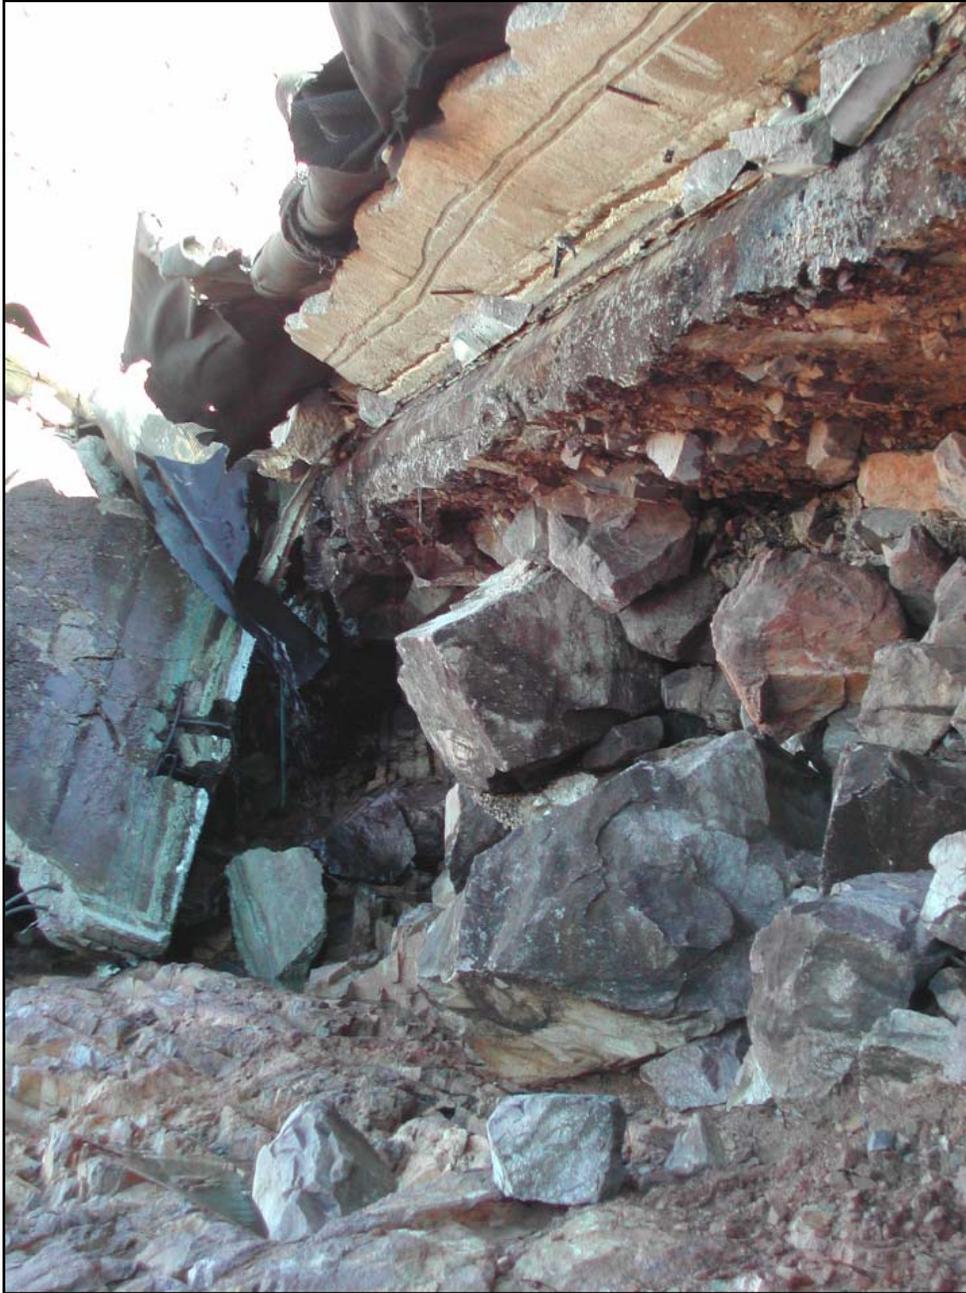
Figure 6-8

Rockfill between top
of rock and base of plinth

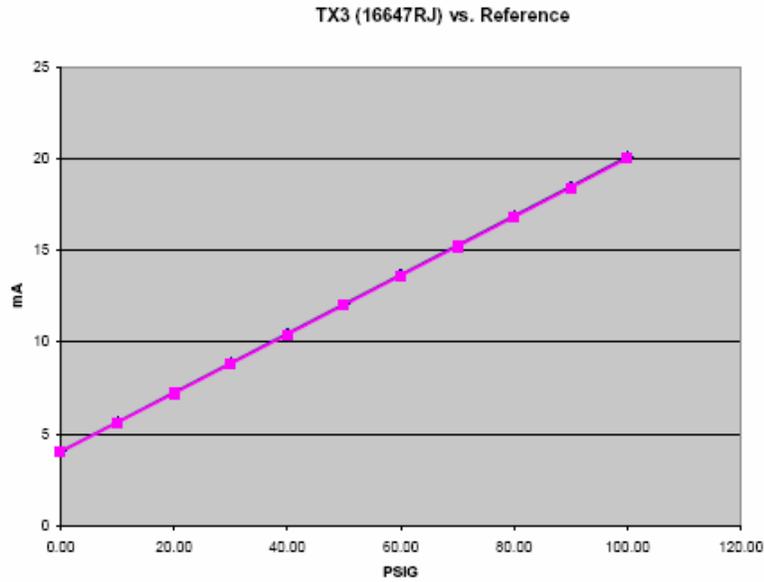
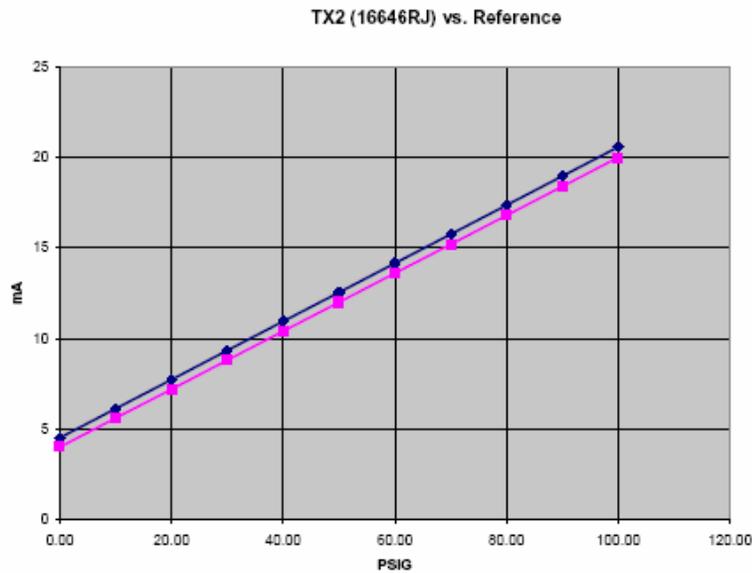
Figure 7-1 shows plots of ma output versus PSIG for TX2 and TX3 compared to a reference (ideal) transducer. Both TX2 and TX3 have linear response to pressure but TX2's ma output represents about a 7.86 feet higher indication than the reference curve while TX3's ma output represents about 0.85 feet higher indication than the reference curve. Figure 6 on page 20 of 76 in Appendix A of the Rizzo report shows that the as found PLC logic includes a subtraction of 9.38 feet from the TX2 pressure indication and a subtraction of 2.4 feet from the TX3 pressure indication. The basis for these adjustment values is not stated in Appendix A of the Rizzo report.

Pressure Transducers TX2 and TX3 Compared to Reference Transducer (TX2 reads average of 7.86 feet high and TX3 reads average of 0.85 feet high)

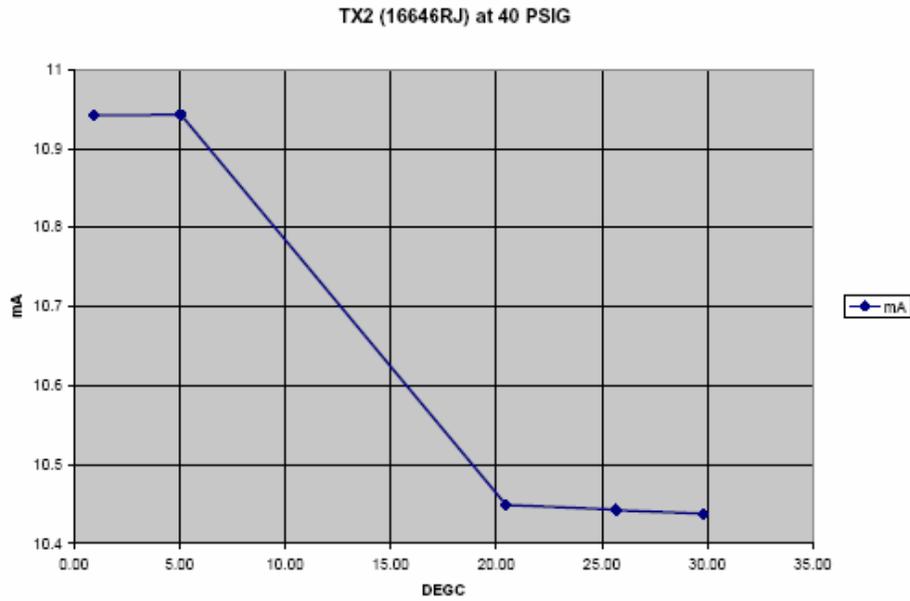
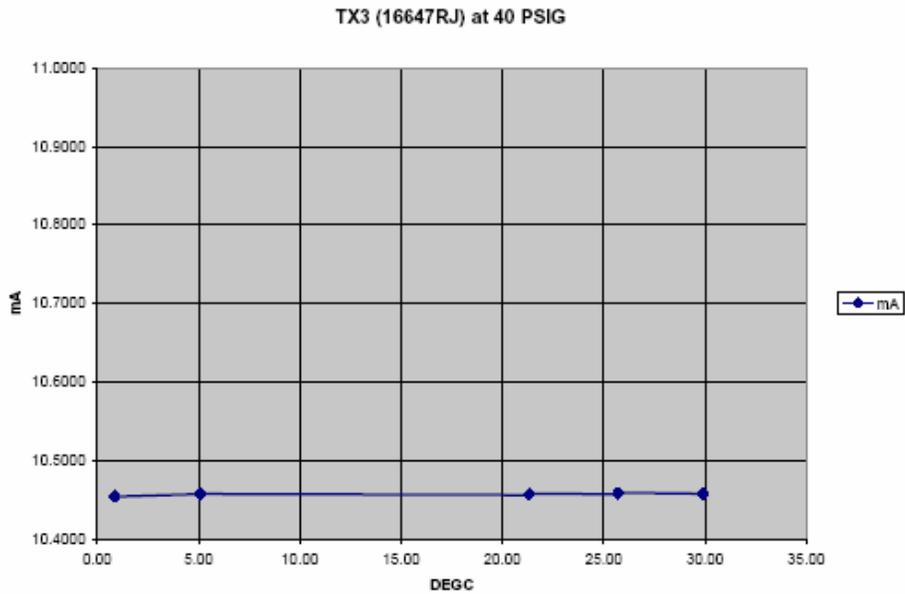
Figure 7-2

**Pressure Transducer Temperature Sensitivity
(TX2 Output Shift Represents +7.11 Ft. of Water Level
at 5 degrees compared to 20 degrees)**

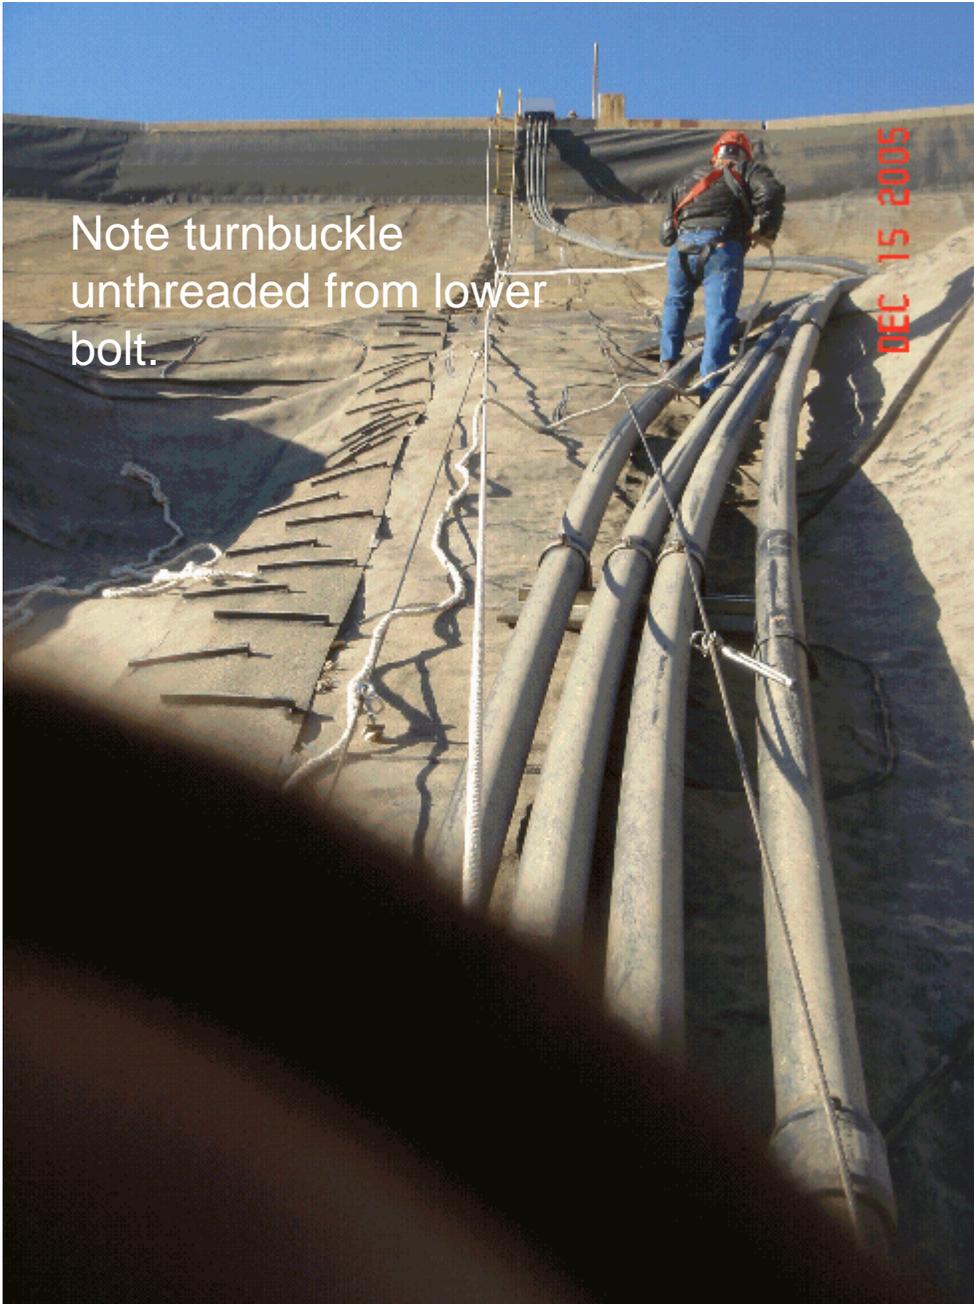
Figure 7-3

Note turnbuckle
unthreaded from lower
bolt.

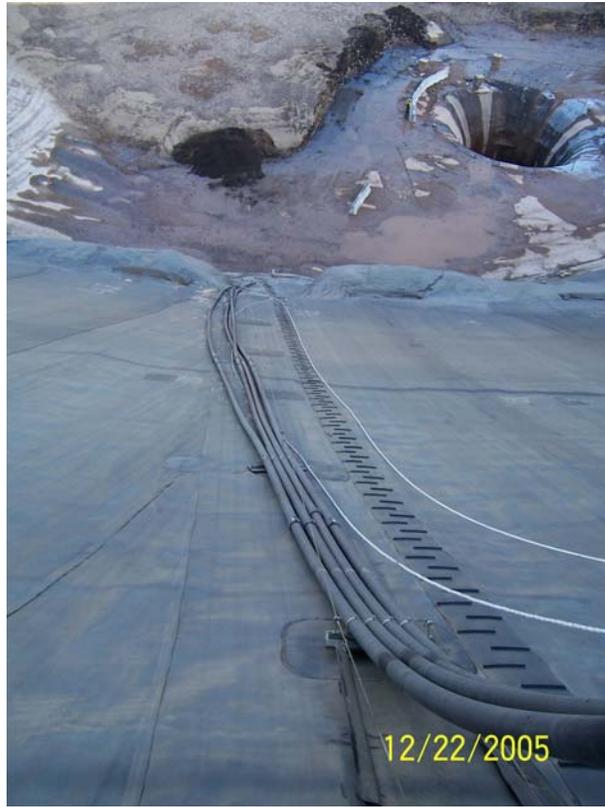
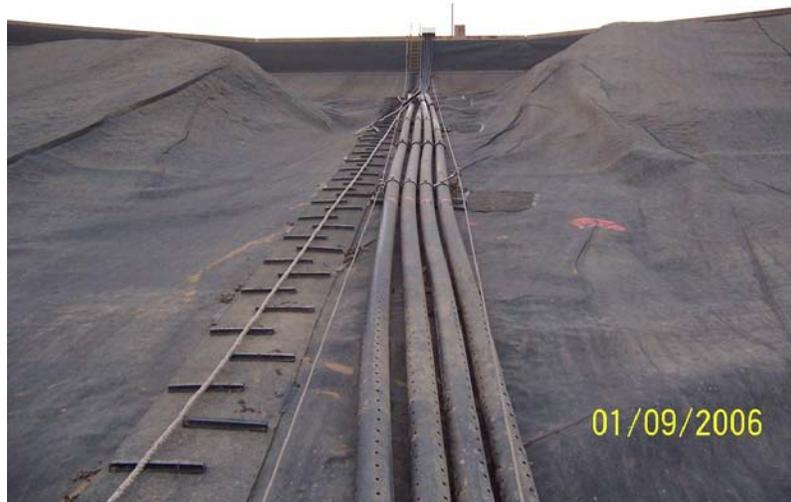
Figure 7-5

Note, straightening of protective pipes between dates of above photos.

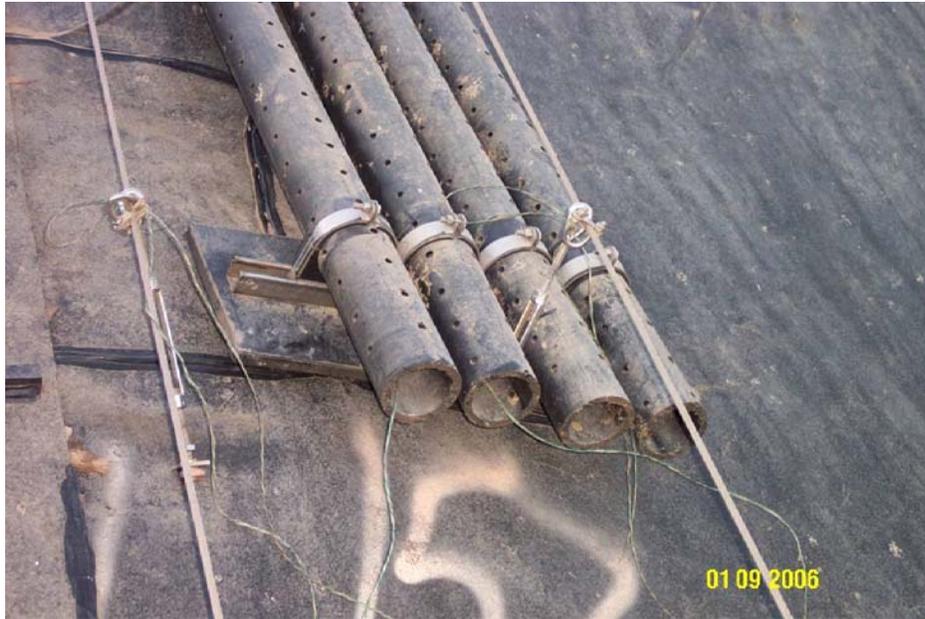
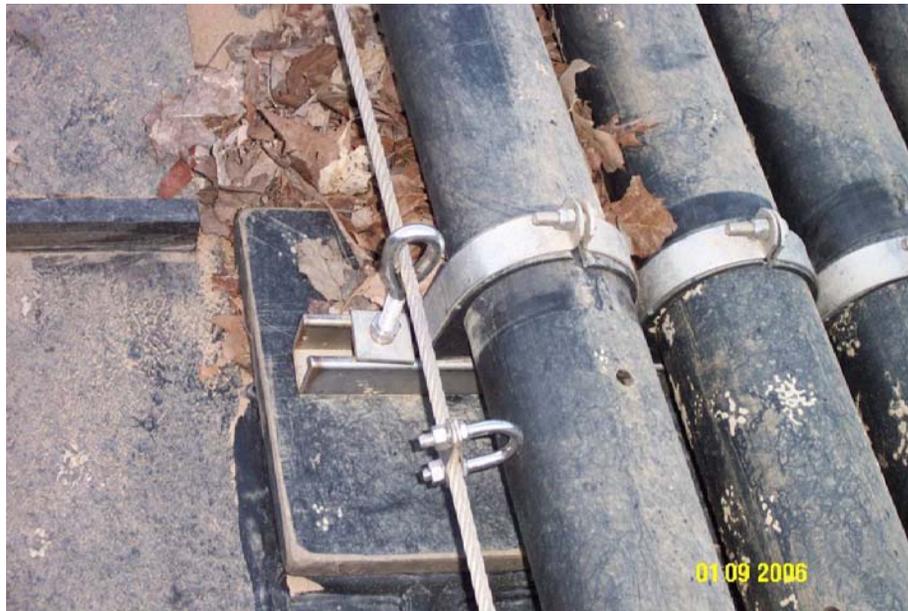
Figure 7-7

To avoid penetrations of the liner material and the creation of possible leakage paths, the protective pipes were supported on plastic plates that were connected by eye bolts to two stainless steel guide cables. The cables were secured only at the bottom and top of the reservoir. Figures 7-7 and 7-8 show these support systems as found after the breach event.

Protective pipe base plates are not anchored to reservoir.
Left guy cable has come loose from base plate in top photo.

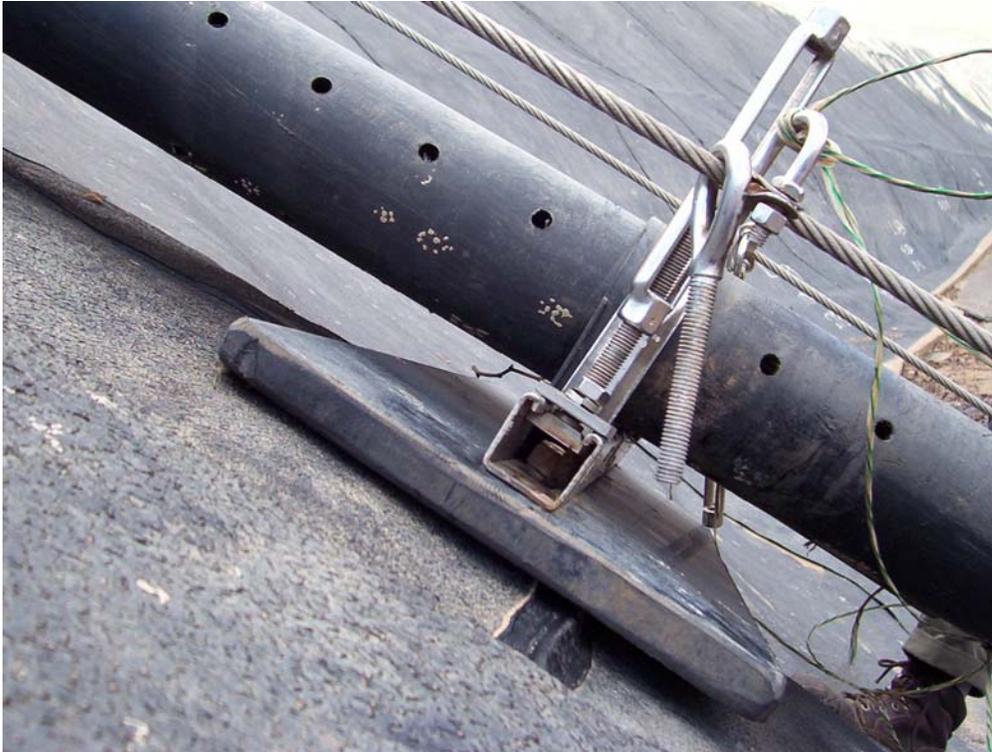
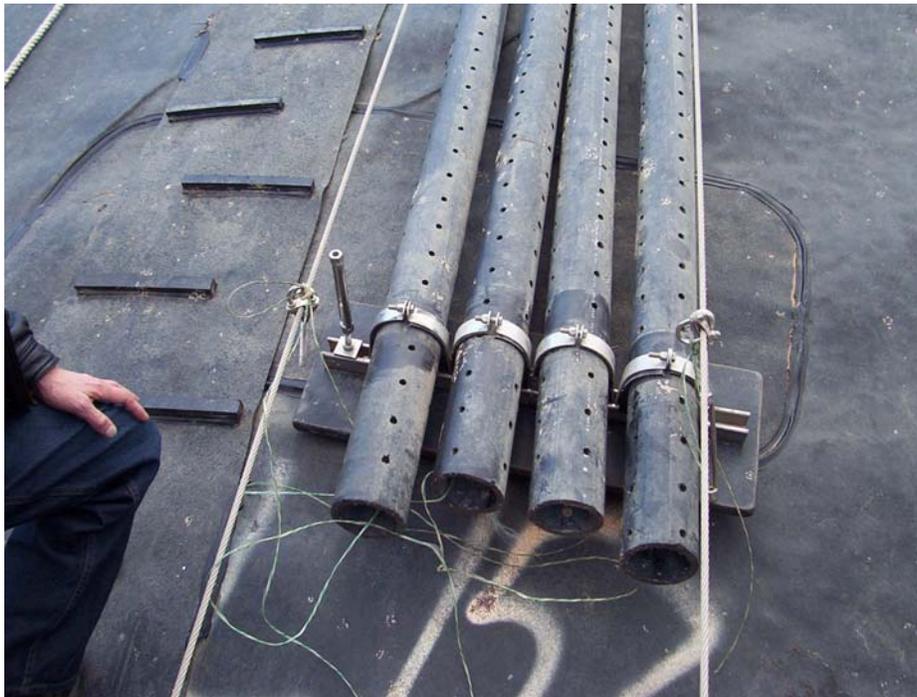
Figure 7-8

Protective pipe support system as found. Note eye bolt unthreaded from turnbuckle. Also note lock washer in place at connection to U channel but lack of lock washer at turnbuckle.

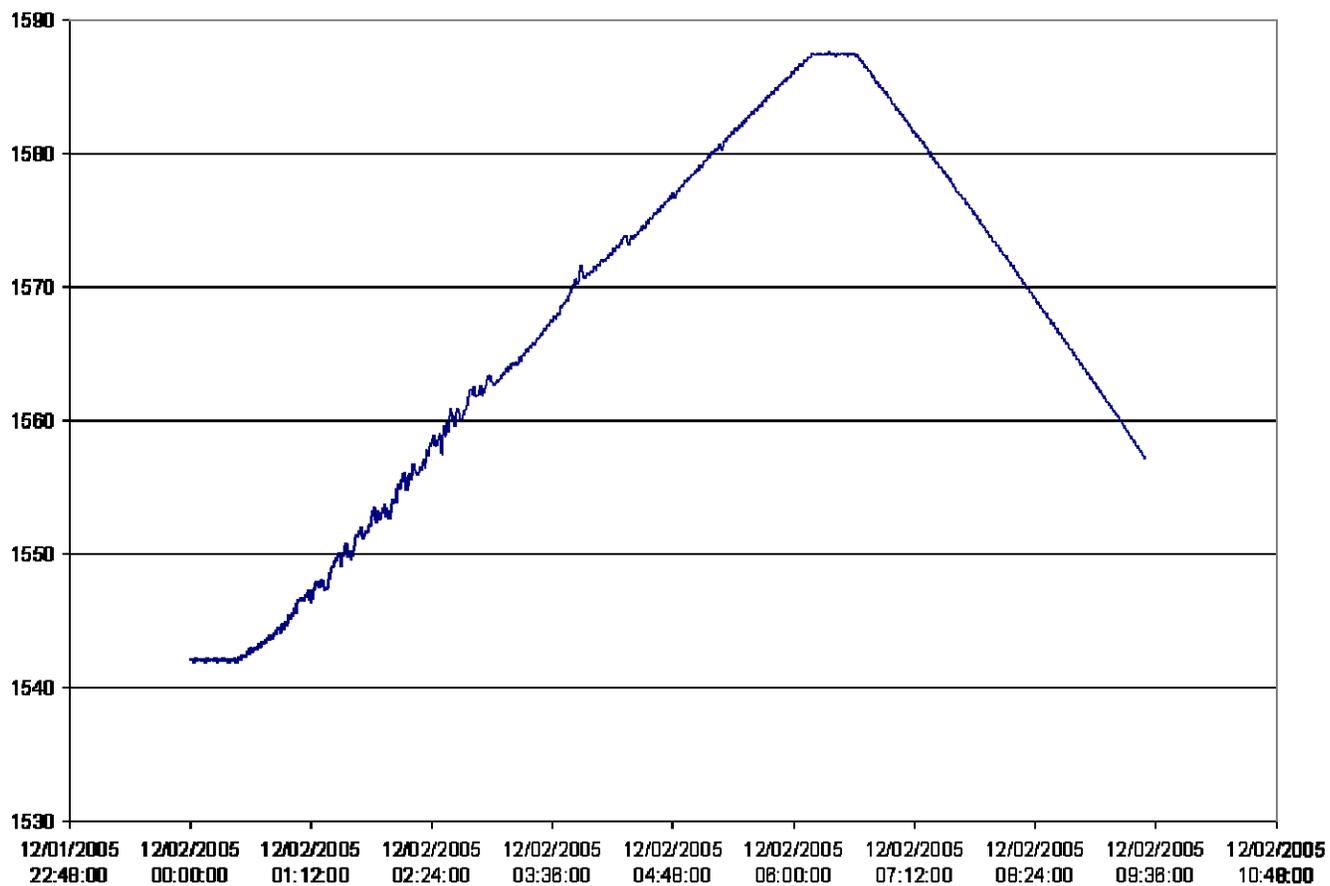
Figure 7-14 shows a continuation of water level readings from December 2, 2005. Once the level rose above about Elev. 1563, the large fluctuations decrease significantly and are very small when the water level was falling during generation later in the day. This pattern of water level fluctuations is found on most days after December 2, 2005. This evidence suggests that the pump discharge pattern created substantial forces acting on the protective pipes and/or the support cables when the water level is lower and that these forces diminish as the flow discharge pattern shifts upward at higher water levels. The evidence also suggests that the generation mode flow pattern into the intake is more stable and produces much less disturbance to the protective pipes. This is consistent with the much higher exit losses associated with discharge into an open reservoir compared to entrance losses for the same geometry.

Dec. 2nd. Note erratic behavior on rising and lower level compared to falling level.

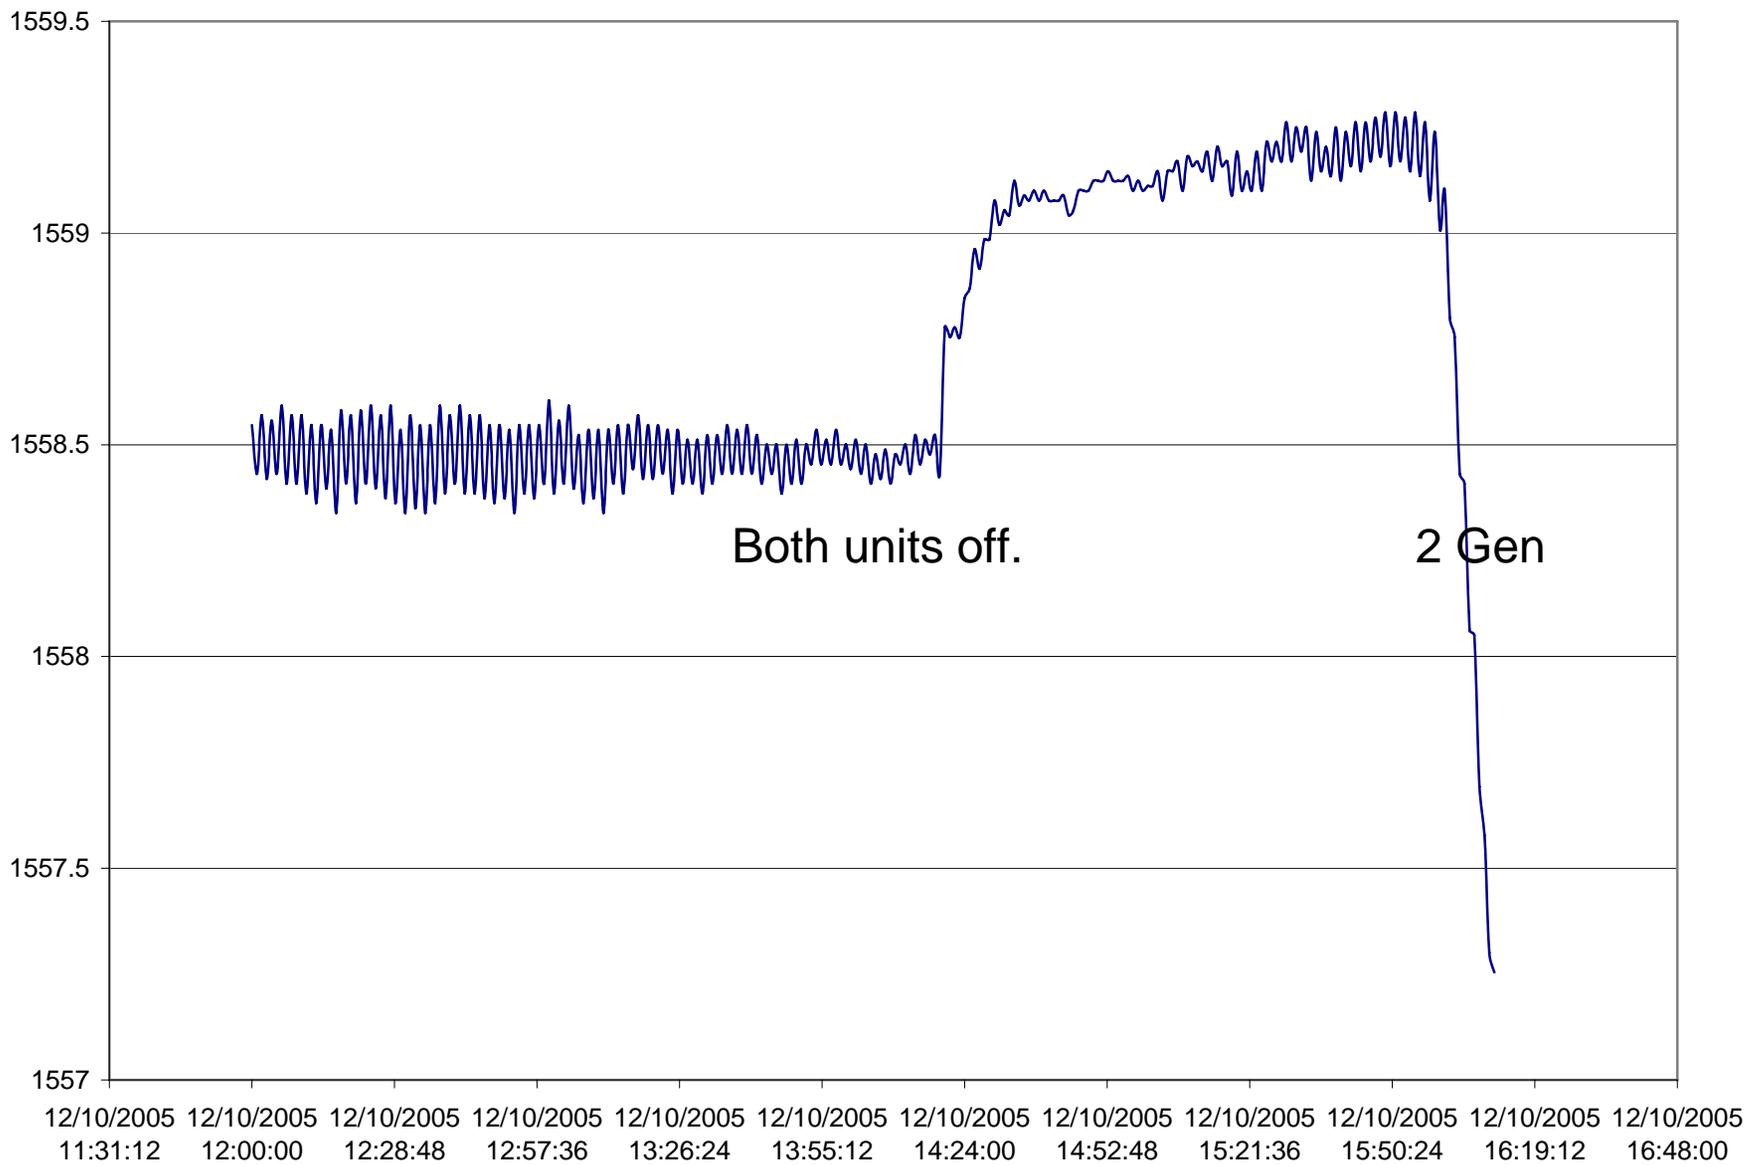
Figure 7-23 shows an interesting pattern of water level readings for December 10, 2005 with both units off followed by both units generating. We don't know if these level fluctuations are due to transducer movement or other causes. The left portion of the plot seems to be damping out until the disturbance around 14:24. The subsequent fluctuations appear to be building in amplitude until the two generators began operation.

Erratic level indications on Dec. 10th.

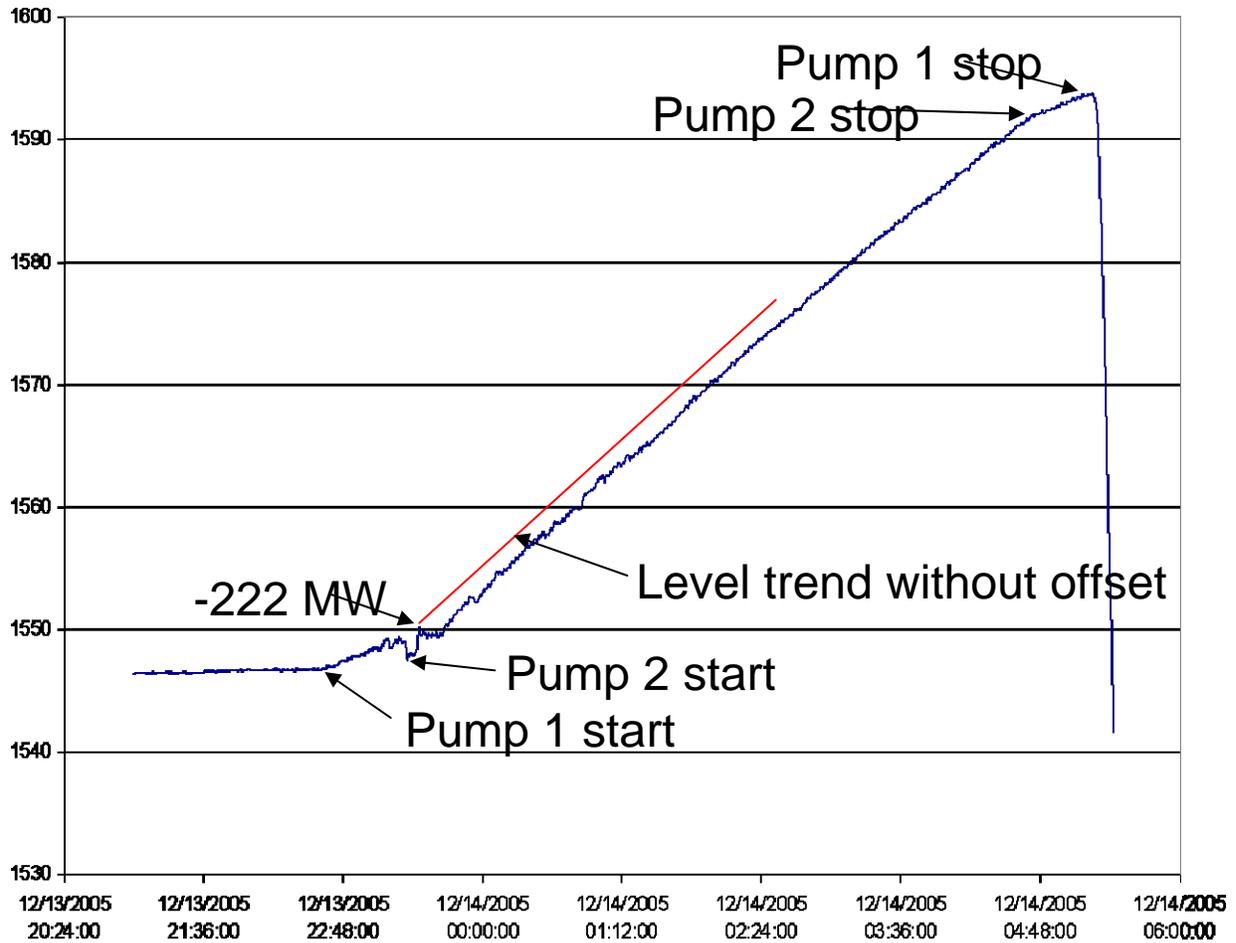
Figure 7-24 shows the water level readings from the start of both pumps on December 13, 2005 through the reservoir failure on December 14, 2005. The – 222 MW arrow shows the indicated water level when pump 2 completed its start sequence. The water level indication remained level for about 12 minutes rather than immediately beginning the more rapid rate of rise that it should have. At that level of Elev. 1550, two pumps were producing a level rise of about 10 feet per hour or about 2 feet in those 12 minutes. While there were smaller subsequent level indication fluctuations, they did not restore the level readings back to the trend line shown.

The most logical explanation is that during those twelve minutes the transducers were moving up at about the same rate as the water level, hence showing no level change during the interval. The line labeled “Level trend without offset” shows where the water level indications should have been without the offset. It should be noted that the level indication at the beginning of the plot is not necessarily accurate given the many indications of prior transducer movement and erratic readings. It is also possible that generating mode flows past the transducers may have tended to bring the protective pipes back to near their original positions resulting in some periodic level error corrections.

**Level indications after pump 2 start shows an offset.
 -222 MW = Completion of pump 2 start sequence.**

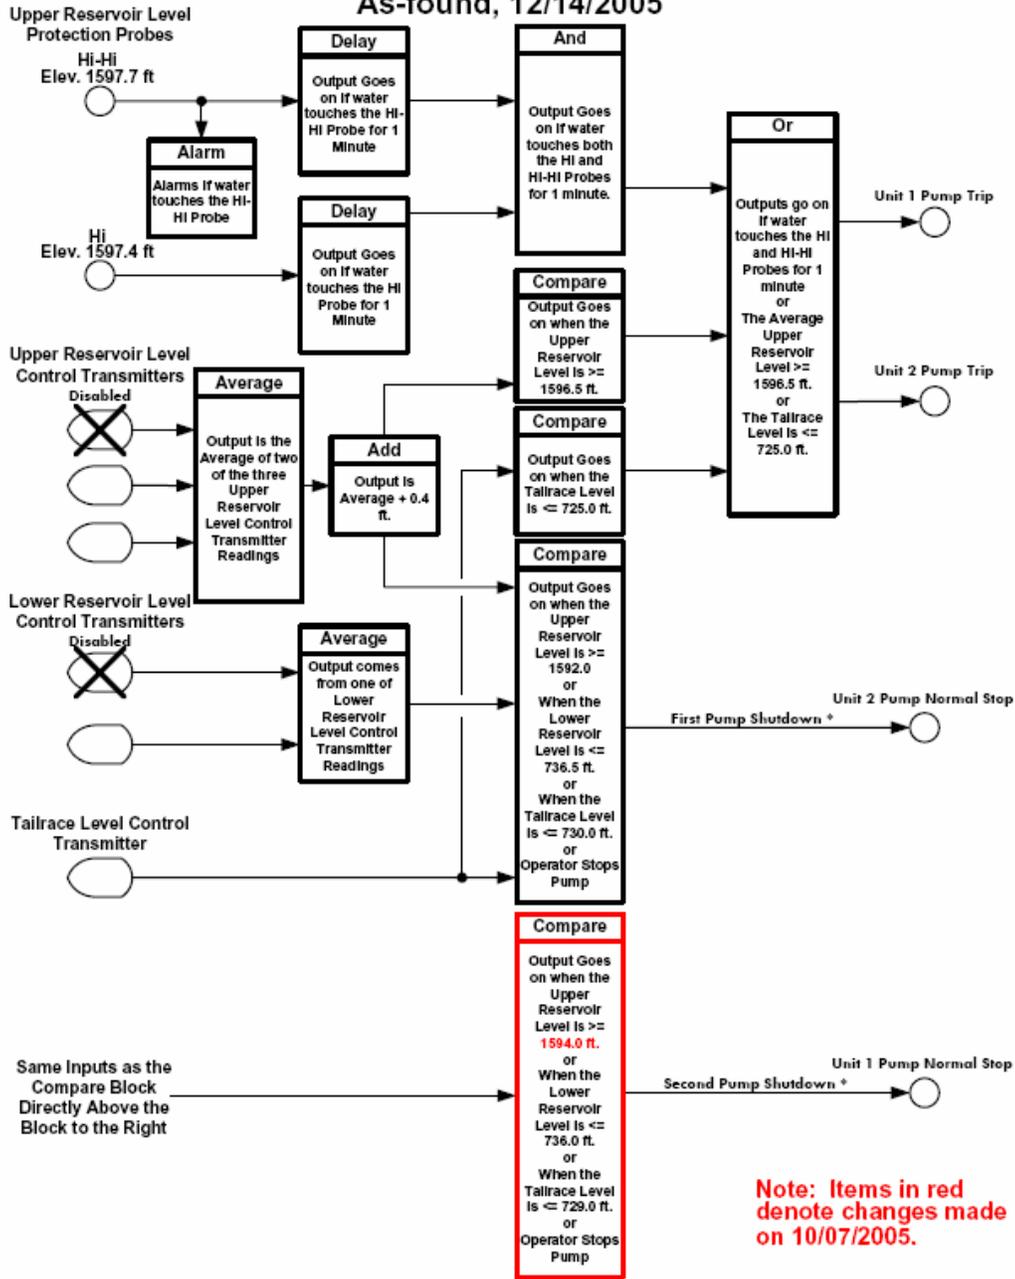
Figure 7-31

Note: Due to programming error made on Sept. 16, 2005, Unit 2 pump shutdown due to level protection probe response was disabled.
