Ethical Issues from the Kansas City Hyatt Hotel Collapse

Course No: LE2-001

J. Paul Guyer, P.E., R.A., Fellow ASCE, Fellow AEI

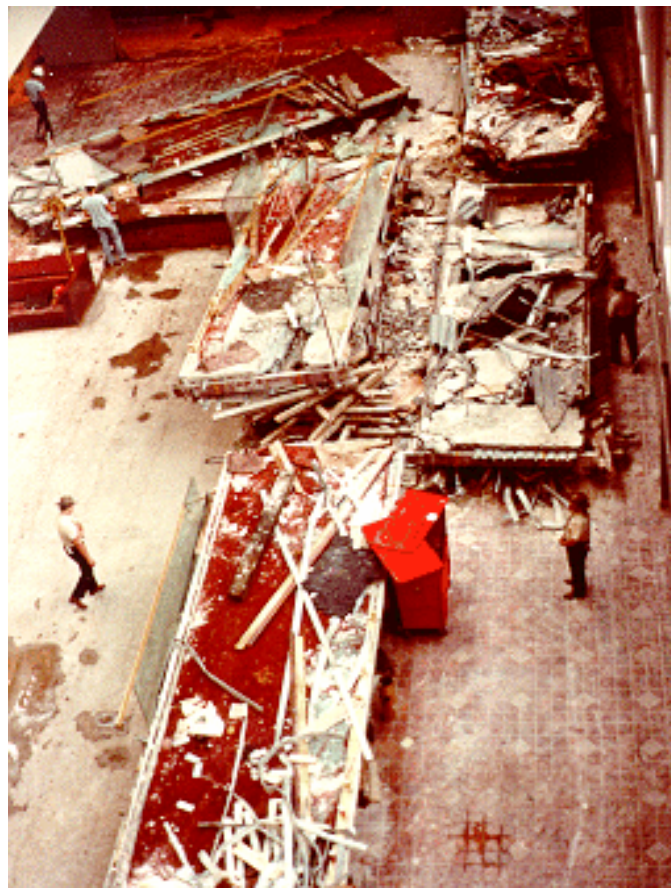
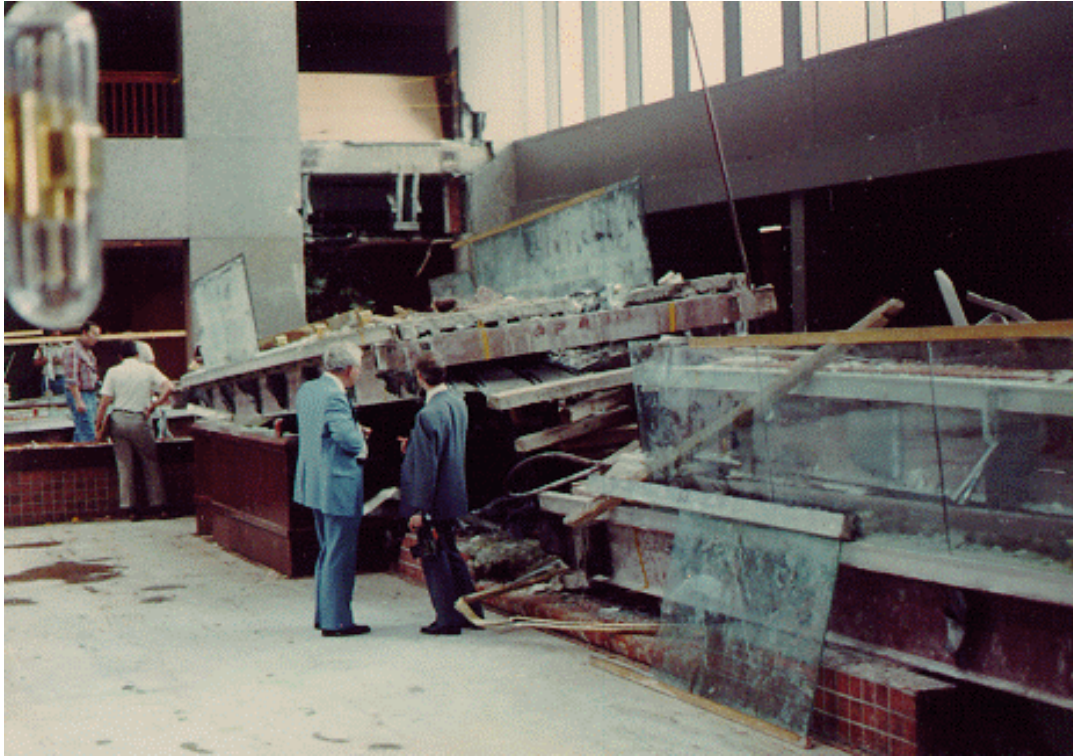
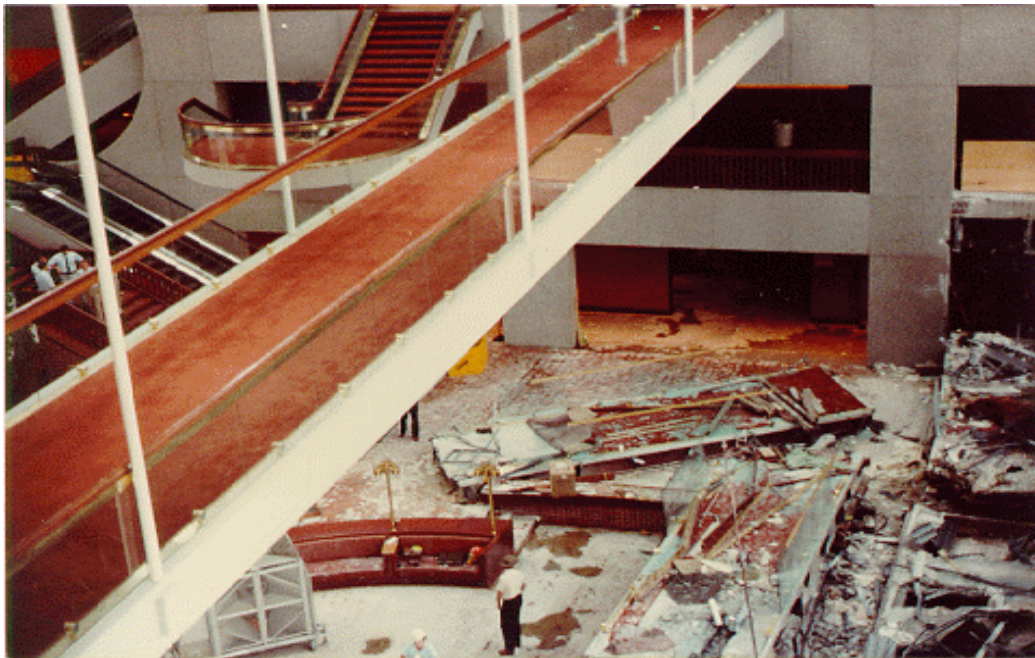
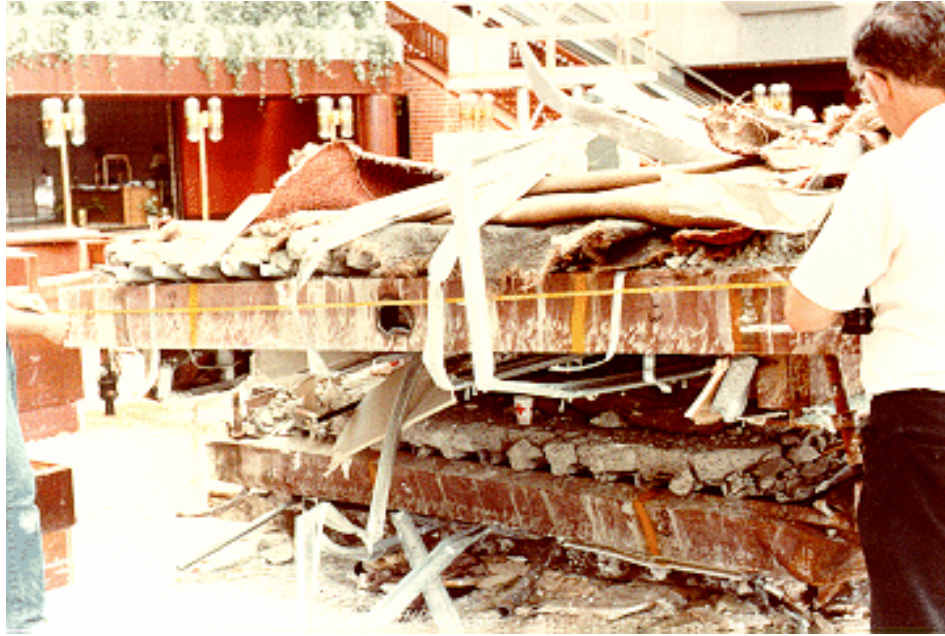
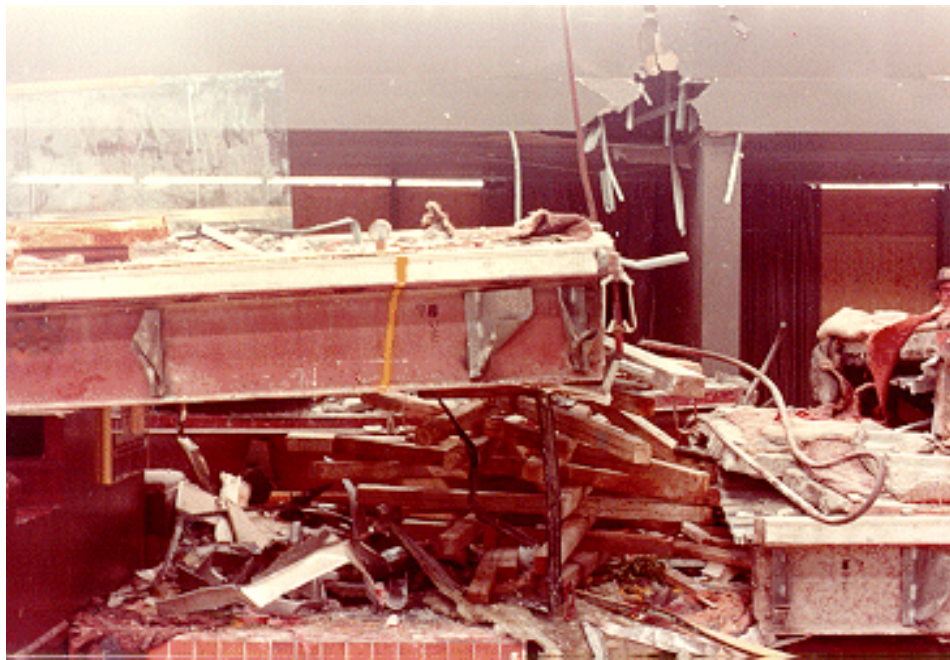
The fourth floor walkway failed, collapsed onto the second floor walkway, both crashed to the lobby floor, and 114 people were killed and 200 injured.

Here is what the incident scene looked like....

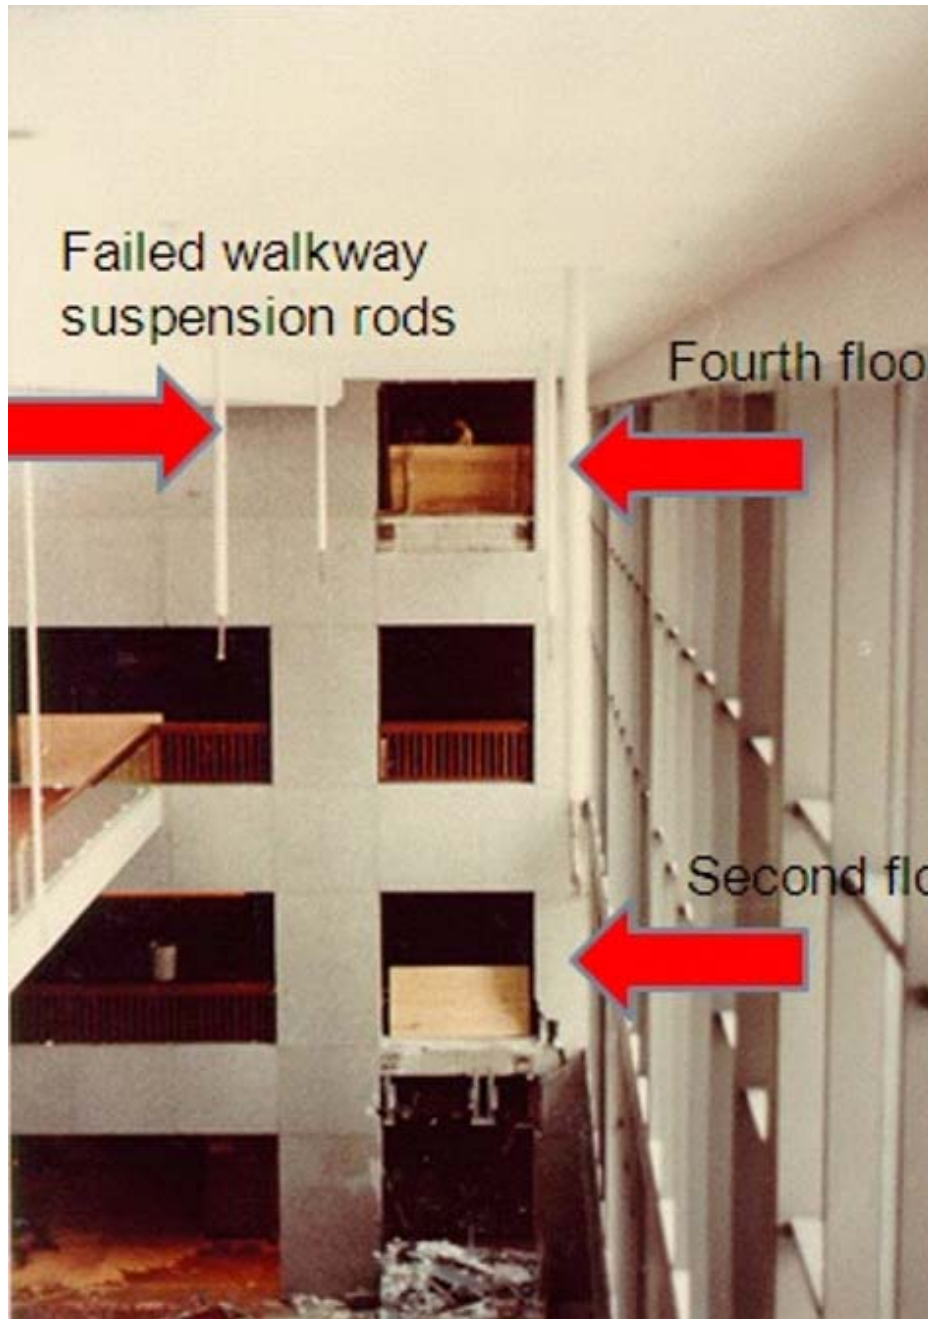
Figure 9
Collapsed Walkways at 2nd and 4th Floors

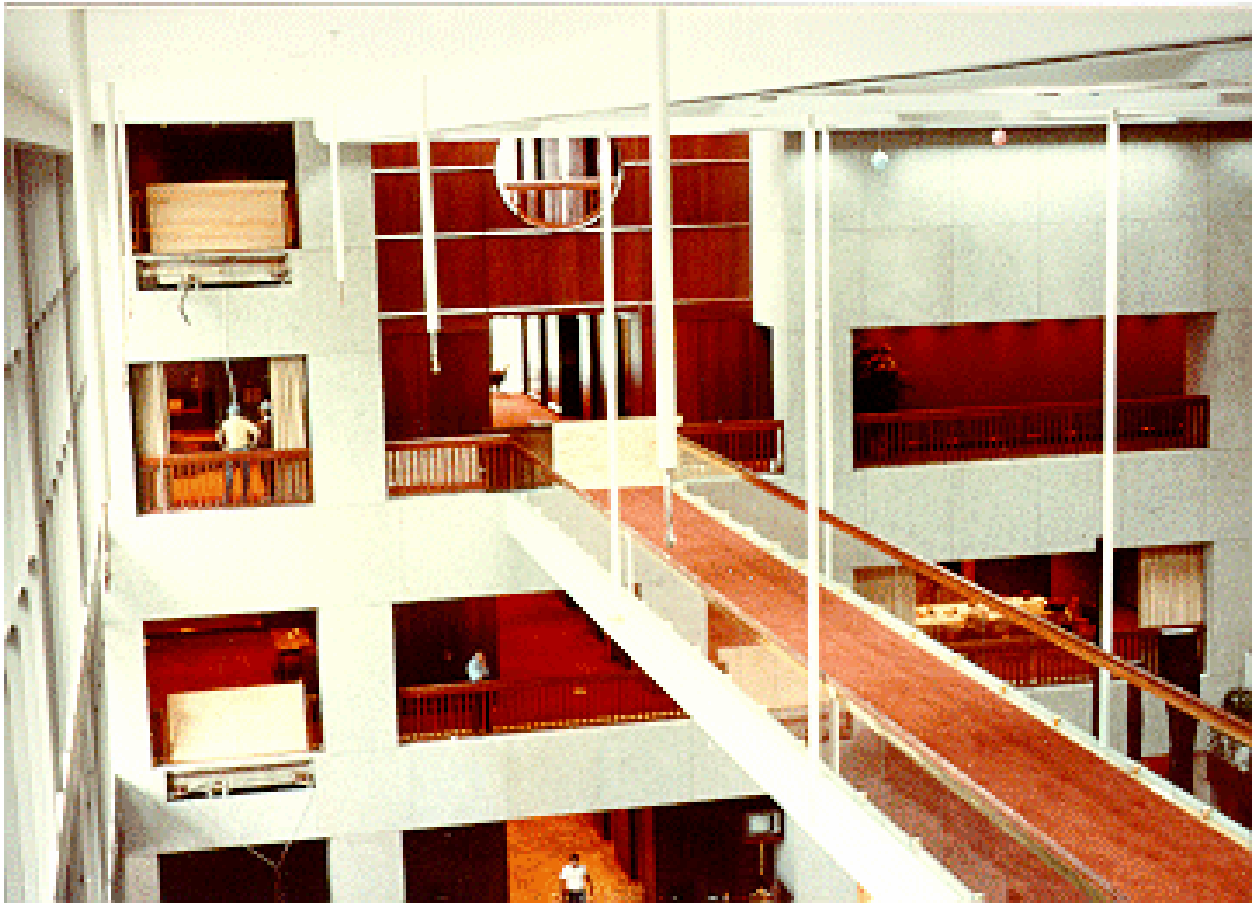
The structural failure occurred at two of the three suspended walkways that traversed from one side to the other of the atrium lobby. Walkways that failed were directly in line with each other and crossed from one side to the other at the second and fourth floors. The third walkway, at the third floor, was offset from the other two and was not involved in the failure.

Figure 10
Surviving 3rd Floor Walkway

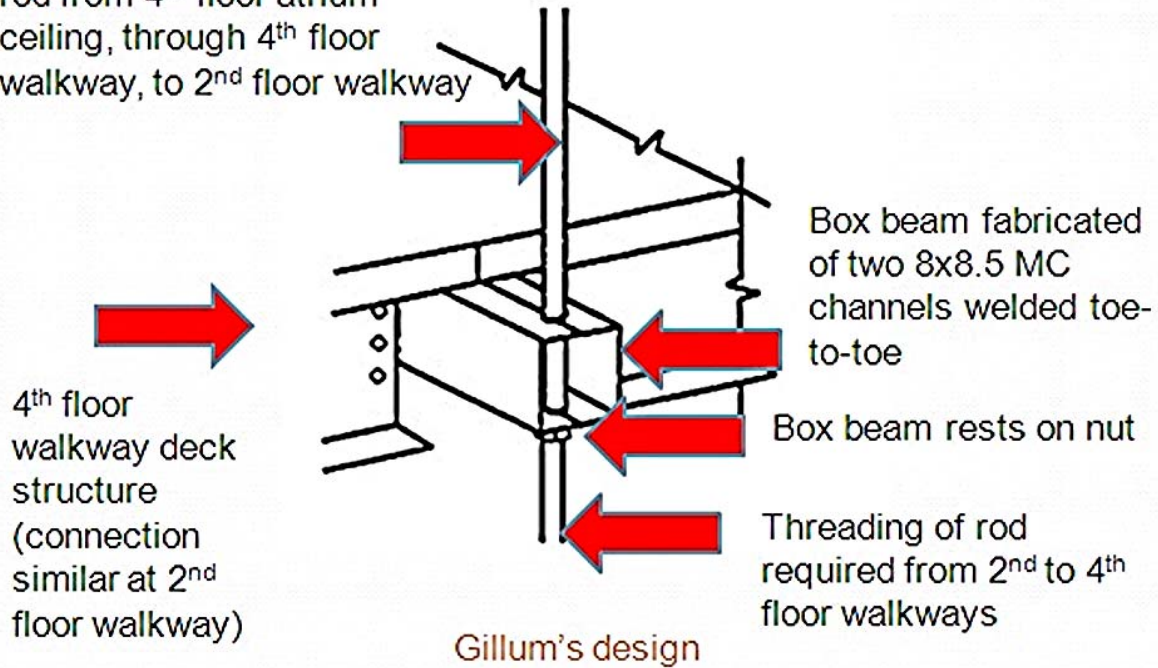
First, the Gillum design required continuous suspension rods approximately 40-feet long. Havens determined these would be unacceptably expensive to procure and install.

Second, the suspension rods would have to be threaded for approximately 30-feet of their length in order to install the nut on the rod that supported the fourth floor walkway. This was determined by Havens to be unacceptably expensive to fabricate and install.

1-1/4" continuous suspension rod from 4th floor atrium ceiling, through 4th floor walkway, to 2nd floor walkway

Figure 13
The Structural Engineer's Original Design

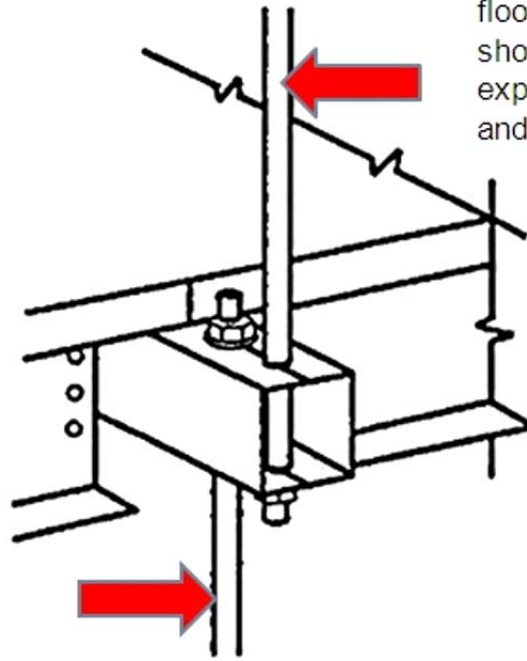
The cause of the failure was a change made by the steel detailer (WRW, a sub-contractor to Havens, which in turn was a sub-contractor to Eldridge) to the suspension rods design shown on the structural engineer Gillum's drawings.

One rod from 4th floor atrium ceiling to 4th floor walkway; shorter rods, less expensive to procure and install.

Second rod from 4th floor walkway ceiling to 2nd floor walkway; shorter rods, less expensive to procure and install, and lengthy threading of rod eliminated.

Havens/WRW changed design

Figure 14
The change made by the Steel Fabricator-Erector/Detailer

- **the design change which led to the failure at the box beam-nut-suspension rod connection**

6.1.1 Havens/WRW had properly designed the changed detail

6.1.2 The improperly changed detail had been noted and corrected by Gillum

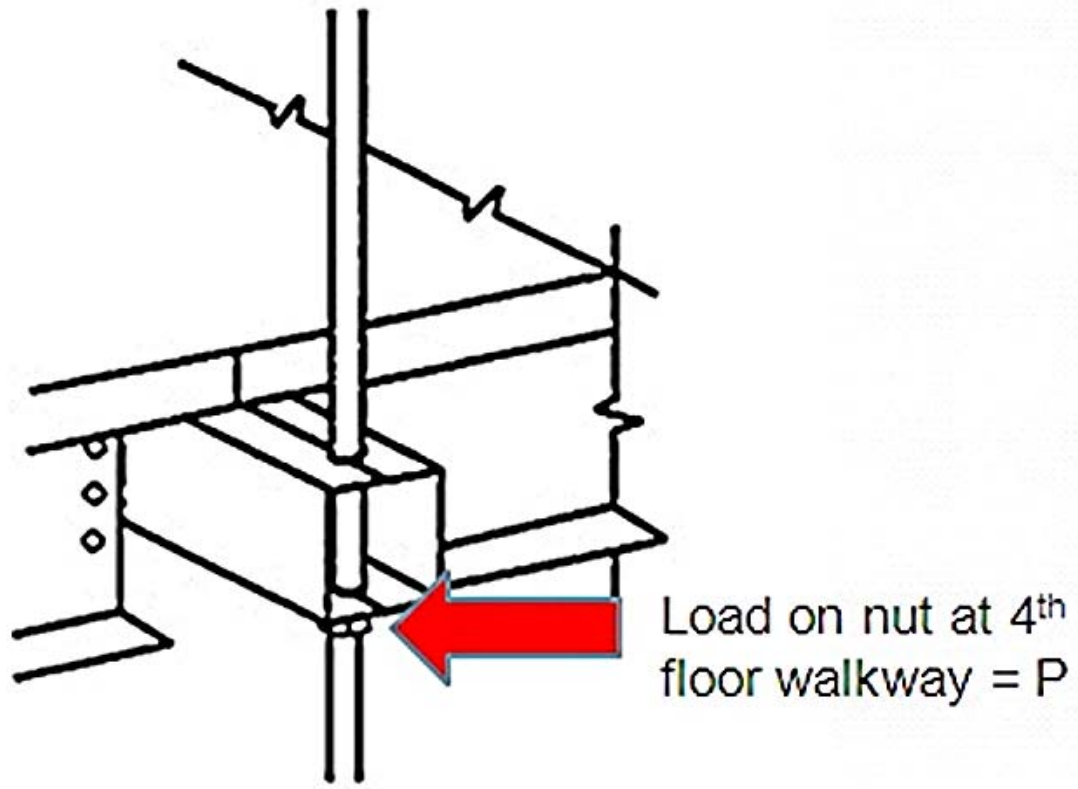
Gillum's design

Figure 15
The Structural Engineer's Original Design

THE NBS specifically concluded that “Under the original hanger rod arrangement (continuous rod) the box beam-hanger rod connections as shown on the contract drawings *would have had the capacity to resist the loads estimated to have been acting at the time of collapse.*”

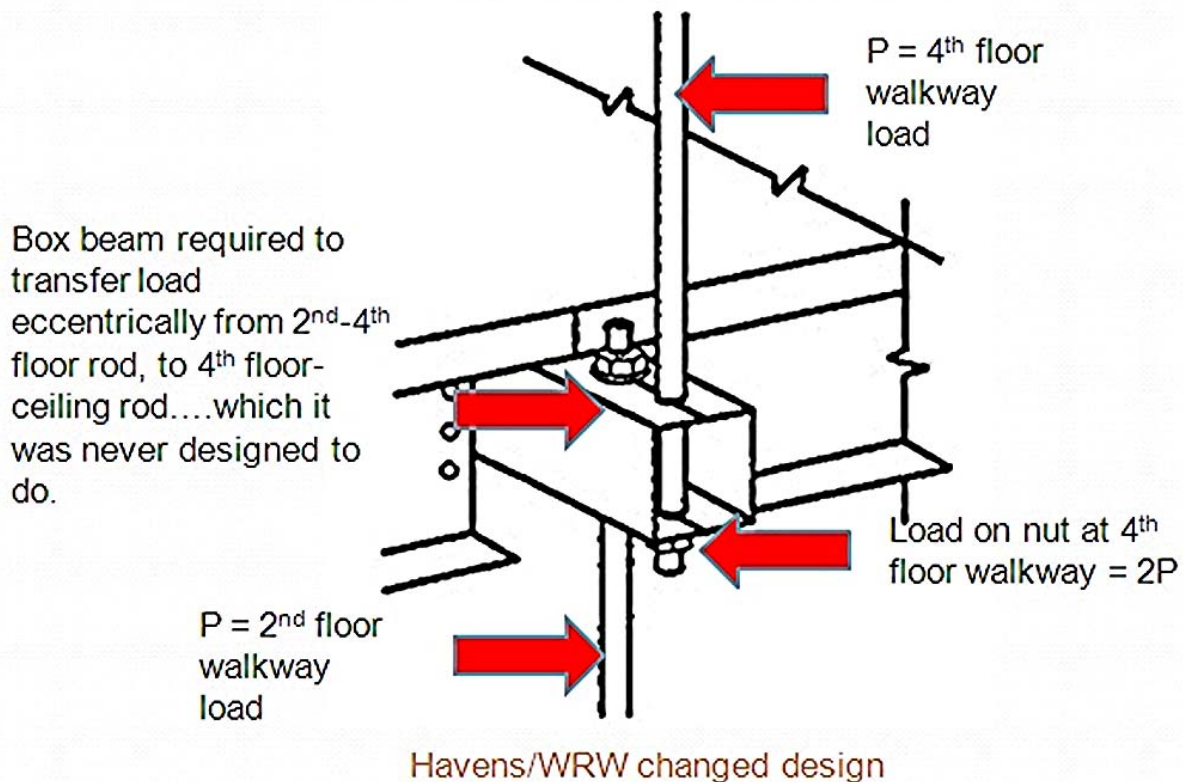
Figure 16
The change made by the Steel Fabricator-Erector/Detailer

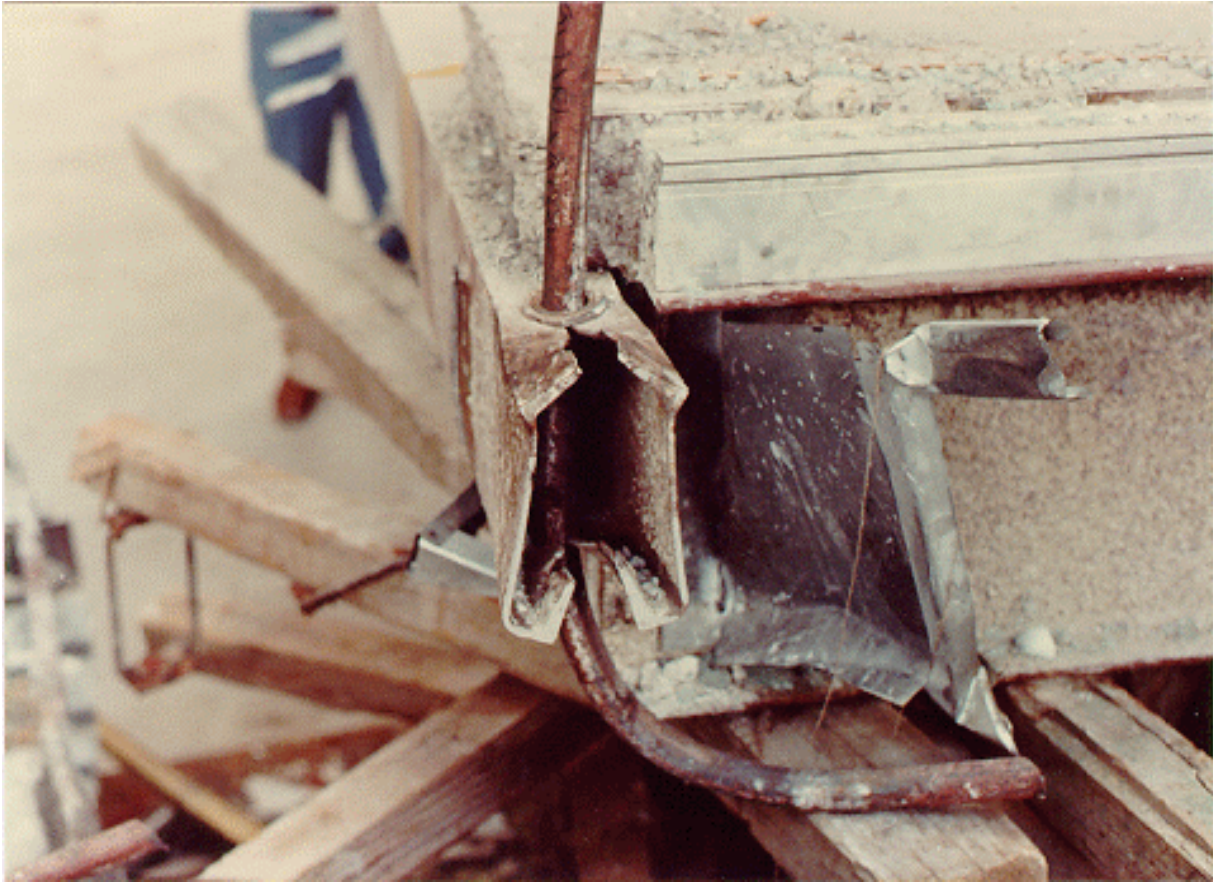
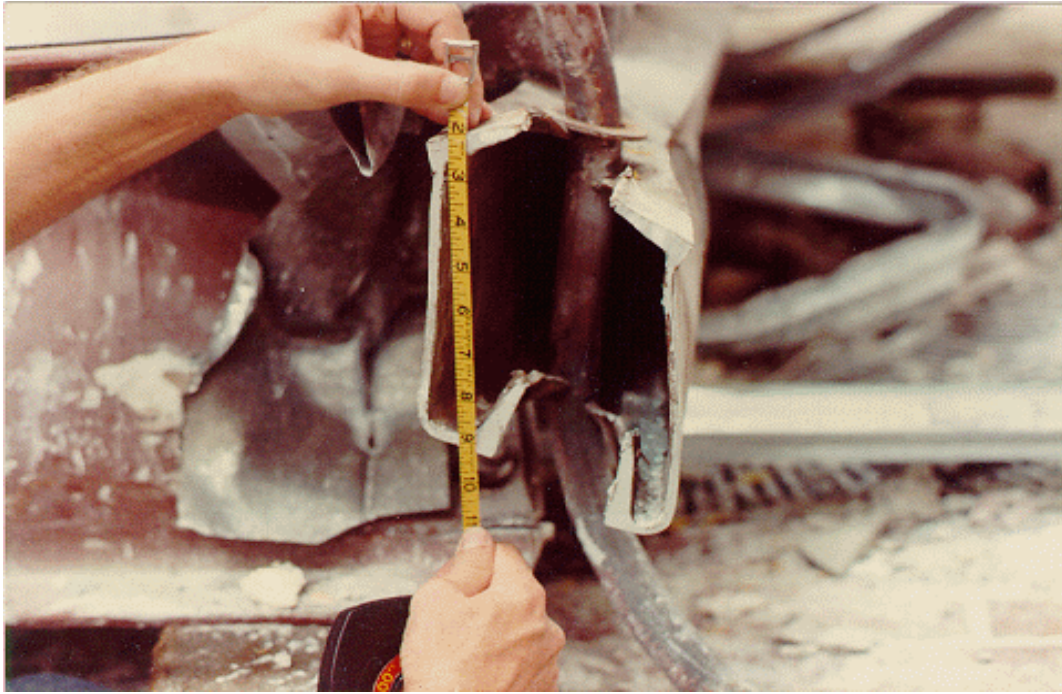
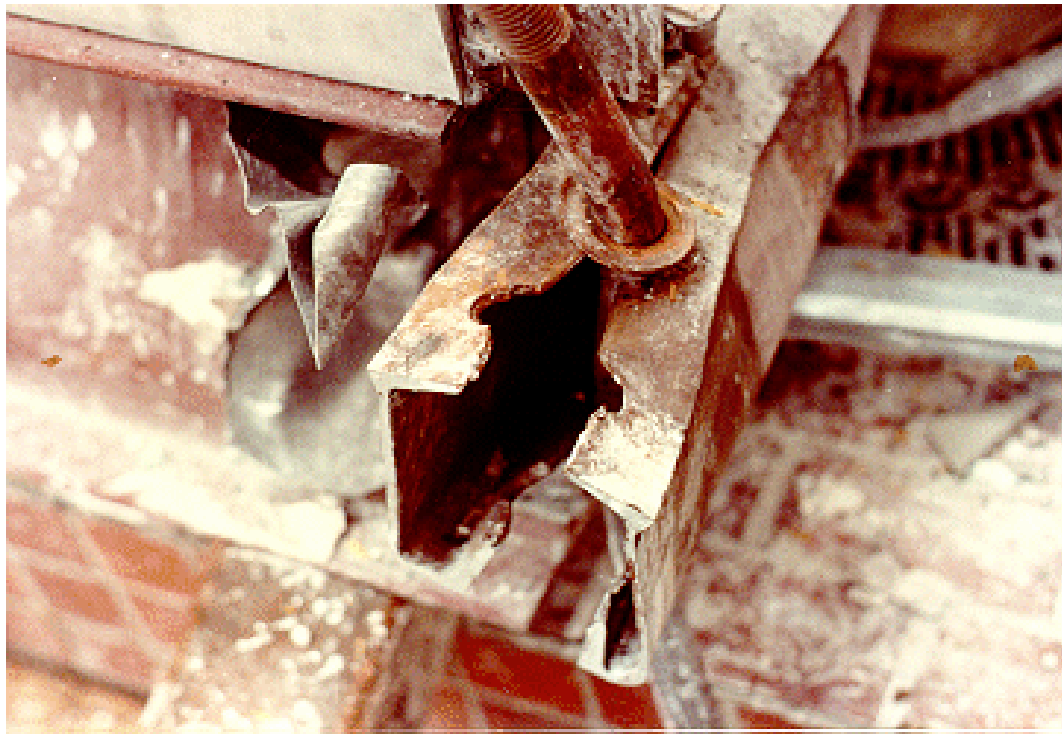
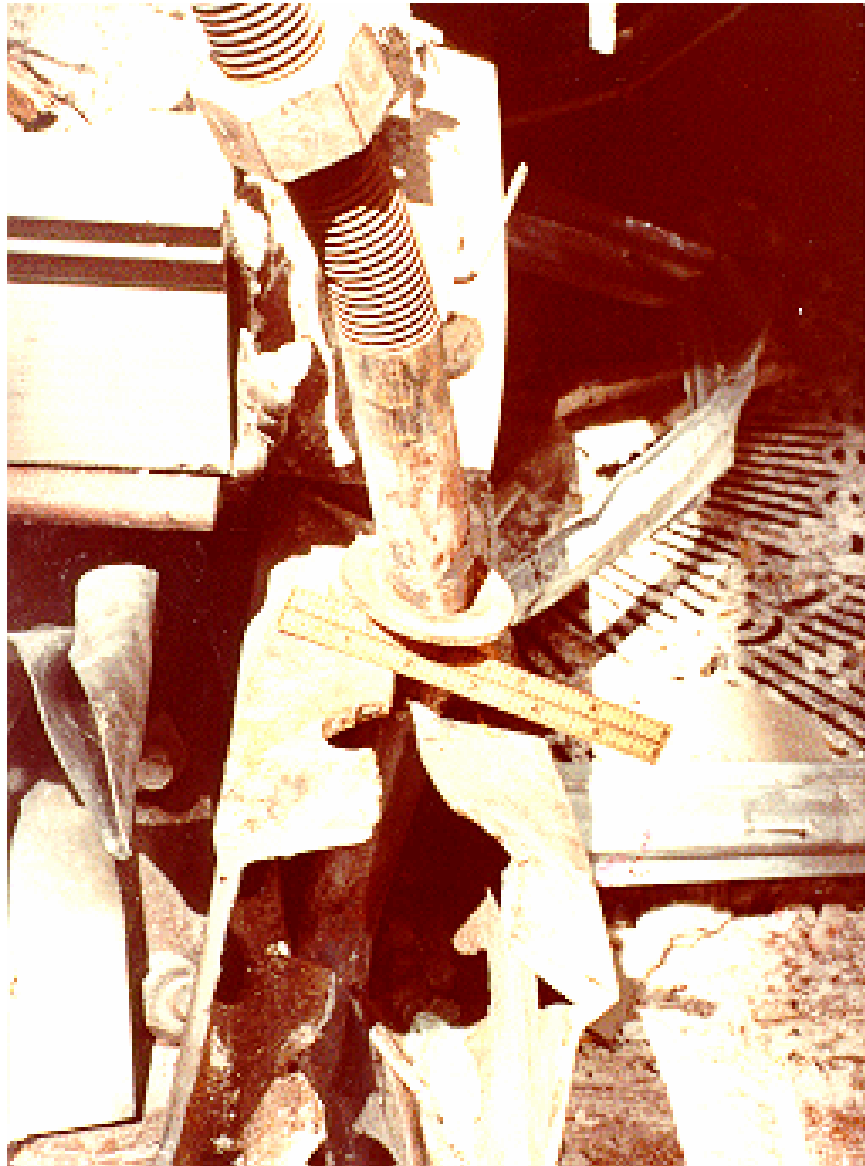
4.4.1 SUSPENSION RODS UNDERSIZED. Gillum's original design sized the suspension rods such that they were strong enough to support only 60% of the imposed load....based on code-allowable stresses. But given the difference between code-allowable and yield stresses of the materials....was this a fatal error? The investigations clearly indicated the failure occurred at the nuts and box beams, not at the rods.

4.5 AND HERE IS WHAT HAPPENED....
