# **Ethical Issues from the Kansas City Hyatt Hotel Collapse**

Course No: LE2-001

J. Paul Guyer, P.E., R.A., Fellow ASCE, Fellow AEI

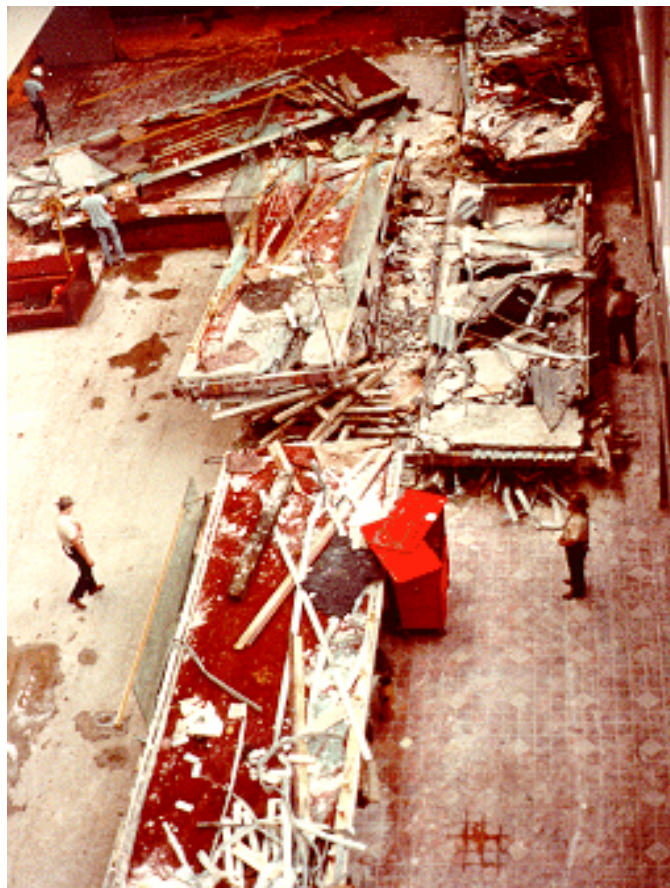
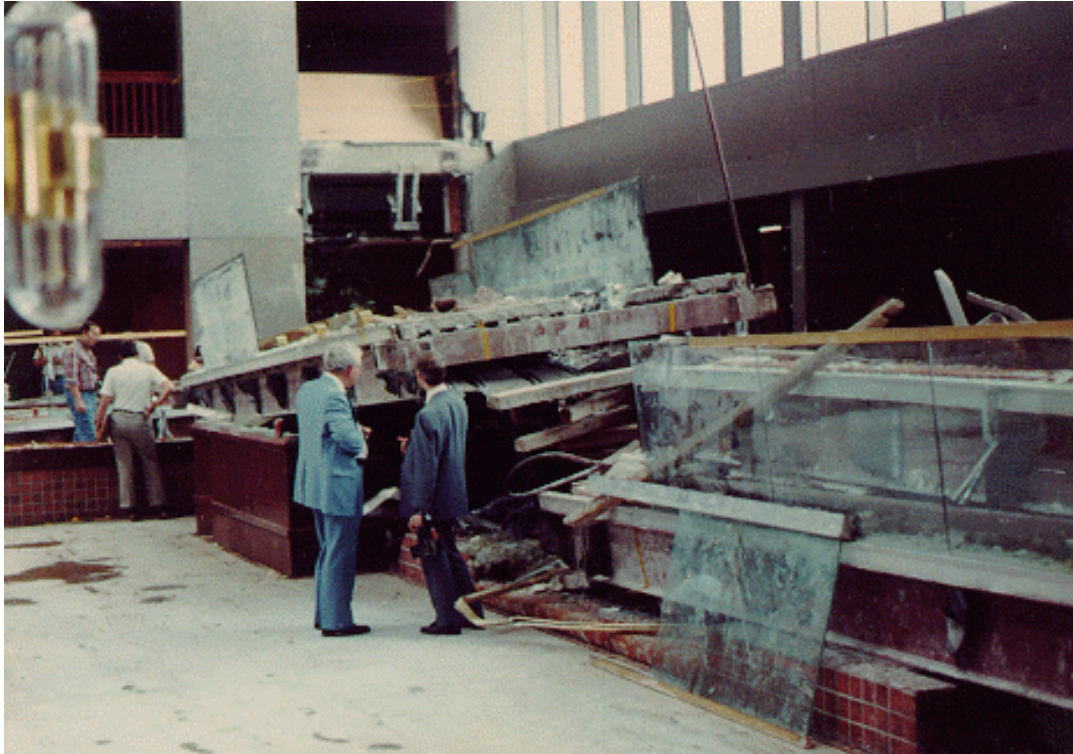
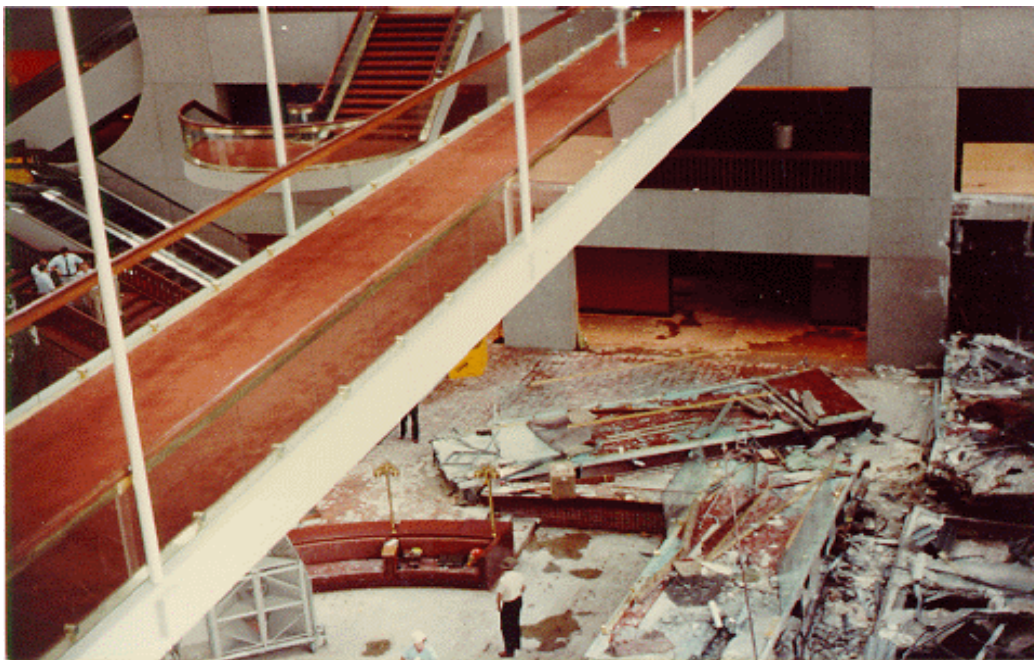
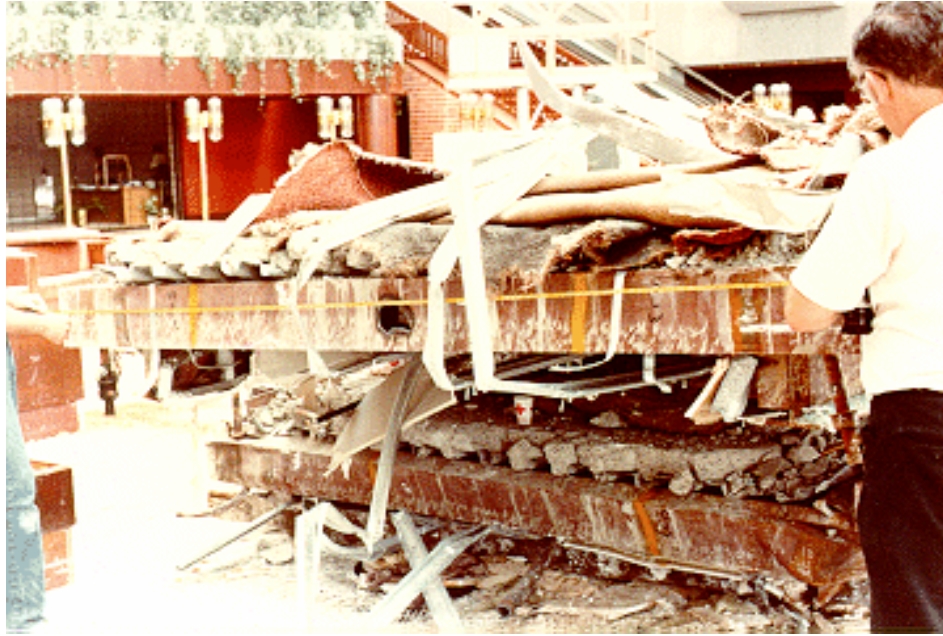
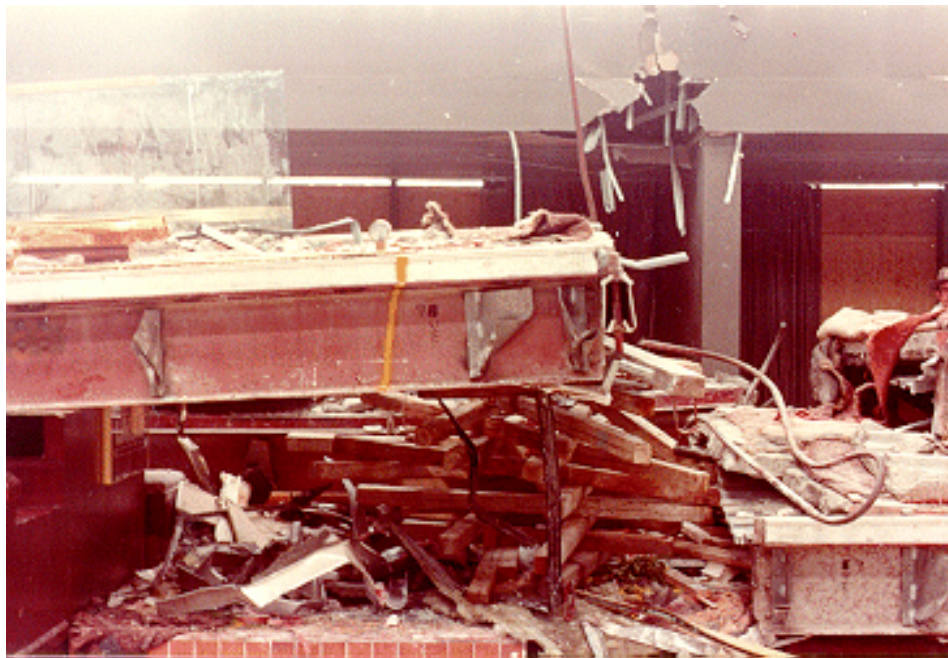
Here is what the incident scene looked like....

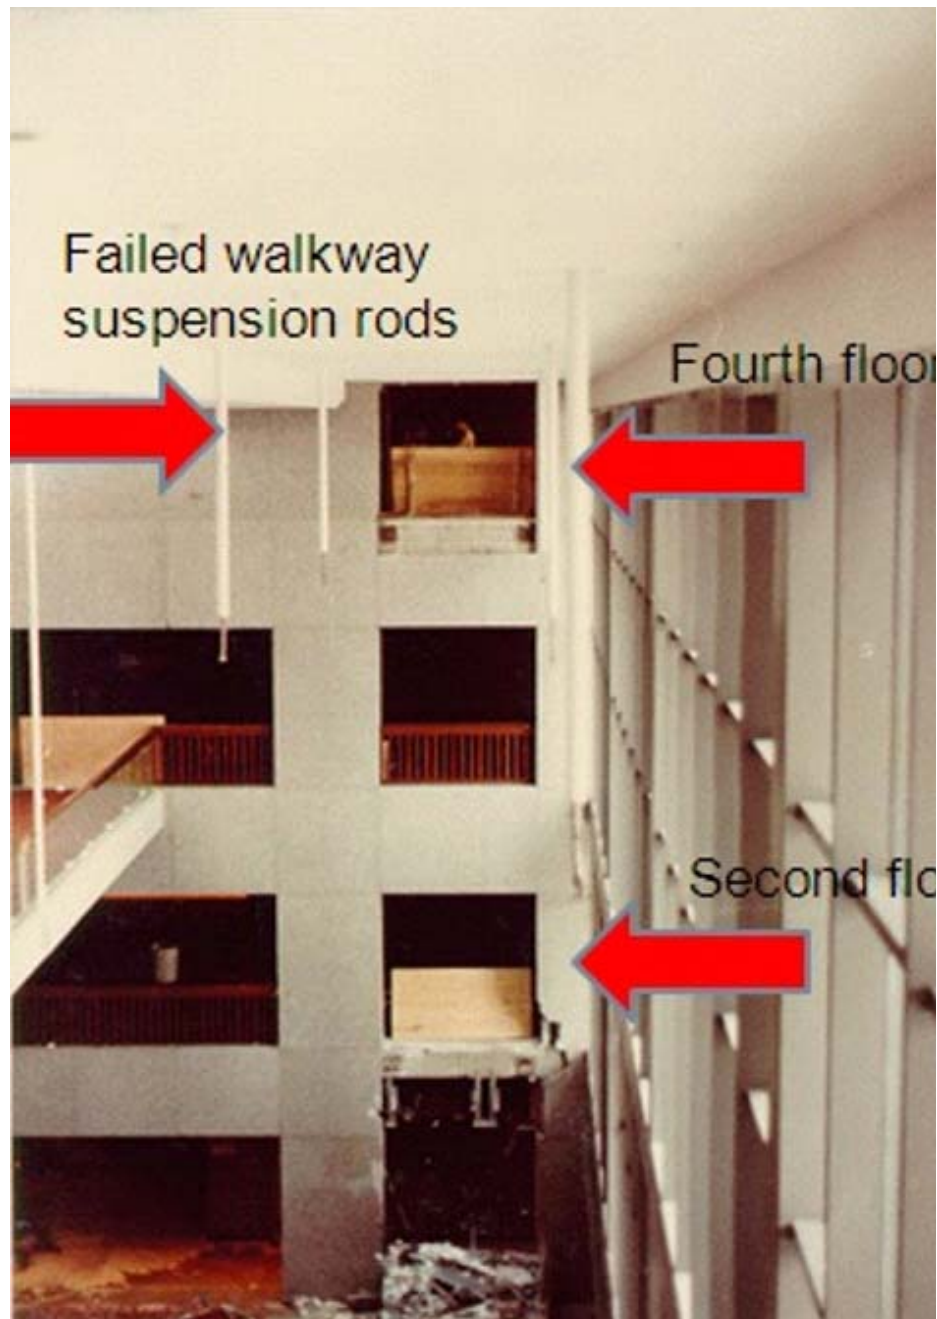
The fourth floor walkway failed, collapsed onto the second floor walkway, both crashed to the lobby floor, and 114 people were killed and 200 injured.

Figure 9  
Collapsed Walkways at 2<sup>nd</sup> and 4<sup>th</sup> Floors

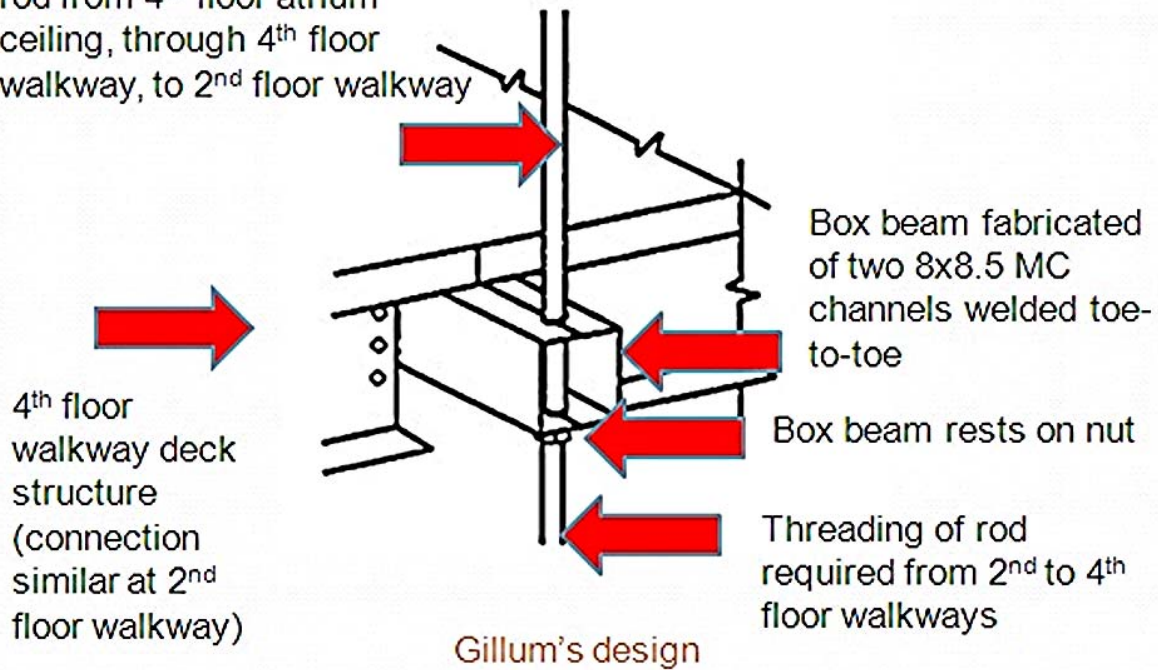
**First**, the Gillum design required continuous suspension rods approximately 40-feet long. Havens determined these would be unacceptably expensive to procure and install.

**Second**, the suspension rods would have to be threaded for approximately 30-feet of their length in order to install the nut on the rod that supported the fourth floor walkway. This was determined by Havens to be unacceptably expensive to fabricate and install.

1-1/4" continuous suspension  
rod from 4<sup>th</sup> floor atrium  
ceiling, through 4<sup>th</sup> floor  
walkway, to 2<sup>nd</sup> floor walkway

Figure 13  
The Structural Engineer's Original Design

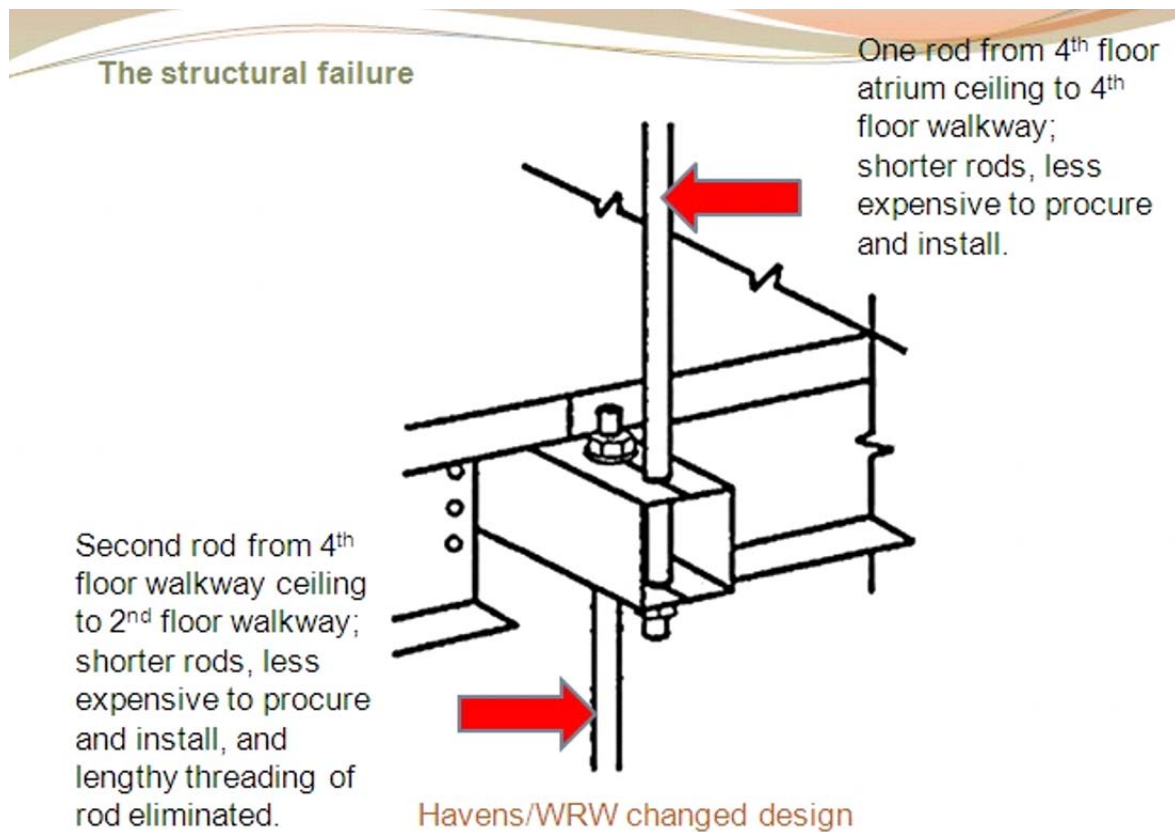
The cause of the failure was a change made by the steel detailer (WRW, a sub-contractor to Havens, which in turn was a sub-contractor to Eldridge) to the suspension rods design shown on the structural engineer Gillum's drawings.

**4.3 THE CHANGE.** This is the change WRW/Havens made to Gillum's design....

Figure 14  
The change made by the Steel Fabricator-Erector/Detailer

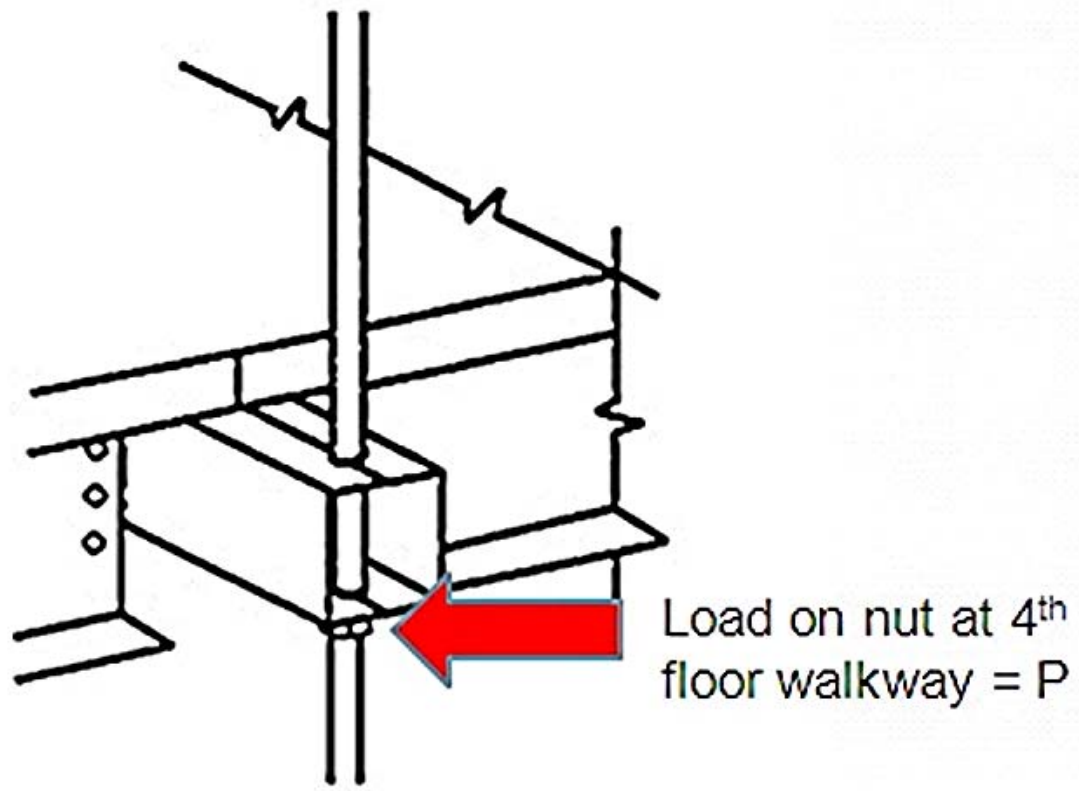
Gillum's design

Figure 15  
The Structural Engineer's Original Design

THE NBS specifically concluded that “Under the original hanger rod arrangement (continuous rod) the box beam-hanger rod connections as shown on the contract drawings *would have had the capacity to resist the loads estimated to have been acting at the time of collapse.*”

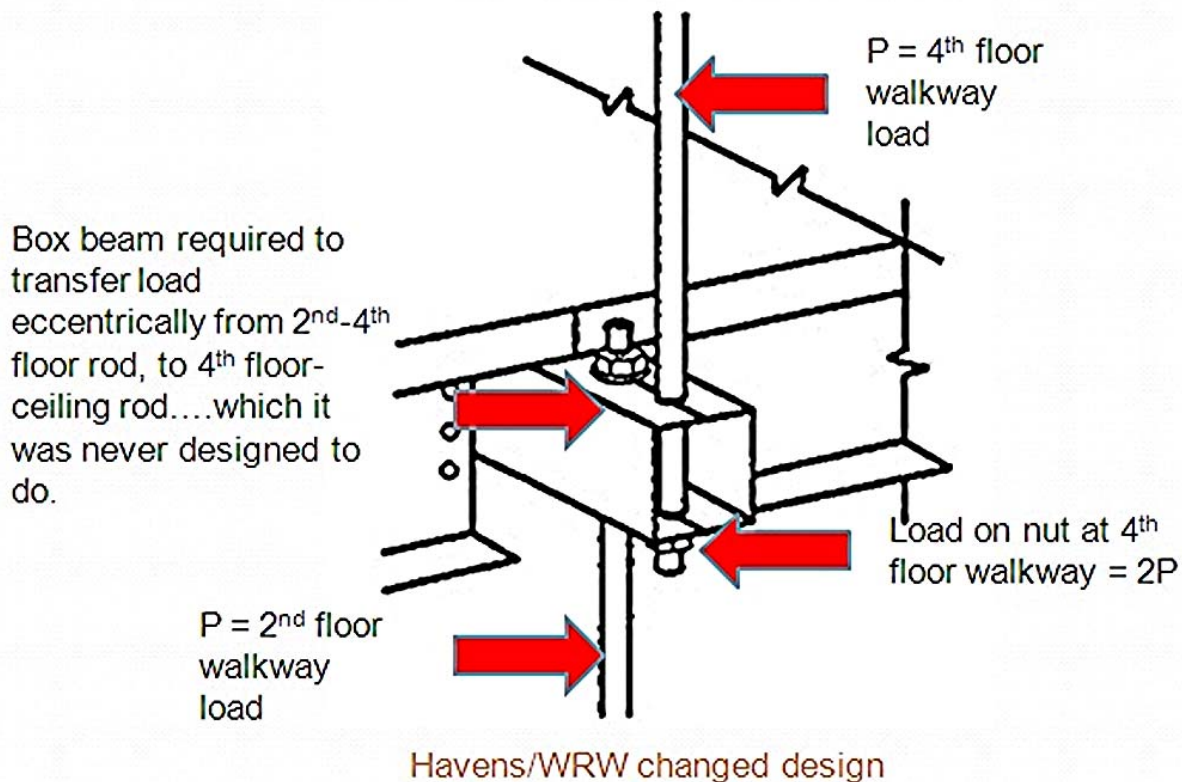
Figure 16  
The change made by the Steel Fabricator-Erector/Detailer

- **the design change which led to the failure at the box beam-nut-suspension rod connection**

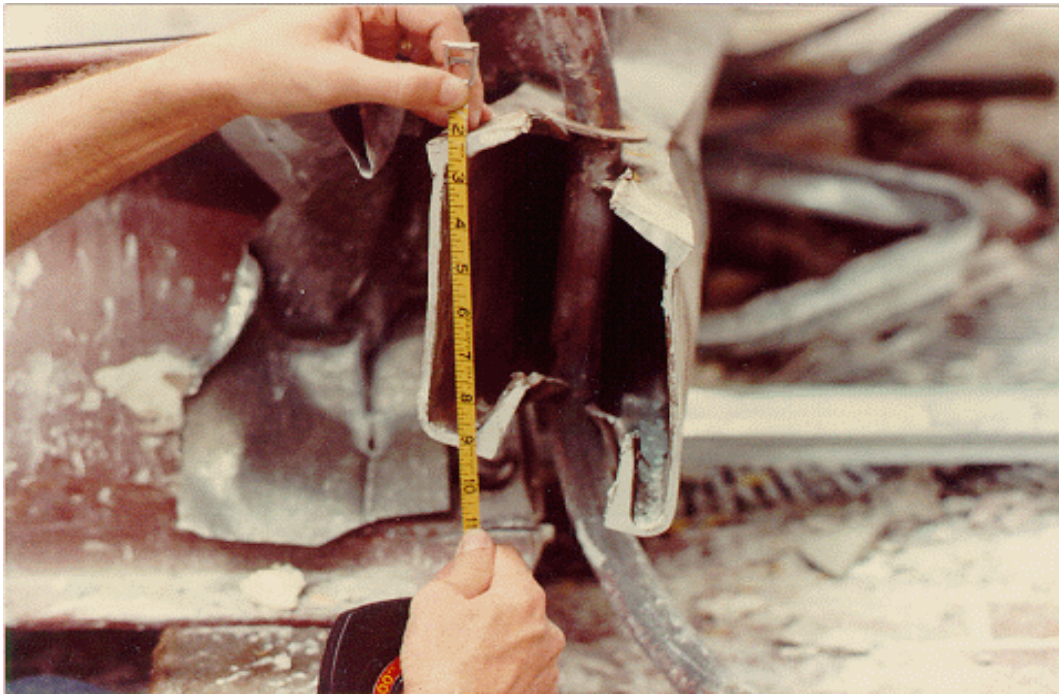
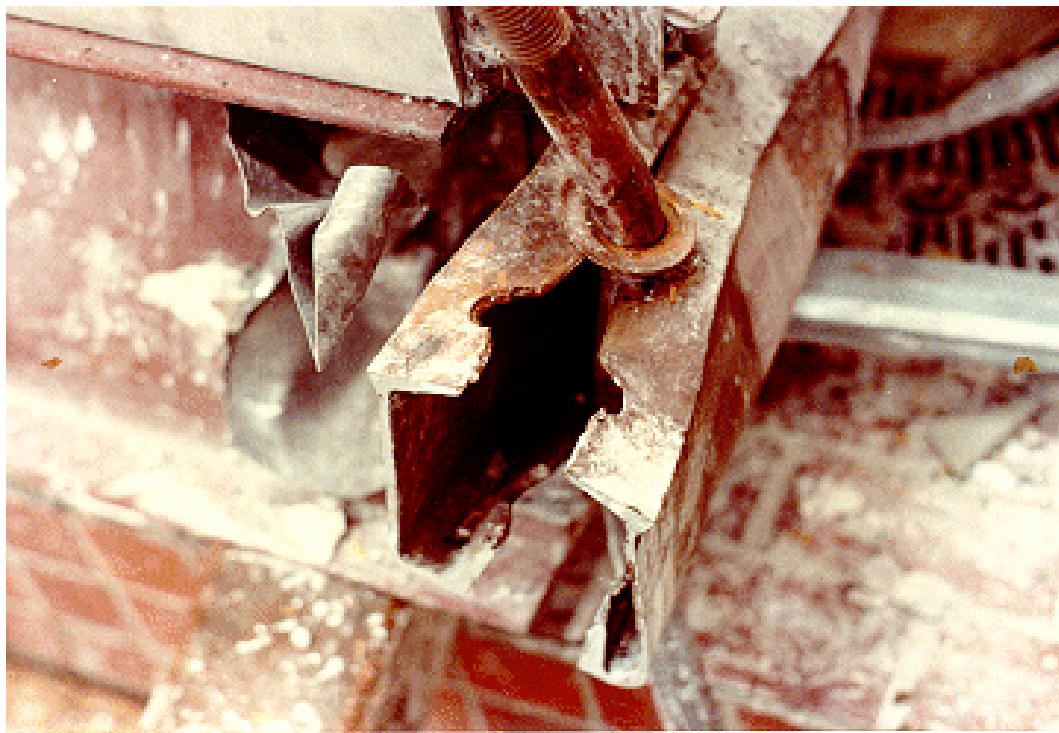
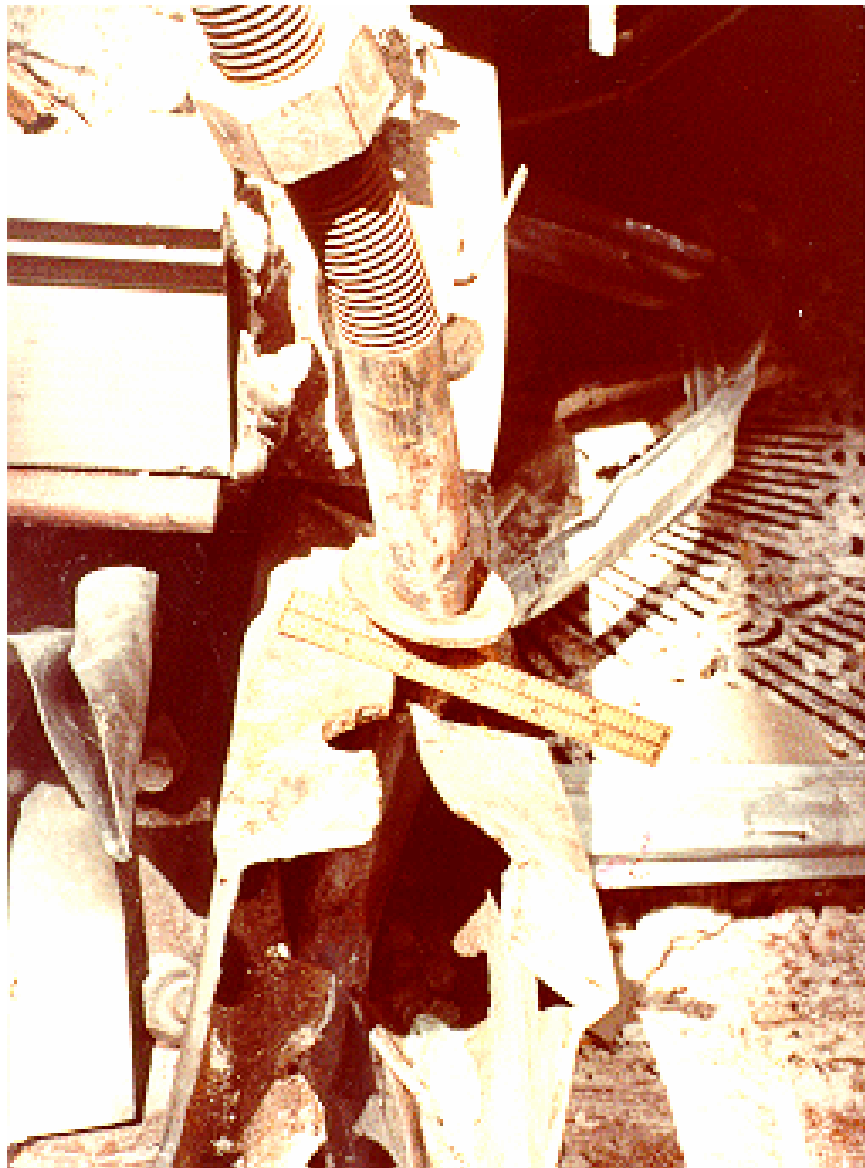
**4.4.1 SUSPENSION RODS UNDERSIZED.** Gillum's original design sized the suspension rods such that they were strong enough to support only 60% of the imposed load....based on code-allowable stresses. But given the difference between code-allowable and yield stresses of the materials....was this a fatal error? The investigations clearly indicated the failure occurred at the nuts and box beams, not at the rods.

#### **4.5 AND HERE IS WHAT HAPPENED....**
