## **The Apollo 1 Fire**

Course No: LE1-011

# The Apollo 1 Fire

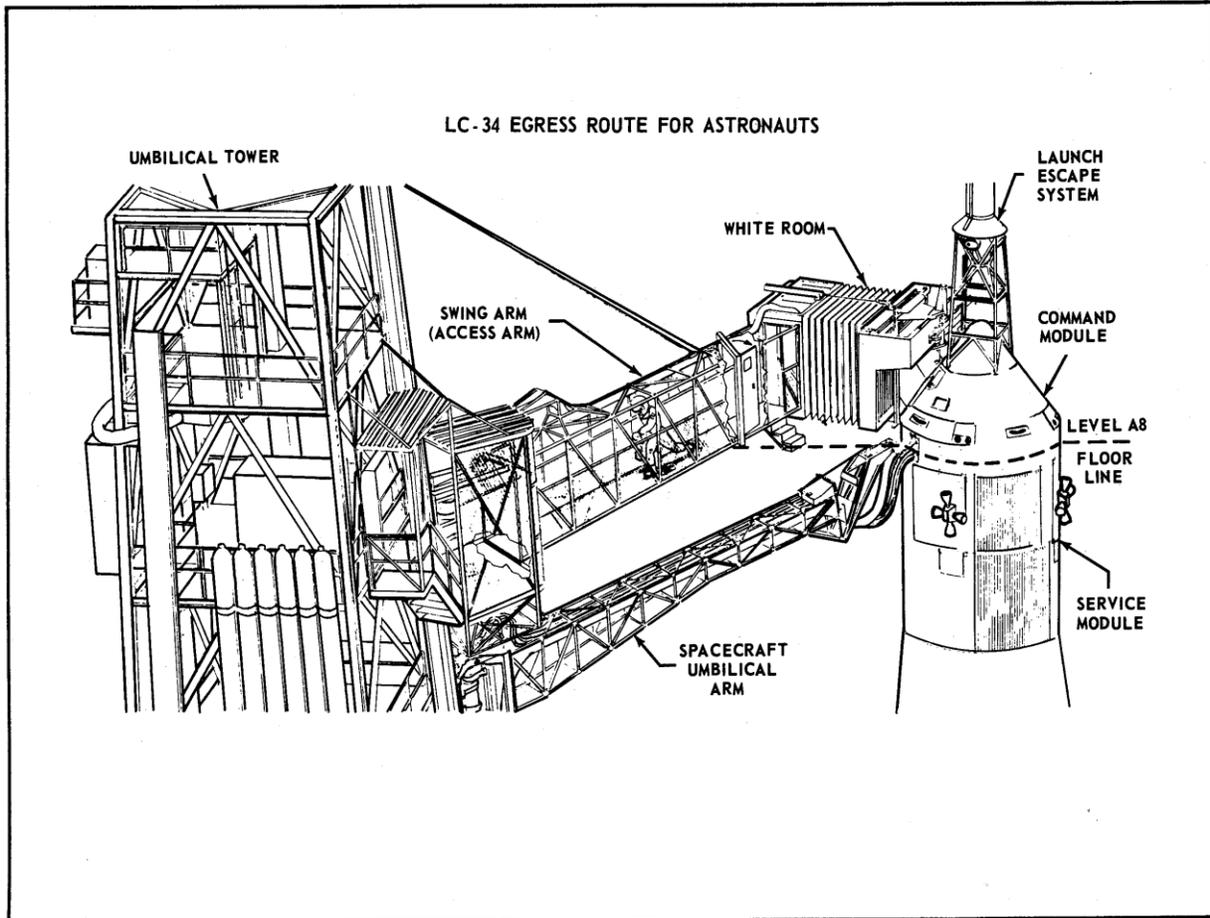
Figure 5 Sketch of the egress route

The egress route for the astronauts was attached to the umbilical tower. This was to provide an escape route for the astronauts in the case of an emergency before launch. The egress route is shown in the NASA sketch below. The “White Room” surrounds the hatch and is where the crew would step immediately upon egress (exit).

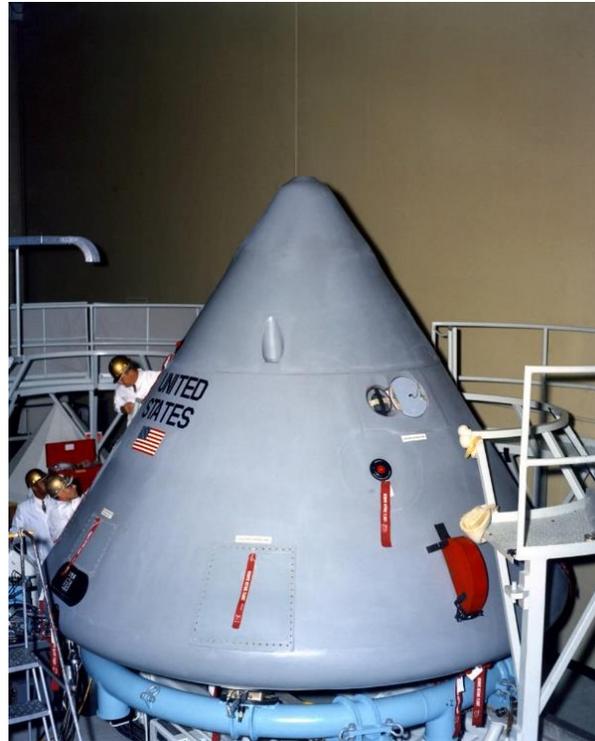
Figure 7 Spacecraft Command Module

The spacecraft (Command Module) was designated as Spacecraft 012. It was built by North American Aviation, Inc. This was a different contractor than McDonnell Aircraft Corporation, the company that built the spacecraft for Project Mercury. It arrived at Kennedy Space Center on August 26, 1966. After mating with the service module (considered as part of the spacecraft), combined systems tests were conducted. There were several malfunctions noted and some of the corrections were put off until a later date.

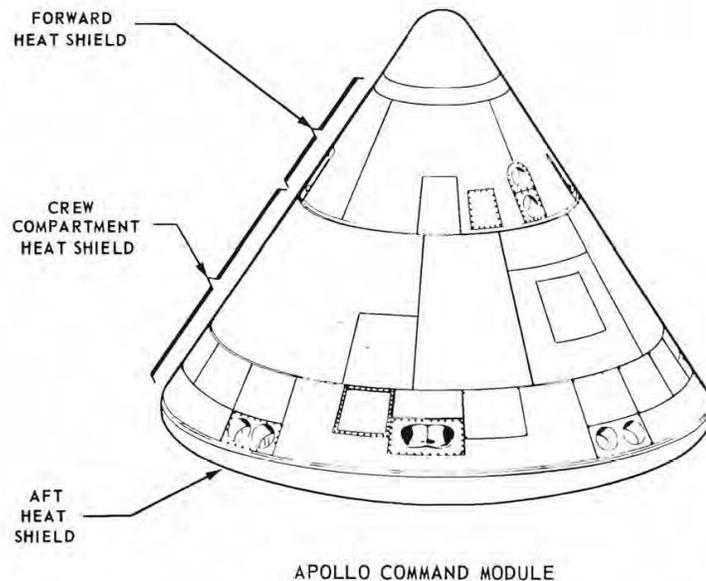
An item to note from the tests, is that the altitude chamber tests had the Command Module pressurized with pure oxygen four times with pressures above 14.7 psia (atmospheric). The total time of the pressurization was 6.25 hours. This is significant to note because it was 2.5 times longer than the Command Module was pressurized with oxygen during the Plugs-Out Test and fire that occurred.

There were several events that occurred during testing that may have a relation to the fire. These are possibly related to the water/glycol (coolant) spillage or leakage from the Environmental Control System. The water/glycol coming into contact with electrical connectors could cause corrosion of the connectors. Also, dried water/glycol on wiring insulation can leave an electrically conductive and combustible residue. There were six instances where water/glycol leakage or spillage occurred. There was only one instance that wetting of the connectors and wiring was detected. Actions were taken to clean the connectors and wiring on this occasion. It is possible that there was inadequate cleaning or undetected wetting occurred.

After the fire, small amounts of water/glycol were found in the Command Module. The investigation into the fire speculated that this could have been due to a water/glycol line breakage that occurred during the fire. Water/glycol and the residue may have contributed to the spread of the fire.

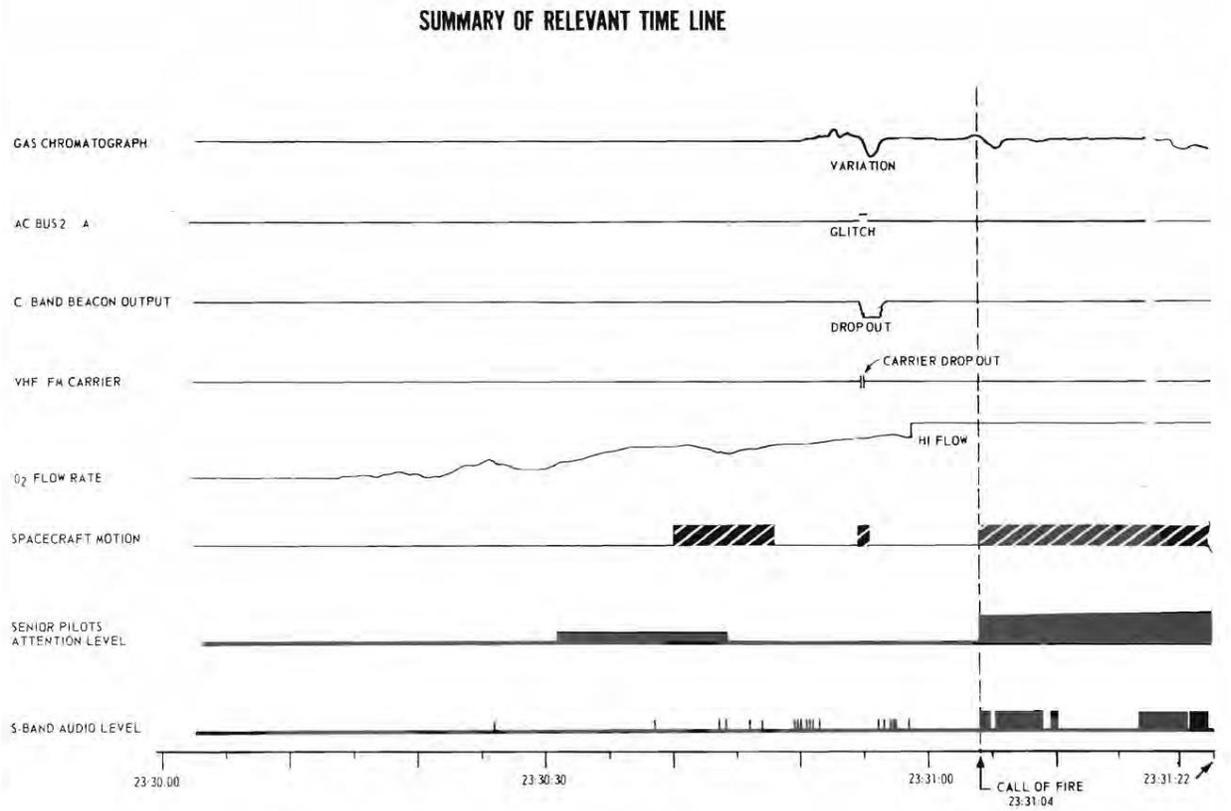
**Figure 8 NASA summary timeline**

The first verbal indication of the fire came from the crew at 23:31:04.7 GMT with an exclamatory remark by one of the astronauts. Analysis indicates the statement was made by White, stating “Hey Flames”. He then said “Hey! We’ve got a fire in the cockpit”. His second transmission was cut off. Chaffee is heard a few seconds later stating “We have a bad fire! We’re burning up!” A scream is then heard. The emergency procedures dictated for the Senior Pilot to unlatch and remove the hatch. The Senior Pilot, White, occupied the center couch. Indications are that Grissom initiated the hatch-opening procedure and was reaching for the inner hatch handle. Witnesses observed the television picture of the Command Module hatch window. There were personnel stationed on the adjustable level that was adjacent to the command module that responded to the report of the fire. The Pad Leader ordered the start of crew egress procedures to get them out of the Command Module. The technicians then started towards the

All transmissions of voice and data stopped by 23:31.22.4 GMT, which was approximately three seconds after the Command Module ruptured. The witnesses monitoring the television screen showing the hatch window reported that the flame spread from the left to right side of the Command Module, and then covered the entire area of visibility. A NASA summary timeline is shown below.
