# Ethical Issues from the St. Francis Dam Failure

Course No: LE2-004

J. Paul Guyer, P.E., R.A., Fellow ASCE, Fellow AEI

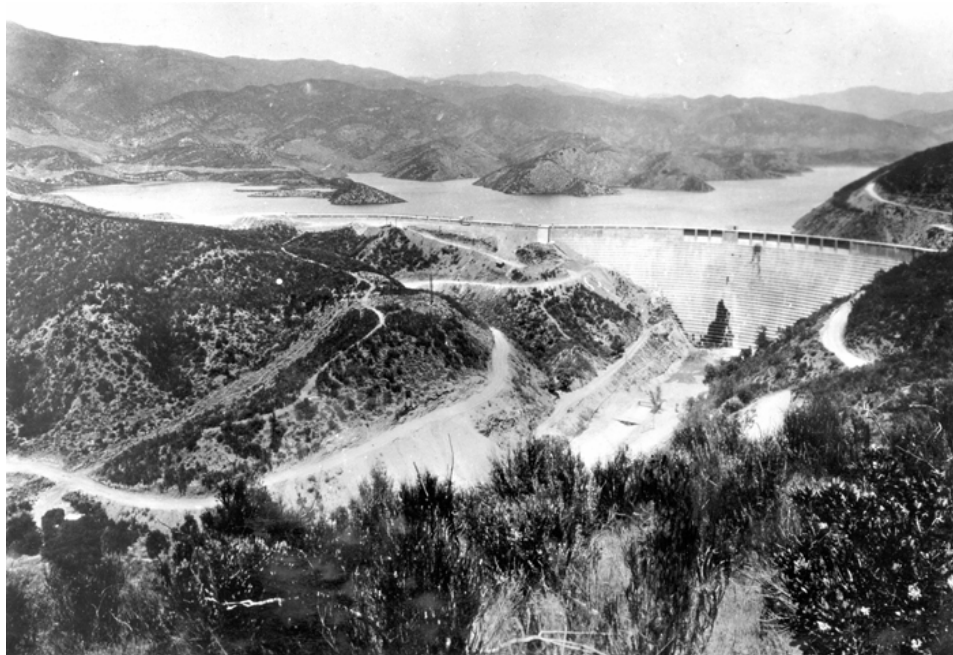
Figure 1

St. Francis Dam

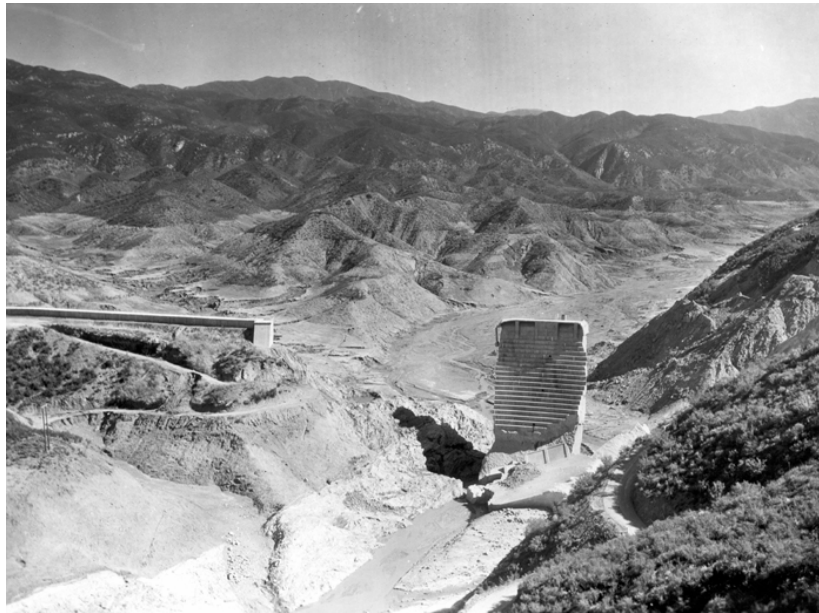
St. Francis Dam, March 17, 1928  
(Attribution: U.S. Geological Survey Photographic Library)  
Figure 3

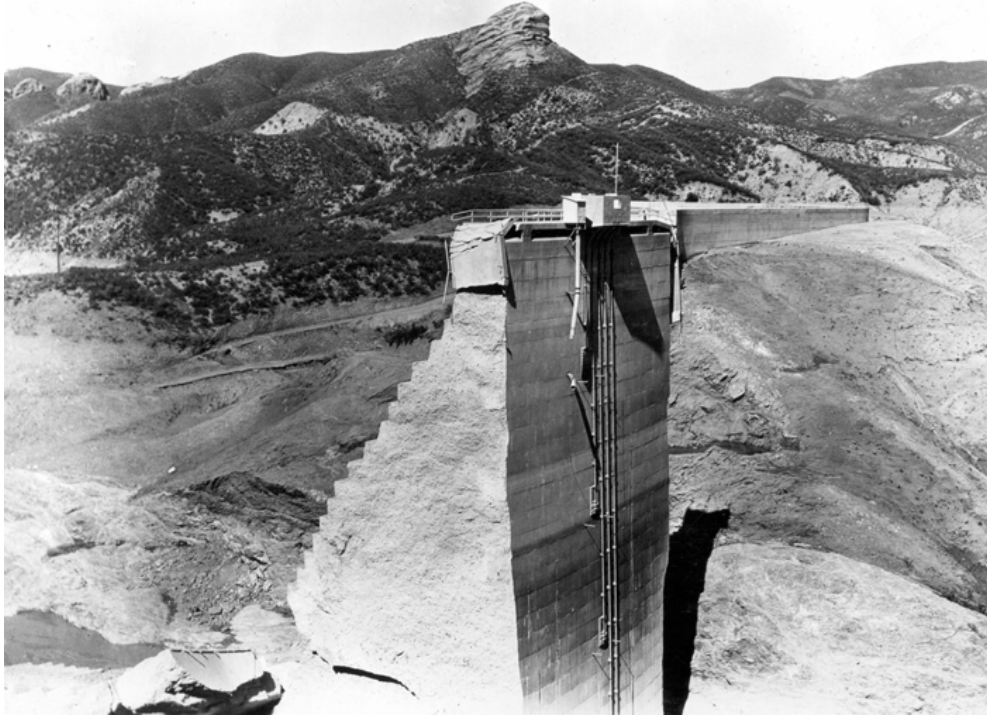
**St. Francis Dam, March 17, 1928**  
(Attribution: U.S. Geological Survey Photographic Library)  
**Figure 4**

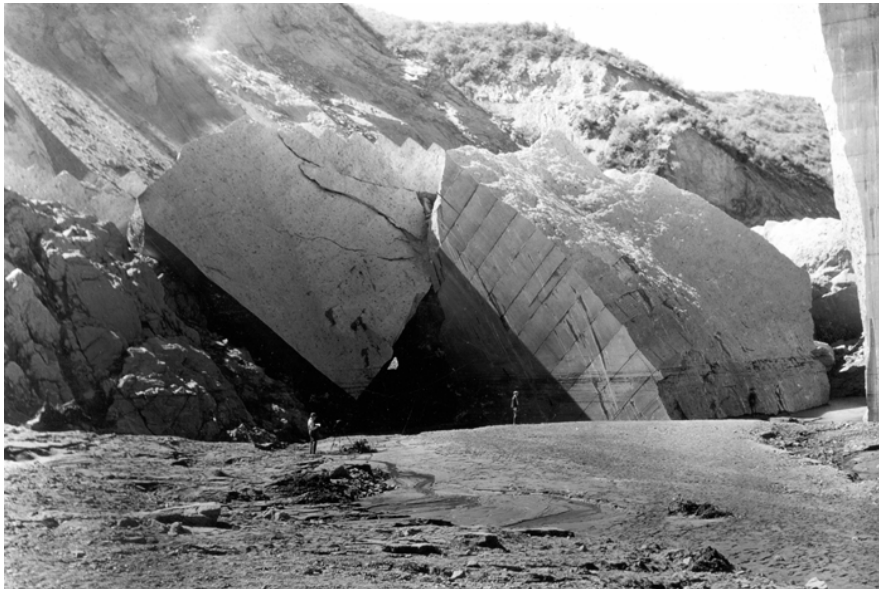
**St. Francis Dam, Concrete Debris Blocks**  
(Attribution: U.S. Geological Survey Photographic Library)  
**Figure 5**

The dam broke into several large concrete blocks, some of which were carried almost 1/2 mile downstream, while the center section of the dam remained standing. The upright center section was subsequently demolished. The St. Francis Dam was not rebuilt, although Bouquet Reservoir in nearby Bouquet Canyon and Castaic Dam in the town of Castaic were subsequently built as replacements for the St. Francis Dam.

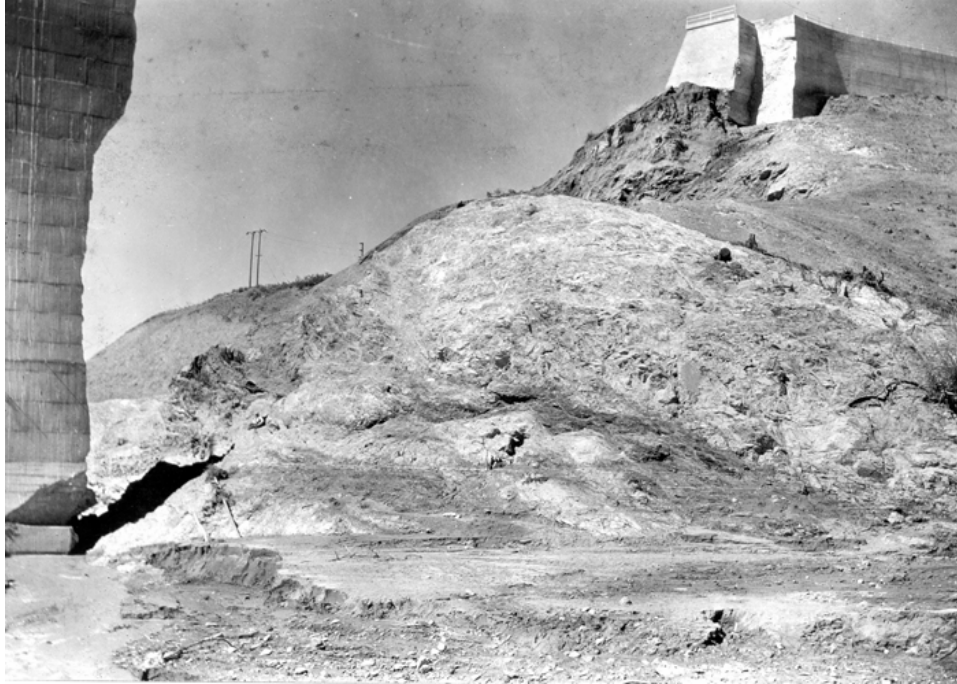
**St. Francis Dam, Former West Abutment**  
(Attribution: U.S. Geological Survey Photographic Library)  
**Figure 6**

The Los Angeles Coroner's Inquest concluded the disaster was primarily caused by the unsuitable soil conditions on which the eastern abutment of the dam was built, but which would have been impossible for the geologists of the 1920s to detect. Therefore, the inquest determined responsibility for the disaster lay with the governmental organizations which oversaw the dam's construction and the dam's designer and engineer, William Mulholland. Mulholland, however, was cleared of any charges since it was determined that neither he nor anyone at the time could have known of the instability of the rock formations on which the dam was built. The hearings also recommended, "the construction and operation of a great dam should never be left to the sole judgment of one man, no matter how eminent." It has also been suggested that raising the height of the dam 20 feet (as described above) during construction failed to recognize that accompanying design changes might be needed (such as increasing the width of the base of the dam).

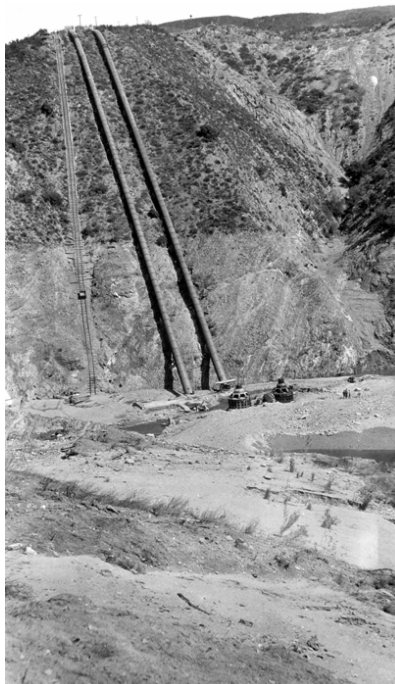
**Remains of downstream powerhouse**  
(Attribution: U.S. Geological Survey Photographic Library)  
**Figure 7**

Studies concluded that water behind the dam took about five minutes to travel 1.5 miles to Powerhouse No. 2 located below the dam. The height of the wall of water for the first few miles was 100 to 140 feet, and huge pieces of the dam, some weighing ten thousand tons, were washed one-half mile or more down the canyon.

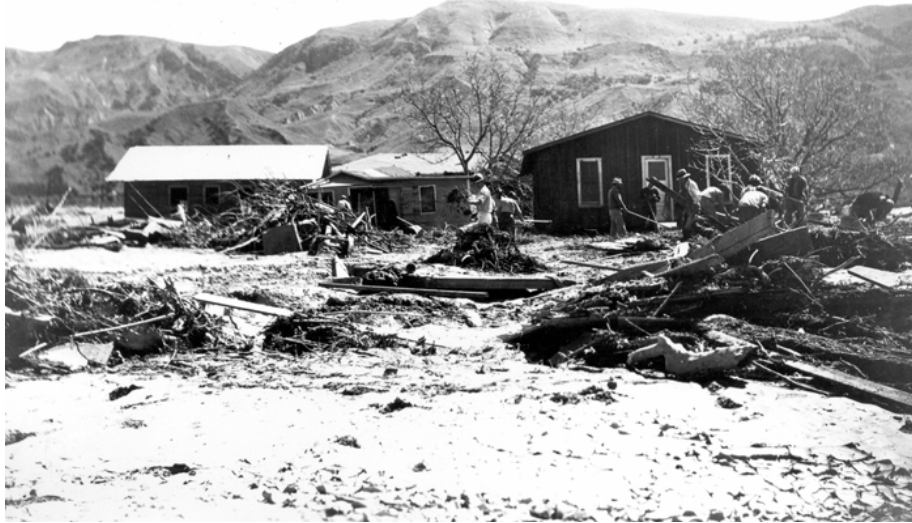
Flood damage at Santa Paula  
(Attribution: U.S. Geological Survey Photographic Library)  
Figure 8

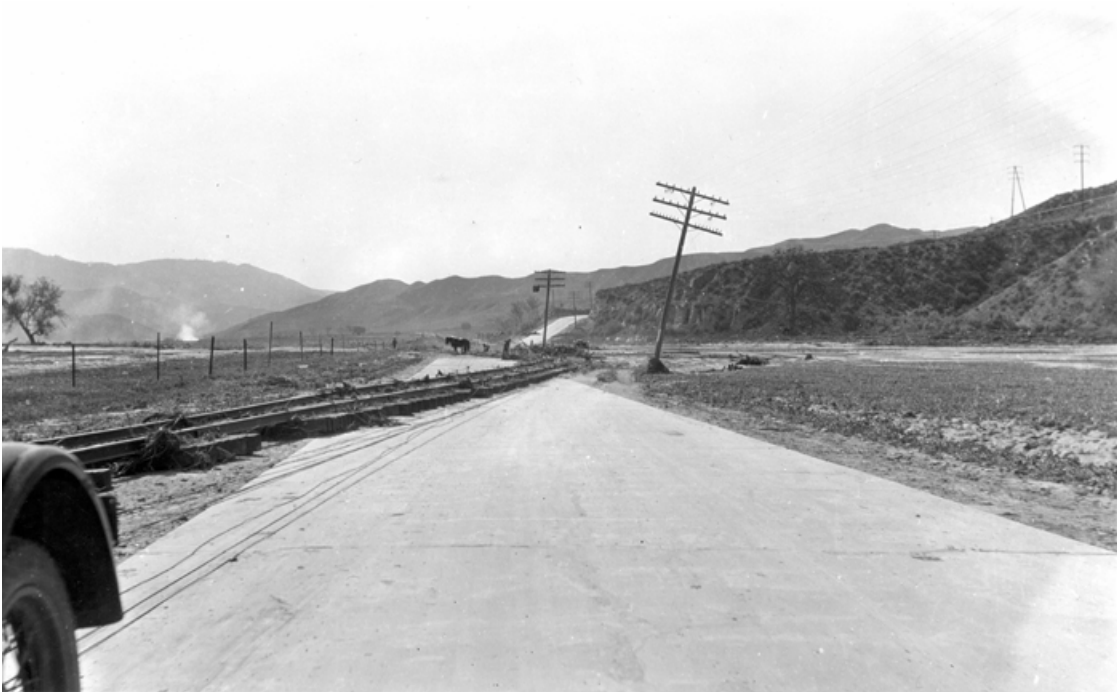
**Dislocated railroad tracks**  
(Attribution: U.S. Geological Survey Photographic Library)  
**Figure 9**

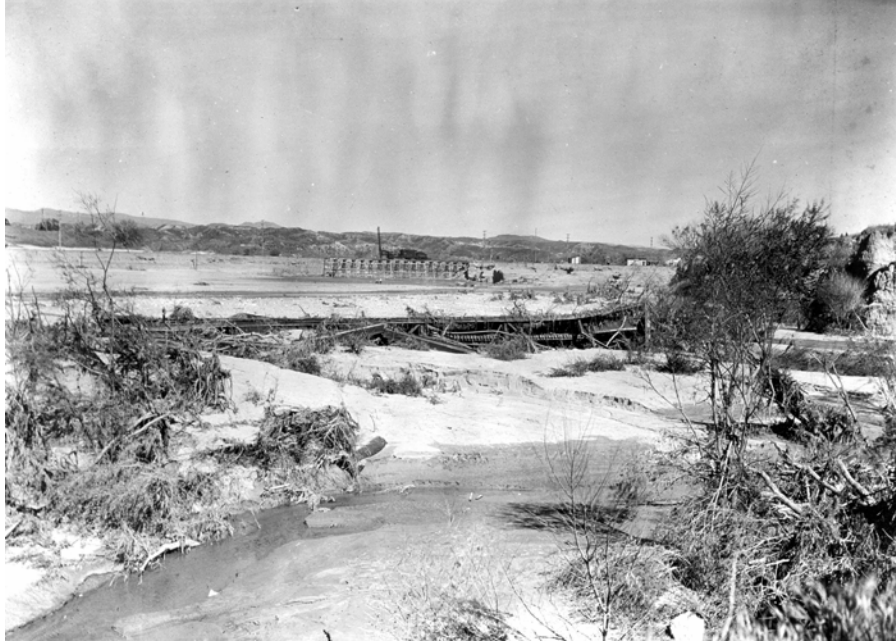
**Highway damage**  
(Attribution: U.S. Geological Survey Photographic Library)  
**Figure 10**

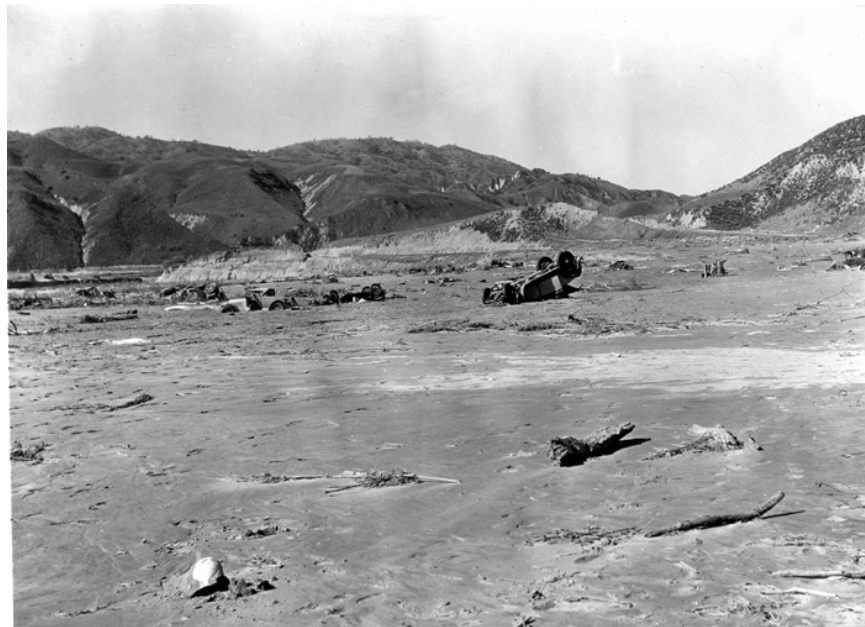
**Flood damage**  
(Attribution: U.S. Geological Survey Photographic Library)  
**Figure 11**
