Analysis of Cracking in Jointed Plain Concrete Pavements

SUMMARY REPORT

FHWA Publication No.: FHWA-HRT-16-073

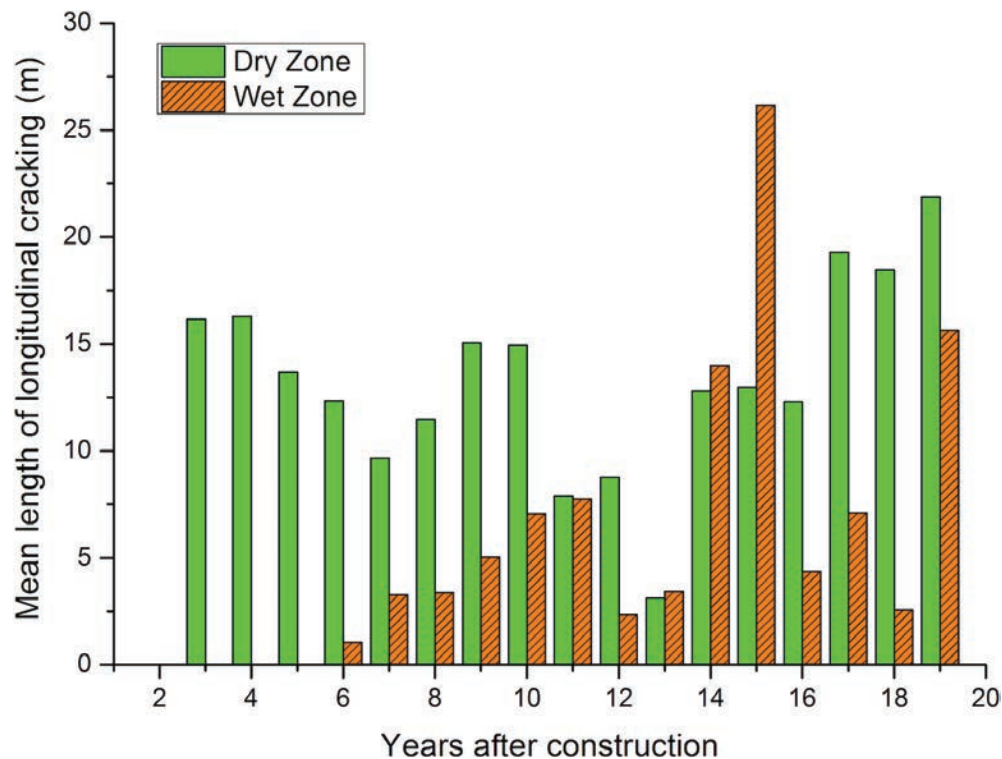
Figure 1. Mean crack length of longitudinal cracking per section for two climatic zones.

Figure 1 and figure 2 show the mean length of longitudinal and transverse cracking in all SPS-2 sections as a function of the year post construction for two climatic zones, respectively. Sections in the dry zone cracked sooner and more extensively than those in the wet zone for both longitudinal and transverse cracks. Significant cracks appeared in the dry zones in year 3. Pavements in the wet zones cracked more gradually, with minor transverse cracking from year 4. However, major longitudinal and transverse cracks were only present from about year 8 onward. Maintenance work was performed at various times but particularly in years 10 and 12, when a significant reduction in crack lengths was apparent.

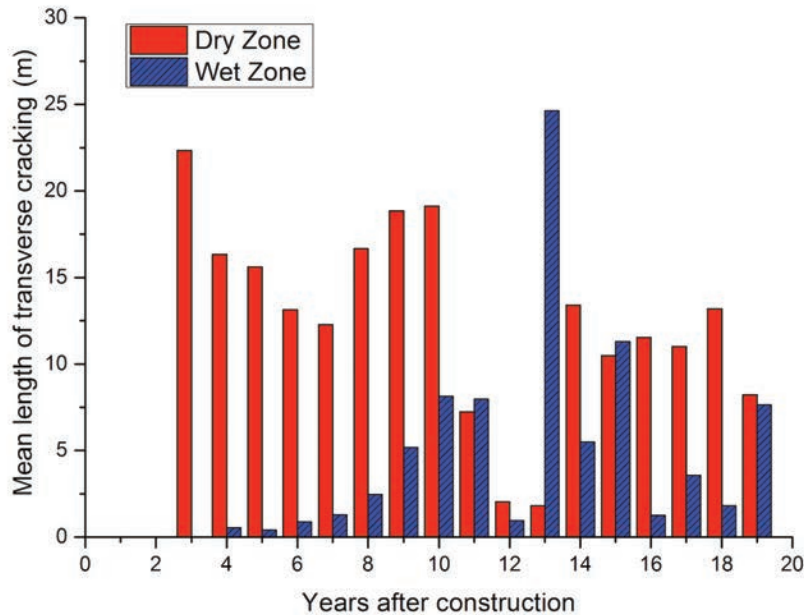
Figure 2. Mean crack length of transverse cracking per section for two climatic zones.

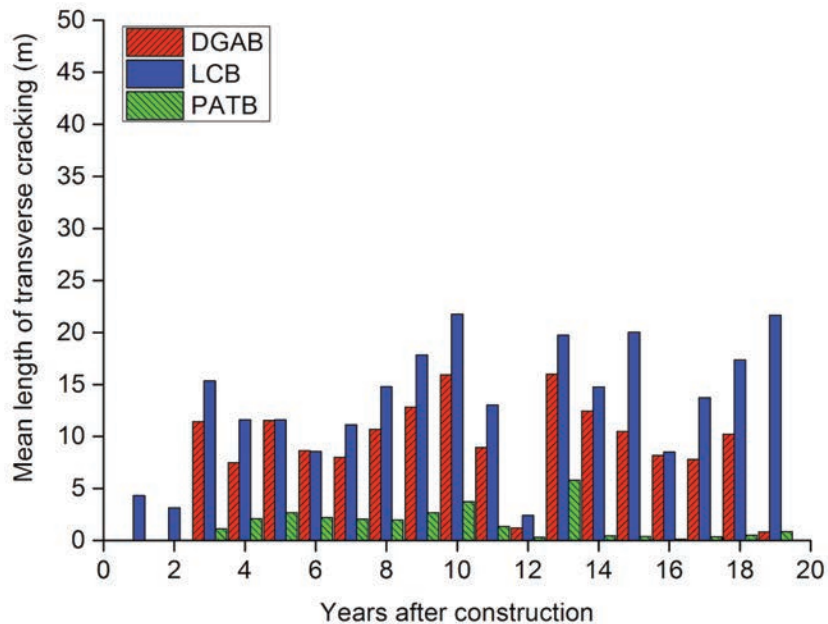
Figure 4. Mean transverse crack length per section over time for three different pavement base types.

Figure 3 and figure 4 show the effects of pavement base type on longitudinal and transverse cracking performance throughout the life of the SPS-2 sections. The SPS-2 sections were constructed with three types of base: dense-graded aggregate base (DGAB), lean concrete base (LCB), and permeable asphalt-treated base (PATB).^(4,5) As shown in figure 3

and figure 4, the PATB bases provided pavements with the best cracking resistance. DGAB provides pavements with moderate cracking resistance, while LCB provided pavements with the worst cracking resistance. This conclusion concerning the influence of base type for transverse cracking was also drawn in some earlier studies.^(6,5)

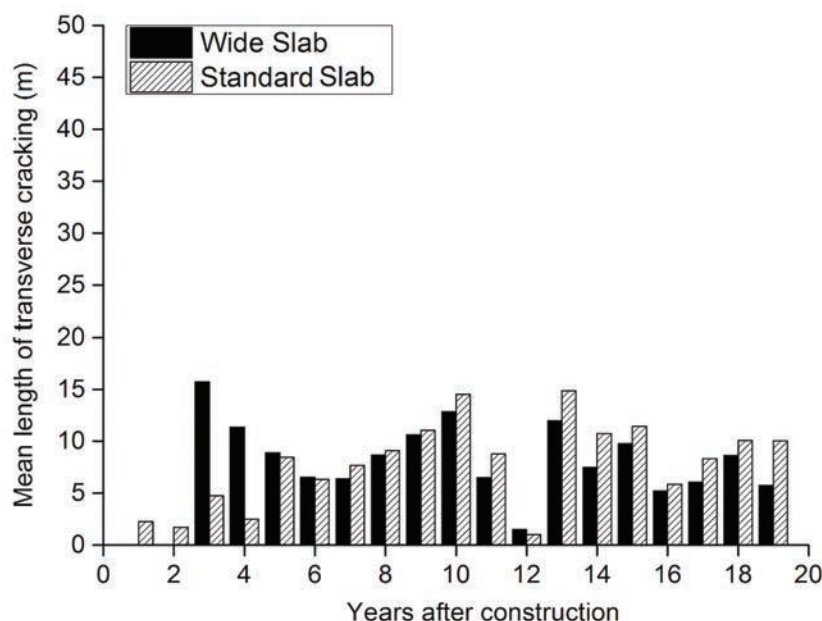
Figure 8. Mean transverse crack length per section over time for wide PCC slabs and standard PCC slabs.

The SPS-2 pavement sections were constructed with two different slab widths: “standard” slabs of 3.66 m and “wide” slabs of 4.27 m.⁽⁵⁾ Figure 7 and figure 8 show that, on average, the sections with widened PCC slabs developed more extensive

longitudinal cracking. Conversely, standard slabs appeared to start cracking transversely earlier in life. Overall, the long-term levels of transverse cracking were approximately the same for both slab widths.

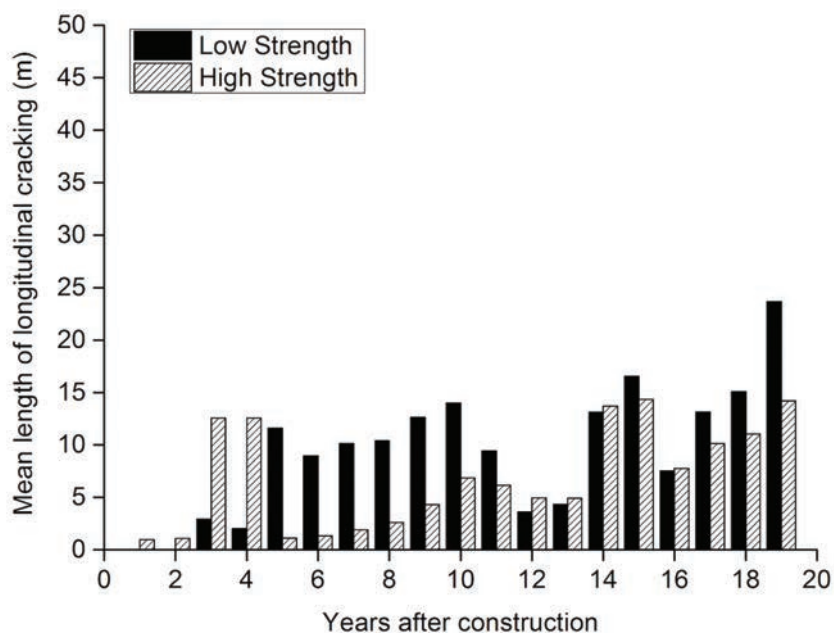
Figure 9. Mean longitudinal crack length per section over time for low-strength slabs and high-strength slabs.

The SPS-2 experiment specification included two levels of concrete strength (at 14 d): 3.8 and 6.2 MPa. Figure 9 and figure 10 show that some sections with high slab strength display earlier longitudinal and

transverse cracking. Between 6 and 12 years after construction, the weaker concrete showed more cracking, but, in the long term, there was little to distinguish between them.

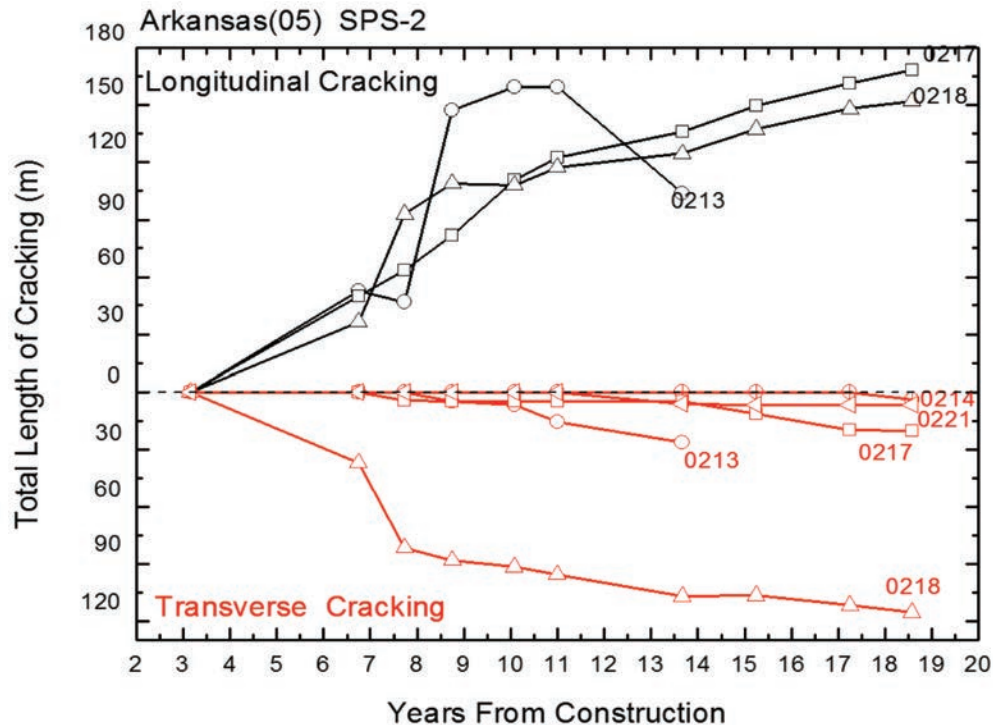
- Sections 0213, 0217, and 0218 had both longitudinal and transverse cracks.
- Sections 0214 and 0221 had only transverse cracks with low severities.
- Sections 0215, 0216, 0219, 0220, 0222, 0223, and 0224 had no cracks.

Figure 13. The total length of cracking over time in the Arkansas SPS-2 sites. (Transverse cracking is plotted below the axis for convenience.)

Figure 13 shows the total length of longitudinal cracking and transverse cracking over time on the Arkansas SPS-2 site. The following can be seen:

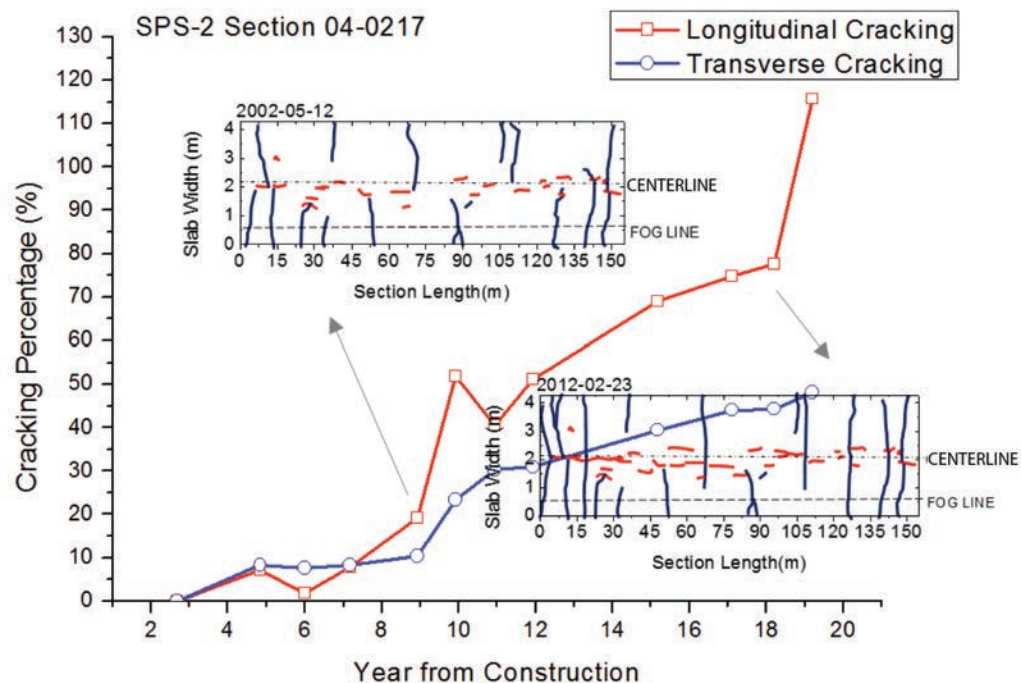
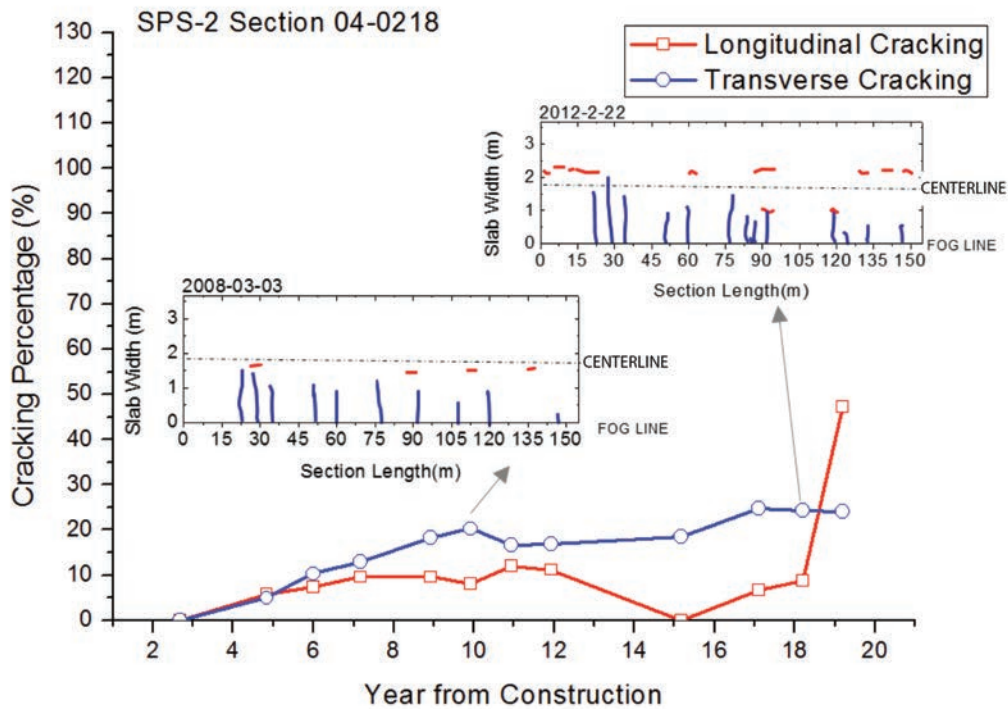
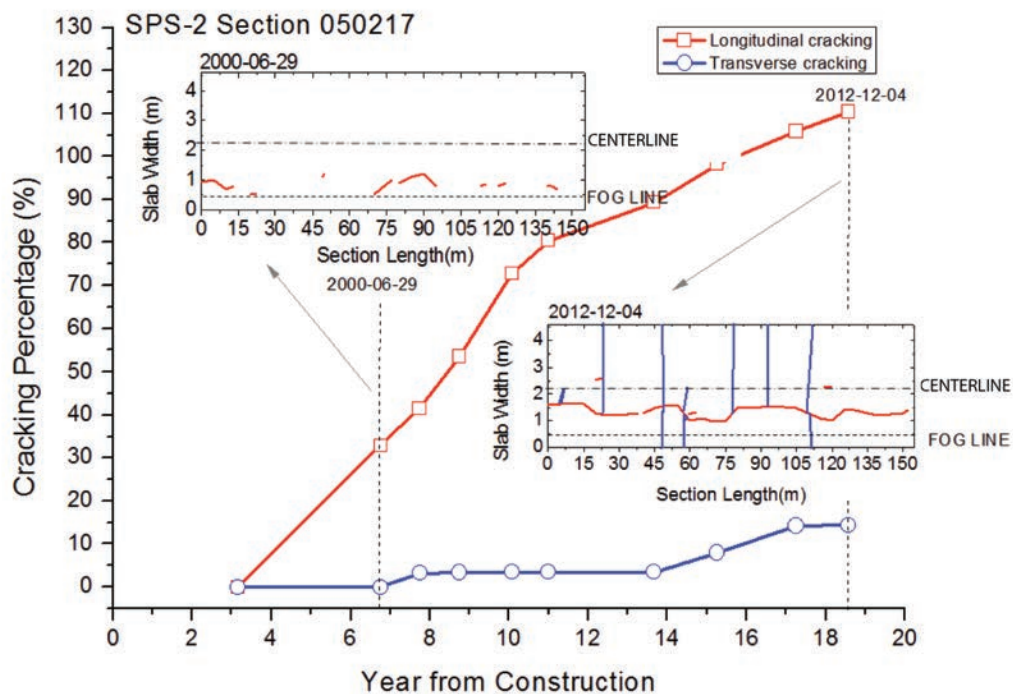
The crack patterns revealed that most longitudinal cracks initiated at slab transverse edges, and the rest initiated from transverse cracks. Most transverse cracks initiated at the concrete slab edge close to the shoulder, and the rest initiated either at the slab edge in the middle of the lane (i.e., with the longitudinal joints) or from longitudinal cracks.

Figure 15. The development of cracking in Arizona-0213 section.

Figure 16. The development of cracking in Arizona-0217 section.

Figure 17. The development of cracking in Arizona-0218 section.

Figure 18. The development of cracking in Arkansas-0213 section.

Figure 19. The development of cracking in Arkansas-0217 section.

Figure 20. The development of cracking in Arkansas-0218 section.

Figure 15 through figure 20 display details of the cracking process in three sections (0213, 0217, and 0218) for Arizona and Arkansas, respectively. Each figure shows the percentage cracking along with recorded snapshots of the patterns of longitudinal and transverse cracks.

- Almost continuous single crack relatively near the shoulder (as seen for sections 04-0213, 05-0213, and 05-0217).

- A set of discrete cracks closer to the longitudinal centerline of slabs (as seen for sections 04-0217, 04-0218, and 05-0218).

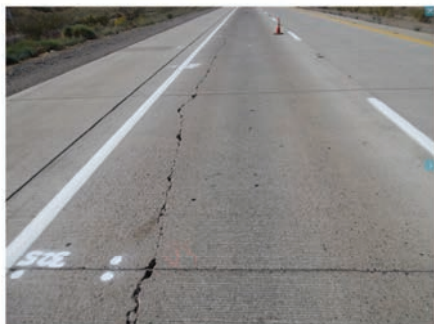
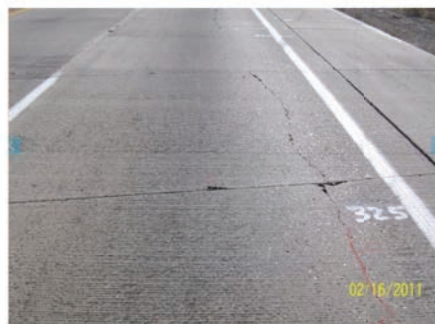
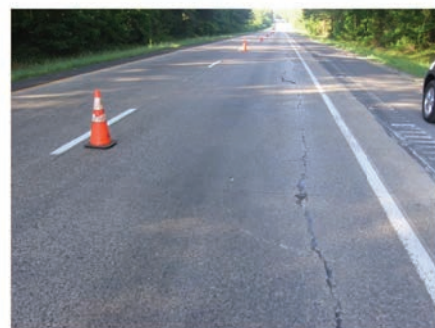
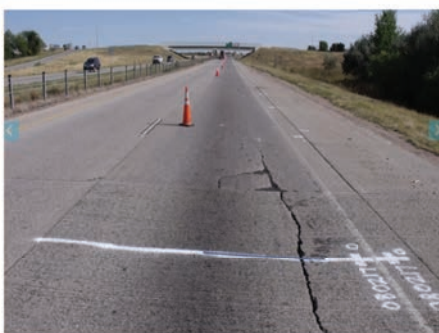
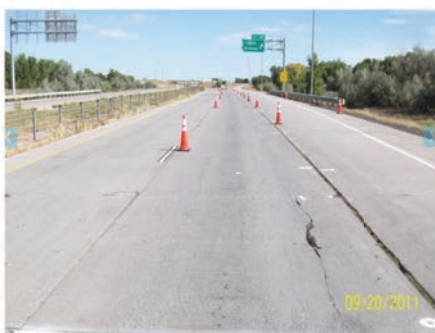
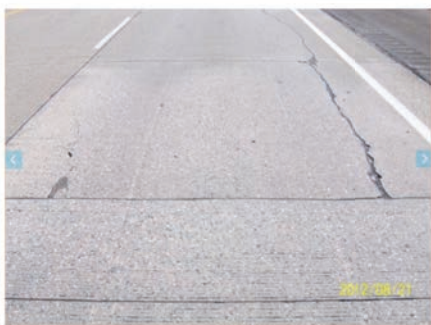
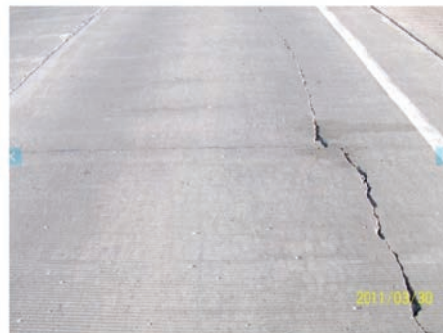
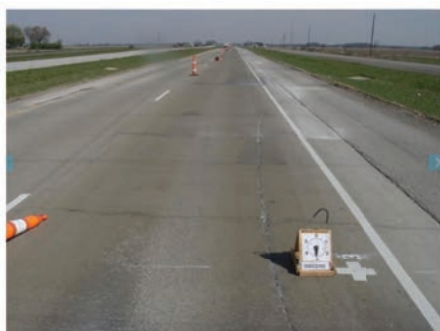
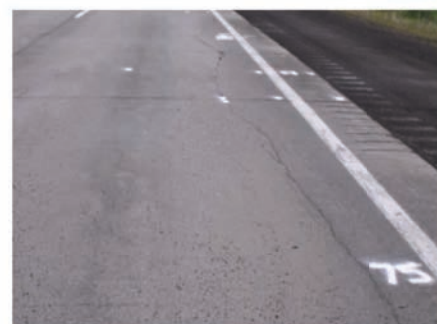
Figure 21. Longitudinal cracking near the shoulder in Arizona-0213 section (February 16, 2011).

Figure 22. Longitudinal cracking near the shoulder in Arizona-0262 section (February 16, 2011).

Figure 23. Longitudinal cracking near the shoulder in Arkansas-0213 section (May 24, 2007).

Figure 24. Longitudinal cracking near the shoulder in Arkansas-0217 section (December 4, 2012).

Figure 25. Longitudinal cracking near the shoulder in Colorado-0217 section (September 20, 2011).

Figure 26. Longitudinal cracking near the shoulder in Colorado-0218 section (September 20, 2011).

Figure 27. Longitudinal cracking near the shoulder in North Dakota-0217 section (August 21, 2012).

Figure 28. Longitudinal cracking near the shoulder in Iowa-0217 section (March 30, 2011).

Figure 29. Longitudinal cracking near the shoulder in Ohio-0206 section (September 12, 2006).

Figure 30. Longitudinal cracking near the shoulder in Washington-0206 section (May 23, 2013).

The snapshots featured in figure 21 through figure 30 were selected from 10 different sections in 7 sites (States). They share almost continuous single cracks relatively near the shoulder. These cracks occurred only

in the sections with DGAB (section 0213) and LCB (sections 0217, 0218, and 0206). This pattern of cracking was only found in the 10 sections in LTPP SPS-2 (according to monitoring results updated in 2013).
