# **Distresses and Treatment/Repair Methods in Flexible and Rigid Pavements**

Course No: C05-030  
Credit: 5 PDH

Najib Gerges, Ph.D., P.E.

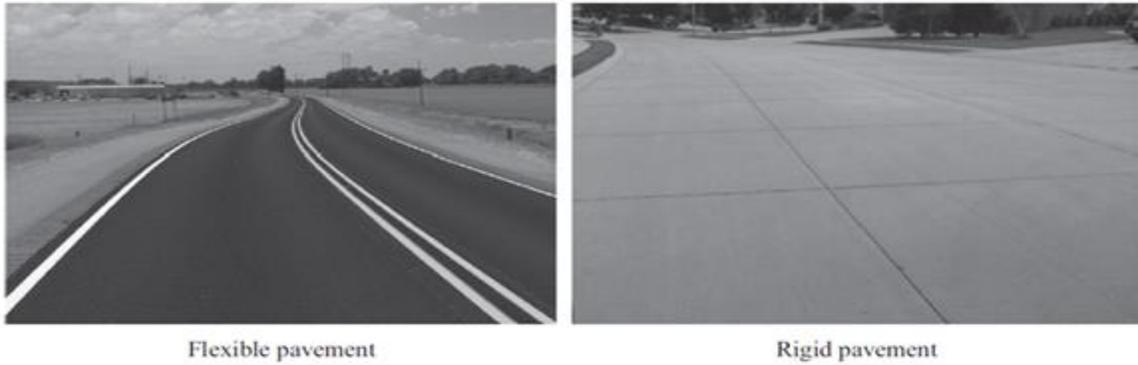
Two types of pavements are generally recognized: Flexible Pavements and Rigid Pavements, as shown in Figure 1.

*Figure 1 Flexible and Rigid Pavements*

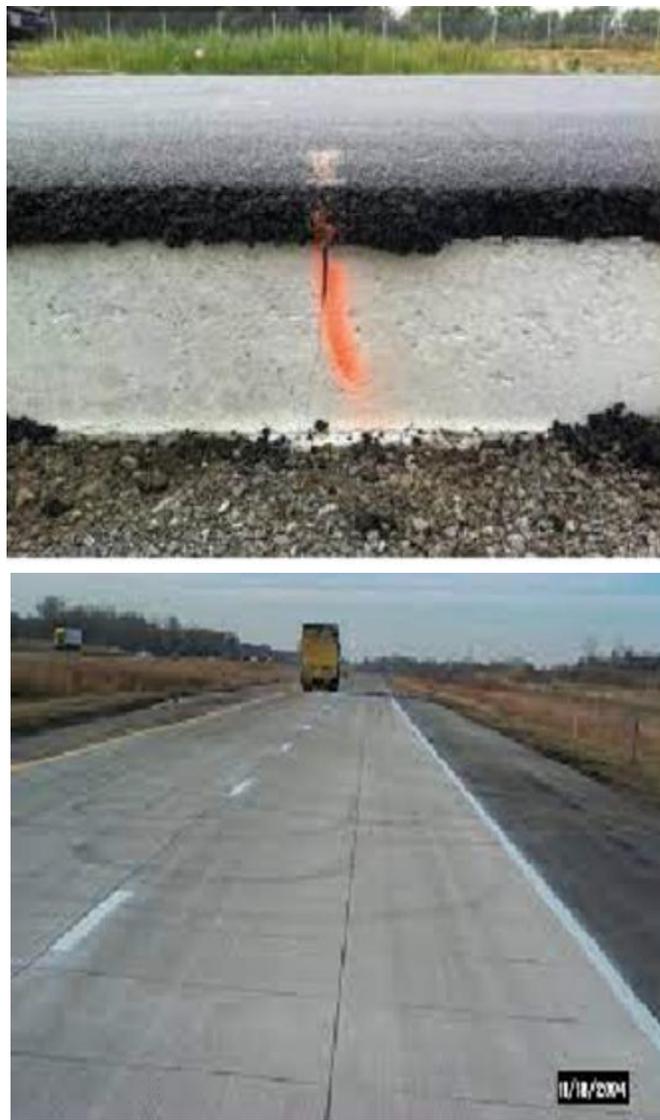
A combination of these two pavements is also possible, and is termed Composite Pavement as shown in Figure 2.

*Figure 2 Composite Pavement Black Topping (top) and White Topping (bottom)*

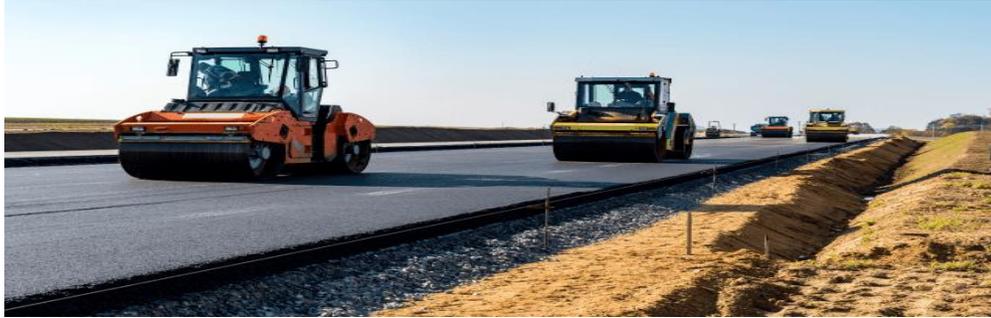
The surface course consists of multiple layers of pavement structure where the top layer is directly exposed to traffic as shown in Figure 4. The surface course is also called the wearing course. For flexible pavements, the bituminous surface is the wearing course, whereas in rigid pavements the concrete surface act as the base course cum wearing course. The wearing course reduces the percolation of water and provides an anti-skid and abrasion-resistant riding surface. The functions of surface or wearing course are as follows:

*Figure 4 Surface Course/ Wearing Course*

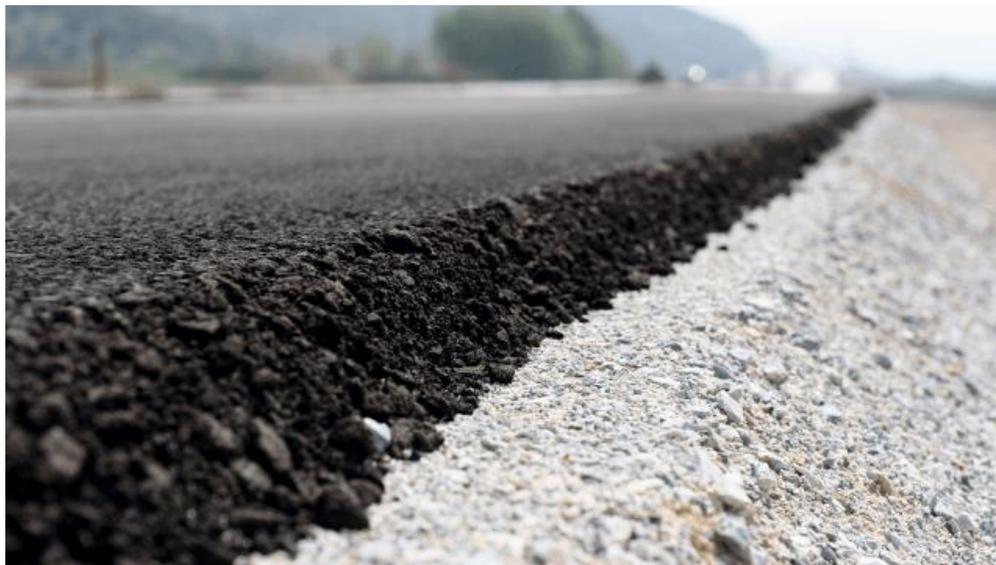
The base course is the most important layer of a road structure which transfers the stresses developed due to traffic impacts through the wearing course. The base course layer provides the required foundation stiffness and structural strength.

*Figure 5 Base Course*

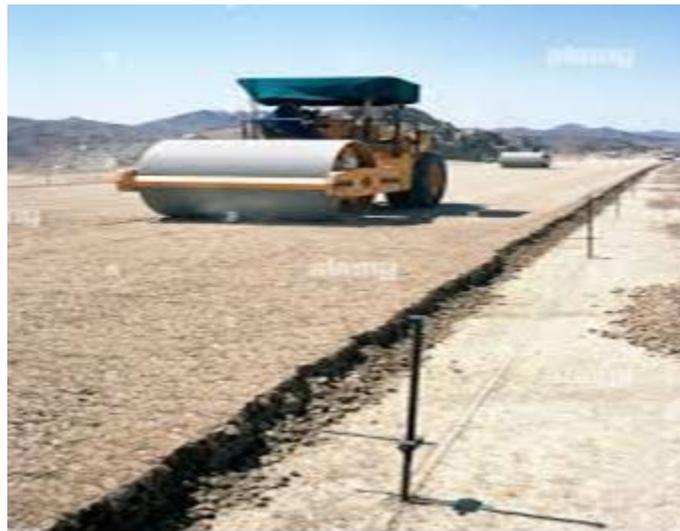
This layer is necessary if the subgrade is of poor quality. In that case, an additional layer of burnt clinkers, gravel, slag, etc., is provided to strengthen the sub grade. The functions of the subbase course are as follows:

*Figure 6 Subbase Course*

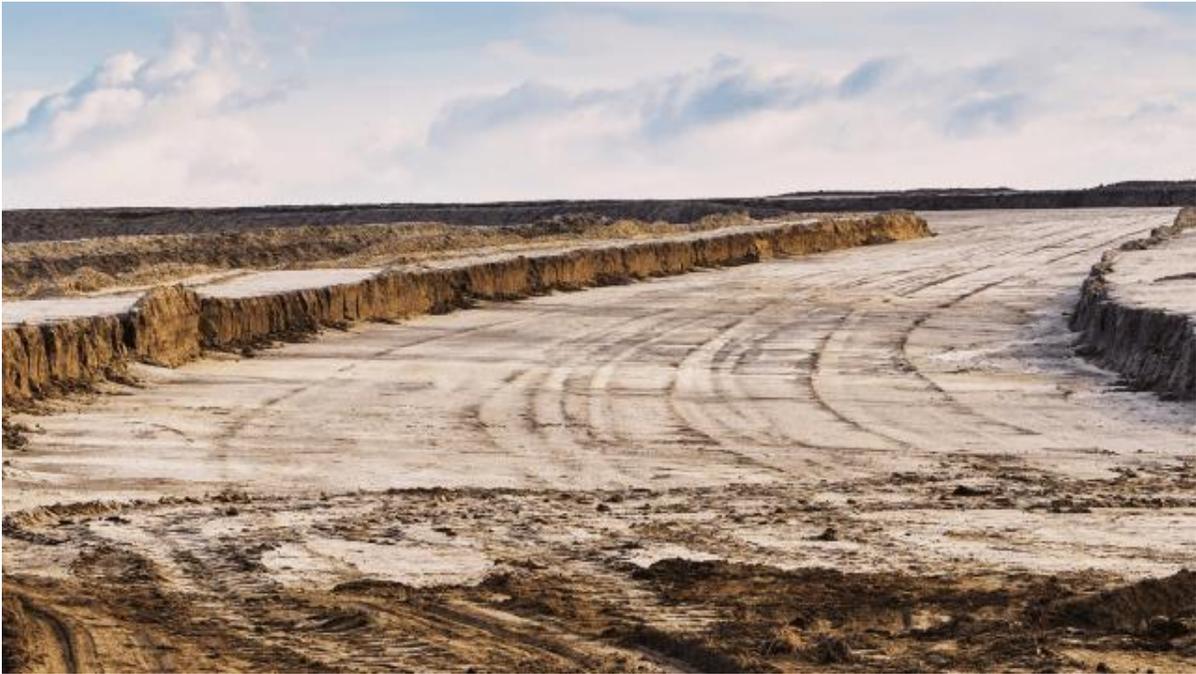
The subgrade is the compacted natural soil below the pavement layers and it is the finished or compacted surface on which the pavement rests. The subgrade course is also known as the formation and serves as the foundation of the pavement layers as shown in Figure 7.

*Figure 7 Subgrade Course*

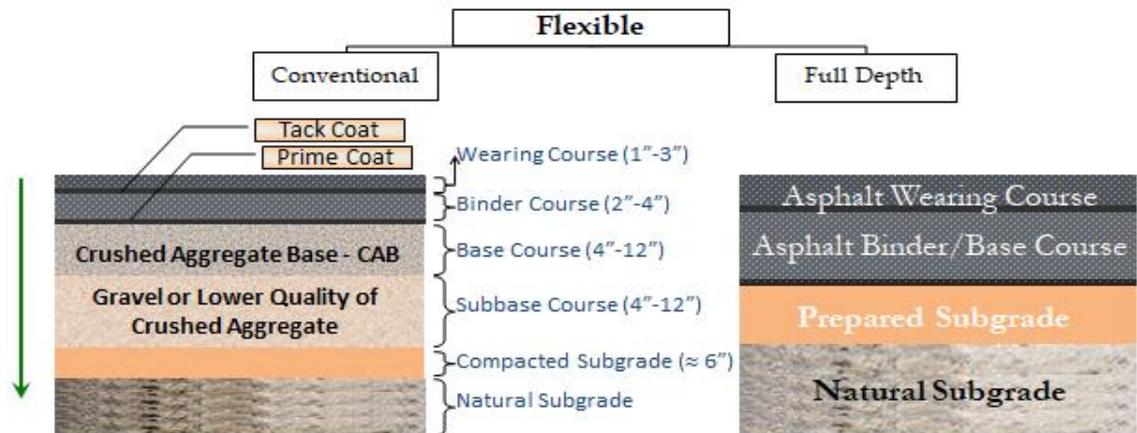
Flexible pavements can be classified into two types as shown in Figure 8:

- Conventional (the base layer consists of crushed aggregates).
- Full-Depth (the base layer, also known as black base, consists of hot mix asphalt instead of crushed aggregates).

*Figure 8 Cross-Sectional View of Flexible Pavements*

- Resists distortion under traffic.
- Provides smooth & skid-resistant riding surface.
- Waterproof to protect pavement and subgrade (SG).  
(Refer to Figure 8).

- HMA too thick to be compacted in one layer.
- Larger size aggregates, (compact 2-3” at a time).
- The term binder course refers to a European standard description of the second layer of asphalt pavement, described in the UK as a base course.  
(Refer to Figure 8).

- Asphalt emulsion diluted with water.
- Bond between surface being paved & overlying course.
- Very thin & uniformly cover entire surface.  
(Refer to Figure 8).

Low-viscosity cutback asphalt applied to an absorbent surface. (Refer to Figure 8).

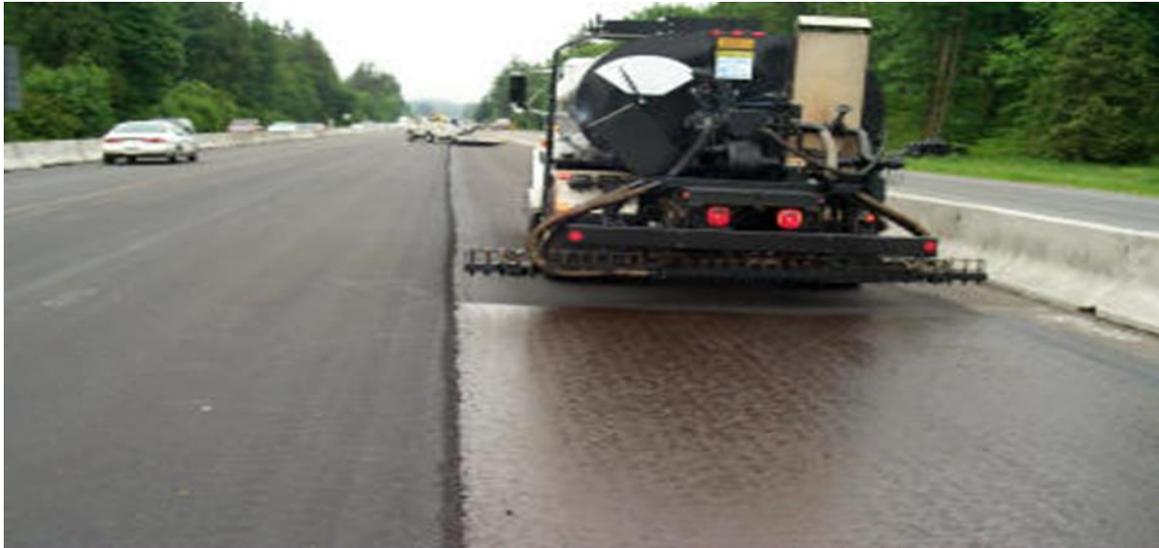
The application of the tack coat is clearly shown in Figure 9.

*Figure 9 Tack Coat Application*

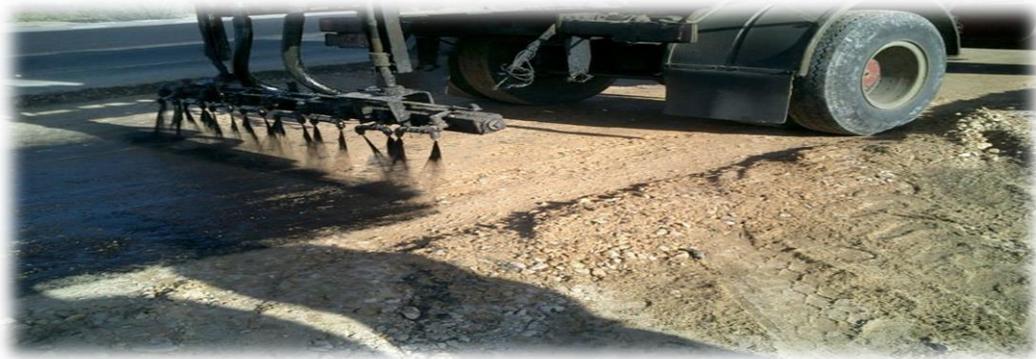
The application of the prime coat is clearly shown in Figure 10.

*Figure 10 Prime Coat Application*

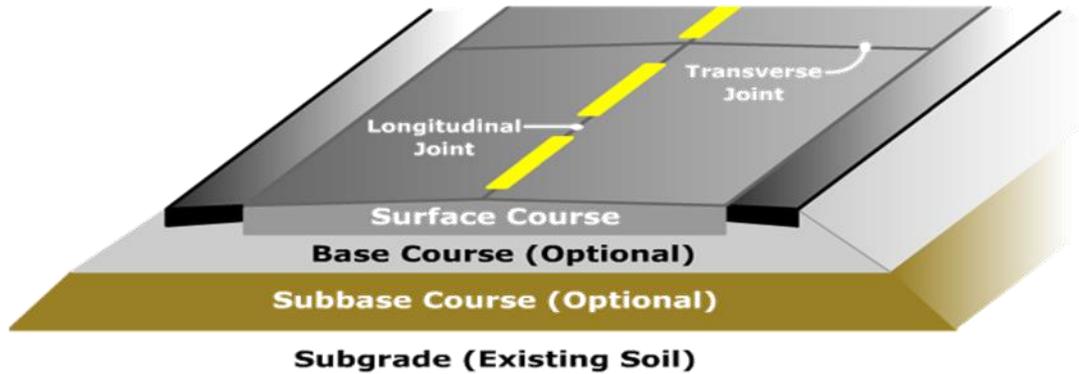
Figure 11 clearly displays a typical cross-sectional view of a rigid pavement.

*Figure 11 Cross-Sectional View of Typical Rigid Pavements*

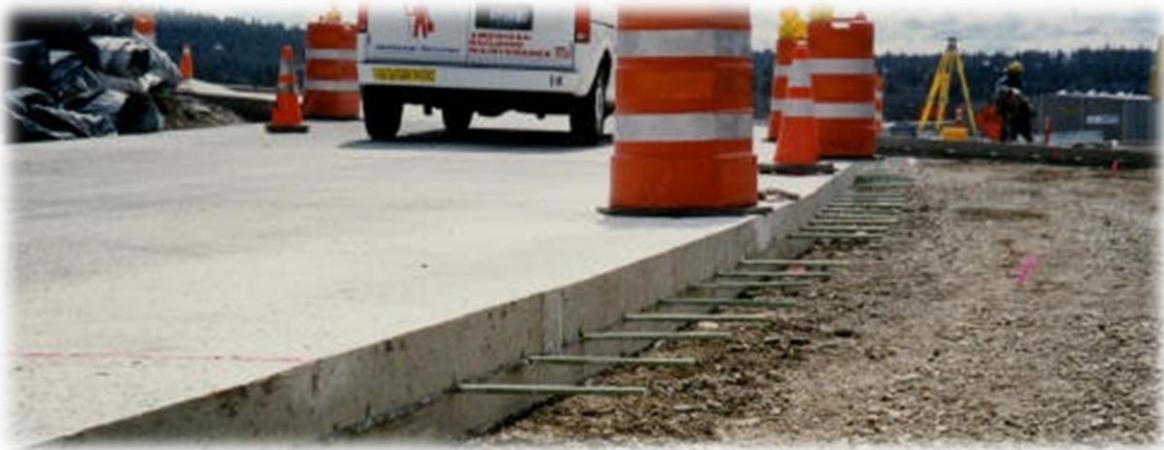
Tie bars, also known as Deformed Steel Bars or Connectors, are placed along the longitudinal joint used to hold the faces of abutting slabs in contact (AASHTO, 1993) as shown in Figure 16. Although they may provide some minimal amount of load transfer, they are not designed to act as load transfer devices and should not be used as such (AASHTO, 1993).

*Figure 16 Tie Bars in Rigid Pavements*

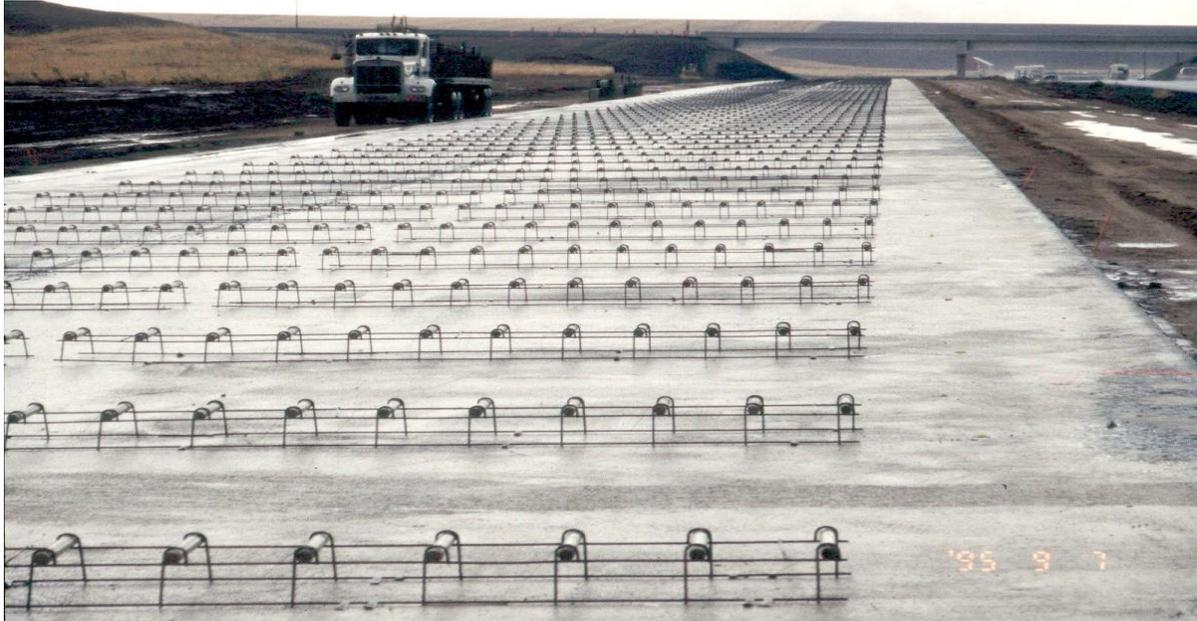
expansion and contraction of adjacent slabs independently. Dowel bars are short steel bars that are installed in concrete slabs to provide a mechanical connection that does not restrict horizontal joint movement. They are designed to reduce joint deflection and stress in the approach and leave slab by increasing load transfer efficiency.

*Figure 17 Dowel Bars in Rigid Pavements*

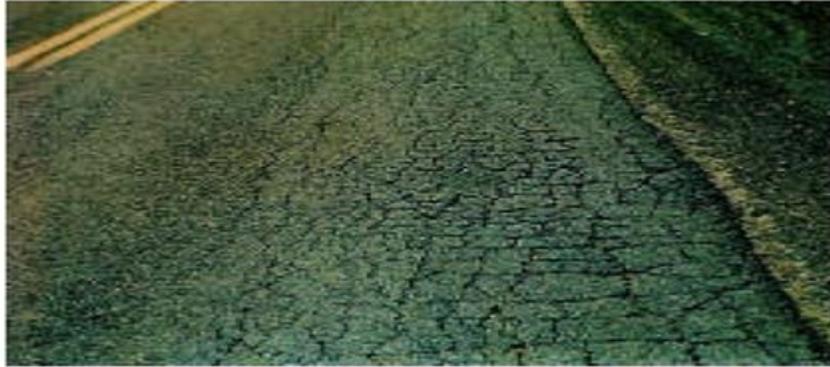
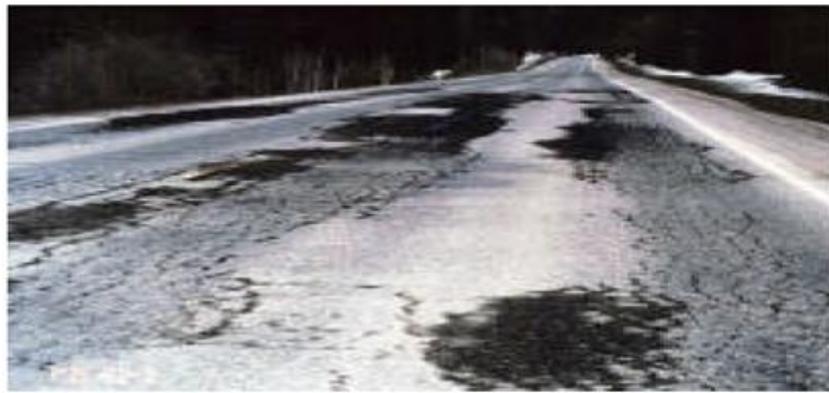
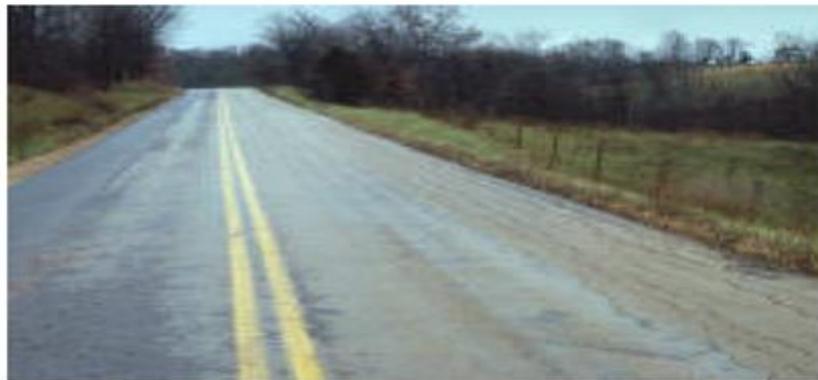
*Description:* Fatigue or alligator cracking is defined as a series of interconnected cracks caused by fatigue failure of the HMA surface (or stabilized base) under repeated traffic loading. In thin pavements, cracking initiates at the bottom of the HMA layer where the tensile stress is the highest then propagates to the surface as one or more longitudinal cracks. This is commonly referred to as "bottom-up" or "classical" fatigue cracking. In thick pavements, the cracks most likely initiate from the top in areas of high localized tensile stresses resulting from tire-pavement interaction and asphalt binder aging (top-down cracking). After repeated loading, the longitudinal cracks connect forming many-sided sharp-angled pieces that develop into a pattern resembling the back of an alligator or crocodile. Figures 19, 20, and 21 illustrate various forms of alligator/fatigue cracking.

*Figure 19 Bad Fatigue Cracking*

*Figure 20 Fatigue Cracking from Frost Action*

*Figure 21 Fatigue Cracking from Edge Failure*

*Problem:* Indicator of structural failure, cracks allow moisture infiltration, roughness, may further deteriorate to a pothole.

- Decrease in pavement load supporting characteristics.
- Loss of base, subbase or subgrade support (e.g., poor drainage or spring thaw resulting in a less stiff base).
- Stripping on the bottom of the HMA layer (the stripped portion contributes little to pavement strength so the effective HMA thickness decreases).
- Increase in loading (e.g., more or heavier loads than anticipated in design).
- Inadequate structural design.
- Poor construction (e.g., inadequate compaction).

*Repair:* A fatigue cracked pavement should be investigated to determine the root cause of failure. Any investigation should involve digging a pit or coring the pavement to determine the pavement's structural makeup as well as determining whether or not subsurface moisture is a contributing factor. Once the characteristic alligator pattern is apparent, repair by crack sealing is generally ineffective. Fatigue crack repair generally falls into one of two categories:

- Small, localized fatigue cracking indicative of a loss of subgrade support. Remove the cracked pavement area then dig out and replace the area of poor subgrade and improve the drainage of that area if necessary. Patch over the repaired subgrade.
- Large fatigue cracked areas indicative of general structural failure. Place a Hot Mix Asphalt (HMA) overlay over the entire pavement surface. This overlay must be strong enough structurally to carry the anticipated loading because the underlying fatigue cracked pavement most likely contributes little or no strength.

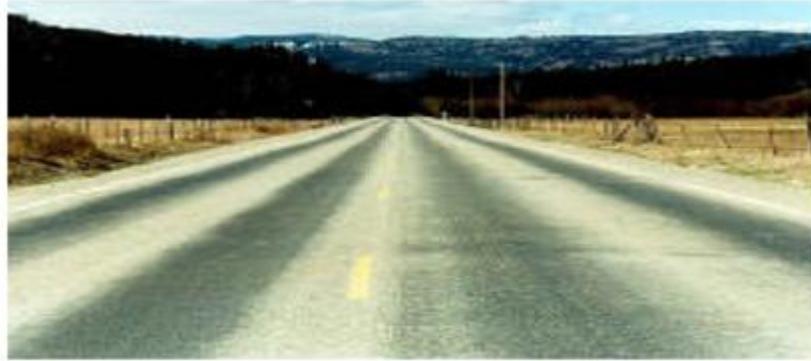
*Description:* Bleeding is defined as a film of asphalt binder on the pavement surface. It usually creates a shiny, glass-like reflecting surface (as in the third photo) that can become quite sticky. Figures 22 and 23 illustrate various forms of bleeding.

*Figure 22 Bituminous Surface Treatment Bleeding in Wheel Paths*

- Excessive asphalt binder in the HMA (either due to mix design or manufacturing).
- Excessive application of asphalt binder during Bituminous Surface Treatment (BST) application (as shown in figures 22 and 23).
- Low HMA air void content (e.g., not enough room for the asphalt to expand into during hot weather).

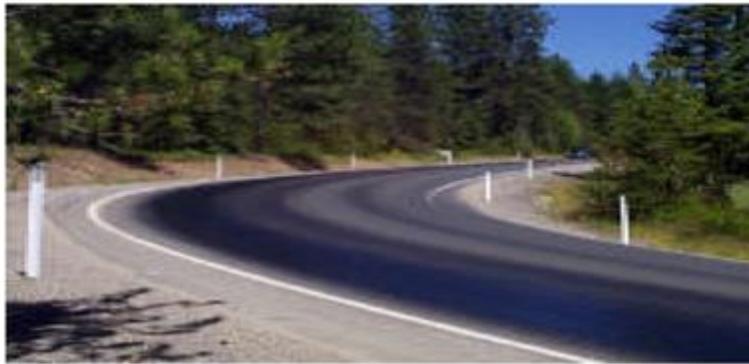
*Figure 23 HMA Bleeding from Overasphalting*

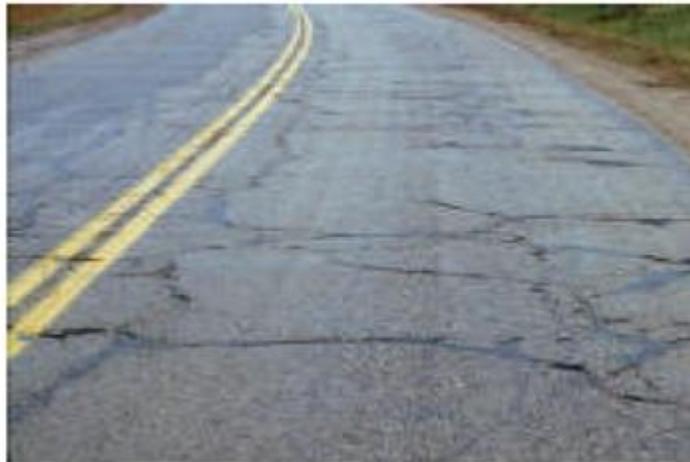
*Description:* Block cracking is defined as interconnected cracks that divide the pavement up into rectangular pieces as shown in Figure 24. Blocks range in size from approximately 0.1 m<sup>2</sup> (1 ft<sup>2</sup>) to 9 m<sup>2</sup> (100 ft<sup>2</sup>). Larger blocks are generally classified as longitudinal and transverse cracking. Block cracking normally occurs over a large portion of pavement area but sometimes will occur only in non-traffic areas.

*Figure 24 Block Cracking*

*Problem:* Allows moisture infiltration, roughness.

*Possible Causes:* HMA shrinkage and daily temperature cycling. Typically, caused by an inability of asphalt binder to expand and contract with temperature cycles because of the following:

*Repair:* Strategies depend upon the severity and extent of the block cracking:

- Low severity cracks (< 1/2 inch wide). Crack seal to prevent (1) entry of moisture into the subgrade through the cracks and (2) further raveling of the crack edges. HMA can provide years of satisfactory service after developing small cracks if they are kept sealed.
- High severity cracks (> 1/2-inch-wide and cracks with raveled edges). Remove and replace the cracked pavement layer with an overlay.

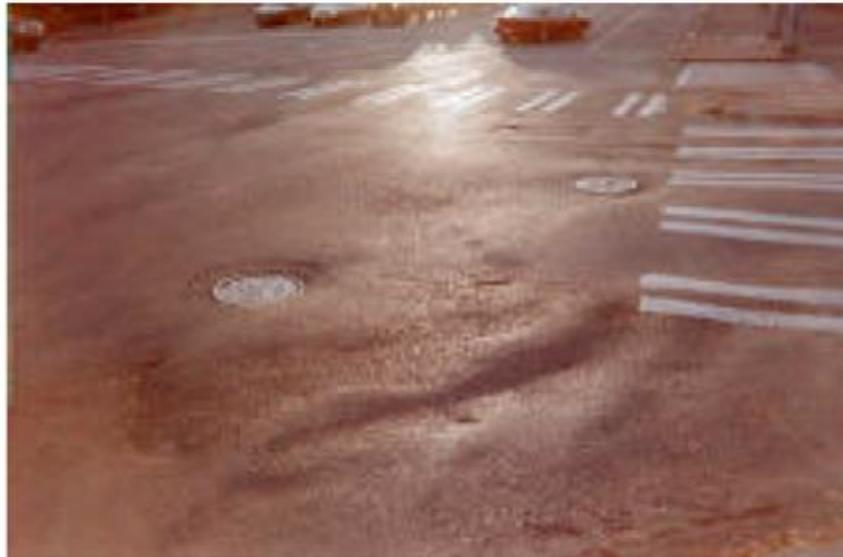
*Description:* Corrugating and shoving is a form of plastic movement typified by ripples (corrugation) or an abrupt wave (shoving) across the pavement surface as illustrated in Figure 25. The distortion is perpendicular to the traffic direction. Usually occurs at points where traffic starts and stops (corrugation) or areas where HMA abuts a rigid object (shoving).

*Figure 25 Corrugation and Shoving*

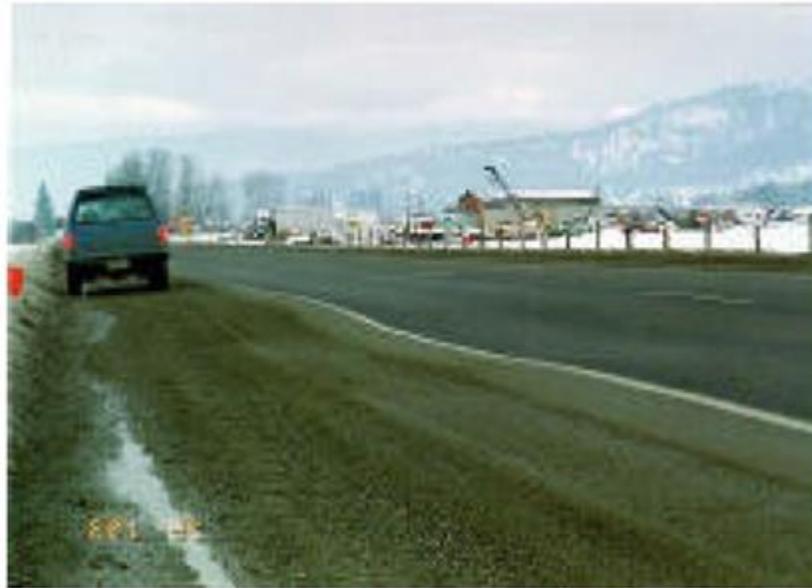
*Description:* Depression is defined as localized pavement surface areas with slightly lower elevations than the surrounding pavement as illustrated in Figure 26. Depressions are very noticeable after a rain when they fill with water.

*Figure 26 Depression in Left Lane and Shoulder*

*Problem:* Roughness, depressions filled with substantial water can cause vehicle hydroplaning.

*Possible Causes:* Frost heave or subgrade settlement resulting from inadequate compaction during construction.

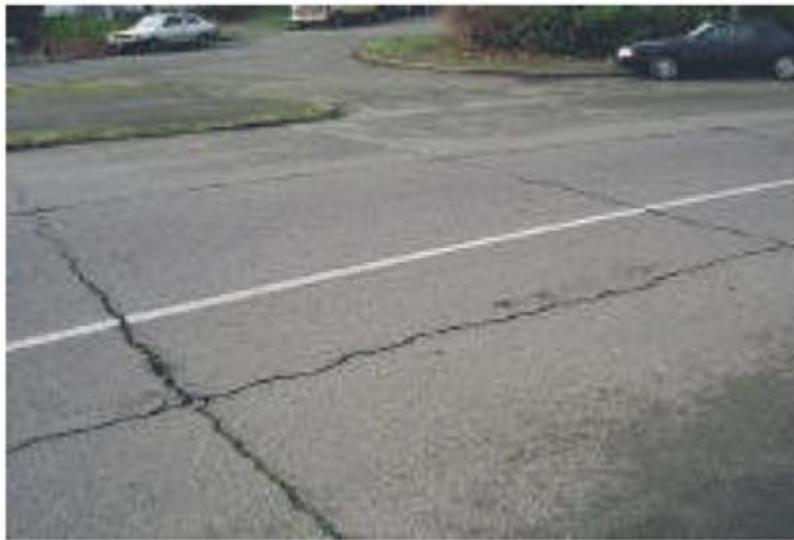
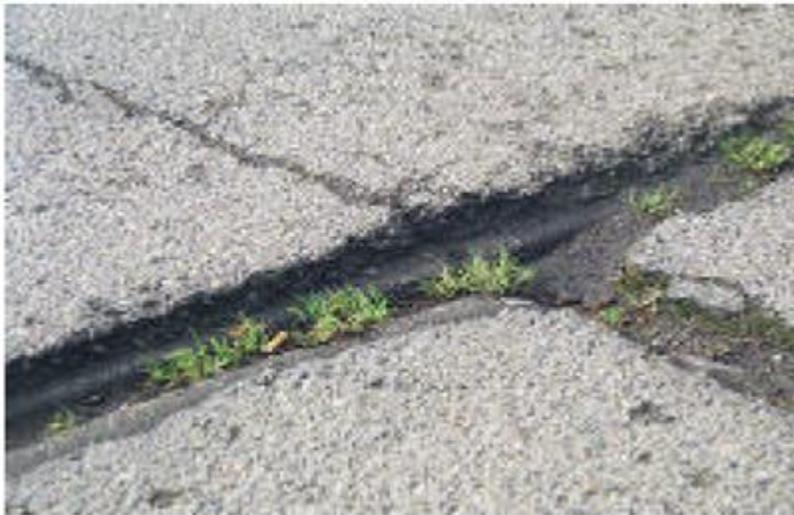
*Problem:* Allows moisture infiltration, roughness.

*Figure 27 Joint Reflection Cracking on an Arterial*

*Figure 28 Joint Reflection Cracking Close-Up*

*Repair:* Strategies depend upon the severity and extent of the cracking:

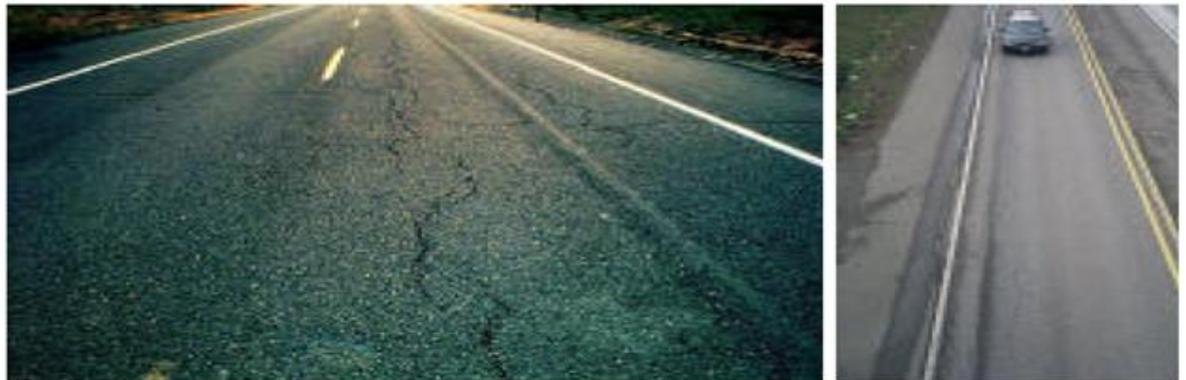
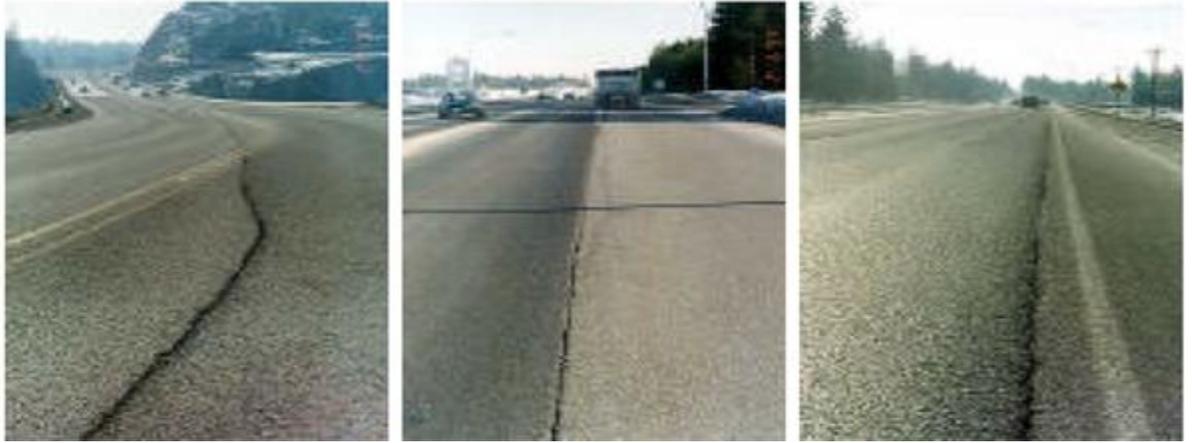
*Description:* Longitudinal cracking are cracks parallel to the pavement's centerline or laydown direction as illustrated in Figures 29 and 30. These cracks are usually a type of fatigue cracking.

*Figure 29 Longitudinal Cracking as the Onset of Fatigue Cracking*

*Figure 30 Longitudinal Cracking from Poor Joint Construction*

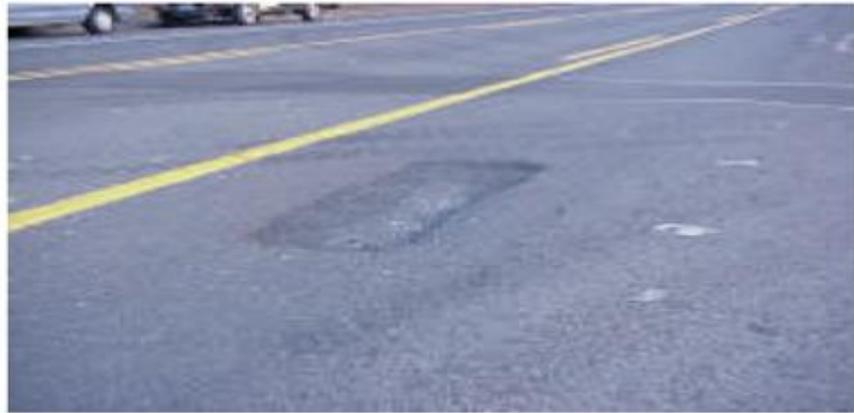
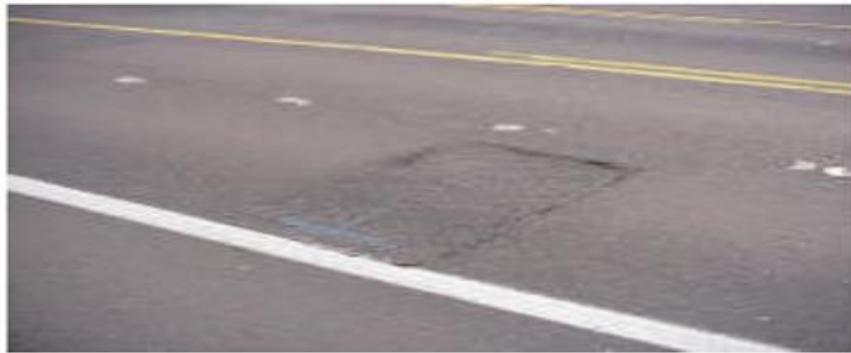
*Description:* Patching is defined as an area of pavement that has been replaced with new material to repair the existing pavement as illustrated in Figures 31, 32, and 33. A patch is considered a defect no matter how well it performs.

*Figure 31 Failing Patch*

*Figure 32 Patch over Localized Distress*

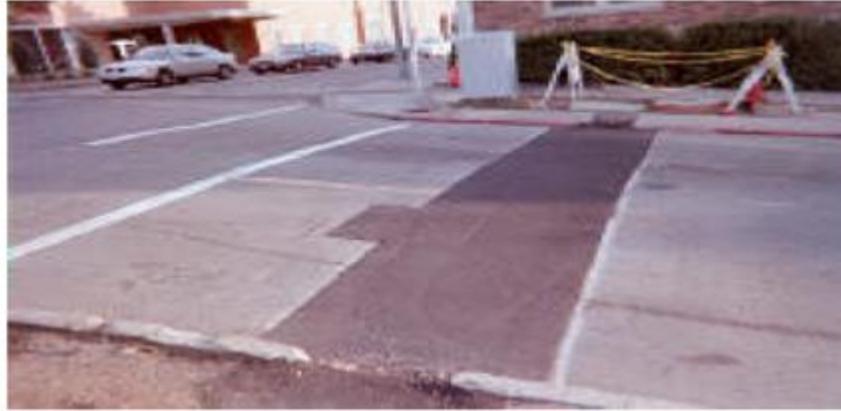
*Figure 33 Utility Cut Patch*

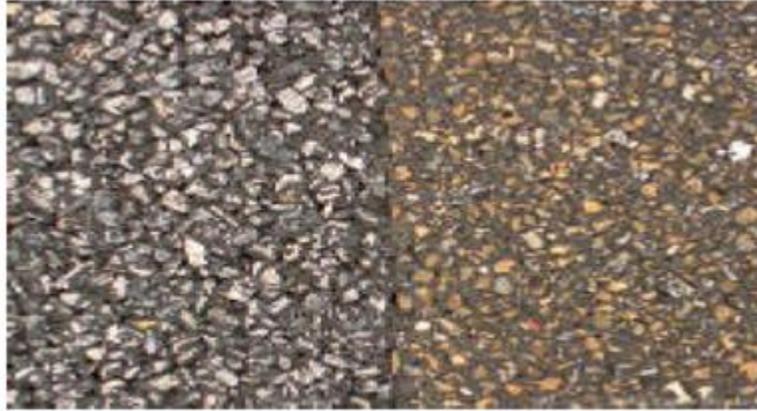
*Description:* Polished aggregates are areas of HMA pavement where the portion of aggregate extending above the asphalt binder is either very small or there are no rough or angular aggregate particles as illustrated in Figures 34 and 35.

*Figure 34 Stone Matrix Asphalt at a Test Track*

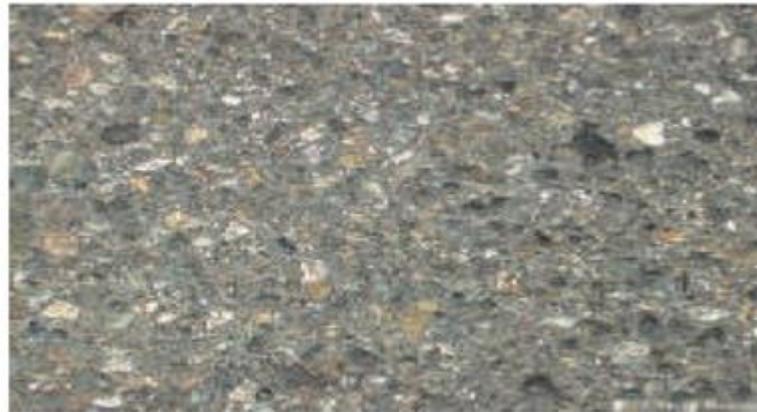
*Figure 35 Five Years of Wear*

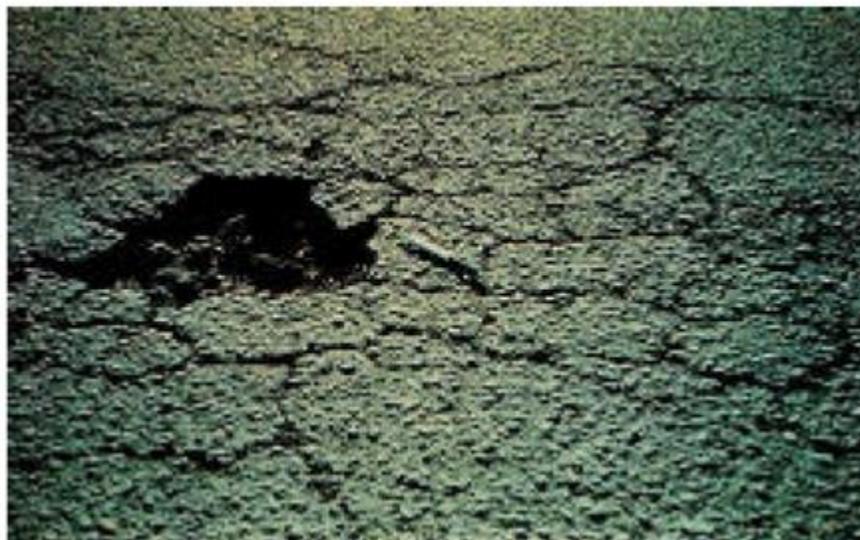
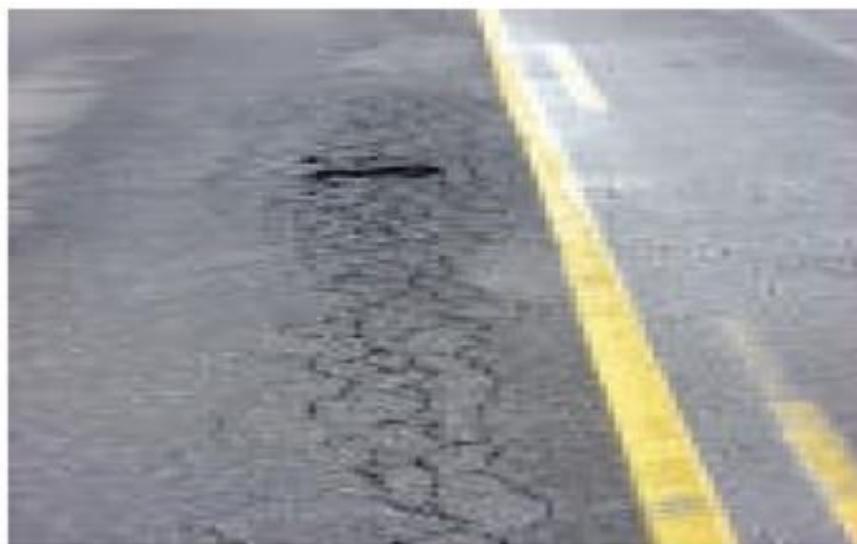
*Description:* Potholes are small, bowl-shaped depressions in the pavement surface that penetrate all the way through the HMA layer down to the base course as illustrated in Figures 36 and 37. They generally have sharp edges and vertical sides near the top of the hole. Potholes are most likely to occur on roads with thin HMA surfaces (25 to 50 mm (1 to 2 inches)) and seldom occur on roads with 100 mm (4 inch) or deeper HMA surfaces.

*Figure 36 Pothole from Fatigue Cracking*

*Figure 37 Developing Pothole*

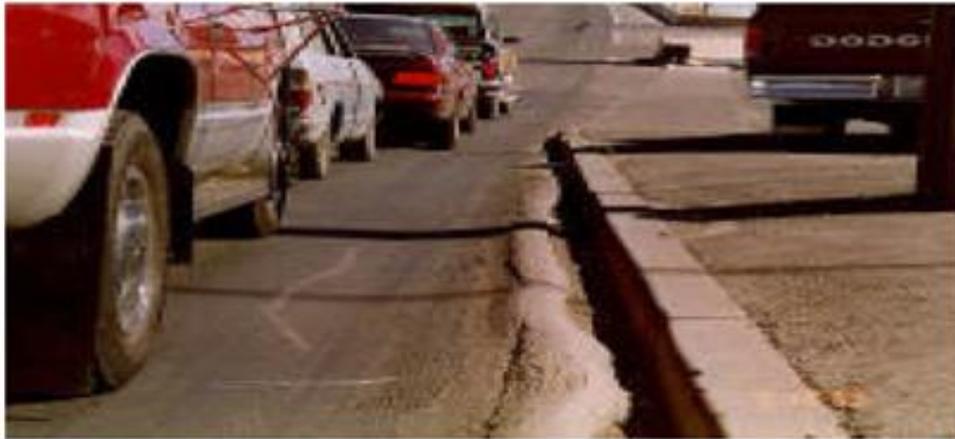
*Description:* Rutting is defined as surface depression in the wheel path as illustrated in Figures 40 and 41. Pavement uplift (shearing) may occur along the sides of the rut. Ruts are particularly evident after a rain when they are filled with water. There are two basic types of rutting: mix rutting and subgrade rutting. Mix rutting occurs when the subgrade does not rut yet the pavement surface exhibits wheel path depressions as a result of compaction/mix design problems. Subgrade rutting occurs when the subgrade exhibits wheel path depressions due to loading. In this case, the pavement settles into the subgrade ruts causing surface depressions in the wheel path.

*Figure 38 Mix Rutting*

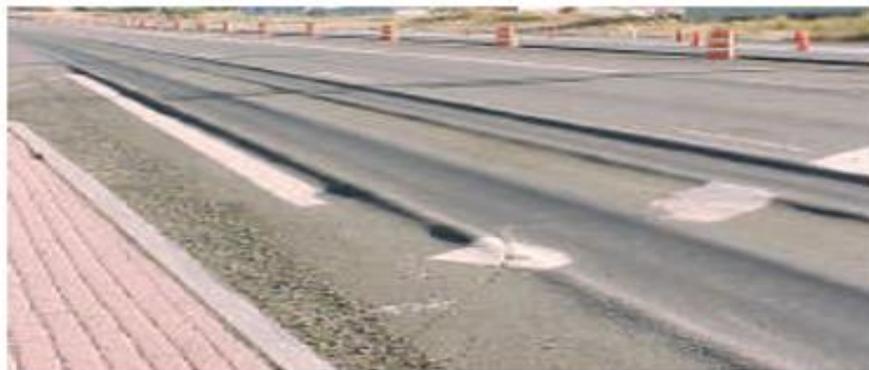
*Figure 39 Rutting from Mix Instability*

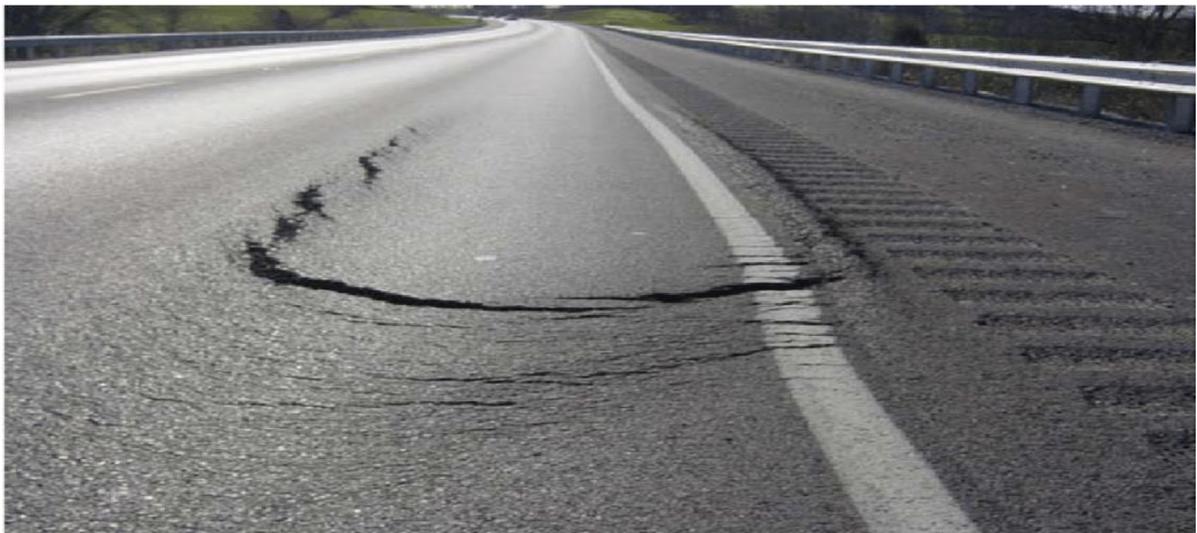
*Description:* Slippage cracking are crescent or half-moon shaped cracks generally having two ends pointed into the direction of traffic as illustrated in Figure 42.

*Figure 40 Slippage Cracking*

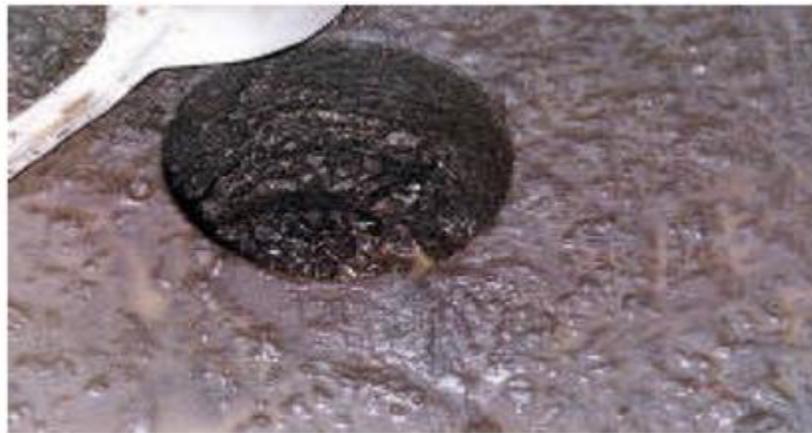
*Description:* Stripping is defined as the loss of bond between aggregates and asphalt binder that typically begins at the bottom of the HMA layer and progresses upward as illustrated in Figures 43, 44, and 45. When stripping begins at the surface and progresses downward it is usually called raveling. Figure 45 shows the surface effects of underlying stripping.

*Figure 41 Core Hole showing Stripping at the Bottom*

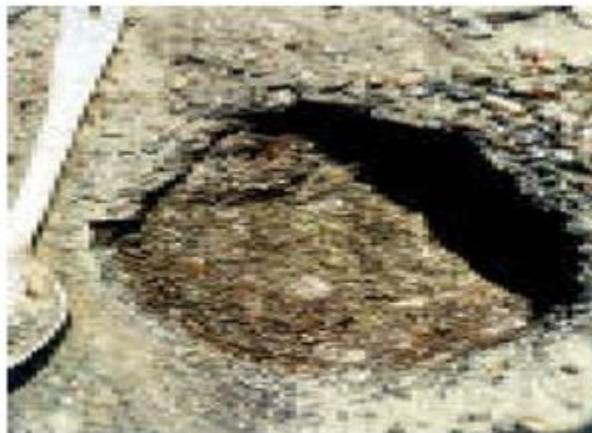
*Figure 42 Stripping at the Bottom of the Hole*

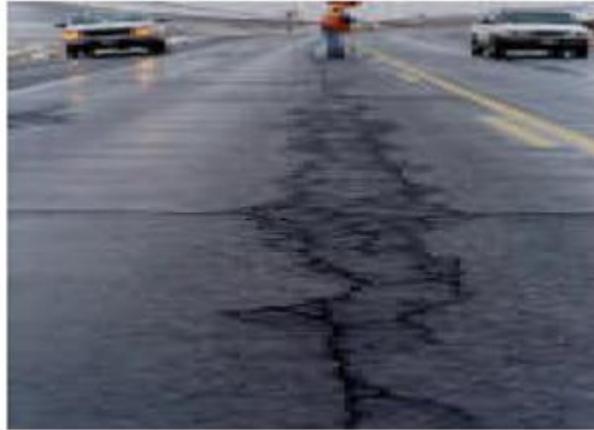
*Figure 43 Fatigue Failure from Stripping*

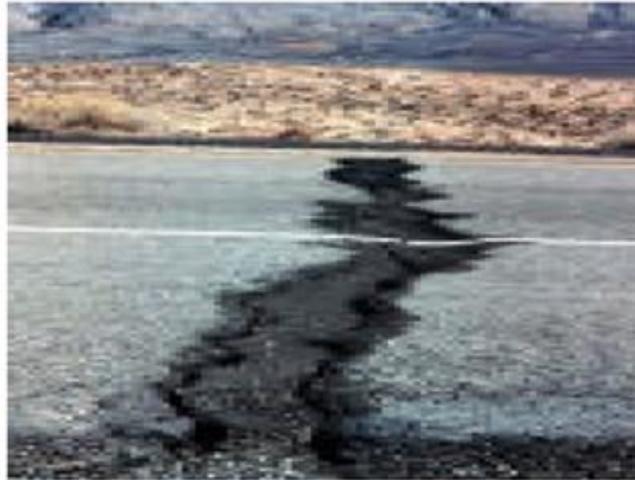
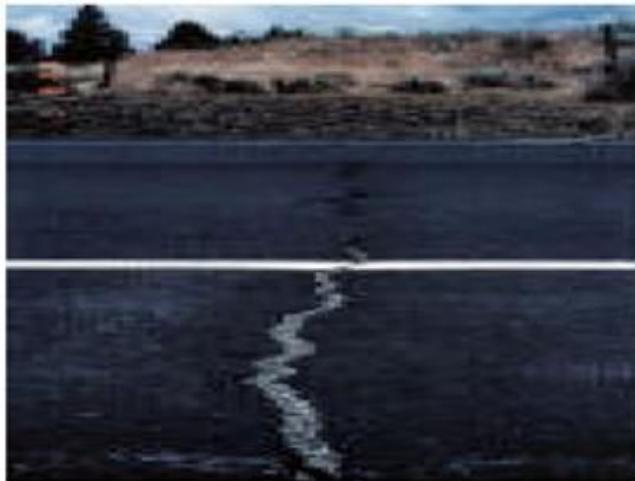
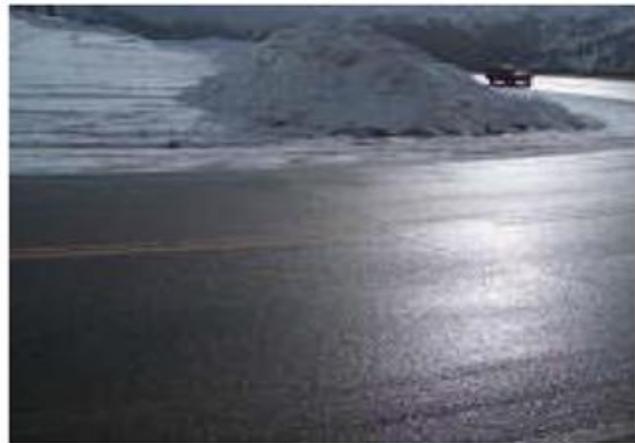
*Description:* Transverse or thermal cracking are cracks perpendicular to the pavement's centerline or lay down direction as illustrated in Figures 46, 47, and 48. Usually a type of thermal cracking.

*Figure 44 Large Patched Thermal Crack*

*Figure 45 Smaller Patched Thermal Crack*

*Figure 46 Small Thermal Crack*

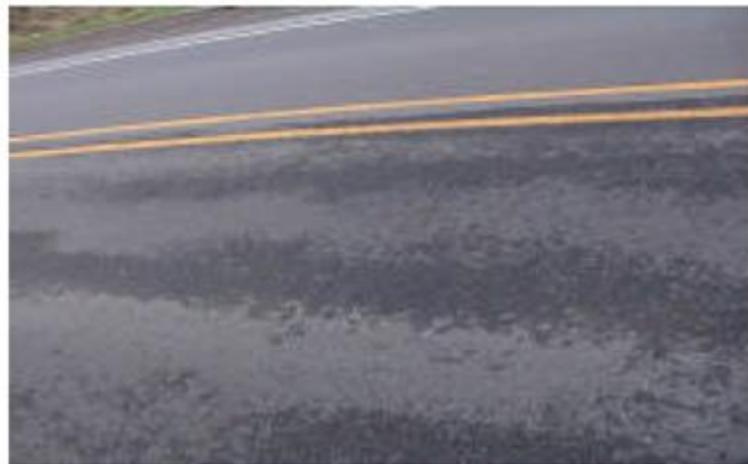
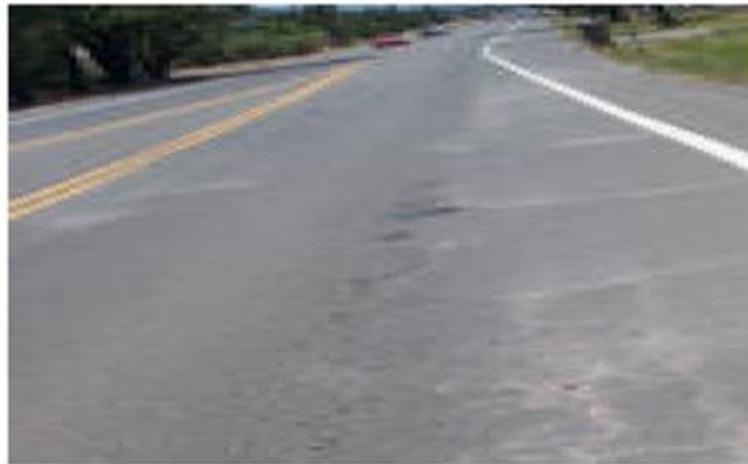
*Description:* Water bleeding occurs when water seeps out of joints or cracks or through an excessively porous HMA layer as illustrated in Figure 49. Pumping occurs when water and fine material is ejected from underlying layers through cracks in the HMA layer under moving loads as illustrated in Figure 50.

*Figure 47 Water Bleeding Up Close*

- Porous pavement as a result of inadequate compaction during construction or poor mix design.
- High water table.
- Poor drainage.

*Figure 48 Cement Treated Base Pumping through HMA Cracks*

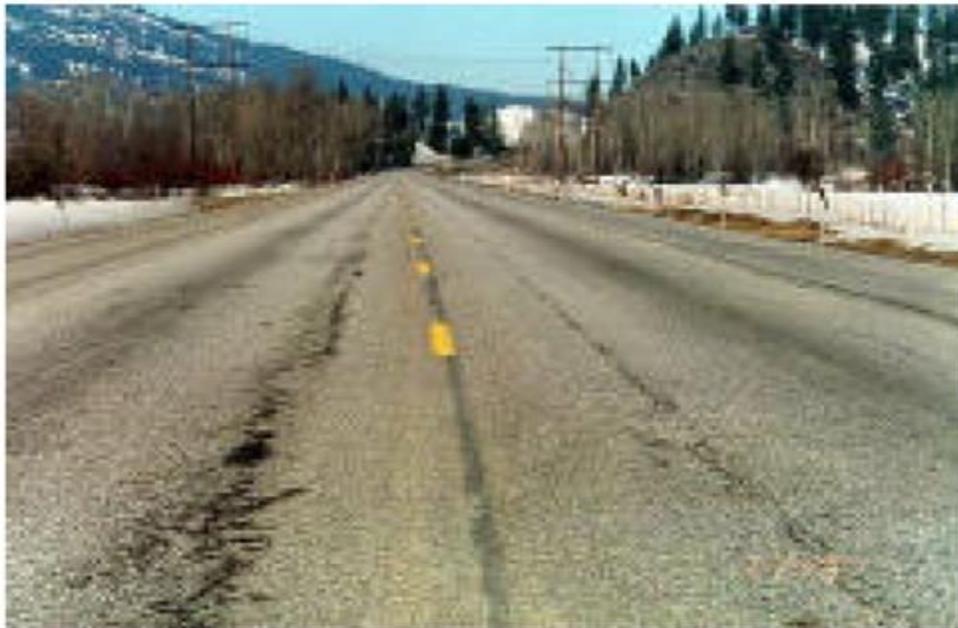
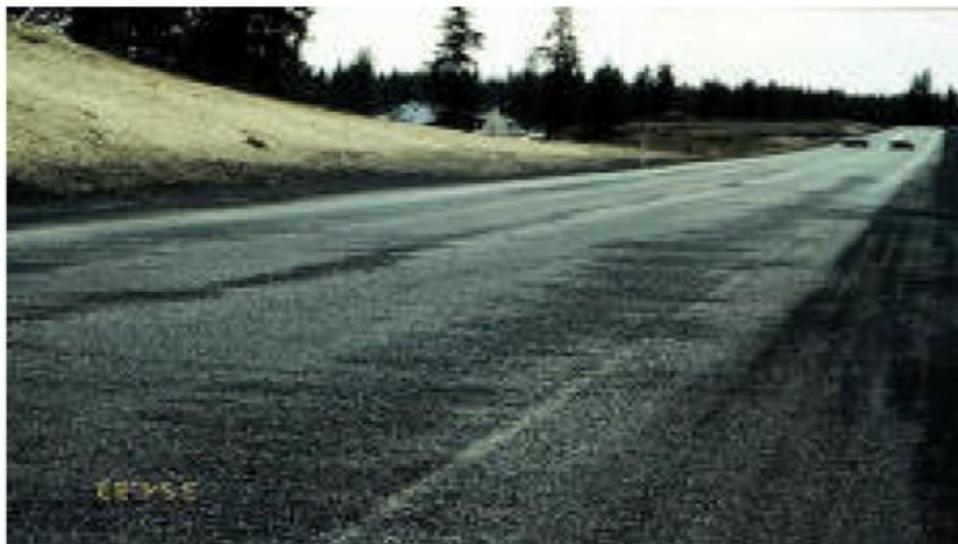
*Description:* As pavement ages and hardens, the asphalt binder and fine aggregate may begin to wear away. This process is called weathering. As weathering progresses, the coarse aggregate becomes exposed, dislodged, and missing, resulting in a distress called raveling; so raveling can be defined as the progressive disintegration of an HMA layer from the surface downward as a result of the dislodgement of aggregate particles as illustrated in Figures 38 and 39.

*Figure 49 Raveling Due to Low Density*

*Figure 50 Raveling from Snow Plot*
