# **Distresses and Treatment/Repair Methods in Flexible and Rigid Pavements**

Course No: C05-030  
Credit: 5 PDH

Najib Gerges, Ph.D., P.E.

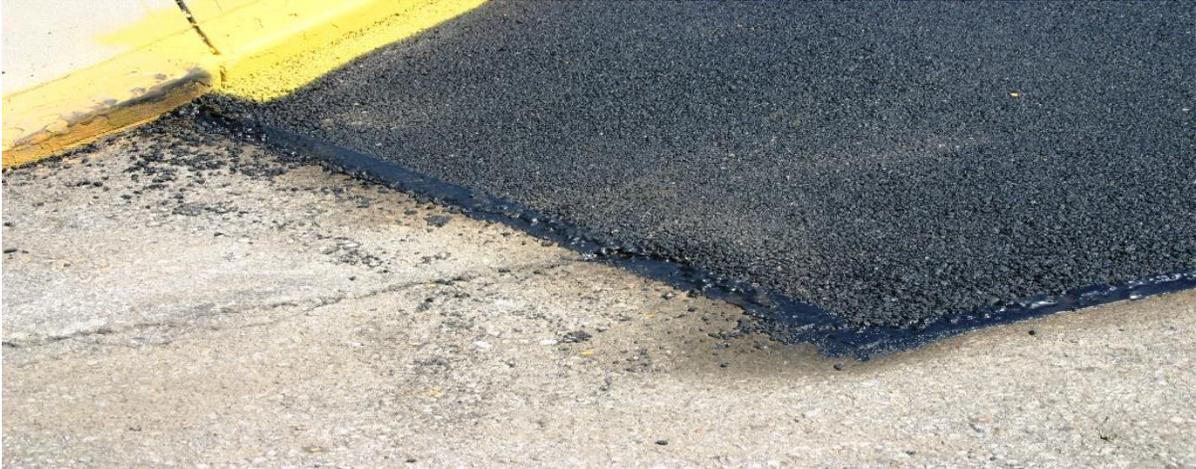
*Definition:* Asphalt Surface Treatments refer to the reconditioning of the wearing (surface) course of older existing asphalt pavements. The term may also be applied to the final phases of new asphalt pavement construction. Surface treatments are installed by placing a layer of new asphalt binder on the existing pavement as illustrated in Figure 51.

*Figure 51 New Asphalt Binder over an Existing Pavement*

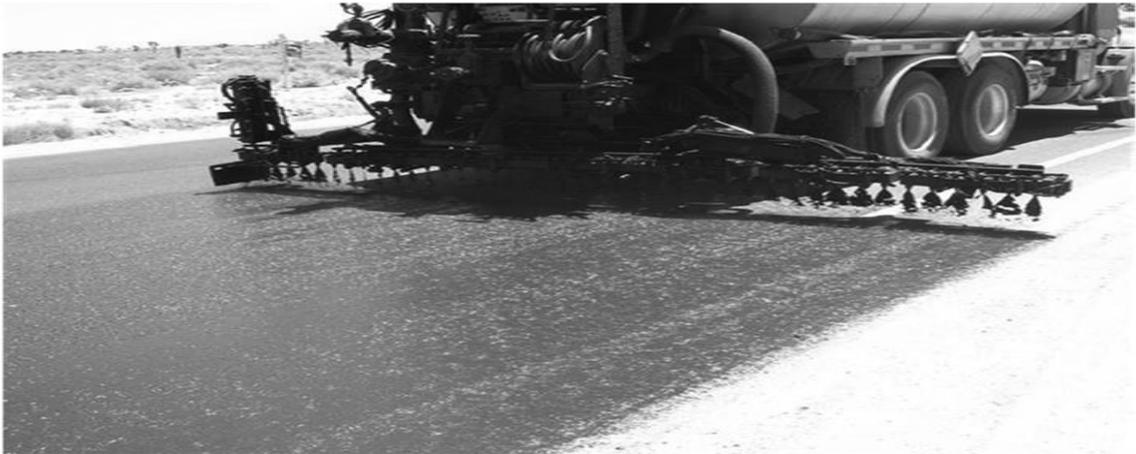
Fog Seal contains globules of paving asphalt, water, an emulsifying agent or surfactant, and sometimes a rejuvenator. Soap is a common form of a surfactant. A rejuvenator is an asphalt additive that when applied to the existing pavement will slightly soften the pavement it is applied to creating a better bond.

*Figure 52 Fog Seal*

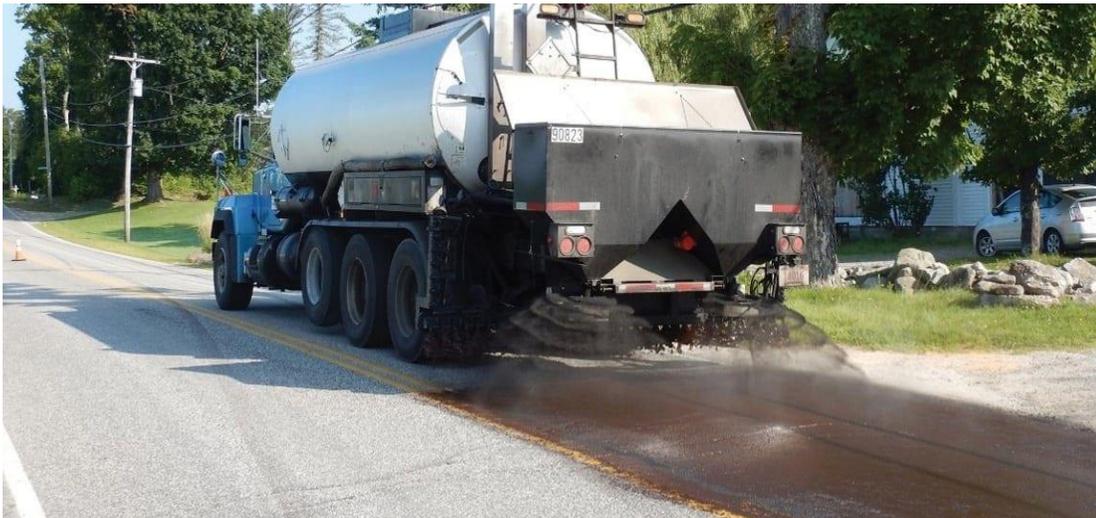
*Figure 53 Fog Seal Application*

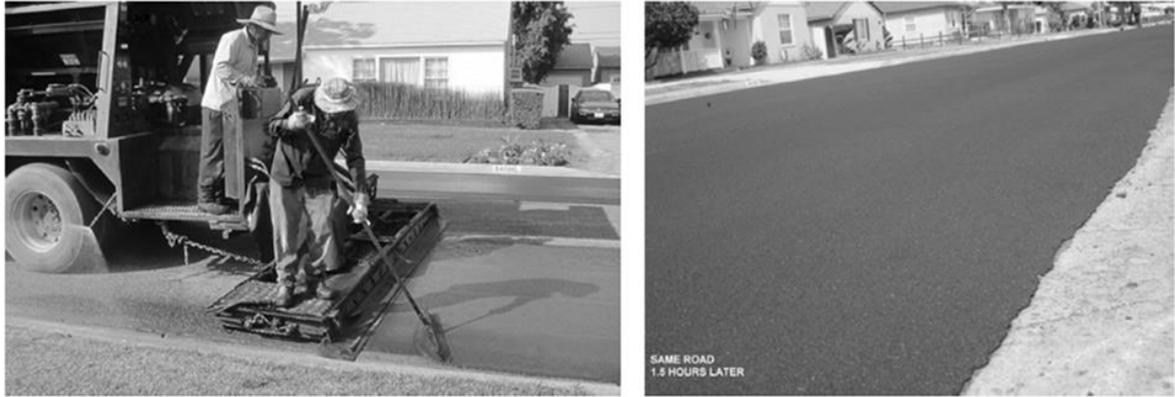
It is applied in a thin layer of 3- to 6-mm layers to seal the pavement. and prevent some minor distresses such as raveling, minor/narrow cracks, crack joints, mat tearing, etc. However, it provides no structural strength. A Slurry Seal is similar to a Fog Seal except the slurry seal has aggregates as part of the mixture.

*Figure 54 Slurry Seal*

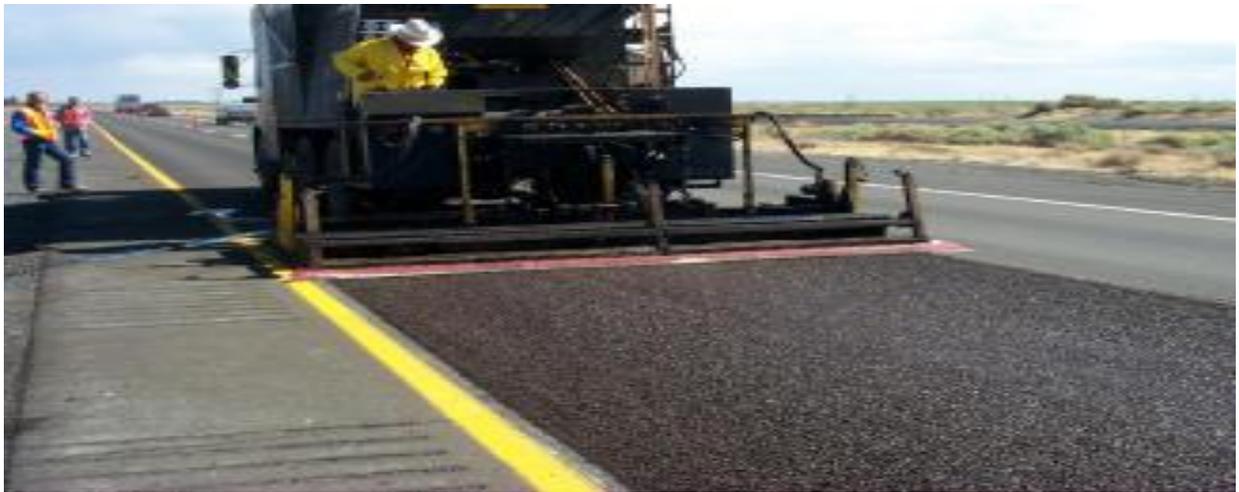
Slurry Seal is the mixture of water, asphalt emulsion, well-graded fine aggregate, and some additives as shown in Figures 54 and 55.

*Figure 55 Slurry Seal Application*

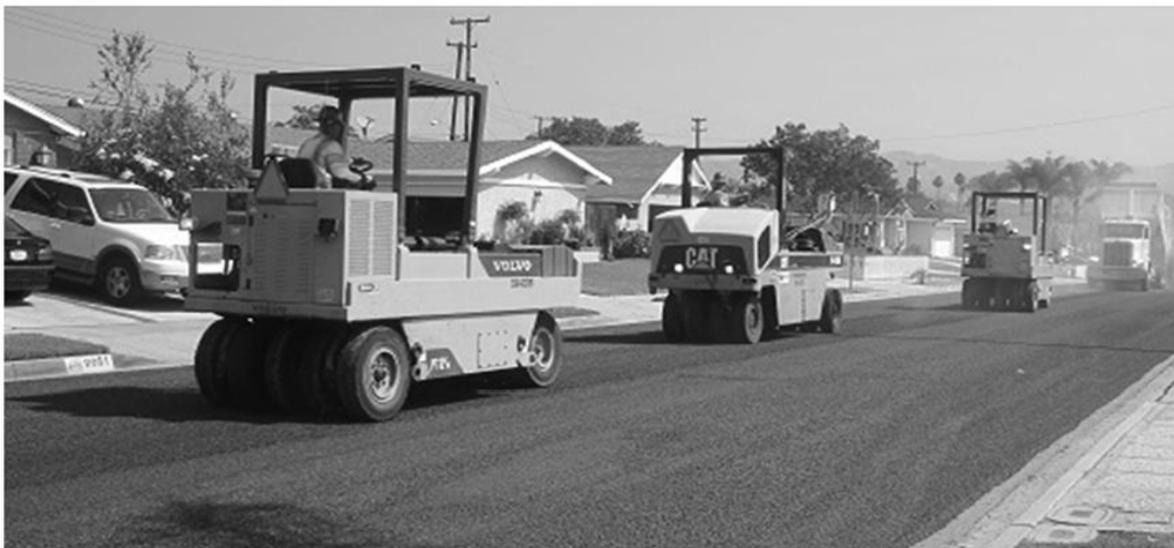
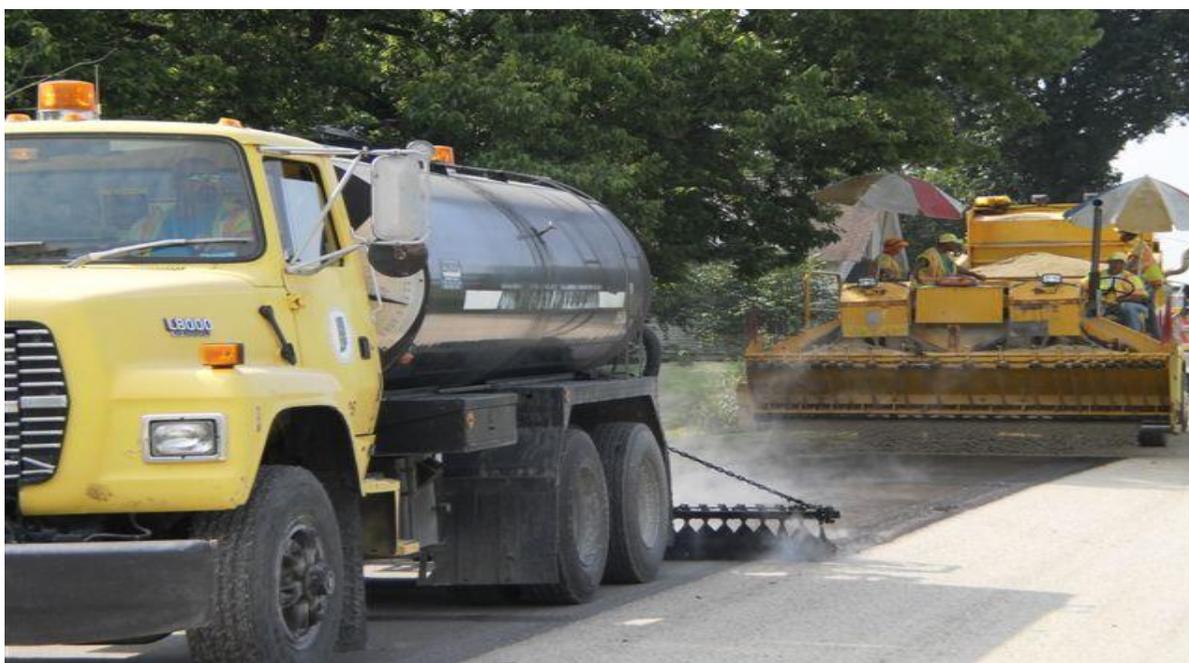
Asphalt emulsions used in Chip Seal applications contain globules of paving asphalt, water, an emulsifying agent or surfactant, polymer, and sometimes a rejuvenator.

*Figure 56 Chip Seal*

*Figure 57 Chip Seal Application*

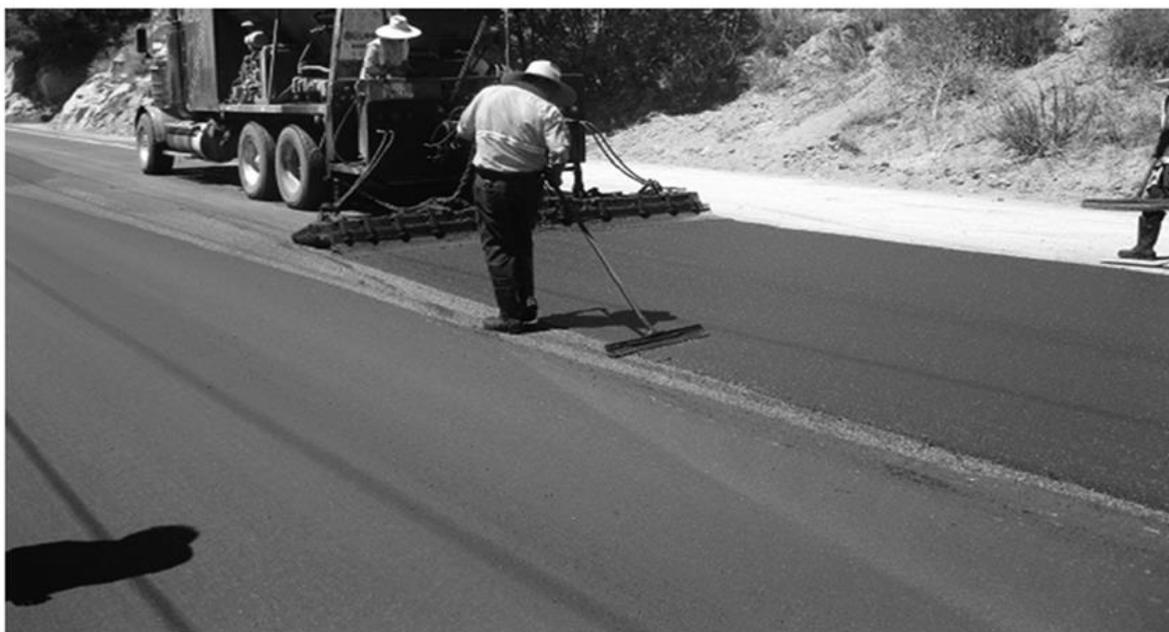
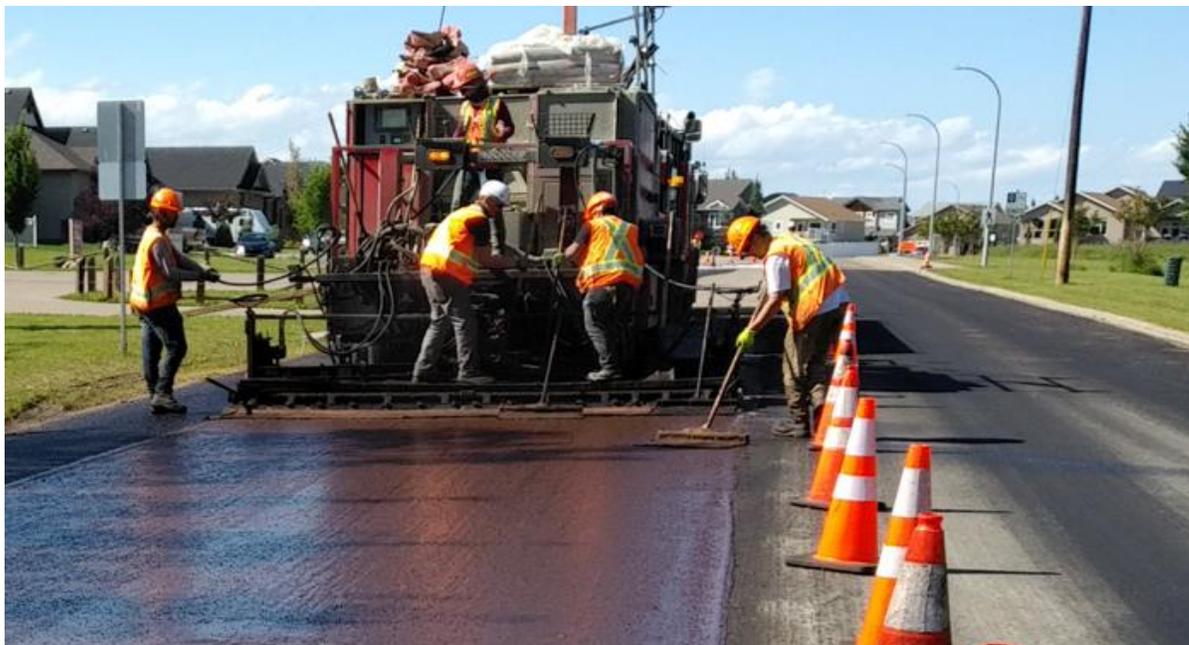
The major difference between Slurry Seal and Microsurfacing is in how they “break” or harden. Slurry relies on evaporation of the water in the asphalt emulsion. The asphalt emulsion used in Microsurfacing contains chemical additives that allow it to break without relying on the sun or heat for evaporation to occur. Refer to Figures 58 and 59.

*Figure 58 Microsurfacing*

*Figure 59 Microsurfacing Application*

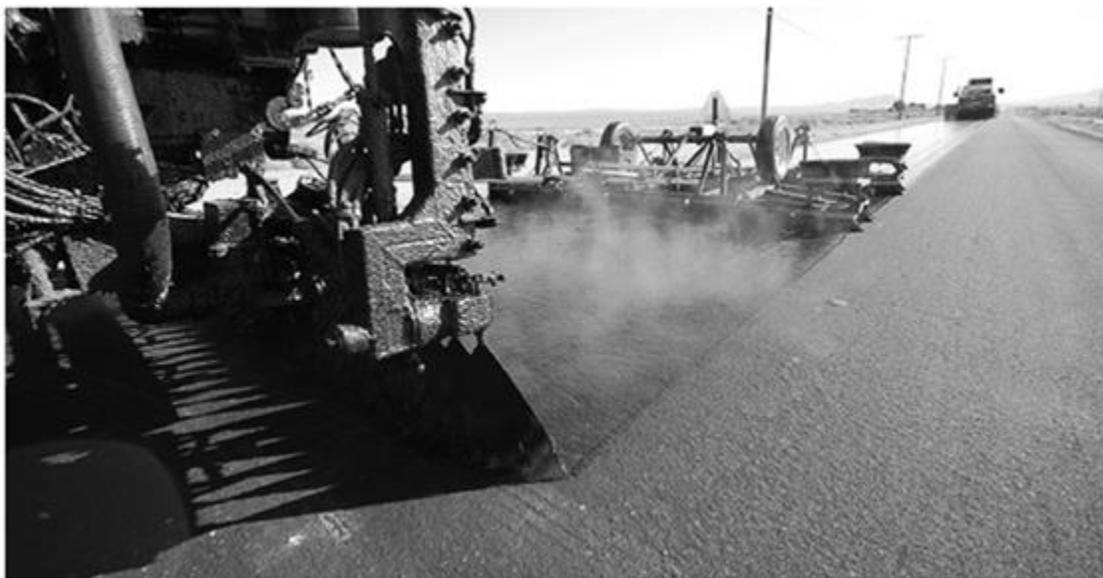
The only difference is that the asphalt emulsion is applied to the surface of the road through a series of brooms placed at different angles.

*Figure 60 Scrub Seal*

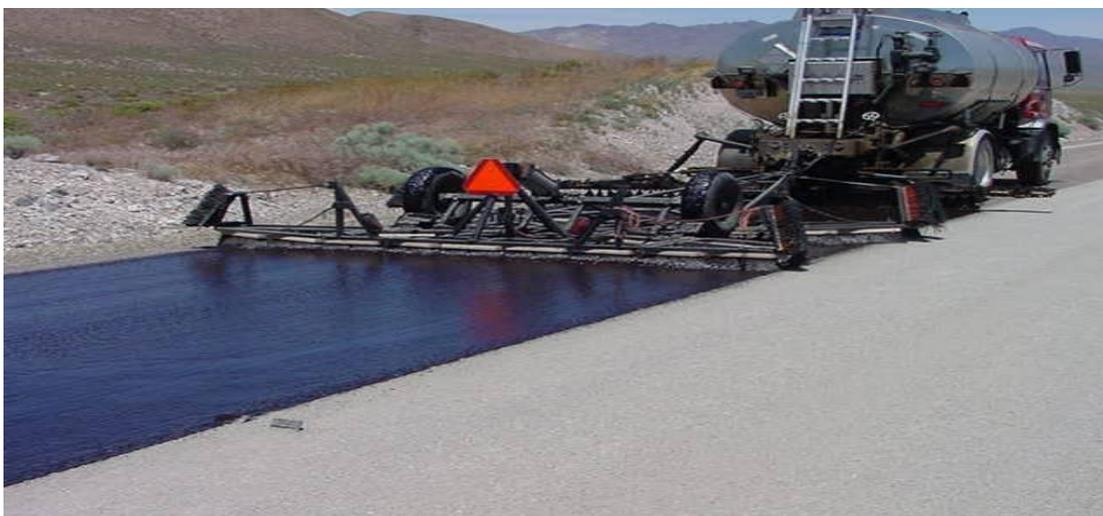
*Figure 61 Scrub Seal Application*

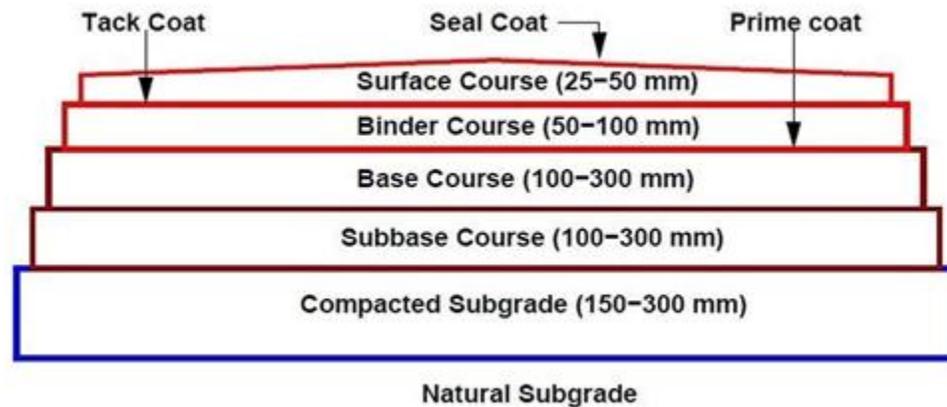
*Figure 64 Typical Layers of a Flexible Pavement*

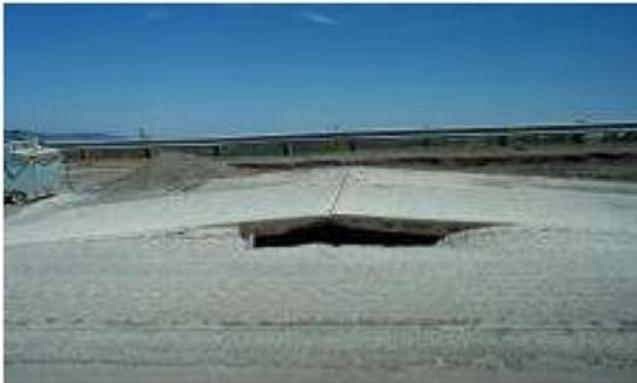
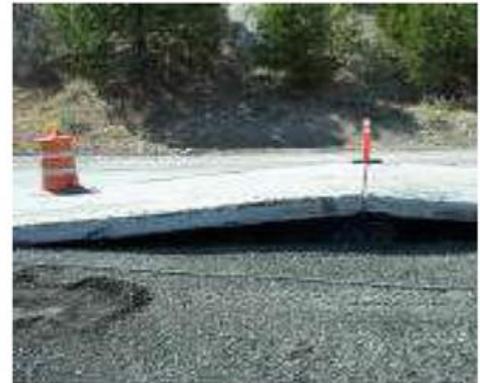
*Description:* Blowup or buckling is a localized upward slab movement and shattering at a joint or crack as illustrated in Figure 65. Usually occurs in spring or summer and is the result of insufficient room for slab expansion during hot weather.

*Figure 65 Severe Blowup*

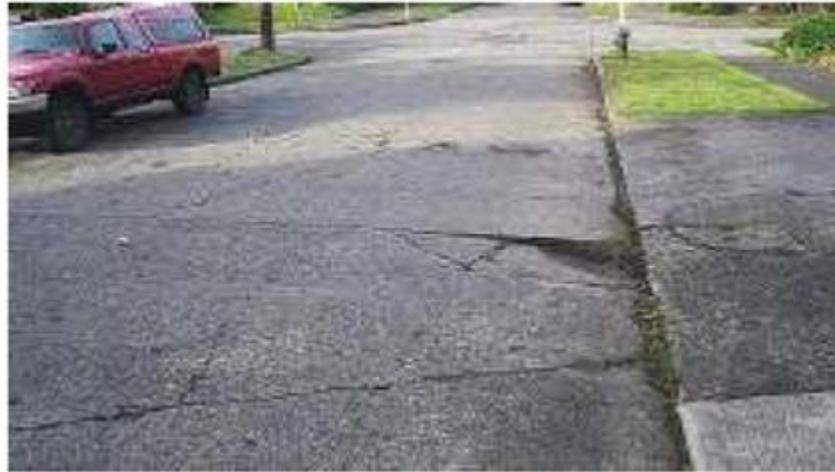
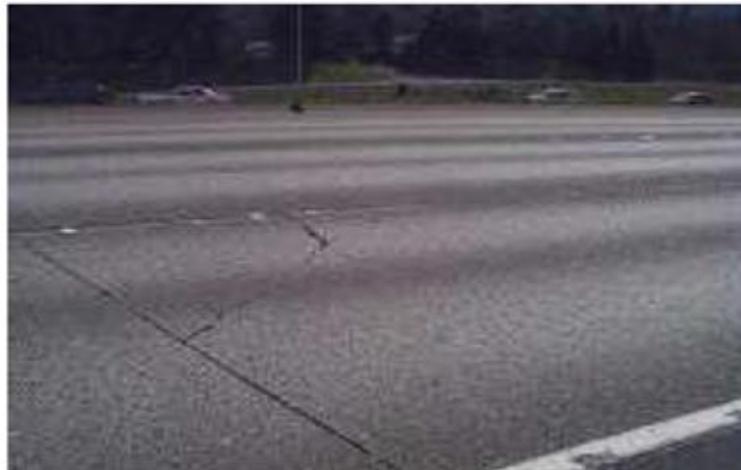
*Description:* Corner break is a crack that intersects the PCC slab joints near the corner as illustrated in Figures 66 and 67. "Near the corner" is typically defined as within about 2 m (6 ft) or so. A corner break extends through the entire slab and is caused by high corner stresses.

*Figure 66 Corner Break on a Residential Street*

*Figure 67 Corner Break on a Highway*

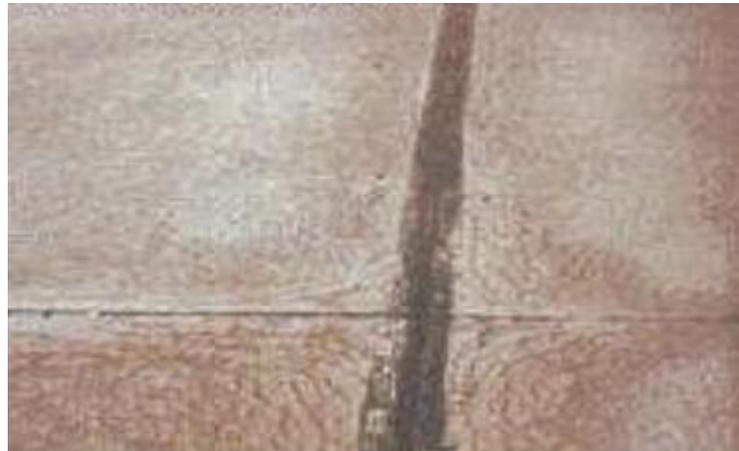
*Description:* Durability cracking is a series of closely spaced, crescent-shaped cracks near a joint, corner or crack as illustrated in Figure 68. It is caused by freeze-thaw expansion of the large aggregate within the PCC slab. Durability cracking is a general PCC distress and is not unique to pavement PCC.

*Figure 68 D Cracking at Panel Corners*

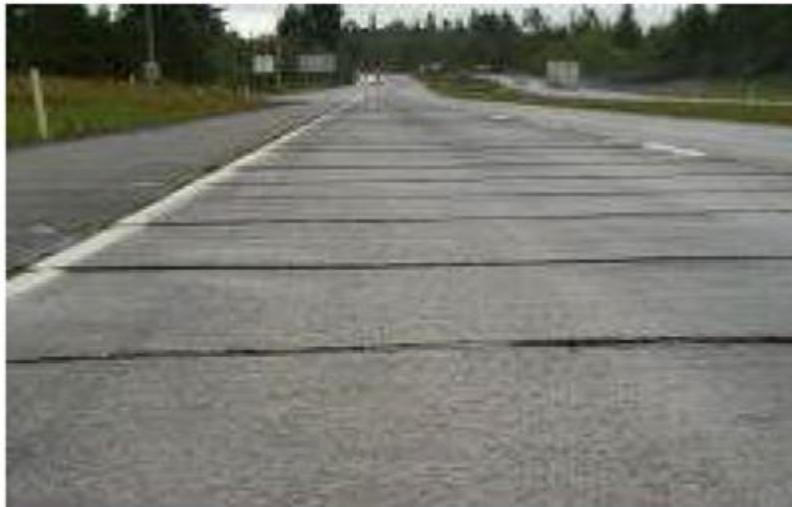
*Description:* Faulting is defined as the difference in elevation across a joint or crack usually associated with undoweled JPCP as illustrated in Figures 69, 70, and 71. Usually the approach slab is higher than the leave slab due to pumping, the most common faulting mechanism. Faulting is noticeable when the average faulting in the pavement section reaches about 2.5 mm (0.1 inch). When the average faulting reaches 4 mm (0.15 in), diamond grinding or other rehabilitation measures should be considered.

*Figure 69 Faulting from Ground Level*

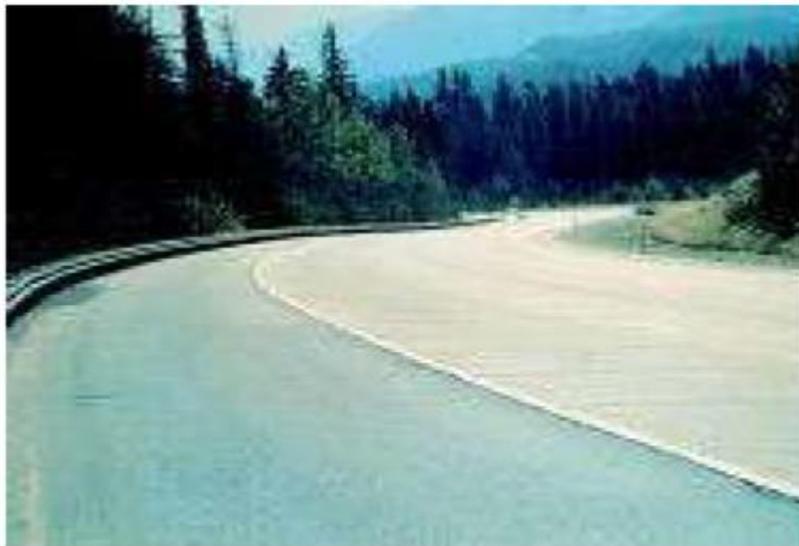
*Figure 70 Faulting in the Truck Lane*

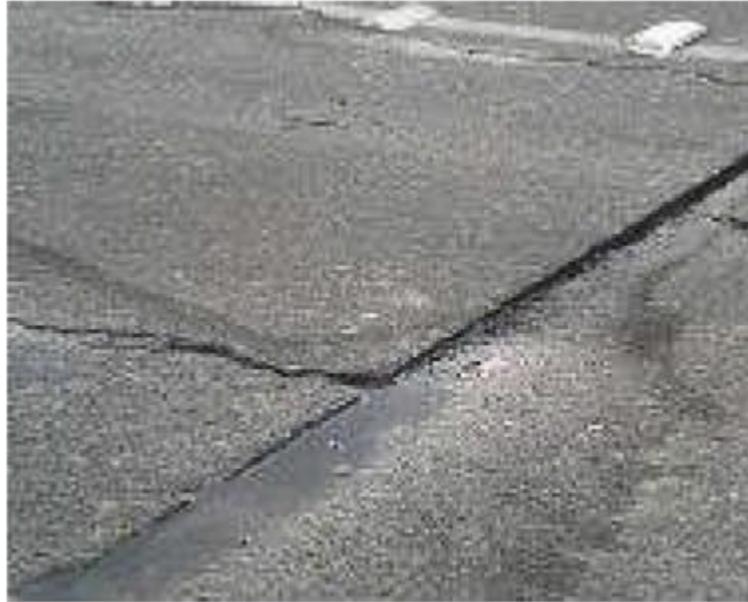
*Figure 71 Faulting Up-Close a Bus Stop*

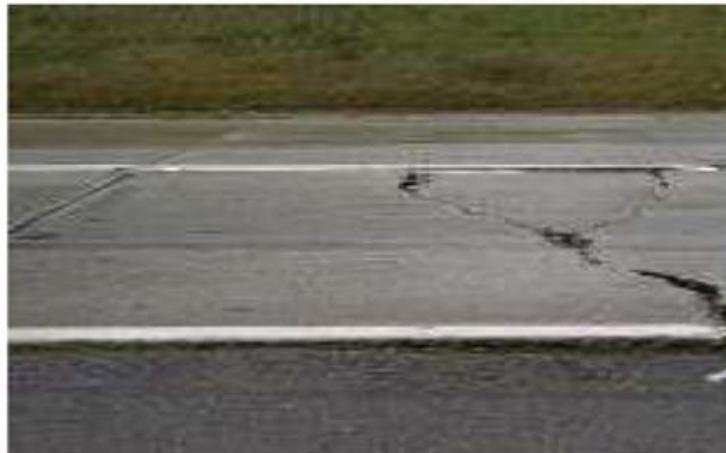
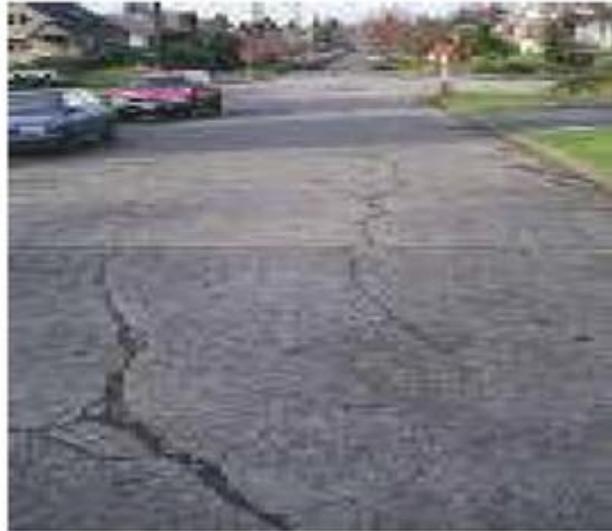
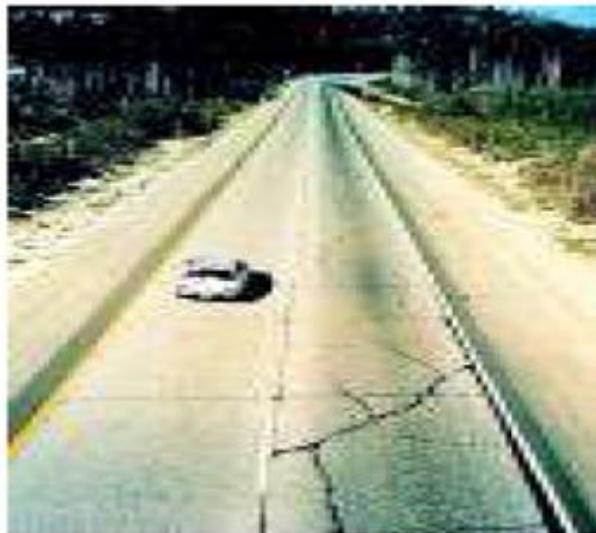
*Description:* Linear cracking are linear cracks not associated with corner breaks or blowups that extend across the entire slab as illustrated in Figures 73, 74, and 75. Typically, these cracks divide an individual slab into two to four pieces.

*Figure 73 Large Panel Crack*

*Figure 74 Panel Crack on a Residential Street*

*Figure 75 Panel Cracking in the Truck Lane*

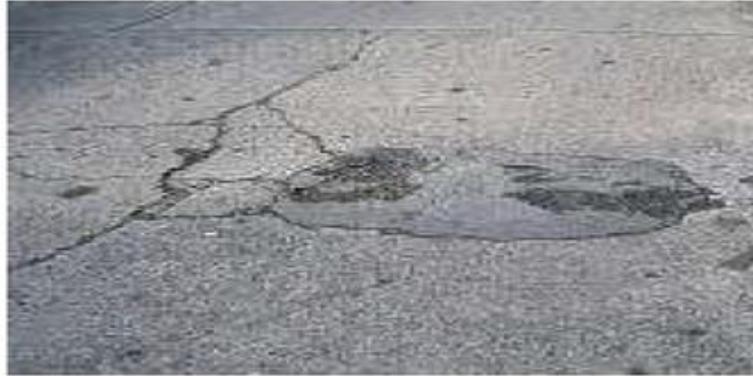
*Description:* Patching is an area of pavement that has been replaced with new material to repair the existing pavement as illustrated in Figures 76 and 77. A patch is considered a defect no matter how well it performs.

*Figure 76 Patching on a Residential Street*

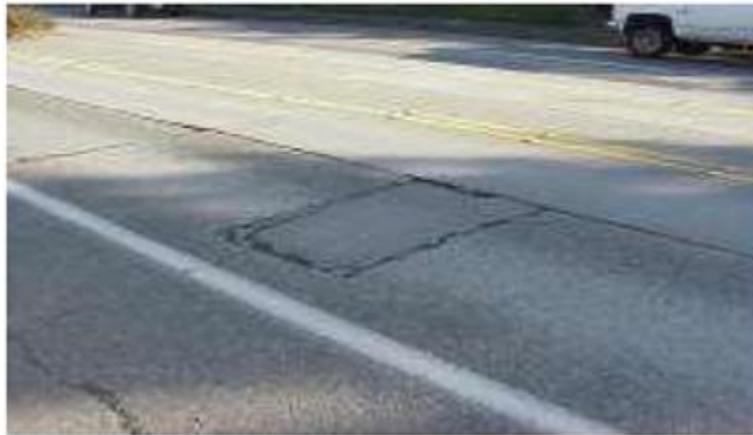
*Figure 77 Patching with Poor Edges*

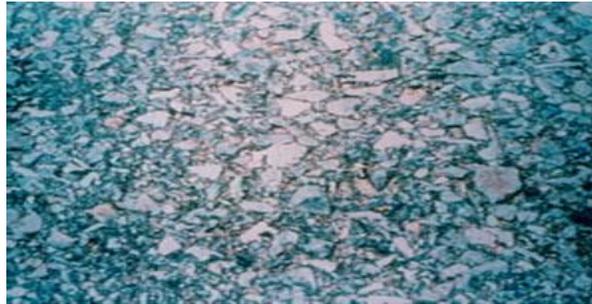
*Description:* Polished aggregates are areas of PCC pavement where the portion of aggregate on the surface contains aggregate particles as illustrated in Figure 78.

*Figure 78 Polished Aggregates*

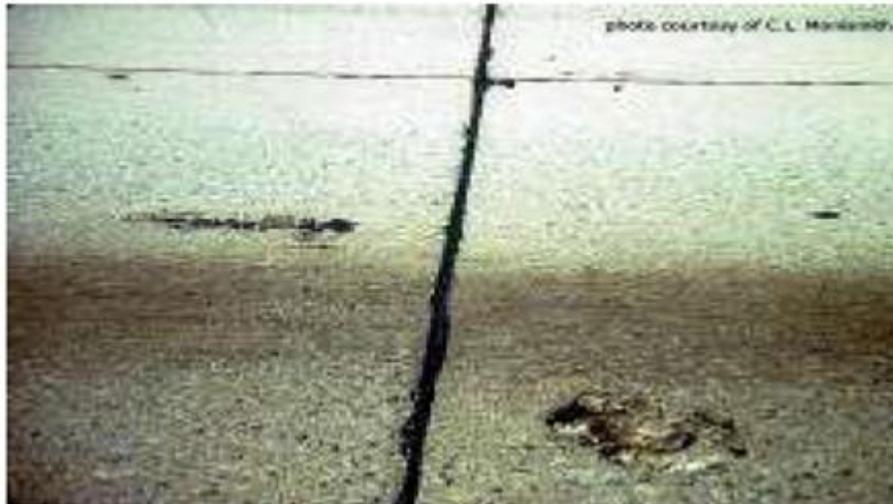
*Figure 79 Large Popouts*

*Repair:* Isolated low severity popouts may not warrant repair. Larger popouts or a group of popouts can generally be repaired with a partial-depth patch.

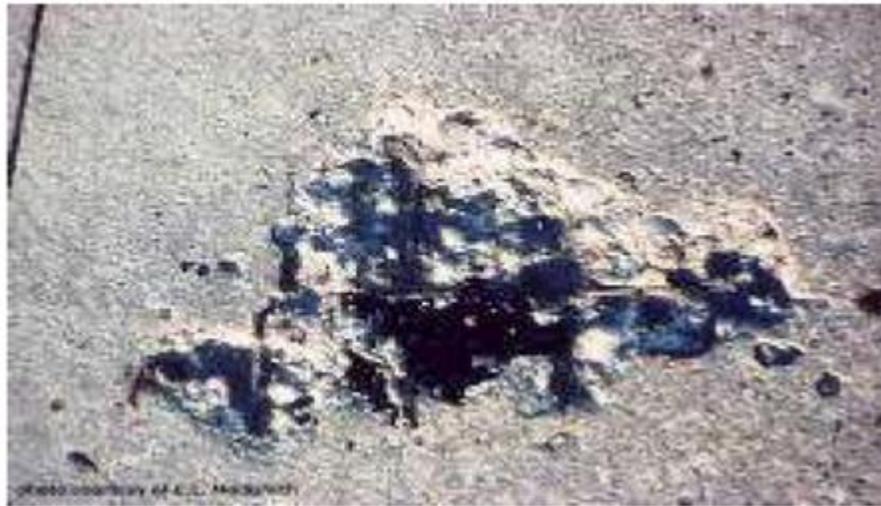
*Figure 80 Popout Close-up*

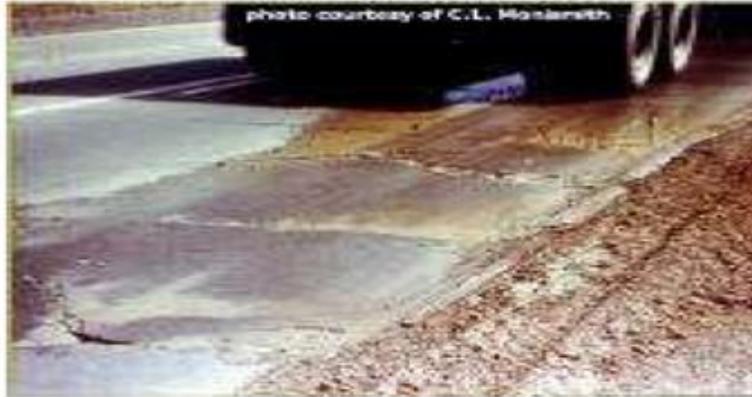
- Move from underneath one slab to underneath an adjacent slab. This type of movement leads to faulting.
- Move out from underneath the slab to the pavement surface. This results in a slow removal of base, subbase and/or subgrade material from underneath the slab resulting in decreased structural support.

*Figure 81 Pumping in Action*

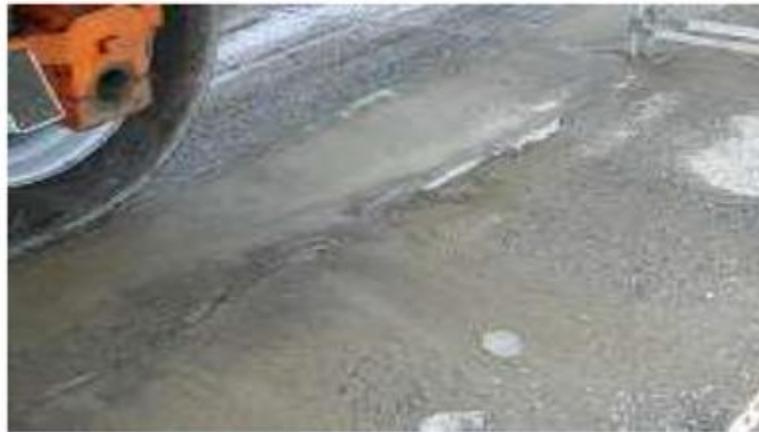
*Figure 82 Pumping Evidence during High Vehicle Simulator (HVS) Test*

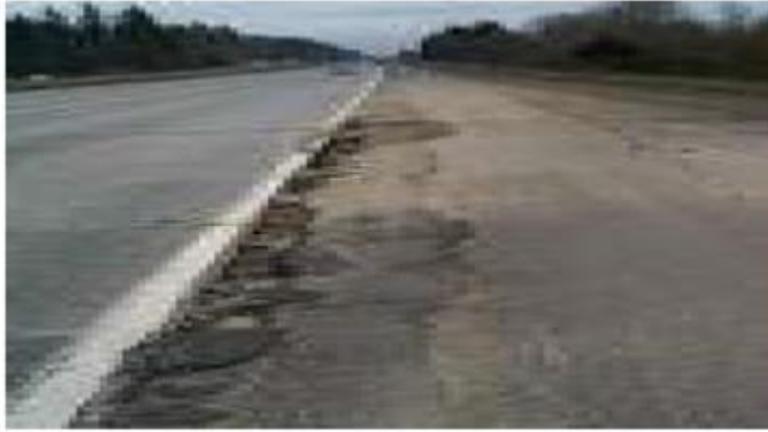
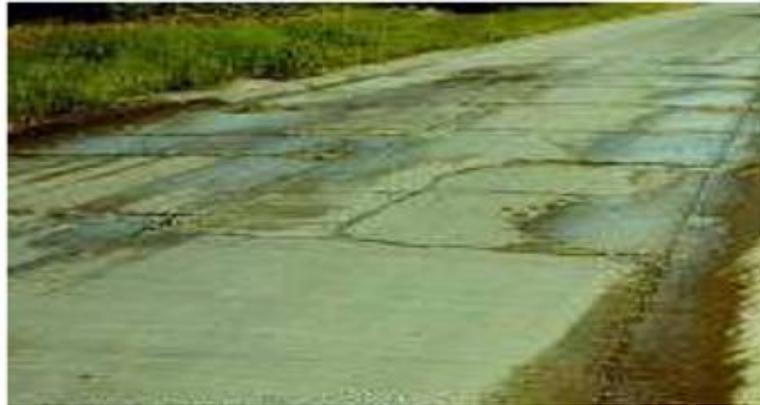
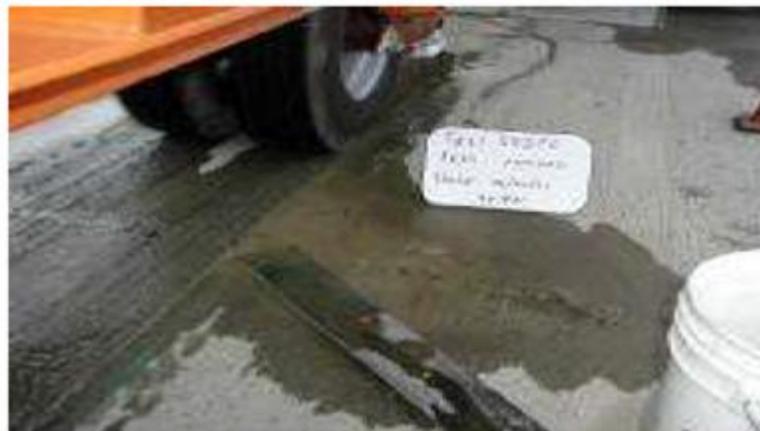
*Figure 83 Pumping Damage*

*Figure 84 Broken Slabs with Pumping Evidence*

*Figure 85 Additional Pumping Evidence during High Vehicle Simulator (HVS) Test*

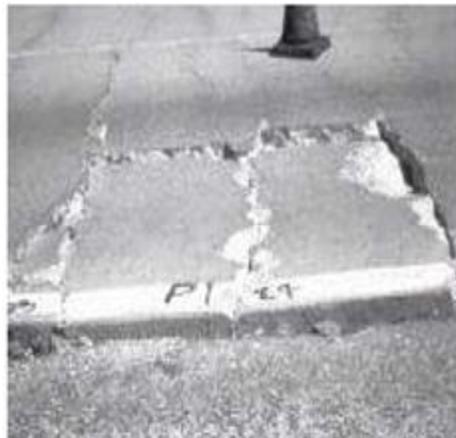
*Description:* Punchout is a localized slab portion broken into several pieces as illustrated in Figure 86. Typically, a concern only with CRCP.

*Figure 86 Severe Punchout*

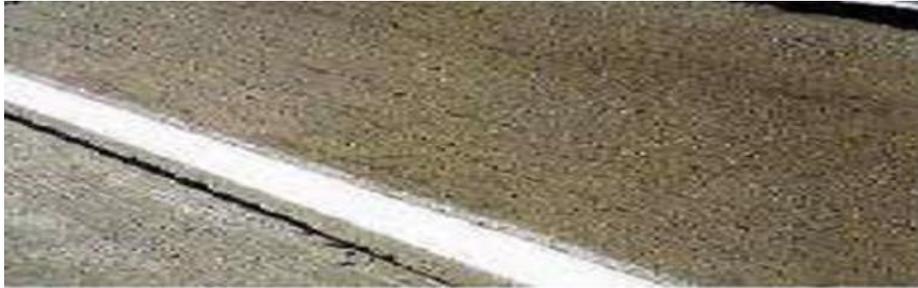
*Description:* Reactive aggregates distresses is a pattern or map cracking (crazing) on the PCC slab surface caused by reactive aggregates as illustrated in Figure 87. Reactive aggregates are those that either expand or develop expansive by products when introduced to certain chemical compounds.

*Figure 87 Severe Crazing*

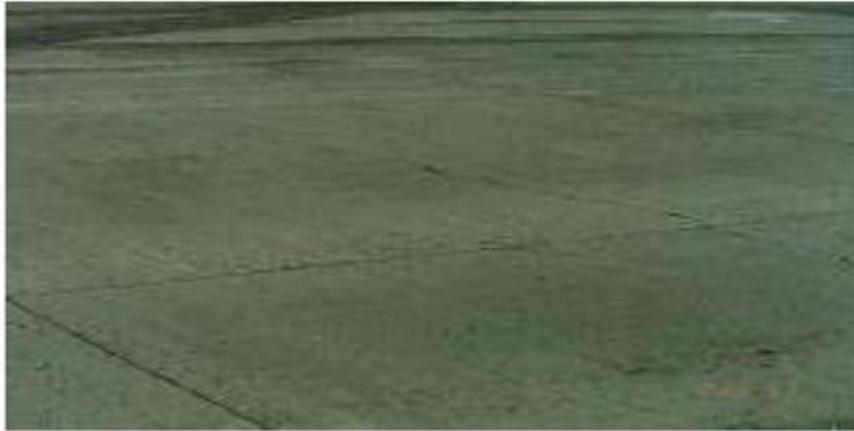
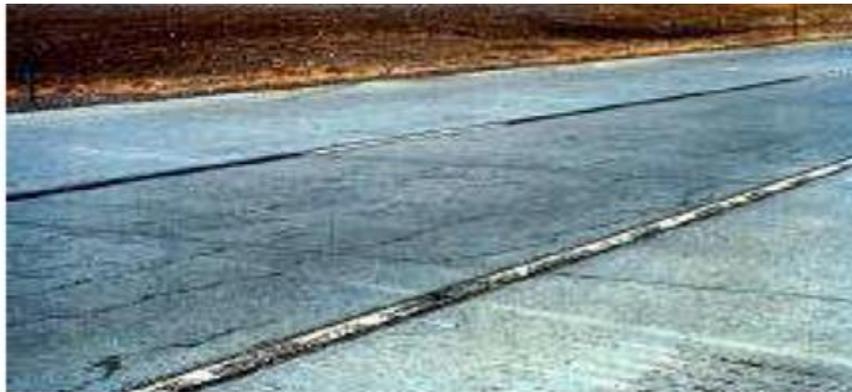
*Description:* Shrinkage cracking is defined as hairline cracks formed during PCC setting and curing that are not located at joints as illustrated in Figures 88 and 89. Usually, they do not extend through the entire depth of the slab. Shrinkage cracks are considered a distress if they occur in an uncontrolled manner (e.g., at locations outside of contraction joints in JPCP or too close together in CRCP).

*Figure 88 Shrinkage Cracks on Brand New Slabs*

*Figure 89 Severe Shrinkage Cracking*

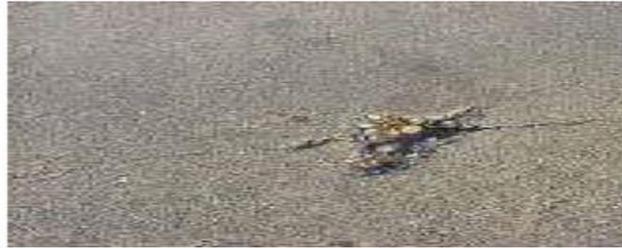
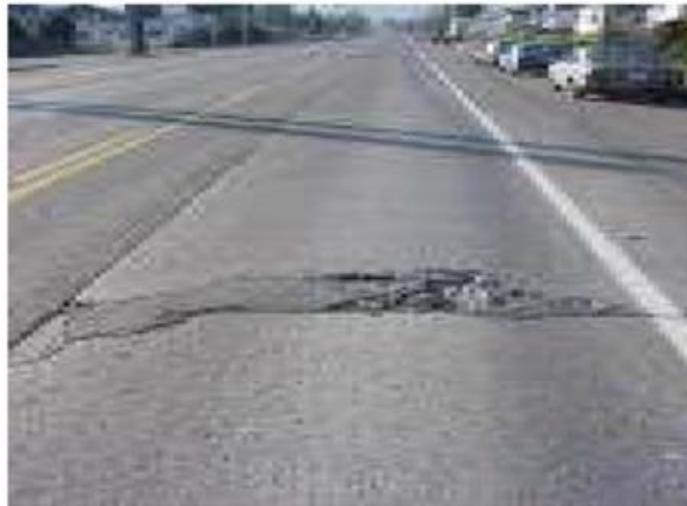
*Description:* Spalling is defined as cracking, breaking or chipping of joint/crack edges as illustrated in Figures 90 and 91. Usually occurs within about 0.6 m (2 ft.) of joint/crack edge.

*Figure 90 Spalling*

*Figure 91 Spalling from a Bad Construction Joint*

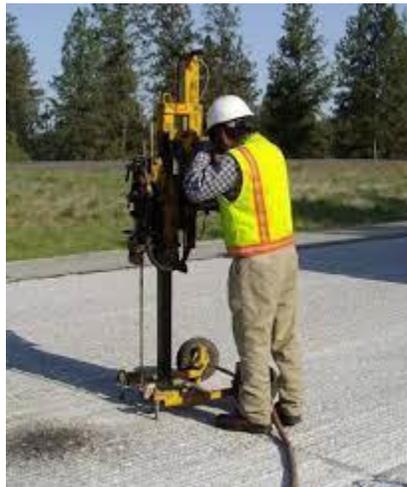
Filling of voids beneath concrete slabs by injecting cement grout, polyurethane, or other suitable materials through drilled holes in the concrete located over the void areas as illustrated in Figure 92.

*Figure 92 Slab Stabilization*

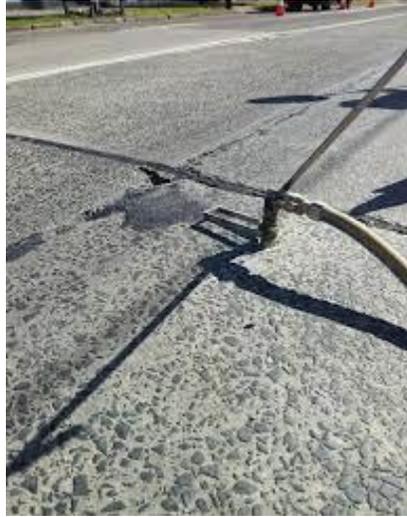
*Figure 93 Slab Jacking*

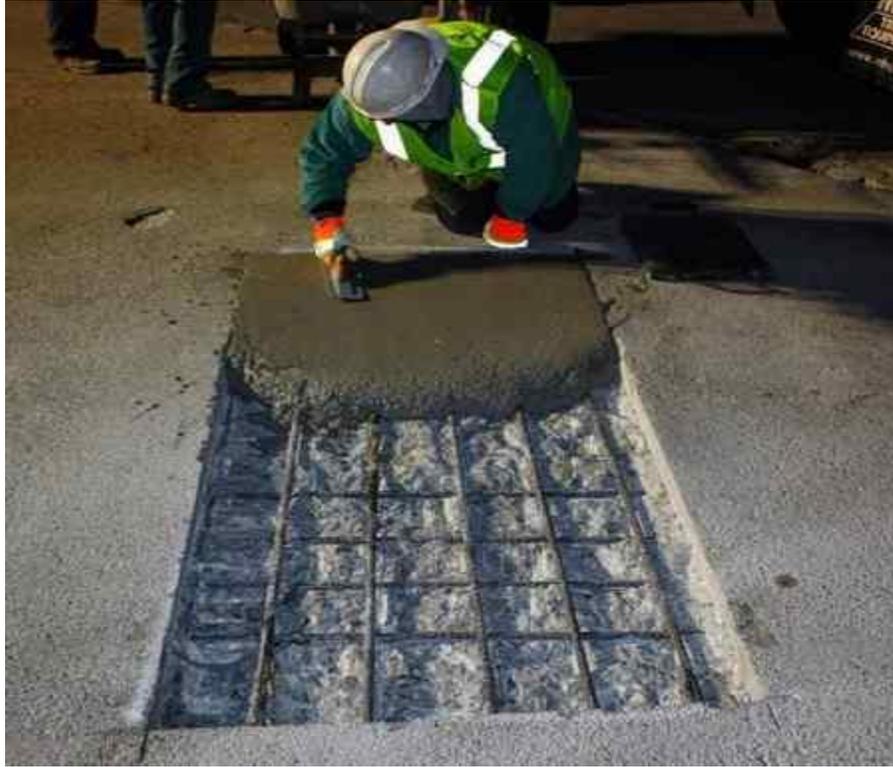
*Figure 94 Partial Depth Repair*

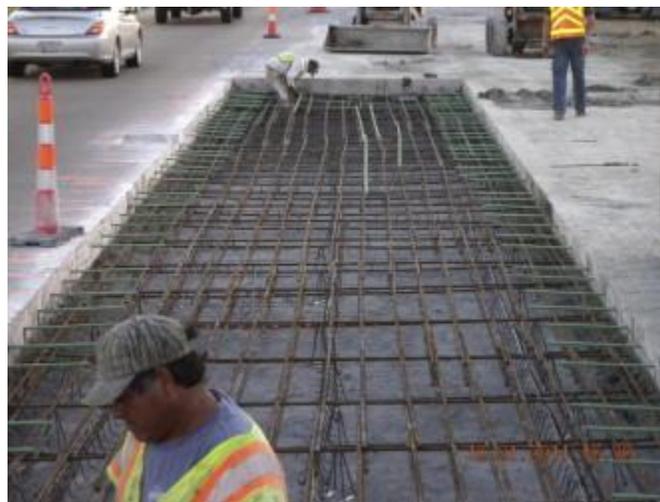
*Figure 95 Full Depth Repair*

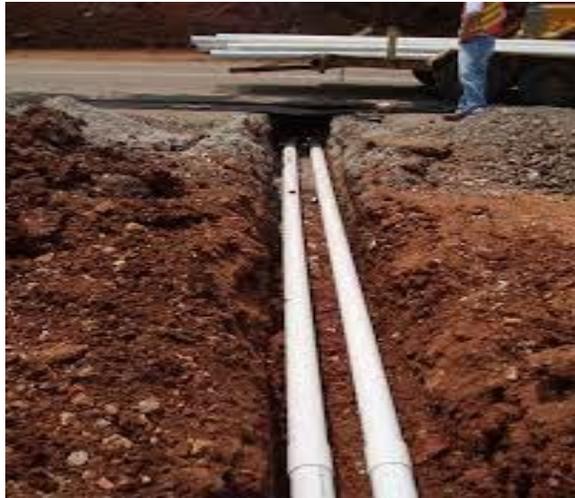
Cutting of a trench along the pavement edge and placement of a longitudinal edge drain system (pipe or geo-composite drain, geotextile lining, bedding, and backfill material) in the trench, along with transverse outlets and headwalls as illustrated in Figure 96.

*Figure 96 Retrofitted Edge Drains*

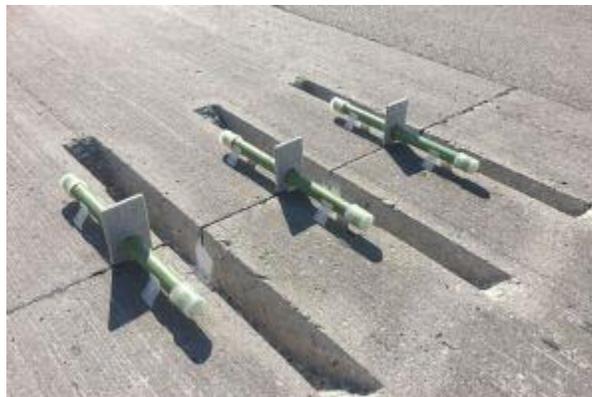
Placement of dowel bars across joints or cracks in an existing concrete pavement to restore load transfer as illustrated in Figure 97.

*Figure 97 Dowel Bars Retrofit*

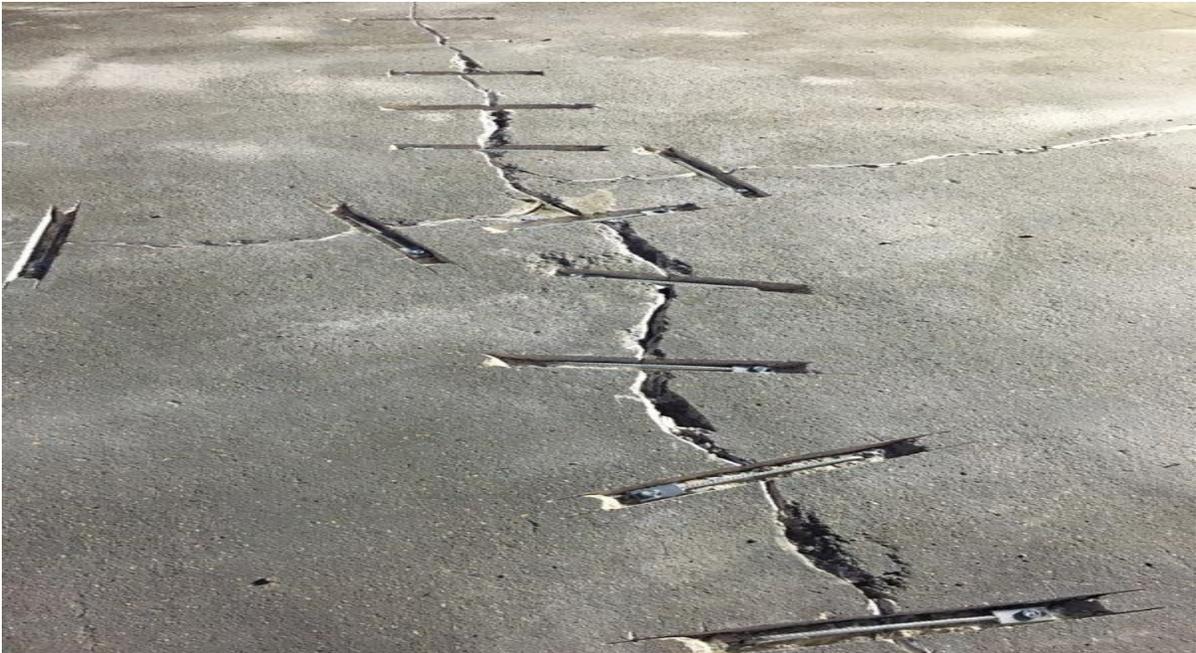
Placement of deformed tie bars into holes drilled at an angle through cracks (or, in some cases, joints) in an existing concrete pavement as illustrated in Figure 98.

*Figure 98 Cross Stitching*

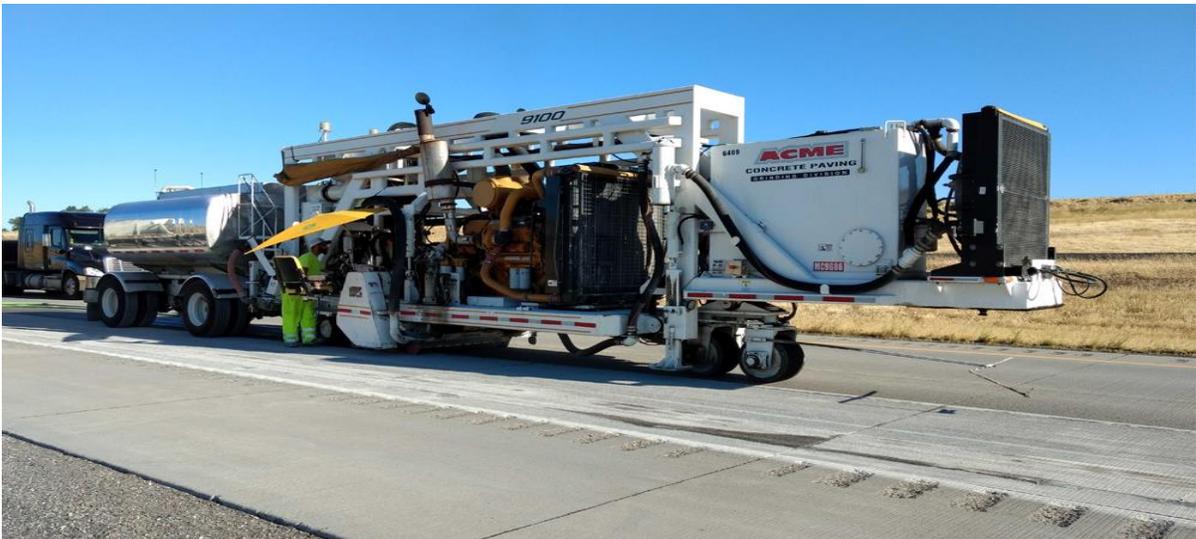
Removal of a thin layer of concrete (typically 0.12 to 0.25 inches) from the pavement surface, using special equipment fitted with a series of closely spaced, diamond saw blades as illustrated in Figure 99.

*Figure 99 Diamond Grinding*

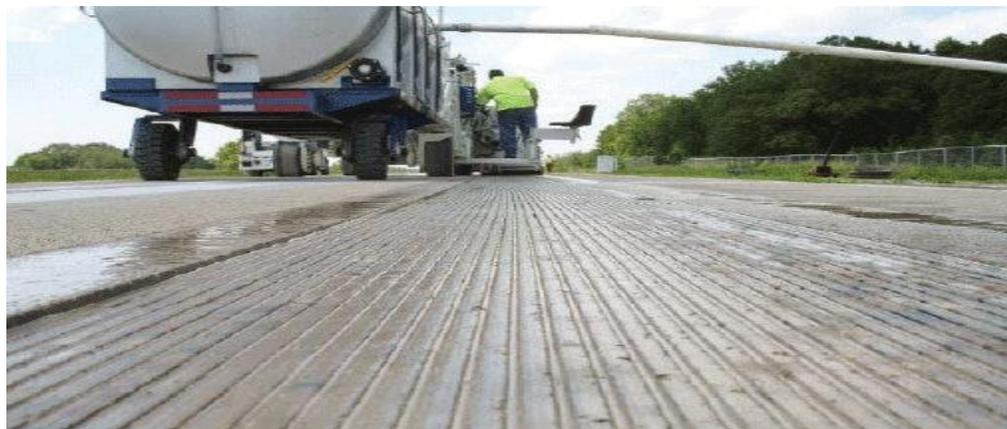
Cutting of narrow, discrete grooves into the pavement surface, either in the longitudinal direction (i.e., in the direction of traffic) or the transverse direction (i.e., perpendicular to the direction of traffic) as illustrated in Figure 100.

*Figure 100 Diamond Grooving*

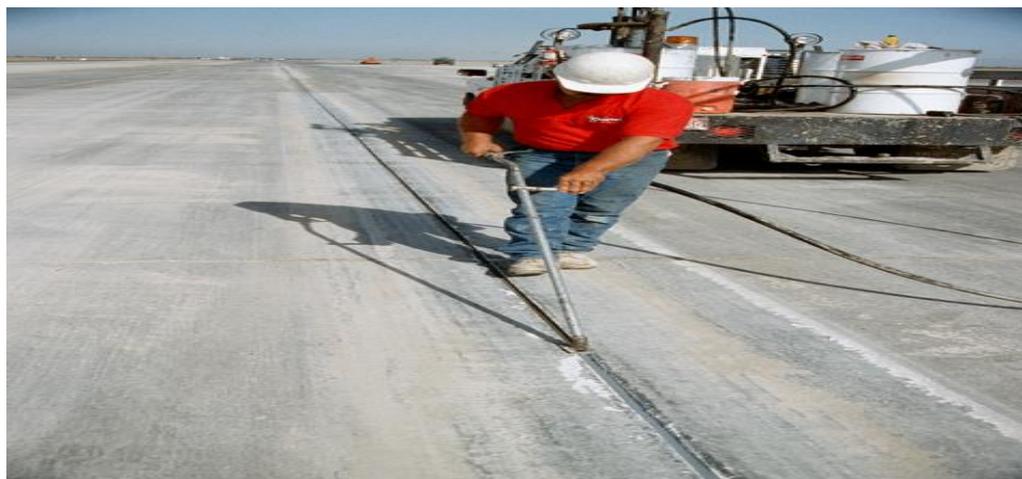
Removal of existing deteriorated transverse and/or longitudinal joint sealant (if present), refacing and pressure cleaning the joint sidewalls, and installing new material (liquid sealant and backer rod or preformed compression seal) as illustrated in Figure 101.

*Figure 101 Joint Resealing*
