# **Distresses and Treatment/Repair Methods in Flexible and Rigid Pavements**

Course No: C05-030  
Credit: 5 PDH

Najib Gerges, Ph.D., P.E.

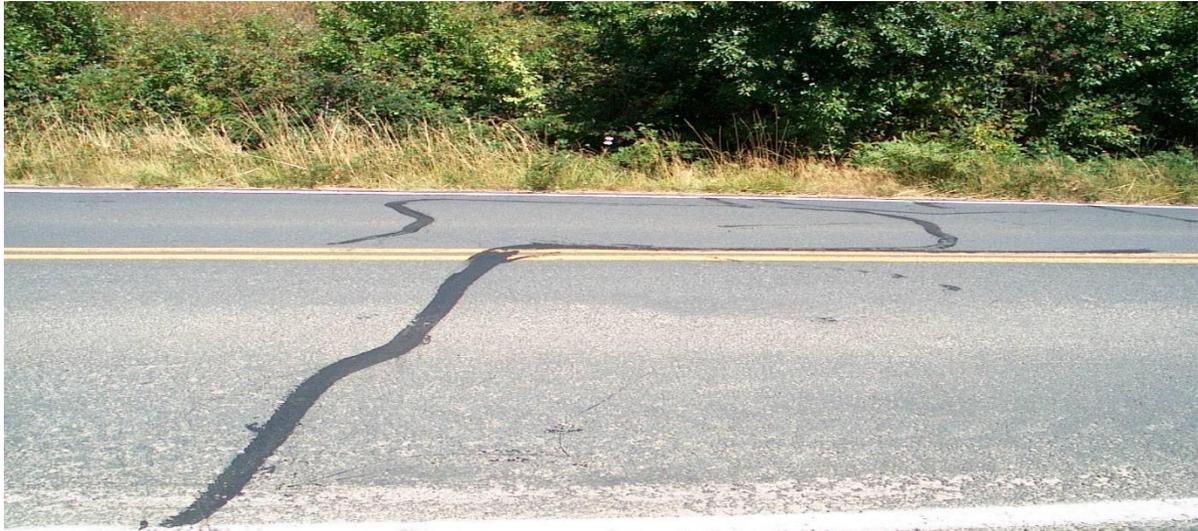
*Figure 102 Crack Sealing*

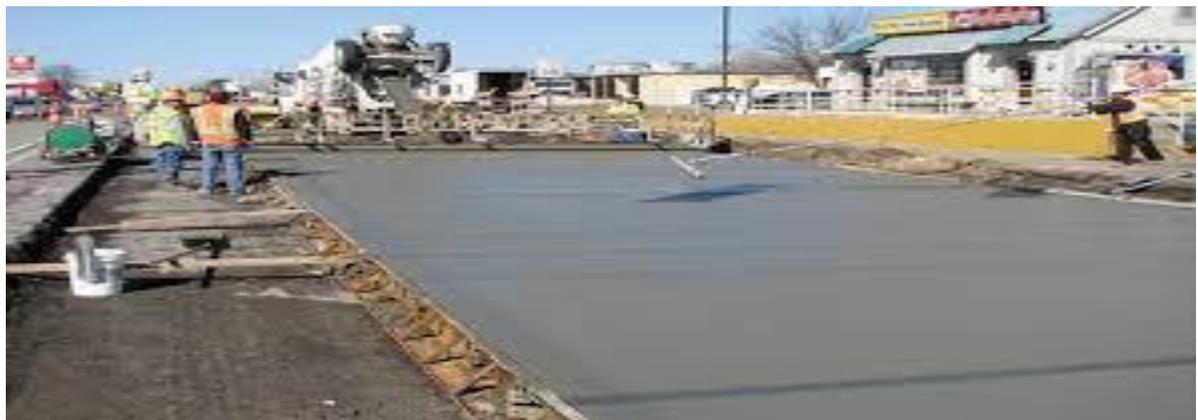
*Figure 103 Concrete Overlay*
