Ethical Issues from the Tacoma Narrows Bridge Collapse

Course No: LE2-003

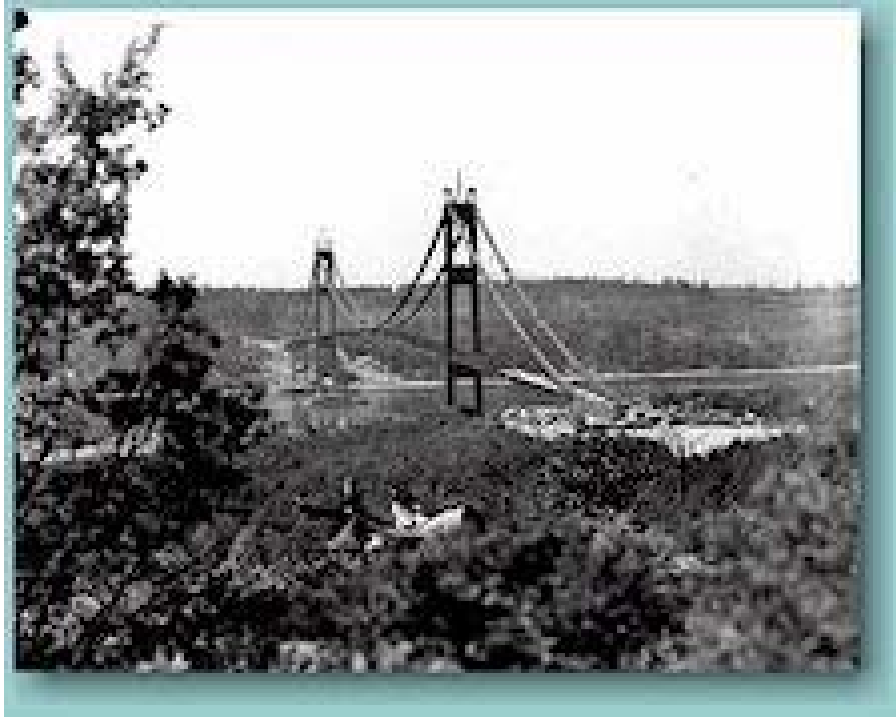
Figure 5

Tacoma Narrows Bridge under Construction

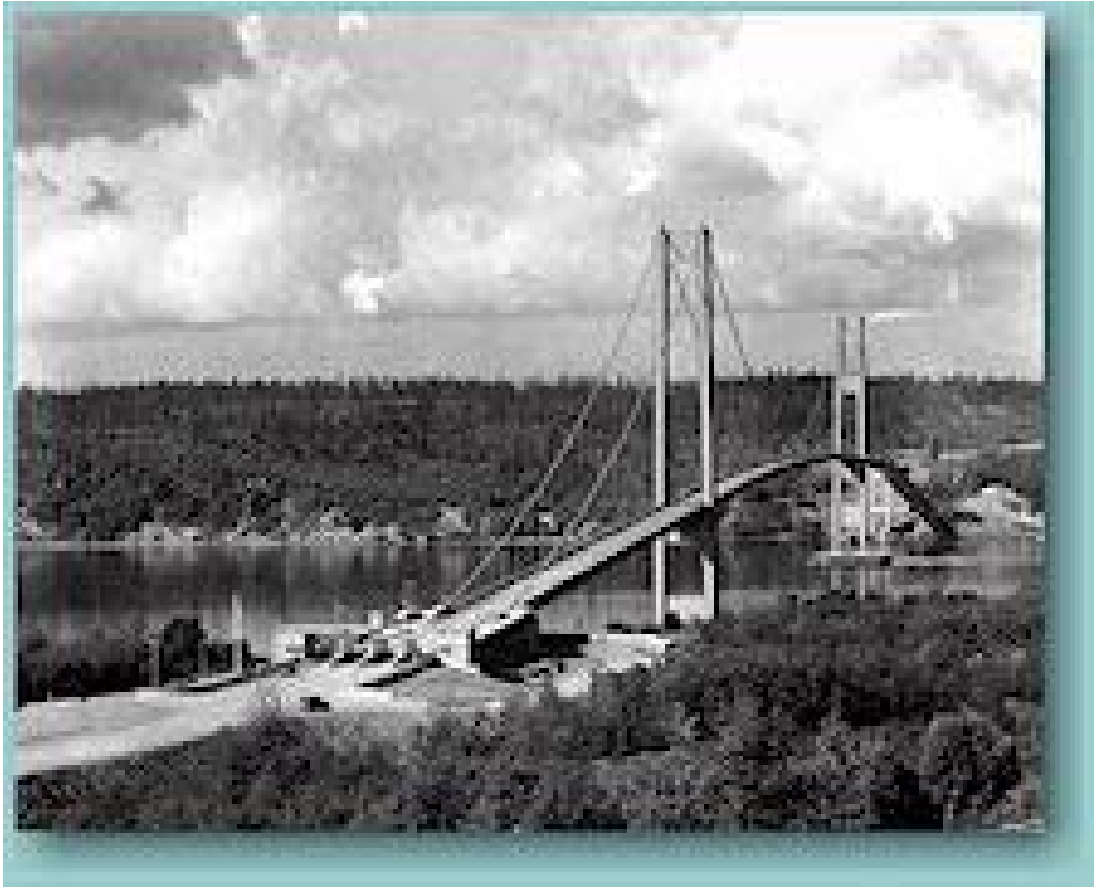
Figure 6

Tacoma Narrows Bridge Completed

The use of such shallow and narrow girders proved to be the undoing of the bridge. With such thin roadway support girders, the deck of the bridge was insufficiently rigid and was easily moved about by winds. The bridge became known for its movement. A modest wind could cause alternate halves of the center span to visibly rise and fall several feet over four- to five-second intervals. This flexibility was experienced by the builders and workmen during construction, which led some of the workers to christen the bridge "Gallopig Gertie." The nickname soon stuck, and even the public felt these motions on the day that the bridge opened on July 1, 1940.

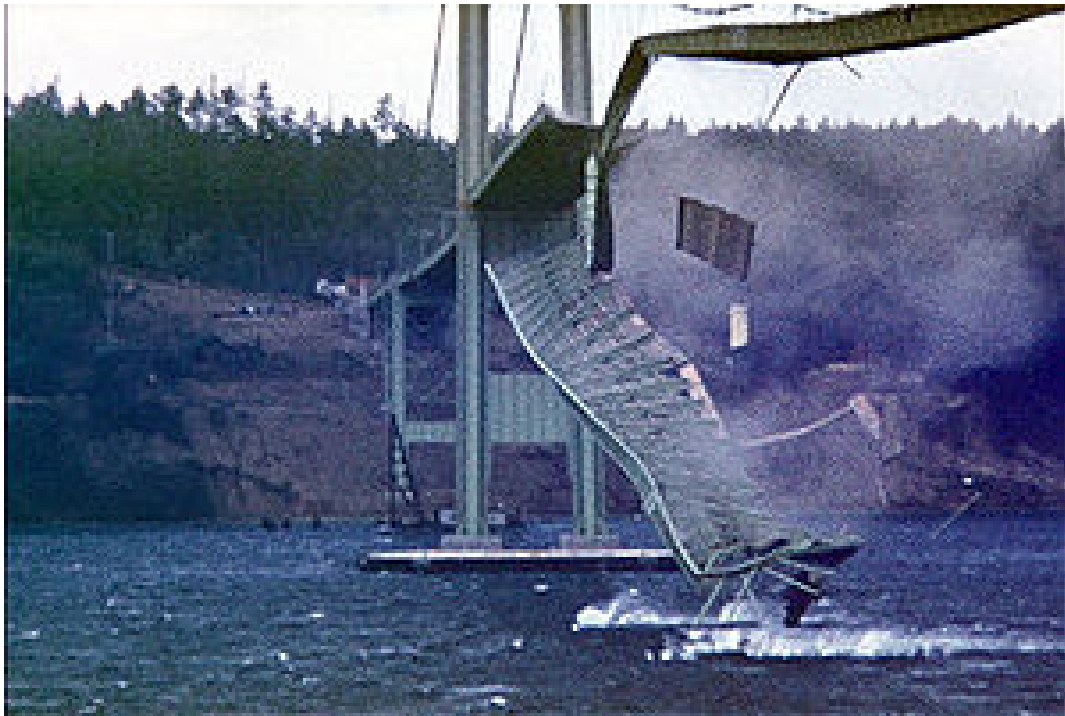
Figure 7

Collapse of the Tacoma Narrows Bridge on November 7, 1940
(University of Washington Libraries. Manuscripts, Special Collections, University Archives Division, PH Coll. 290.36)

On the morning of November 7, 1940 the wind was blowing through the Narrows at a steady speed of about 42 miles per hour. At 10 AM the bridge began to oscillate severely in the torsional mode and the bridge was closed to traffic. At 11:10 AM the center span collapsed.

On November 7 at about 10 AM, a *torsional* vibration mode (that is, "clockwise-counterclockwise") of the roadbed was observed for the first time. The torsional mode of vibration was the "second mode" in which the center of the span remains motionless while the two halves rotate in opposite directions. This torsional oscillation had a frequency of about 5 seconds. This torsional mode may have been triggered by transverse oscillation snapping one of the suspender cables, which created an imbalanced condition causing aeroelastic flutter.

The amplitude of the motion produced by the fluttering increased beyond the strength of the suspender cables. Once several cables failed, the weight of the deck transferred to the adjacent cables that broke in turn until the central deck collapsed.

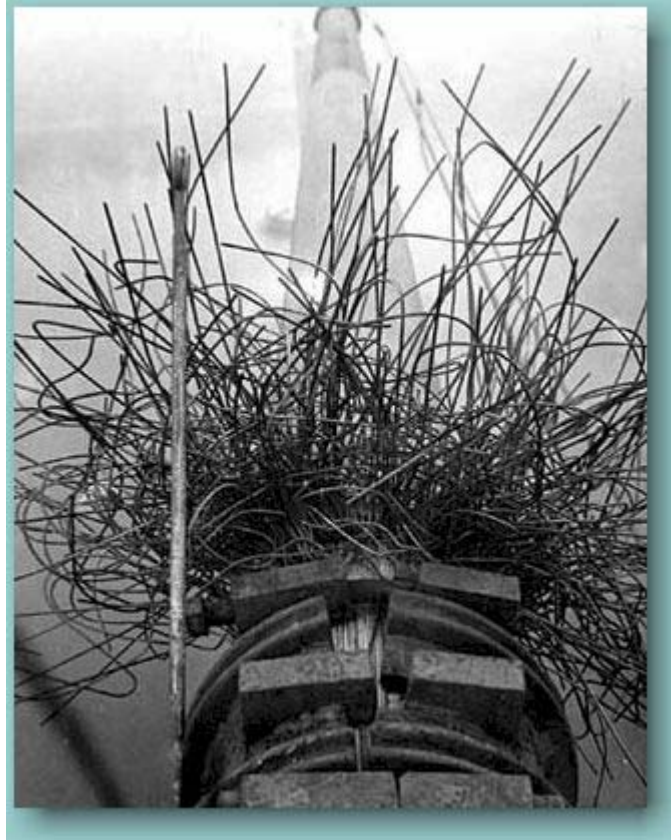
Figure 8

Broken Cable

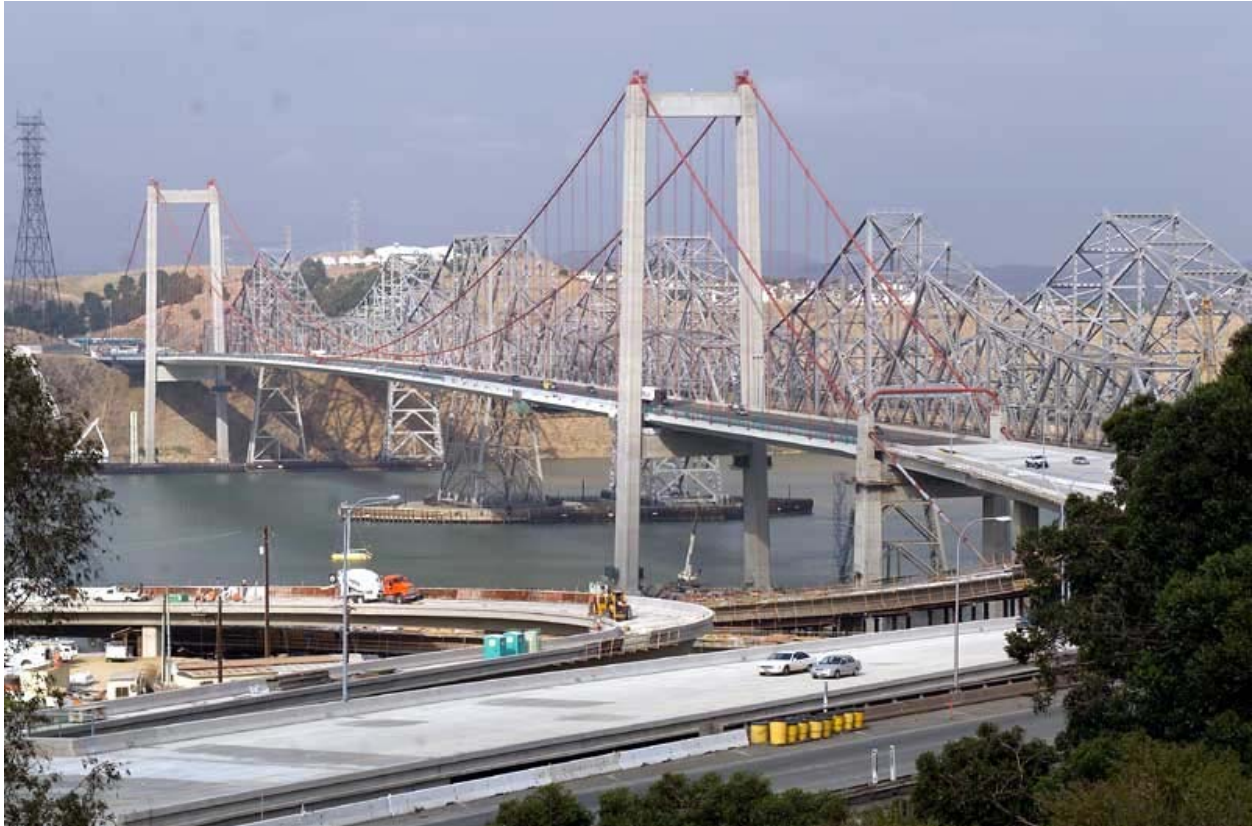
Figure 9

The “third” Carquinez Bridge
(the “first” and “second” bridges are seen beyond; the “first” was subsequently demolished)
(California Department of Transportation)

Today, of course, modeling studies are a primary design tool used by bridge engineer's to design major bridges. And computers using numerical methods such as finite-elements provide a greatly enhanced modeling tool in some instances. The "third" Carquinez Bridge west of Sacramento and completed in 2003 is an example of the state of the art in suspension bridge design. Wind tunnel testing and computer modeling were important tools employed in the design process. Note the slender, solid roadway support girders, similar to those in the Tacoma Narrows Bridge design.
