Rock Engineering: *Rock Slopes*

Course No: G04-003

Practical Rock Engineering

Evert Hoek

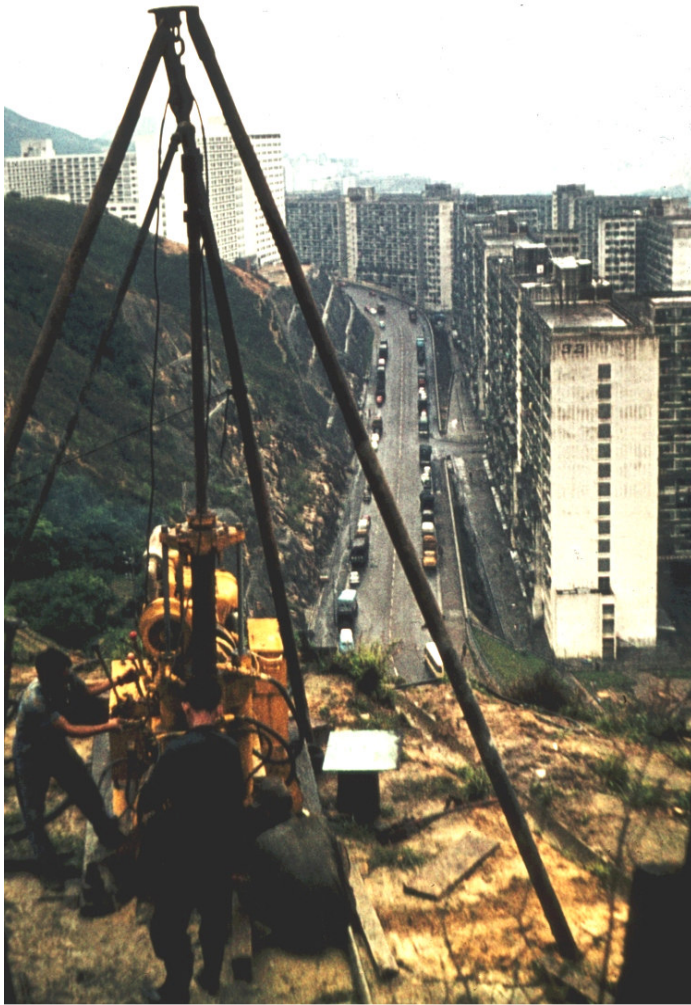
Figure 11: Drilling vertical diamond core holes into the Sau Mau Ping slope. These holes were used for geotechnical investigation purposes and also for the installation of piezometers in the rock mass.

Figure 10 shows the drilling of the horizontal drain holes into the slope face and Figure 11 shows the drilling of the vertical holes into which the piezometers were installed. These piezometers were monitored for the next few years, while preparations for the final stabilisation of the slope were made, and the road was closed to traffic on two occasions when water levels were considered to be dangerously high.

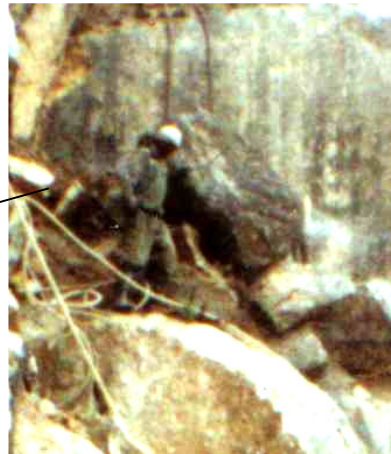
Figure 2: Construction on an active roadway, which is sometimes necessary when there is absolutely no alternative access, increases the rockfall hazard many times over that for slopes without construction or for situations in which the road can be closed during construction.

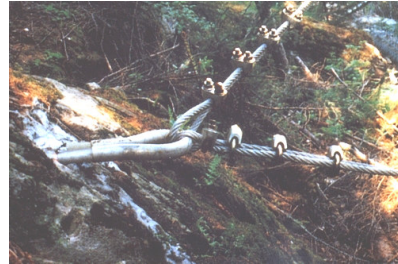
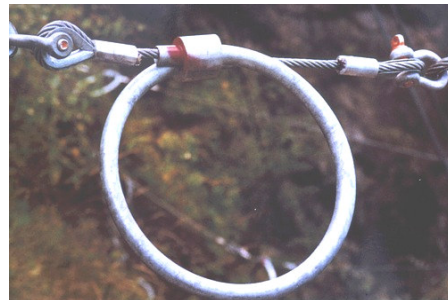
a: Anchor grouted into rock with cables attached.

b: Geobruigg ring net shown restraining a boulder. These nets can be designed with energy absorbing capacities of up to 2500 kNm which is equivalent to a 6 tonne boulder moving at 20 m per second.

c: Geobruigg energy absorbing ring. When subjected to impact loading the ring deforms plastically and absorbs the energy of the boulder

Figure 6: Details of a rockfall net system manufactured by Geobruigg of Switzerland.
