Ethical Issues from the Tacoma Narrows Bridge Collapse

Course No: LE2-003

J. Paul Guyer, P.E., R.A., Fellow ASCE, Fellow AEI

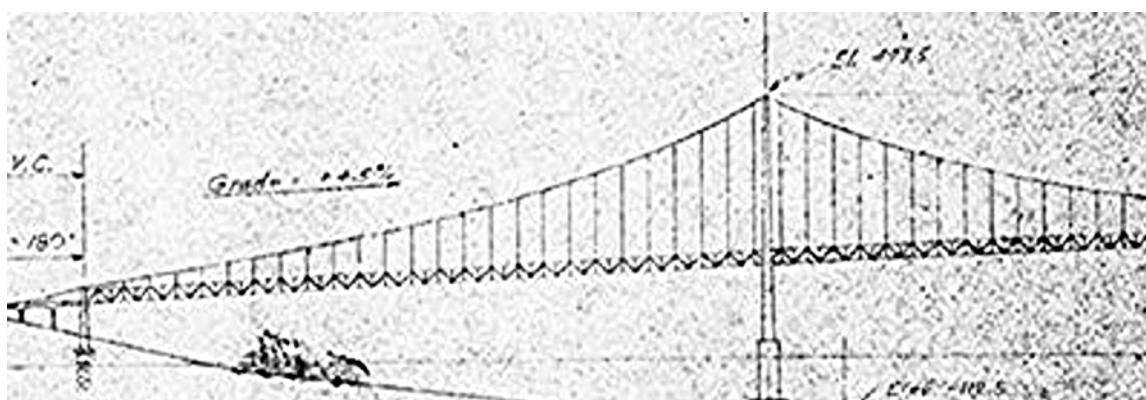
Figure 3

The Eldridge Design
(Washington State DOT records)

With the prospect of federal funding now in view, the Washington Department of Highways, under the direction of engineer Clark Eldridge, prepared plans for a suspension bridge using convention suspension bridge design practices as they were known at that time. Specifically, the roadway deck was supported by deep (25-foot) truss girders to stiffen it. The Authority submitted the Eldridge design to the federal Public Works Administration (PWA) with a request for \$11 million.

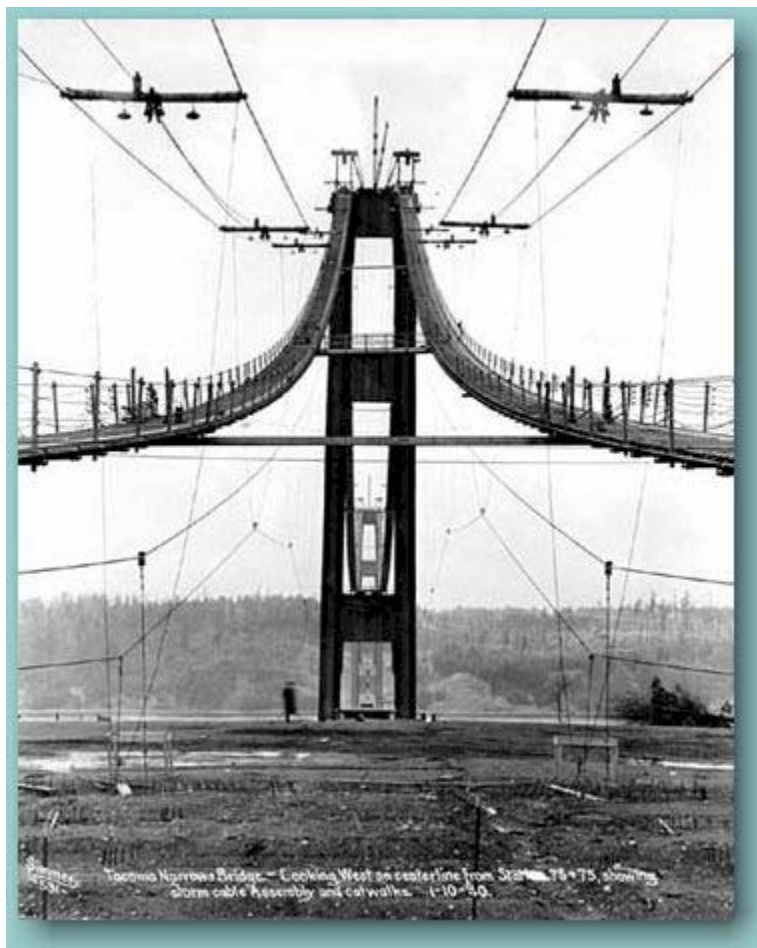
Figure 4

Tacoma Narrows Bridge under Construction
(University of Washington Libraries, Special Collections, PH Coll. 11.19)

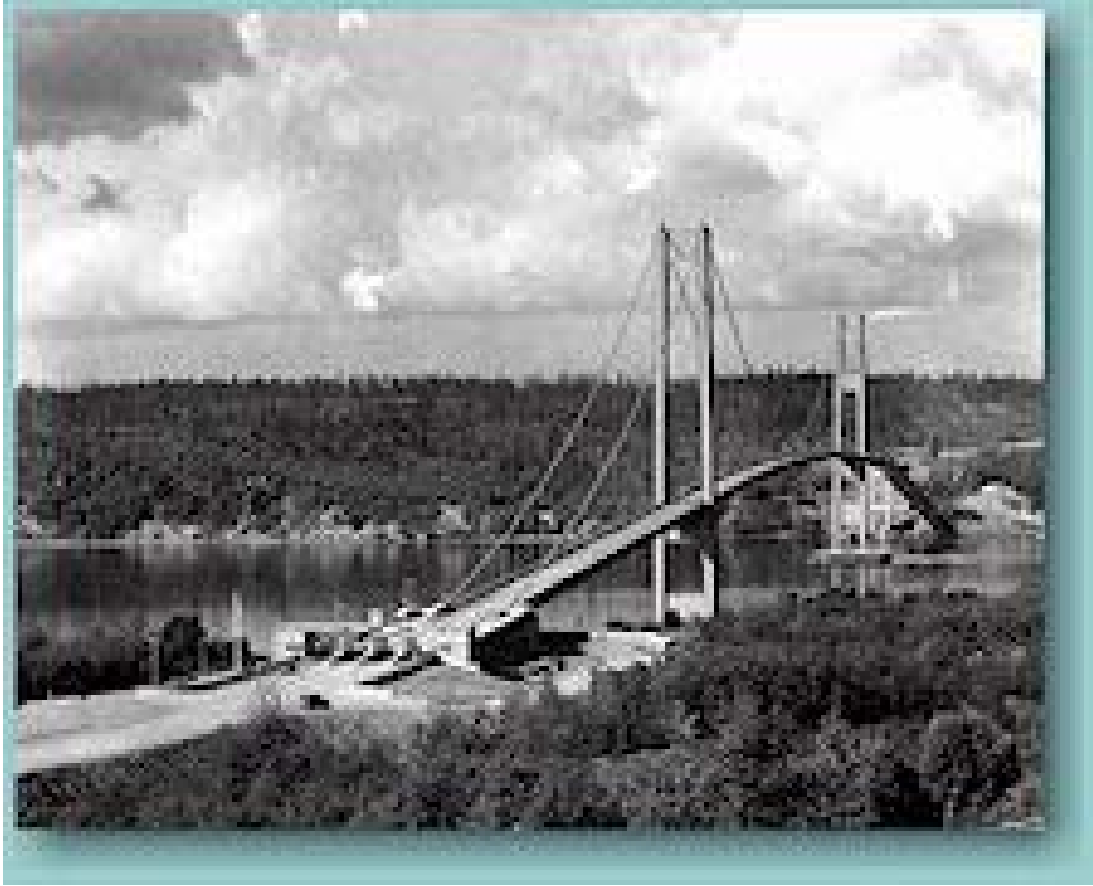
Figure 6

Tacoma Narrows Bridge Completed

The use of such shallow and narrow girders proved to be the undoing of the bridge. With such thin roadway support girders, the deck of the bridge was insufficiently rigid and was easily moved about by winds. The bridge became known for its movement. A modest wind could cause alternate halves of the center span to visibly rise and fall several feet over four- to five-second intervals. This flexibility was experienced by the builders and workmen during construction, which led some of the workers to christen the bridge "Gallopig Gertie." The nickname soon stuck, and even the public felt these motions on the day that the bridge opened on July 1, 1940.

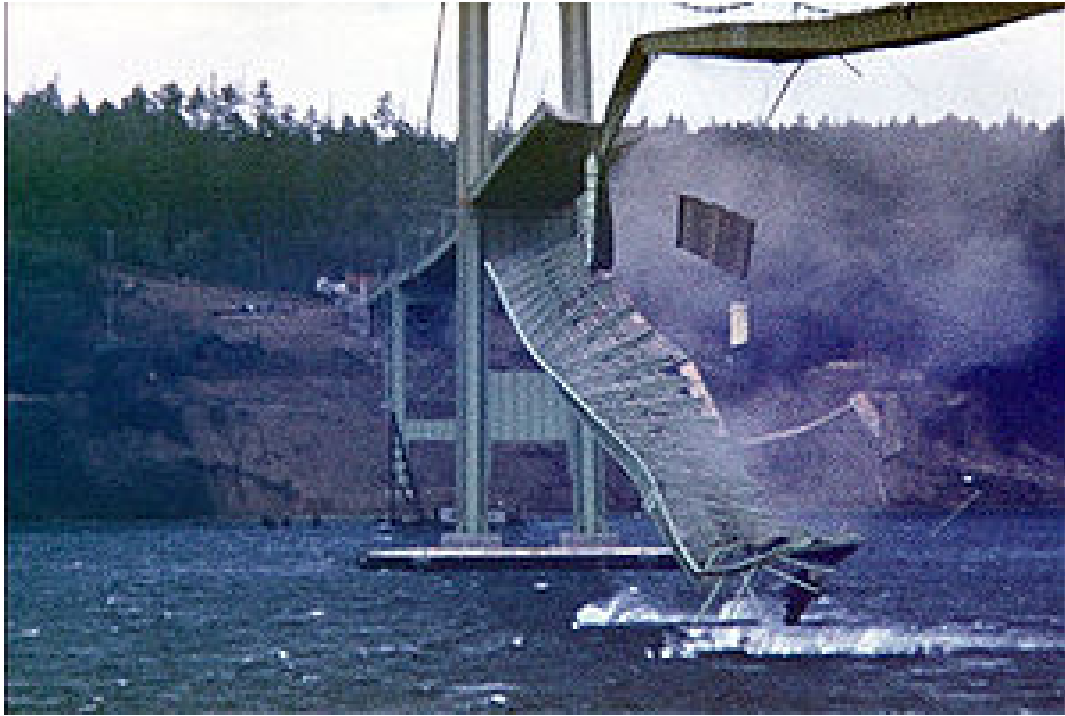
Figure 7

Collapse of the Tacoma Narrows Bridge on November 7, 1940
(University of Washington Libraries. Manuscripts, Special Collections, University Archives Division, PH Coll. 290.36)

On the morning of November 7, 1940 the wind was blowing through the Narrows at a steady speed of about 42 miles per hour. At 10 AM the bridge began to oscillate severely in the torsional mode and the bridge was closed to traffic. At 11:10 AM the center span collapsed.

The amplitude of the motion produced by the fluttering increased beyond the strength of the suspender cables. Once several cables failed, the weight of the deck transferred to the adjacent cables that broke in turn until the central deck collapsed.

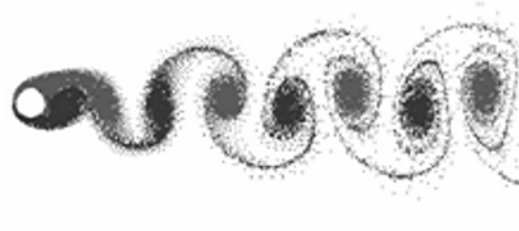
Figure 9
Vortex Shedding

vortices on the downwind side of the body. This is called the “Von Kármán vortex street”. The body will try to move toward the low-pressure zone, in an oscillating movement called vortex-induced vibration. If the frequency of vortex shedding matches the resonance frequency of the structure, the structure will begin to resonate and the structure's movement can become self-sustaining.

The frequency of the vortices in the von Kármán vortex street is called the Strouhal frequency f_s , and is given by:

$$\frac{f_s D}{U} = S$$

where U is the flow velocity, D is a characteristic length of the non-streamlined body and S is the dimensionless Strouhal number, which depends on the body in question. For Reynolds Numbers greater than 1000, the Strouhal number is approximately equal to 0.21. In the case of the Tacoma Narrows, D was approximately 8 feet and S was 0.20.
