Making Schools Safe from Earthquakes

Course No: S05-012

Design Guide

4 Making Schools Safe From Earthquakes

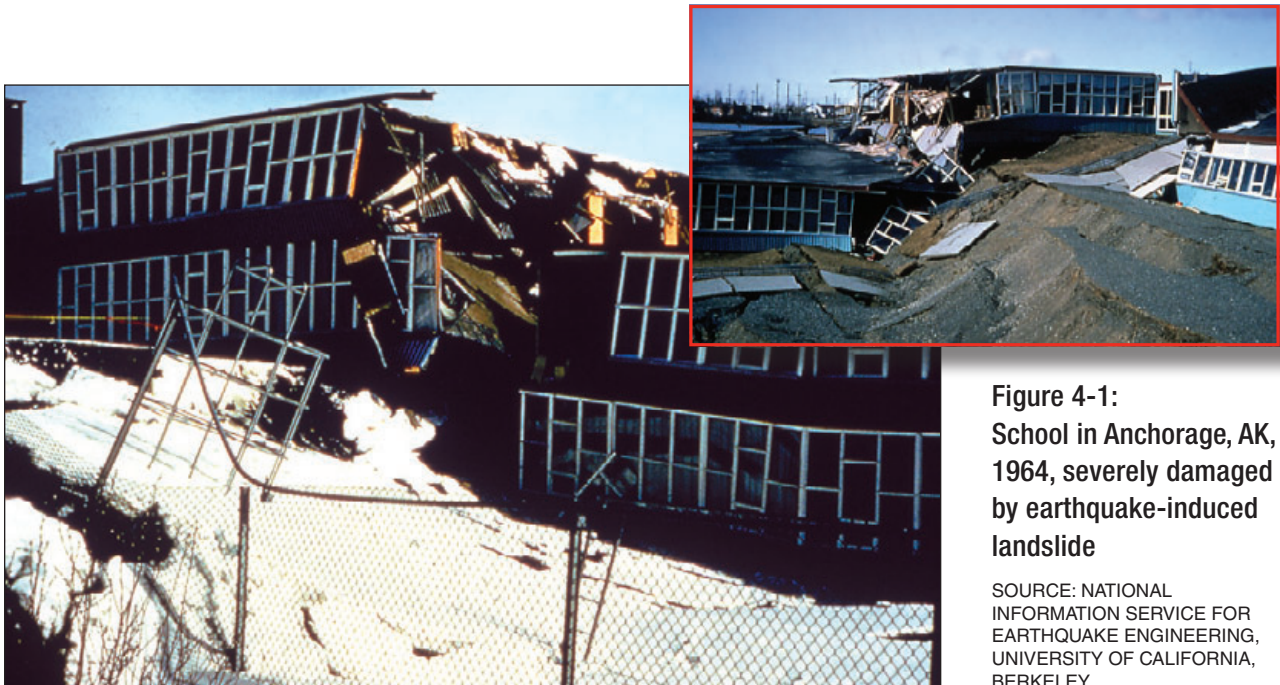
Figure 4-1:
School in Anchorage, AK,
1964, severely damaged
by earthquake-induced
landslide

- **Landslides**, which involve the slipping of soil and rock on sloping ground, can be triggered by earthquake ground motion (see Figure 4-1). The shaking from earthquakes can cause landslides, depending on the slope, type, and configuration of soil stratum. Landslides can cause damage to improvements built within the slide area or near the top of the slide, ranging from complete destruction to distortion from relatively small vertical or lateral movements. Sites can also be threatened by landslides occurring uphill, sometimes completely offsite and quite a distance away.

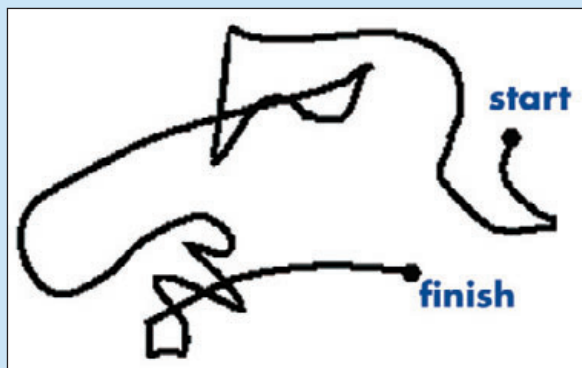
Motion at Site

Scratch left on a floor by a kitchen range in the 1933 Long Beach earthquake that shows the random nature of earthquake motion.

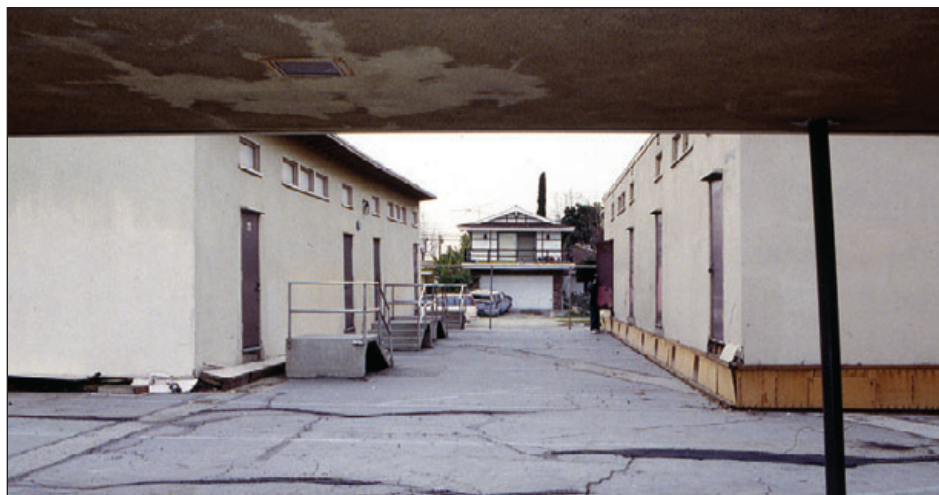
Figure 4-7:
Modular classrooms
pushed off their
foundations; note stairs
at left, Northridge, CA,
1994

Modular structures, often used as temporary classrooms, are liable to topple off their foundations during an earthquake, unless securely attached and braced. This damage is not life-threatening, but makes the building unusable; fractured power, gas, and waste lines may be a hazard (see Figure 4-7).

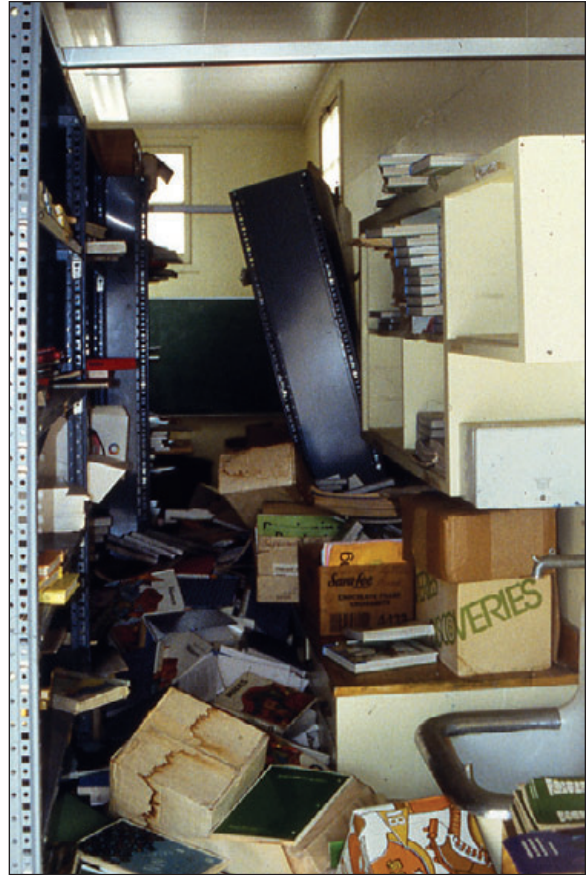
Figure 4-8:
Fallen filing cabinets and shelves, Northridge, CA, 1994

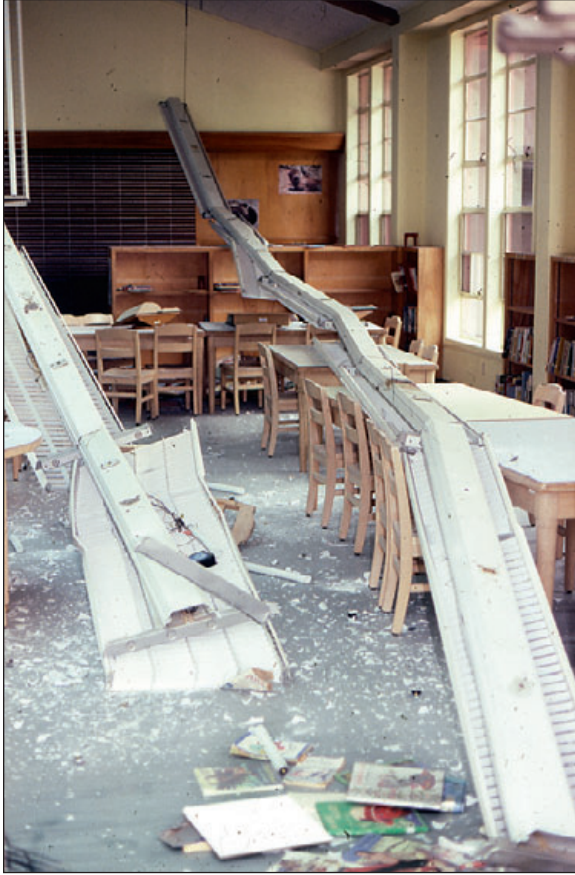
Figure 4-10:
Fallen light fixtures, library, Coalinga, CA, 1983

Pendant light fixtures may fall if they are not securely attached and not designed to swing freely (see Figure 4-10). Large glass walls and windows, not designed to accommodate inter-story drift due to seismic forces, present another hazard for

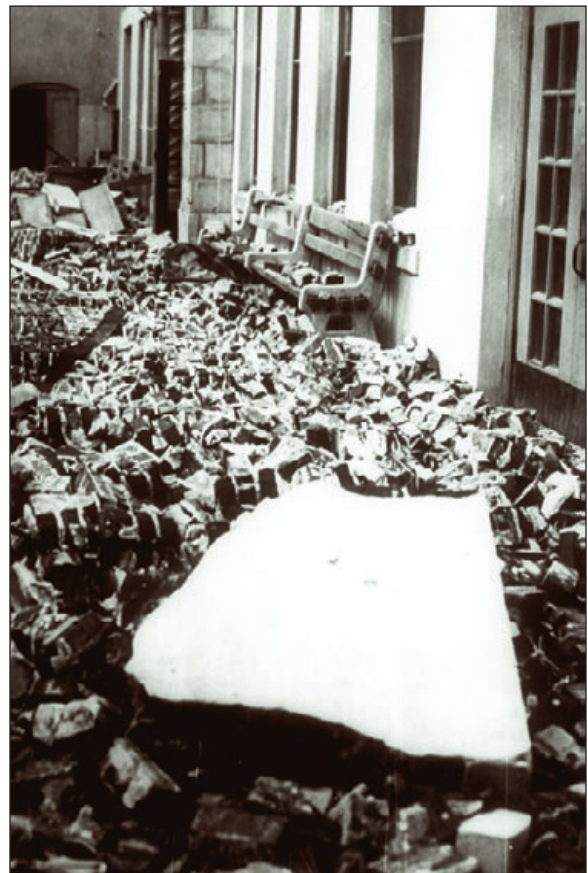
Figure 4-13:
Damage to shop building, Compton Junior High School, Long Beach, CA, 1933

school buildings was so severe that there would have been many casualties had they been occupied (see Figures 4-12, 4-13, and 4-14). As a result, the State passed the Field Act within a month of the earthquake.

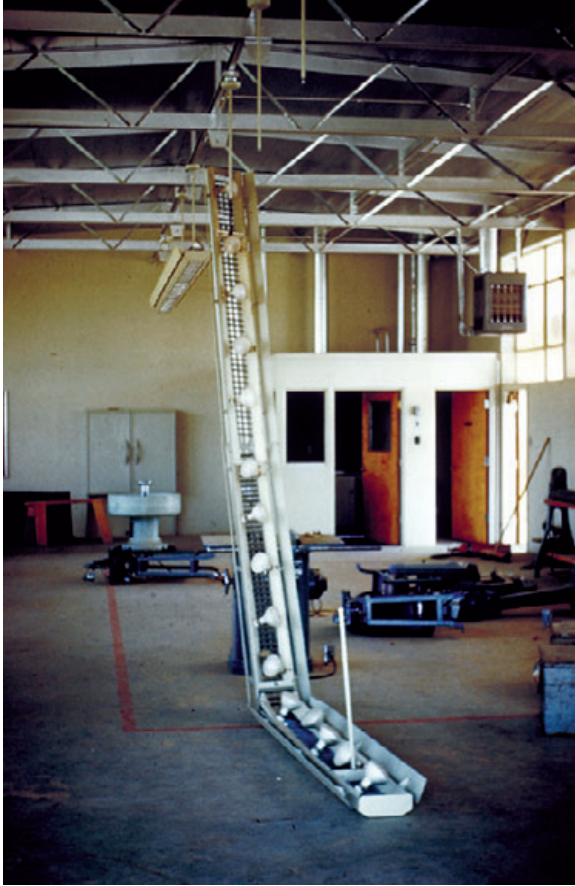
Figure 4-16:
Overturned shop equipment and failed light fixtures, Kern County, CA, 1952

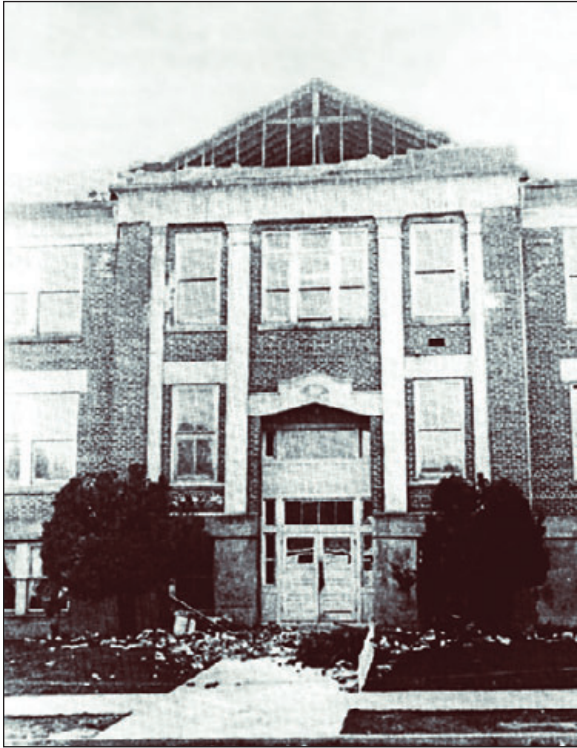
Figure 4-19:
The student body president was killed here by falling brickwork, Seattle, WA, 1949

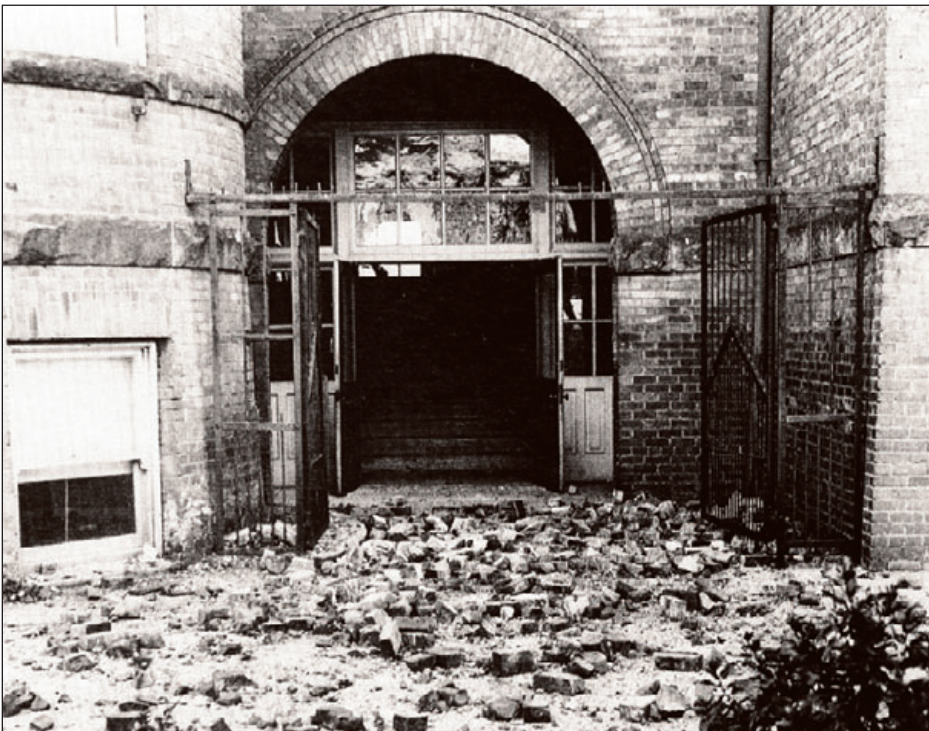
Figure 4-20:
Another dangerous entry collapse, Seattle, WA, 1949

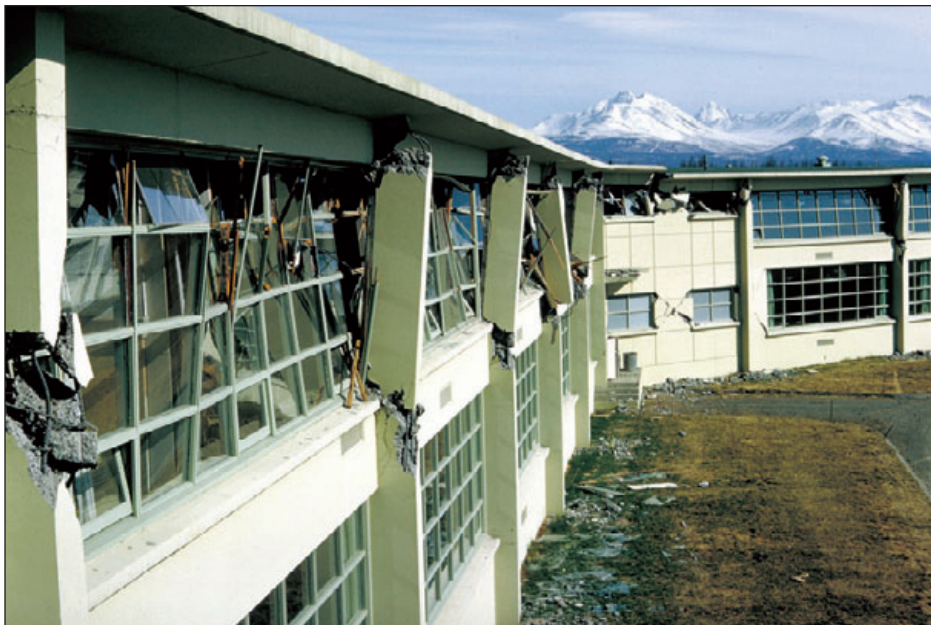
Figure 4-23:
Severe structural damage
to the West Anchorage High
School, Anchorage, AK, 1964

In the Anchorage, AK, earthquake of 1964, which registered 8.4 on the Richter scale, a number of public schools were damaged, but none collapsed. The earthquake occurred on Good Friday at 5:36 p.m. when the schools were unoccupied. The most seriously damaged school (shown in Figure 4-1) was subsequently demolished. At the West Anchorage High School (see Figures 4-23 and 4-24), a two-story nonductile concrete-frame and shear-wall classroom wing suffered severe structural damage and the near total failure of a number of columns. Structural distortion also created a number of severe glass breakages. The second floor was removed during reconstruction and the first floor was repaired and retained. In the San Fernando, CA, earthquake of 1971, there were no injuries and no schools collapsed; however, the earthquake caused \$13.2 million in damages (in 1971 dollars), and 100 pre-Field Act schools were demolished within 1½ years after the earthquake.

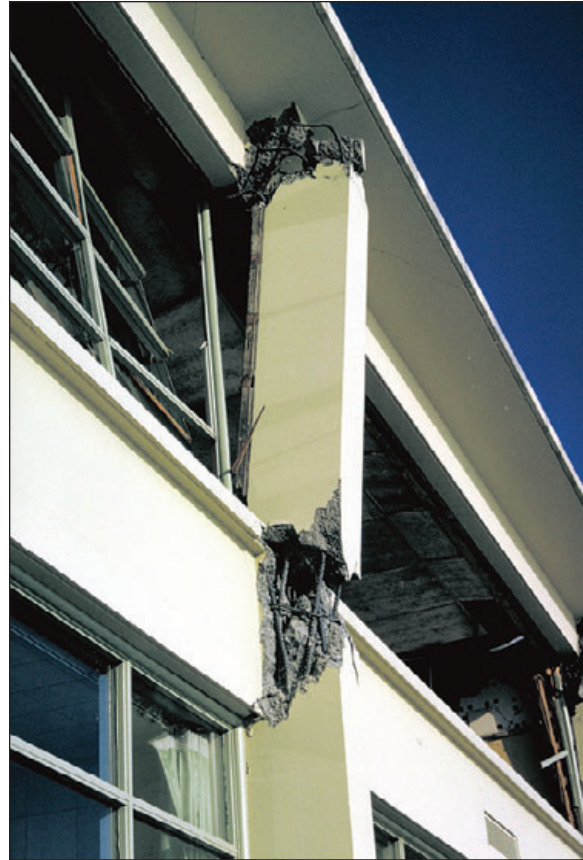
Figure 4-24:
Brittle failure at nonductile concrete column,
West Anchorage High School, 1964

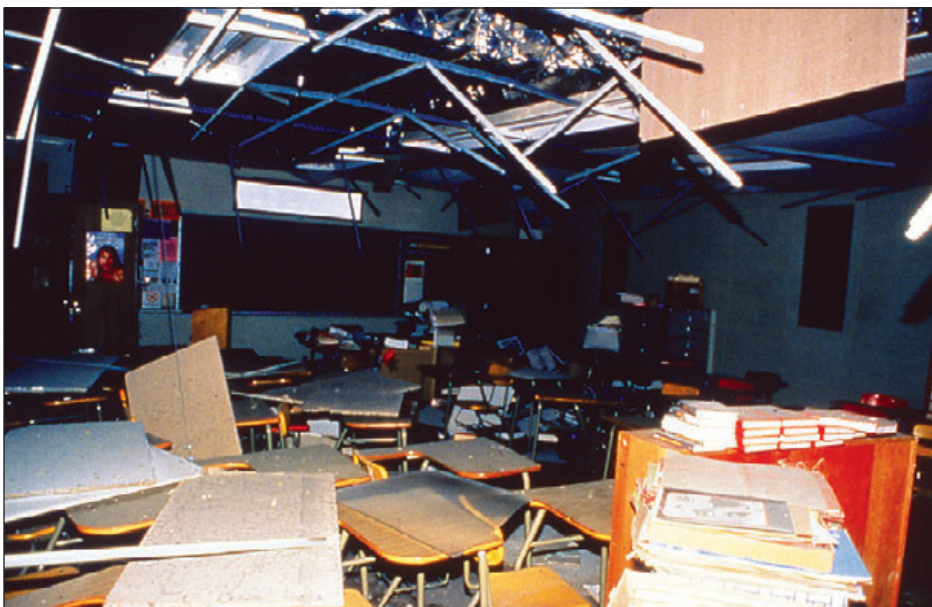
Figure 4-25:
Ceiling damage,
Northridge, CA, 1994

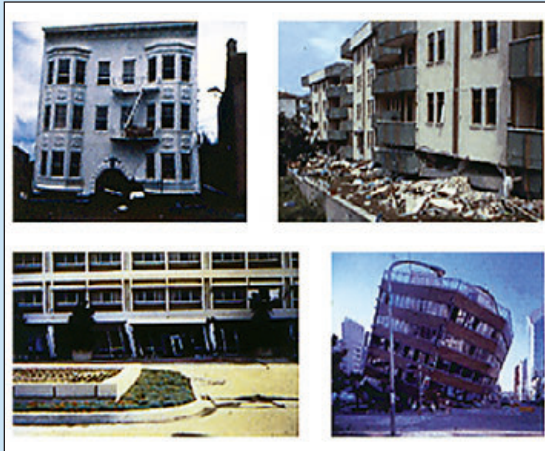
Soft Stories

Typical examples of soft story-induced damage.
