# **Bridge Failures: Causes, Analysis & Lessons Learned**

Course No: S02-032  
Credit: 2 PDH

Ibrahim M. Metwally, Ph.D., P.E.

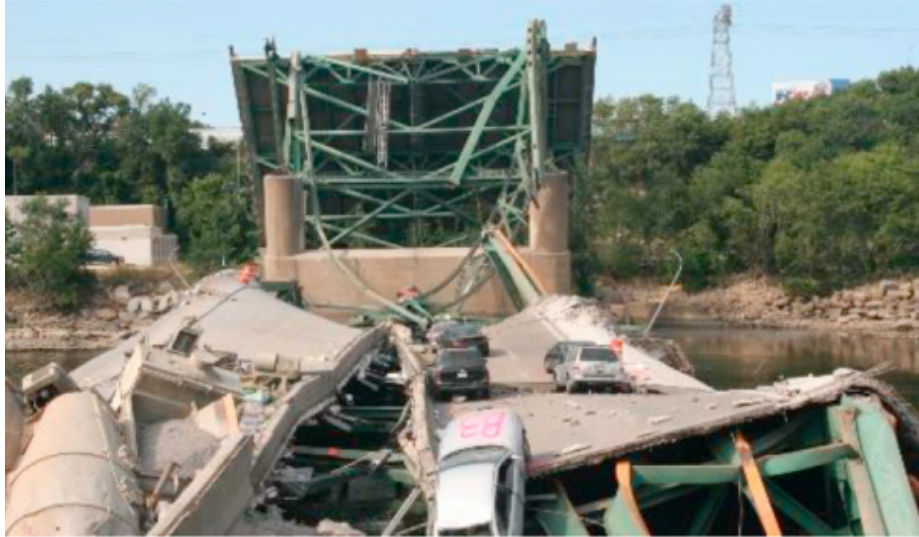
Design error is related to bridge failures caused by defects in design theory and carelessness of designers, which have certain concealment and are difficult to find the errors before the completion of the bridge and verify the causes after it fails. The design theory defects are mainly due to ignorance and cognitive limitations of human beings, and lack of sufficient understanding of the mechanism of bridges. For example, the collapse of the Quebec Bridge was due to insufficient understanding of the stability of members. The collapse of the Tacoma Bridge was due to insufficient understanding of the mechanism of wind on the bridge. The collapse of the I-35W Bridge was due to insufficient understanding of fatigue of truss bridge joints, (Fig. 1).

**Figure 1. Bridge failures due to design errors (Defects in design theory)**

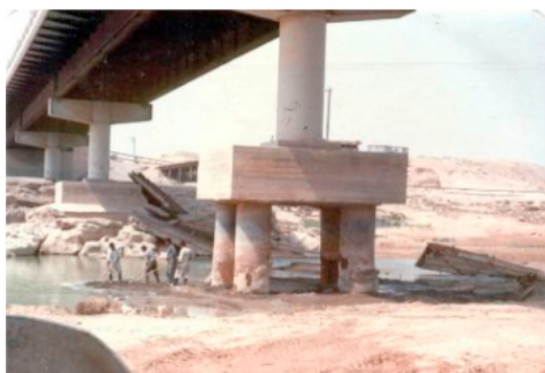
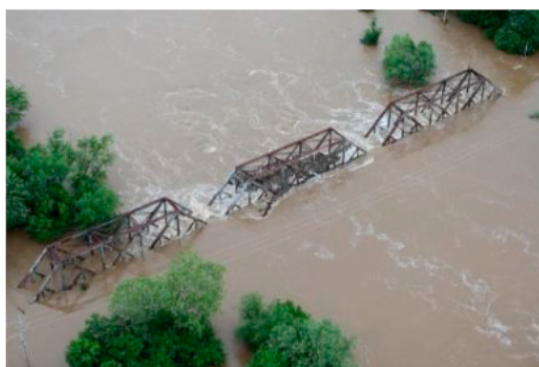
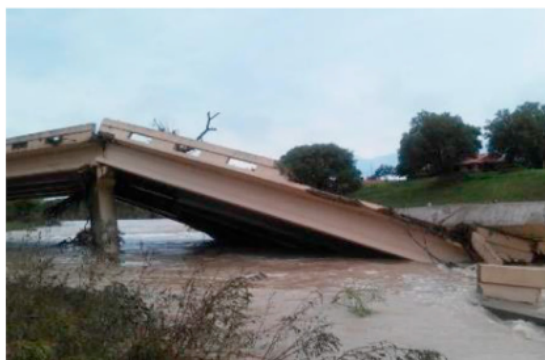
The failed cases are shown in Fig. 4. The causes of bridge failures caused by hydraulic are mainly classified into natural factors and human factors. For natural factors, rivers in some areas suffer from rare catastrophic floods, which exceed the ultimate limit state, thus causing the bridges to fail. The United States experienced 2 catastrophic floods in 1993 and 1996, with 171 bridge failures in these 2 years alone, making the proportion of bridge failures caused by floods far higher than other causes. Similarly, Guangdong Province of China experienced a devastating flood in 2013, with 316 roads cut off, 83 bridges collapsed and more than one hundred million dollars lost. For human factors, the most important factors are:

**Figure 4. Bridge failures due to hydraulic. (a) Foundation scouring. (b) Bridges submerged by flood. (c) Bridge collapse due to flood**

To protect bridges from hydraulics, designers should select proper bridge sites, arrange bridge span properly, and ensure adequate foundation depth. Then, the bridge regulation and protection projects should be improved, and the direction of flood flow should be adjusted to reduce the impact and erosion of floods on bridges.

Finally, bridge maintenance work should be strengthened, and foundation scouring maintenance should be included in the preventive maintenance category, and the diseases should be found in time. The failure of the substructure usually leads to the failure of the superstructure. Therefore, the safety factor of the substructure should be no lower than that of the superstructure. In addition, structural safety should be ensured by strengthening structural capacity protection measures, improving structural toughness and redundancy.

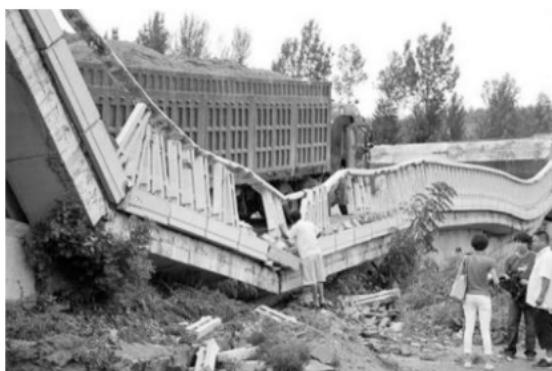
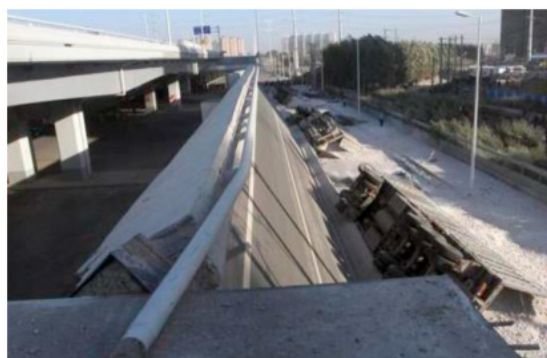
With the increase in traffic volume, the truckloads exceeded the limitations, resulting in bridge failures, especially for older bridges. Such bridge failures are common in developed countries. Some researchers found that the average service age of failed bridges due to overload in the United States was about 64 years. Besides, due to the increasing competition in the transportation market, vehicle overload has become more and more common and has raised serious concerns in developing countries such as China. For example, overturning collapses of single column pier bridges often occurred in recent years in China, the average service age of the overturned bridges did not exceed 20 years, and some even less than 1 year. In addition, overloads may contribute to an acceleration of fatigue damage of steel bridges. Fig. 5 shows some examples of bridge failures due to overload. Beam bridges are the

**Figure 5. Bridge failures due to overload. (a) Girder collapsed. (b) Girder overturned. (c) Main girder of an arch bridge collapsed**

We cannot improve the live load level to meet overload demand, which will cause great waste of resources. Overload should be treated as an extreme event. On one hand, the laws and regulations must be observed and strictly enforced, and those who break the laws must be prosecuted. On the other hand, it is critical for bridges to have sufficient redundancy and capacity protection measures to reduce the probability of bridge failure due to overload.
