Bridge Failures: Causes, Analysis & Lessons Learned

Course No: S02-032
Credit: 2 PDH

Ibrahim M. Metwally, Ph.D., P.E.

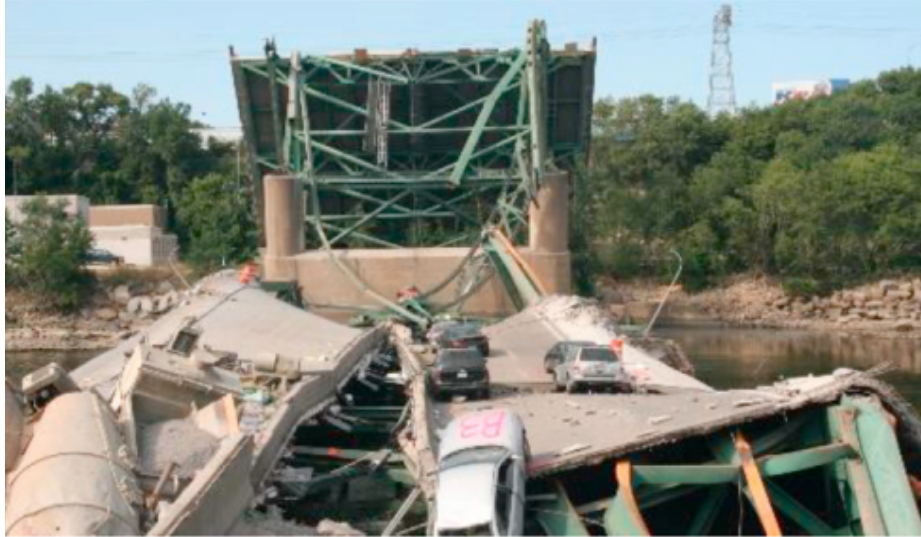
Design error is related to bridge failures caused by defects in design theory and carelessness of designers, which have certain concealment and are difficult to find the errors before the completion of the bridge and verify the causes after it fails. The design theory defects are mainly due to ignorance and cognitive limitations of human beings, and lack of sufficient understanding of the mechanism of bridges. For example, the collapse of the Quebec Bridge was due to insufficient understanding of the stability of members. The collapse of the Tacoma Bridge was due to insufficient understanding of the mechanism of wind on the bridge. The collapse of the I-35W Bridge was due to insufficient understanding of fatigue of truss bridge joints, (Fig. 1).

Figure 1. Bridge failures due to design errors (Defects in design theory)

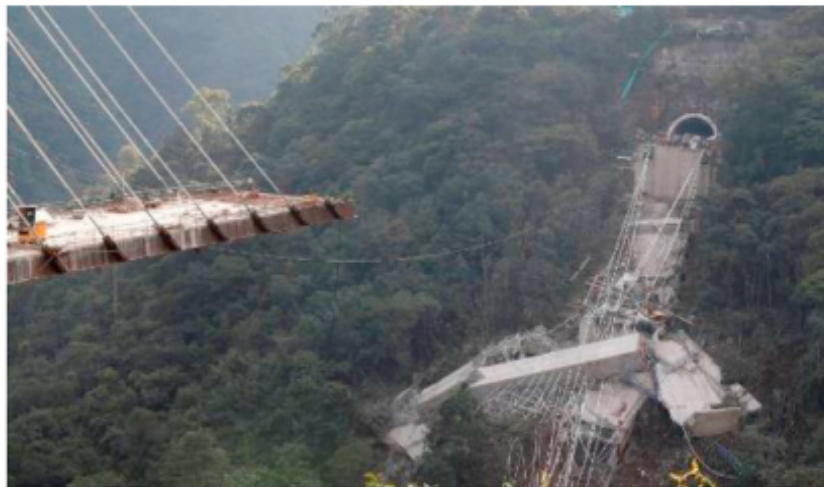
In addition, structural calculation errors or blind application of codes by designers due to lack of experience and knowledge will lead to bridge failure. For example, Chirajara Bridge in Colombia collapsed during construction due to insufficient design of the bearing capacity of the lower beam of the bridge tower. The collapsed bridge is shown in Fig. 2. Designers and researchers gain experience from the failures, continuously develop and perfect bridge design theory. Thus, the number of bridge failures caused by design theory defects is decreasing. Moreover, the number of bridge failures caused by the carelessness of designers is also decreasing with the continuous improvement of the laws and supervision regulations.

Figure 2. Bridge failures due to design errors (Design mistake)

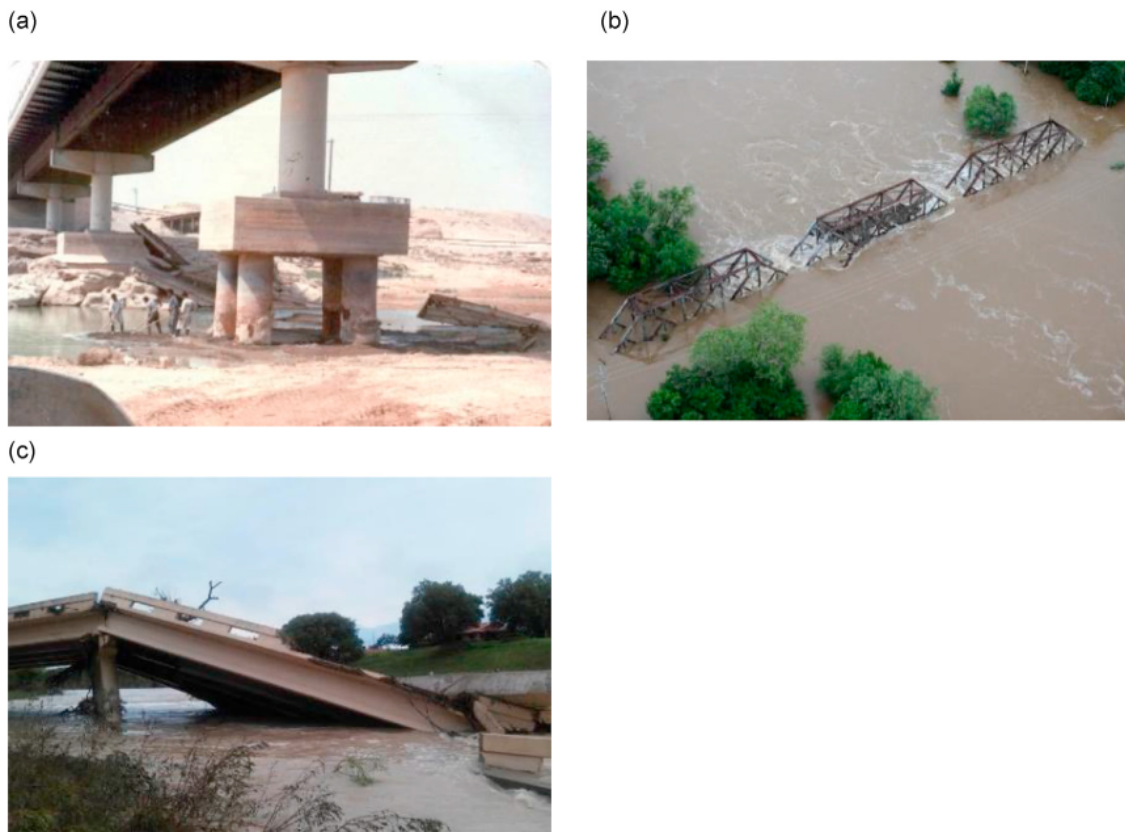
The failed cases are shown in Fig. 4. The causes of bridge failures caused by hydraulic are mainly classified into natural factors and human factors. For natural factors, rivers in some areas suffer from rare catastrophic floods, which exceed the ultimate limit state, thus causing the bridges to fail. The United States experienced 2 catastrophic floods in 1993 and 1996, with 171 bridge failures in these 2 years alone, making the proportion of bridge failures caused by floods far higher than other causes. Similarly, Guangdong Province of China experienced a devastating flood in 2013, with 316 roads cut off, 83 bridges collapsed and more than one hundred million dollars lost. For human factors, the most important factors are:

Figure 4. Bridge failures due to hydraulic. (a) Foundation scouring. (b) Bridges submerged by flood. (c) Bridge collapse due to flood

To protect bridges from hydraulics, designers should select proper bridge sites, arrange bridge span properly, and ensure adequate foundation depth. Then, the bridge regulation and protection projects should be improved, and the direction of flood flow should be adjusted to reduce the impact and erosion of floods on bridges.

Finally, bridge maintenance work should be strengthened, and foundation scouring maintenance should be included in the preventive maintenance category, and the diseases should be found in time. The failure of the substructure usually leads to the failure of the superstructure. Therefore, the safety factor of the substructure should be no lower than that of the superstructure. In addition, structural safety should be ensured by strengthening structural capacity protection measures, improving structural toughness and redundancy.

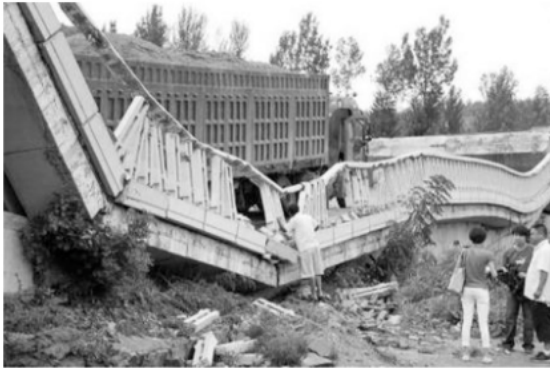
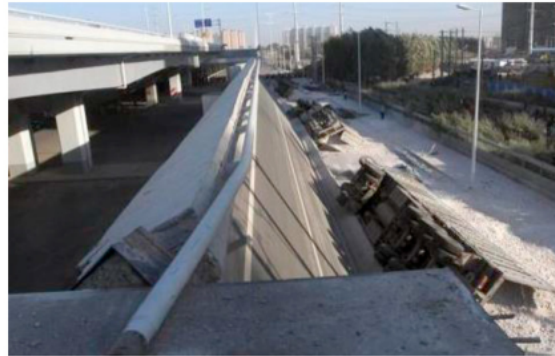
With the increase in traffic volume, the truckloads exceeded the limitations, resulting in bridge failures, especially for older bridges. Such bridge failures are common in developed countries. Some researchers found that the average service age of failed bridges due to overload in the United States was about 64 years. Besides, due to the increasing competition in the transportation market, vehicle overload has become more and more common and has raised serious concerns in developing countries such as China. For example, overturning collapses of single column pier bridges often occurred in recent years in China, the average service age of the overturned bridges did not exceed 20 years, and some even less than 1 year. In addition, overloads may contribute to an acceleration of fatigue damage of steel bridges. Fig. 5 shows some examples of bridge failures due to overload. Beam bridges are the

dominant structural type of failure due to overload. The live load effect accounts for a large proportion of the total effect, which causes beam bridges vulnerable to overloads.

Figure 5. Bridge failures due to overload. (a) Girder collapsed. (b) Girder overturned. (c) Main girder of an arch bridge collapsed

We cannot improve the live load level to meet overload demand, which will cause great waste of resources. Overload should be treated as an extreme event. On one hand, the laws and regulations must be observed and strictly enforced, and those who break the laws must be prosecuted. On the other hand, it is critical for bridges to have sufficient redundancy and capacity protection measures to reduce the probability of bridge failure due to overload.
