# **Earthquake Design Considerations for Non-Residential Buildings**

Course No: S04-014

# Primer for Design Professionals

Communicating with Owners and Managers of New Buildings on Earthquake Risk

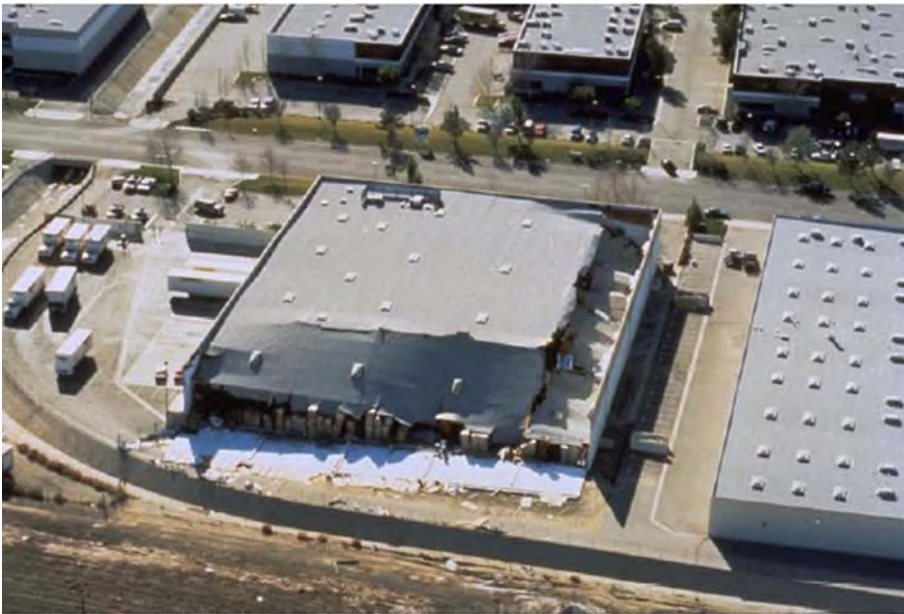
Figure 8-1 Roof and wall collapse of tilt-up building during the 1994 Northridge earthquake. (Photo courtesy of the Earthquake Engineering Research Institute)

Starting in the late 1950s larger light manufacturing buildings have been predominantly tilt-up structures, particularly in California. In seismic regions the perimeter precast walls were used as shear walls and roof structures were generally glued-laminated beams and plywood diaphragms. In the 1964 Alaska earthquake and the 1971 San Fernando (Los Angeles) event, performance of these buildings was poor, with considerable damage being sustained. The most common type of failure was to the wall/diaphragm anchors, but large out-of-plane movement of the panels, out-of-plane bending cracks in pilasters at mezzanine levels, and roof separations were all encountered and many roof collapses occurred. Due to the relatively large size of these buildings roof collapses were localized, rarely extending beyond one or two bays, and the buildings were sparsely occupied, so casualties were few. (Figure 8-1)

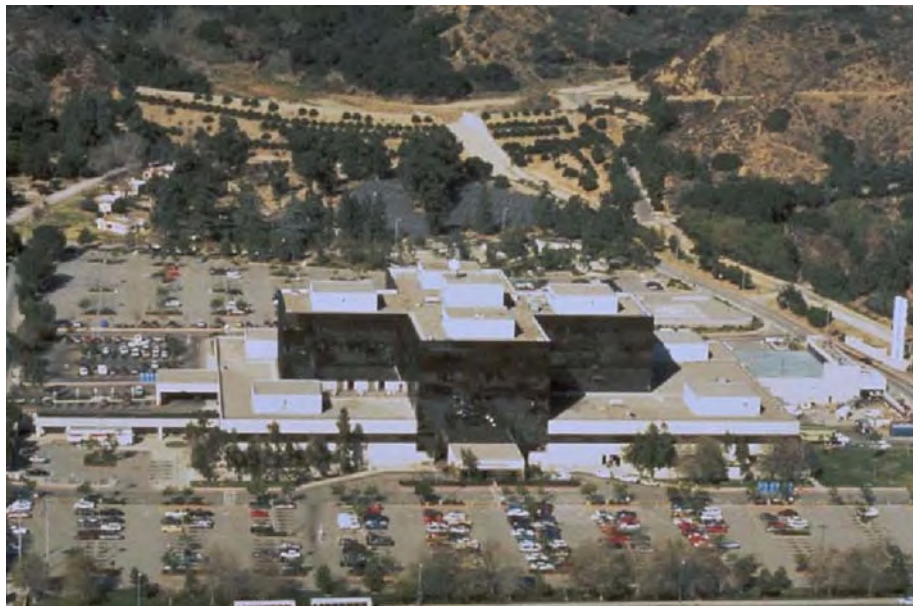
Figure 9-2 Aerial view of Olive View Hospital, which sustained no structural damage during the 1994 Northridge earthquake, but was closed for a short while after the earthquake because of water leakage from broken sprinklers and waterlines. (photo courtesy of the Earthquake Engineering Research Institute)

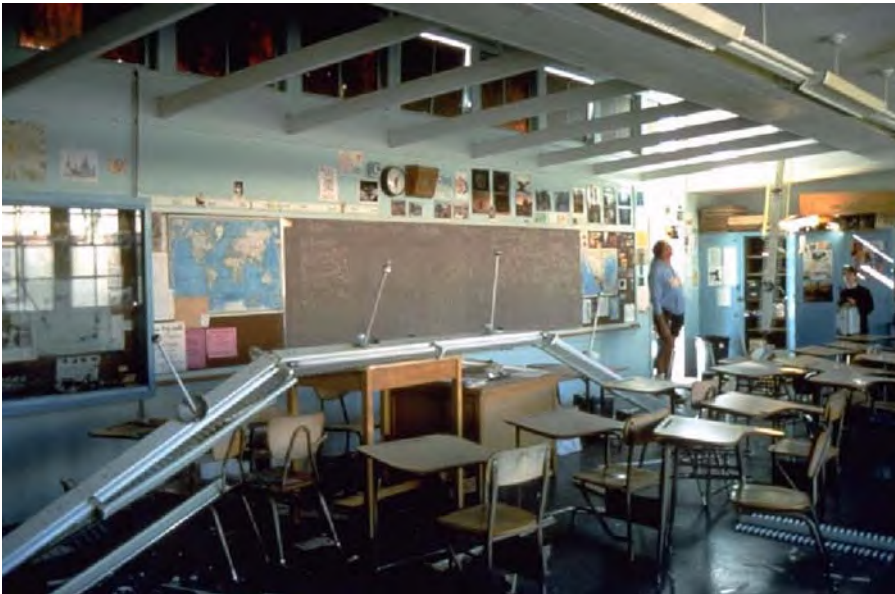
Figure 10-1 Nonstructural damage at Northridge Junior High where lights fell onto desks during the 1994 Northridge earthquake. (photo courtesy of the Earthquake Engineering Research Institute)

Falling nonstructural components and systems present a significant potential for injuries to building occupants as shown in Figure 10-1. In addition to the injury potential and economic loss resulting from repair and clean-up costs, excessive service interruption can result from lighting fixture and water, mechanical, and electrical equipment damage.
