Seismic Assessment of Large Number of Buildings Based on Visual Inspection

Course No: S04-022

Ibrahim M. Metwally, Ph.D., P.E.

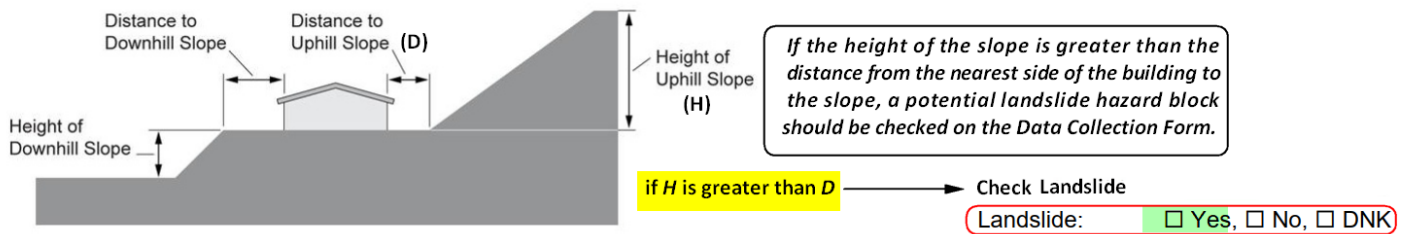
Figure 5. Building with Potential Landslide Hazard (FEMA 154)

NOTE: If the height of the slope is greater than the distance from the nearest side of the building to the slope, a *potential landslide hazard* block should be *checked* on the Data Collection Form. Refer to figure below for landslide hazard potential.

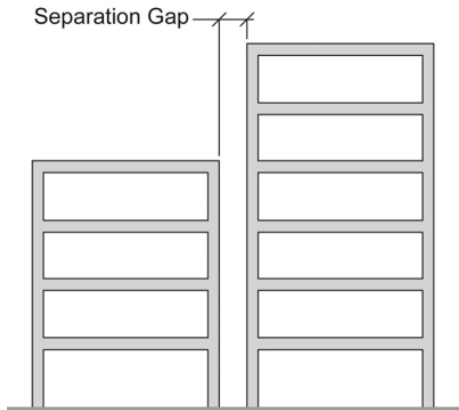
- 2” times number of stories in shorter building (in Very High seismicity region)
- 1 ½ “times number of stories in shorter building (in High seismicity region)
- 1” times number of stories in shorter building (in Moderately High seismicity region)
- ½ “times number of stories in shorter building (in Moderate and Low seismicity region)

- a) Two 2-story buildings next to each other in High seismicity region:
Minimum Separation = $1\frac{1}{2} \times 2 = 3''$
- b) 6-story building next to a 4-story building in Moderate seismicity region: Minimum Separation = $1\frac{1}{2} \times 4 = 2''$

Refer to the Figure 6 for Pounding Calculation and Consideration example

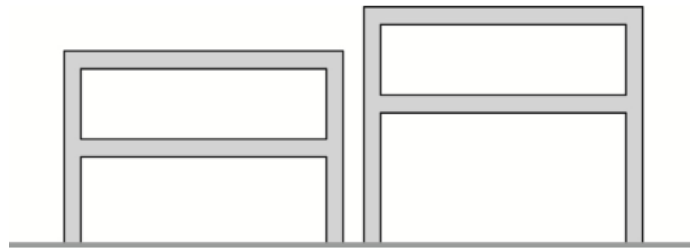
Figure 7. Schematic illustration of floors not aligning vertically.

- a) Floors are separated vertically by more than two feet, as shown in Figure 7. Damage and potential collapse are considered to be more likely when the floor mass of one building can directly impact the columns or walls of the adjacent building.

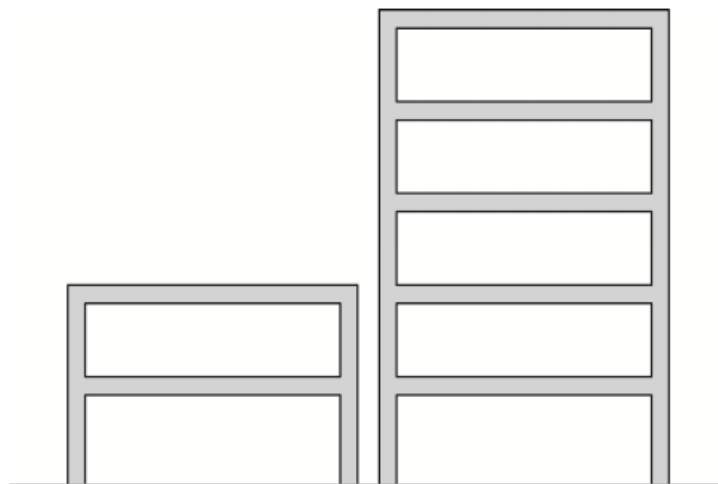
Figure 8. Schematic illustration of buildings of different height

- b) One building is two or more stories taller than the adjacent building, as illustrated in Figure 8. Damage may concentrate in the taller building at the roof level of the shorter building.

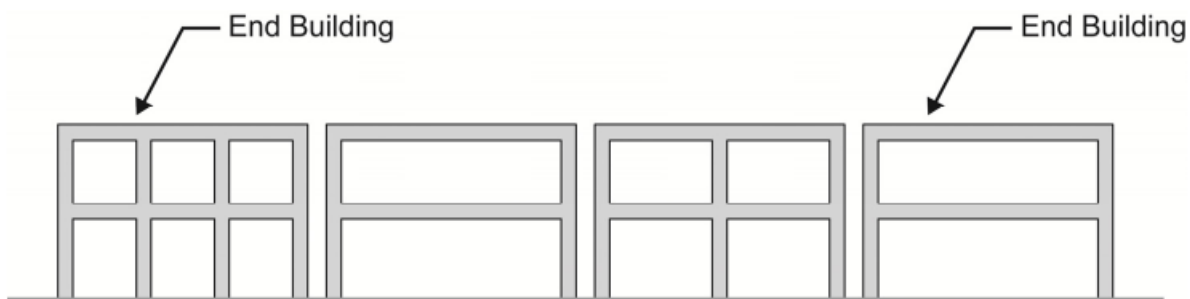
Figure 9. Schematic illustration of end buildings.

- c) The building is at the end of a row of three or more buildings, as illustrated in Figure 9. Higher demands are imposed on the end building when the adjacent building moves toward it and because it does not have a building on the other side to balance the loads. Higher levels of damage have been observed at end buildings in past earthquakes.

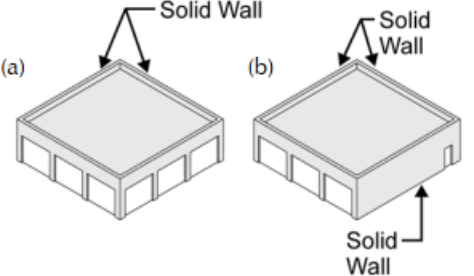
<p>Apply if there is good lateral resistance in one direction, but not the other, or if there is eccentric stiffness in plan (as shown in Figures (a) and (b)); solid walls on two or three sides with walls with lots of openings on the remaining sides).</p>
Non-Parallel Systems

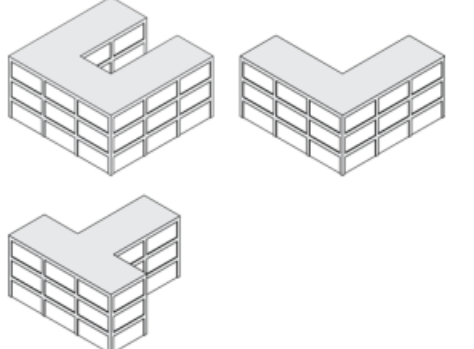
<p>Apply if there is a reentrant corner, i.e., the building is L, U, T, or + shaped, with projections of more than 20 feet. Where possible, check to see if there are seismic separations where the wings meet. If so, evaluate for pounding.</p>
Diaphragm Openings

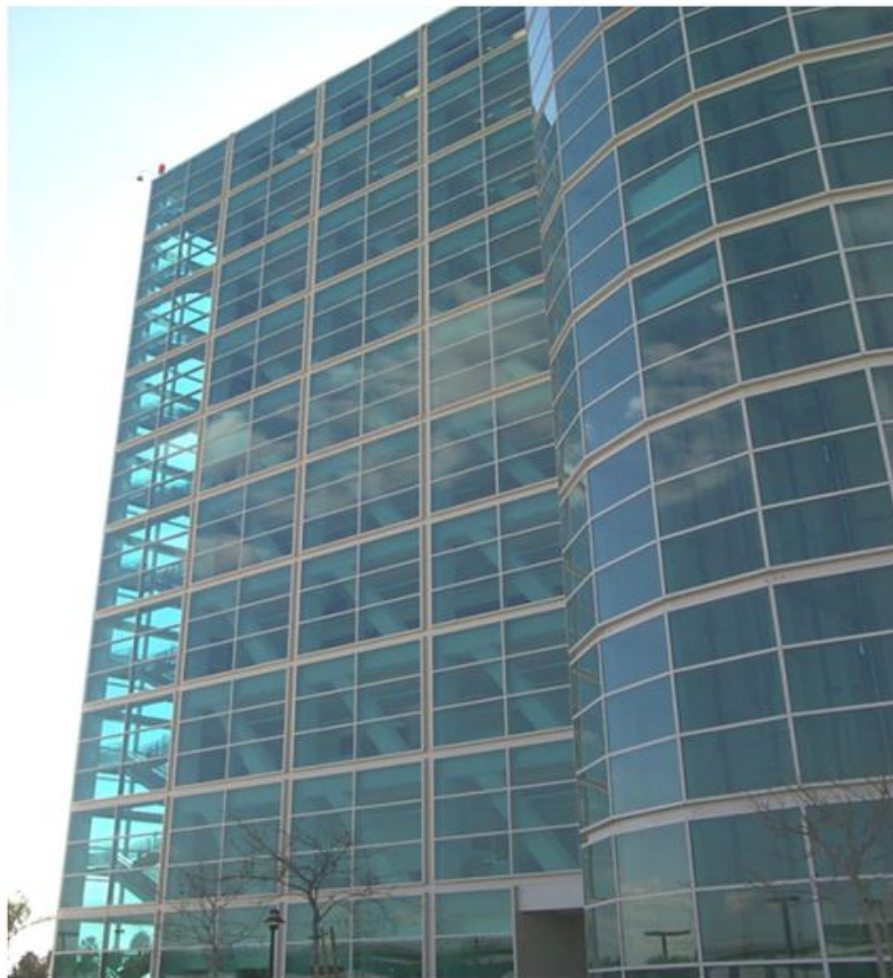
Figure 10. Exterior view of 3703 Roxbury Street.

- Upon arriving at the site, the screener observed the building as a whole (Figure 10) and began the process of verifying the information in the building identification portion of the form (upper right corner), starting with the street address. The screener added her name and the date and time of the field screening to the building identification portion of the form.

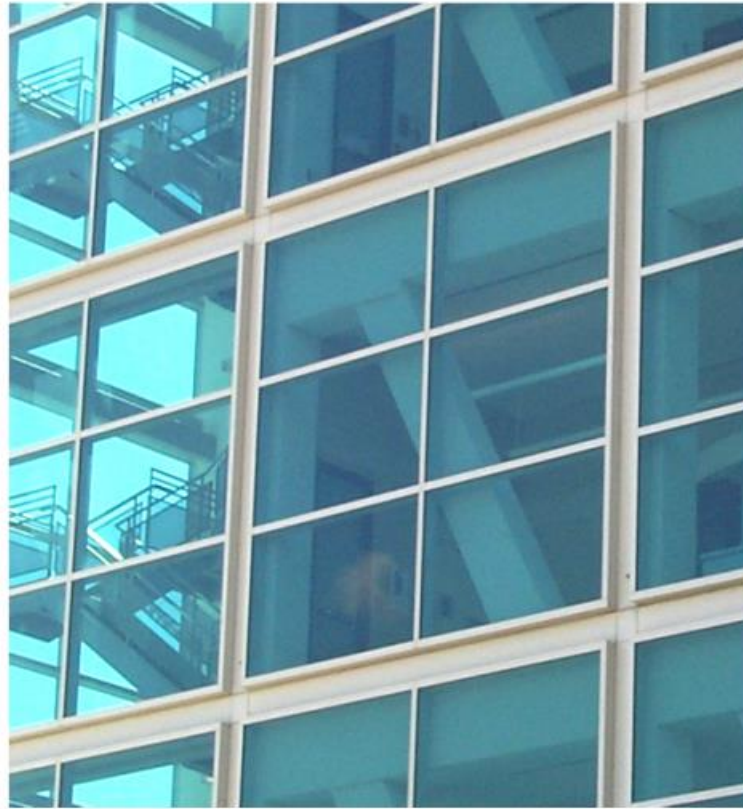
Figure 11. Close-up view of 3703 Roxbury Street exterior showing perimeter braced steel framing.

- The FEMA Building Type (S2, steel braced frame) was verified by looking at the building with binoculars (Figure 11)

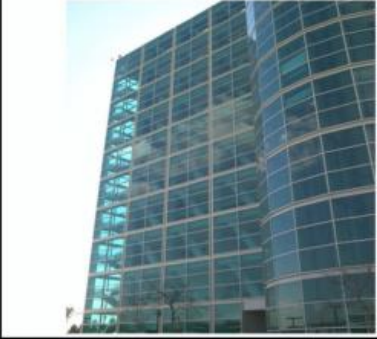
Address: 3703 Roxbury Street
Anyplace Zp: 91234

COMMENTS:
No irregularities, adjacent buildings, or falling hazards observed.

- The screener circled both “Office” and “Commercial” to indicate the observed occupancies
- The screener noted that an adjacent 11-story building was separated from the building being screened by only 12 inches. The screener determined the minimum separation gap for pounding per the Level 1 Pounding Guide (1 ½ inches per story for 11 stories equals 16.5 inches) and found that the actual separation was less than the minimum. In addition, the building being screened was at the end of the block. Based on these two conditions, the screener checked the “Pounding” box in the Adjacency section of the form.

- The screener consulted the Vertical and Plan Irregularity Reference Guides (FEMA P-154, Appendix B.5 & B.6) and determined that the four individual towers extending above the base represented an out-of-plane offset. The screener noted this severe vertical irregularity.

- Sketches of the plan and elevation views of the building were drawn in the “Sketch” portion of the form. The cornices at roof level were observed, and entered on the form.

- Under Extent of Review, the screener noted that he was not able to view all sides of the building by checking the “Partial” box under Exterior. He indicated that he was not able to view the interior of the building by checking “None” under Interior.

- Under Other Hazards, he noted that pounding potential of the building with its neighbor triggers a Detailed Structural Evaluation.
- Because the building's Final Score was less than the cut-off score of 2.0, and because of the other hazards present (pounding), the building required a Detailed Structural Evaluation by an experienced seismic design professional.
- Because of the cornices, the building required a Detailed Nonstructural Evaluation.

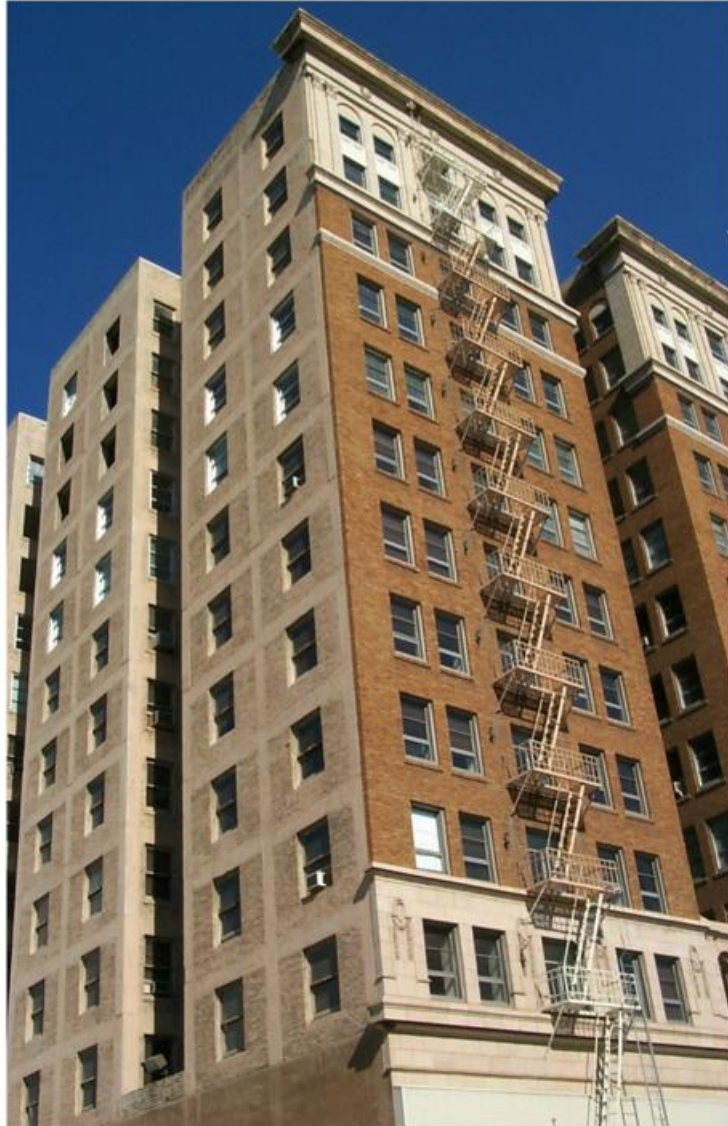
Figure 13. Exterior view of 3711 Roxbury Street

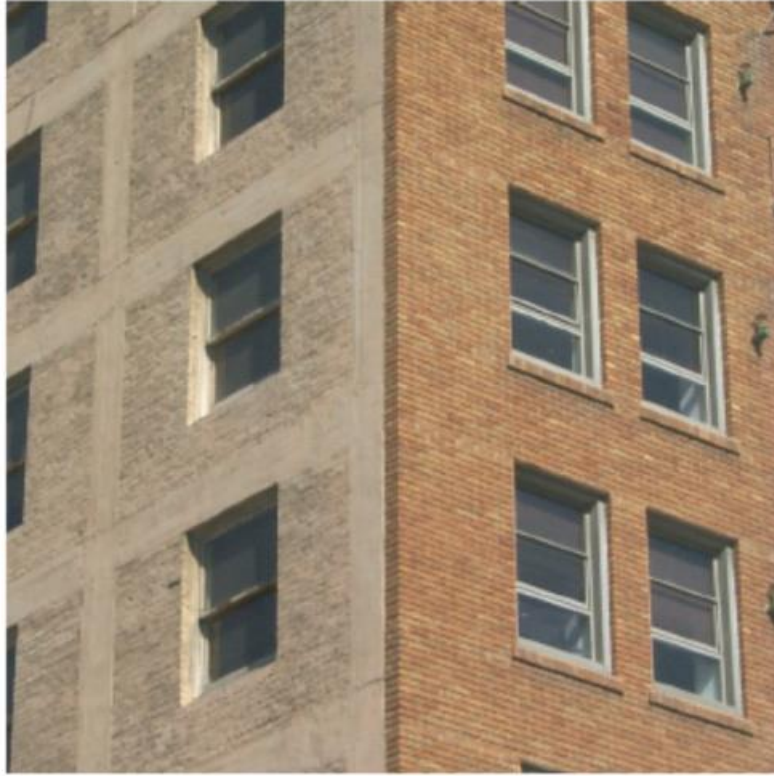
Figure 14. Close-up view of 3711 Roxbury Street building showing exterior infill frame construction

- Noting that it was a 12-story building, a review of the material in Table D-6 (FEMA P-154, Appendix D), indicated that the likely options for FEMA Building Type were S1, S2, S5, C1, C2, or C3. On more careful examination of the building exterior with the use of binoculars (see Figure 14), it was determined the building was Type C3, concrete frame with unreinforced masonry infill, and this alpha-numeric code, and accompanying Basic Score, were circled on the Data Collection Form.

- Because the four individual towers extending above the base represented a vertical irregularity, this modifier was circled. The screener checked the Quick Reference Guide and compared the estimated date of construction to the pre-code year for FEMA Building Type C3. Since 1945 was after the pre-code year of 1941, the screener did not circle the pre-code modifier.

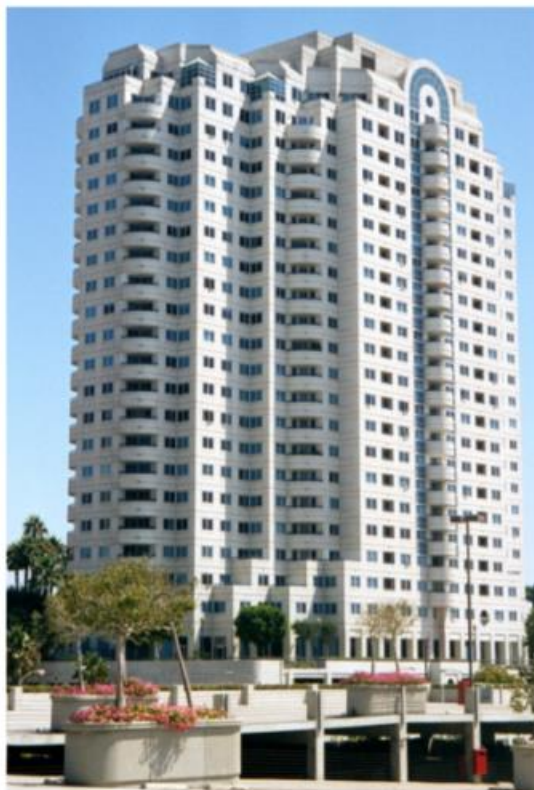
Figure 16. Exterior view of 5020 Ebony Drive

The building was a high-rise residential building (Figure 19) in a new part of the city in which new development had begun within the last few years. The building was not included in the electronic Building RVS Database; consequently, there was not a partially prepared Data Collection Form for this building (No Pre-field Planning Stage). The screeners wrote the address of the building on a blank form along with their names and date and time of the screening.

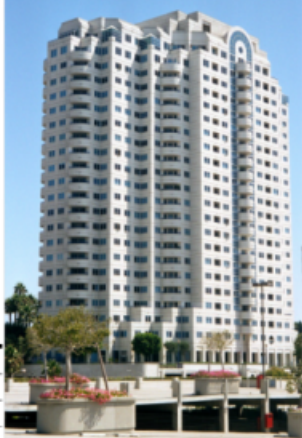
SKETCH

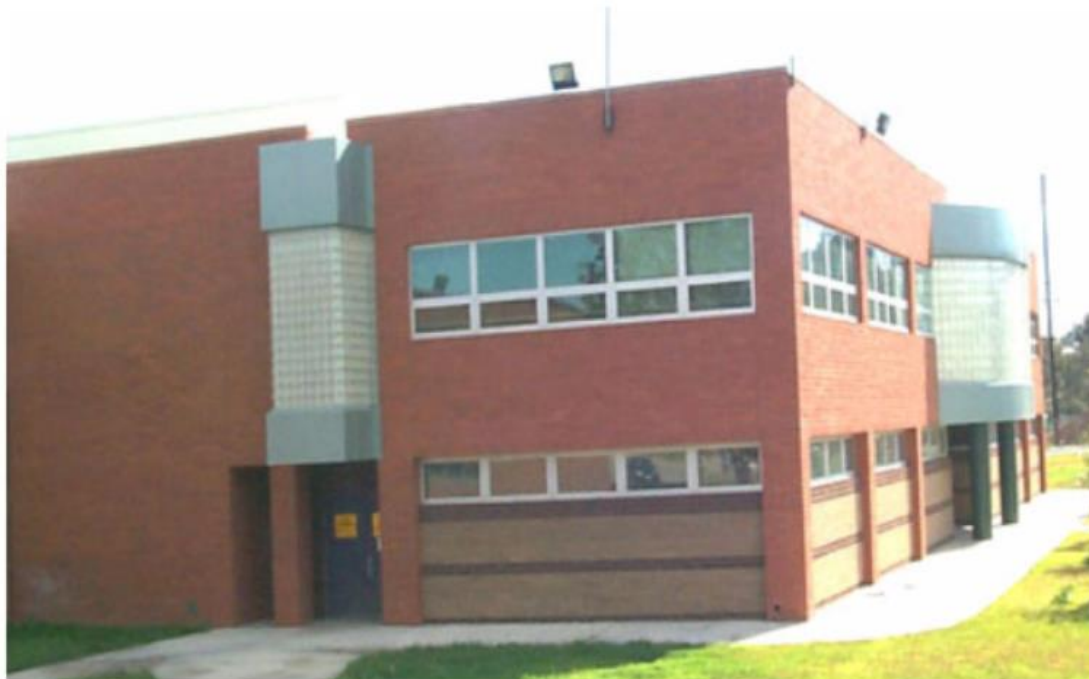
Figure 18. Exterior view of modern reinforced brick masonry building at Roosevelt Elementary School

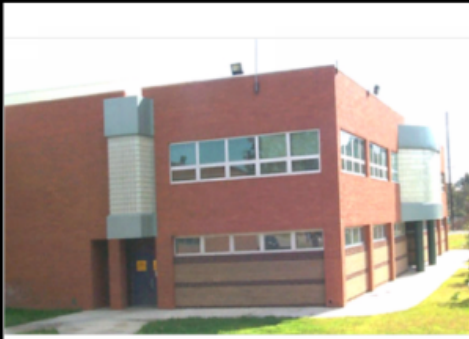
Address: 169 Parkway Blvd
Green City, Any State Zip: 90922

Other Identifiers: Roosevelt Elementary School

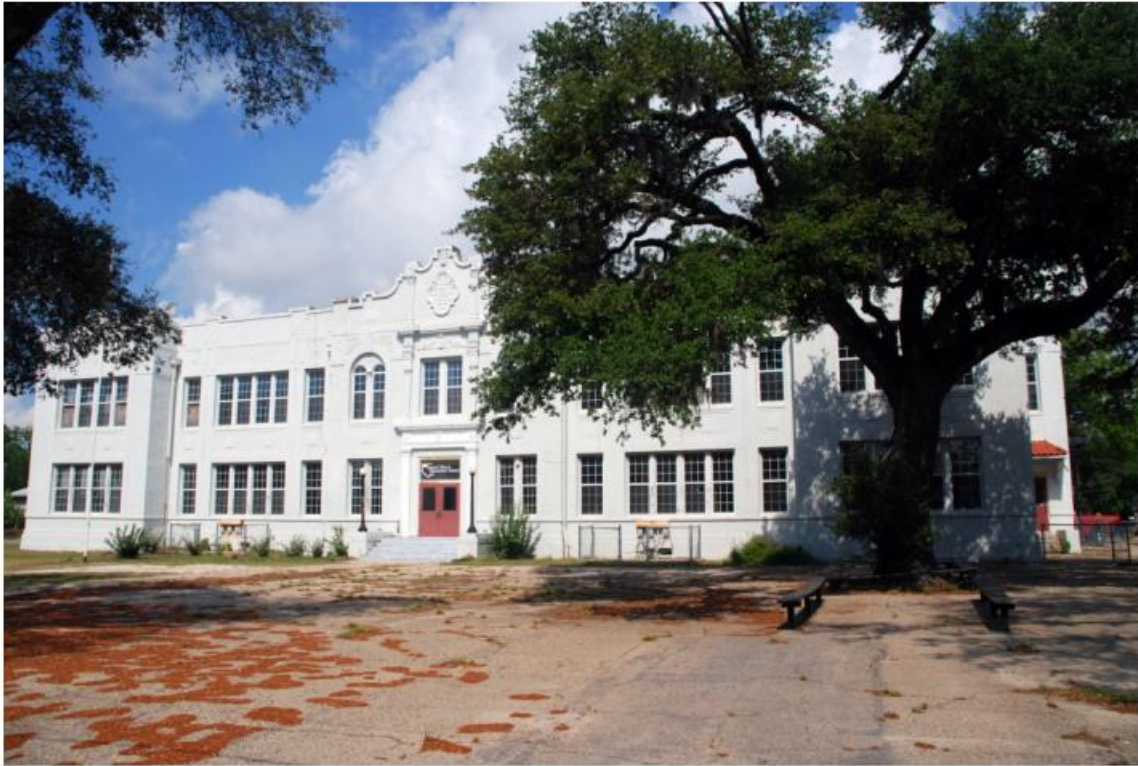
Figure 21. Photo of exterior of Washington Middle School

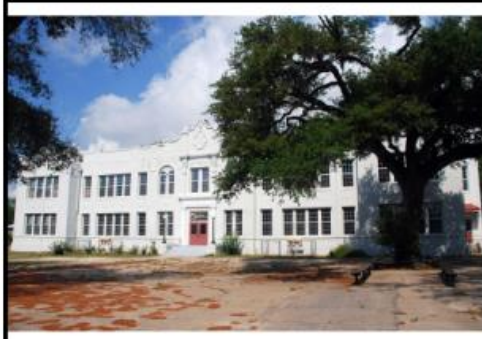
Address: 1515 Northwest Drive
Old Town, Any State Zip: 90907
 Other Identifiers: Washington Middle School
 Building Name: Main Building + Addition
 Use: Classrooms
 Latitude: 42.836 Longitude: -73.322
 S: 1.21 S: 0.54
 Screener(s): J. Howard Date/Time: 8/28/13 9am

No. Stories: Above Grade: 3 Below Grade: 0 Year Built: 1931 EST
 Total Floor Area (sq. ft.): ~~28,800~~ 29,800 Code Year: _____
 Additions: None Yes, Year(s) Built: 1994
