Making Schools Safe from Earthquakes

Course No: S05-012

for Improving School Safety
in Earthquakes, Floods, and High Winds

4 Making Schools Safe From Earthquakes

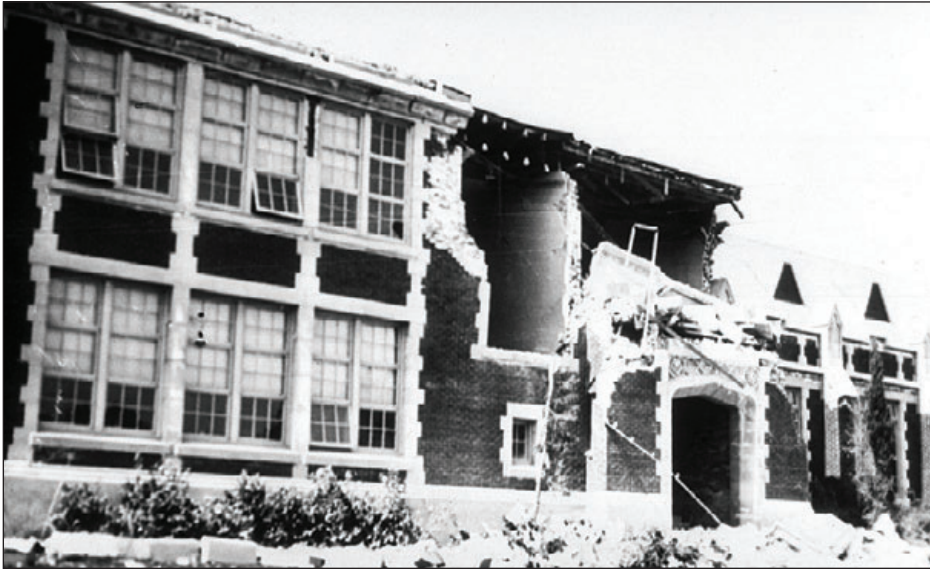
Figure 4-12:
Damage to the John Muir School, Long Beach, CA, 1933

Considering the number of significant earthquakes in California since the early years of the 20th century, severe structural damage to schools and casualties has been relatively limited, except in the Long Beach earthquake of 1933. No student has been killed or seriously injured in a California school during an earthquake since 1933. In the Long Beach earthquake, which struck at 5:55 p.m. on March 10, 1933, damage to unreinforced masonry (URM)

school buildings was so severe that there would have been many casualties had they been occupied (see Figures 4-12, 4-13, and 4-14). As a result, the State passed the Field Act within a month of the earthquake.

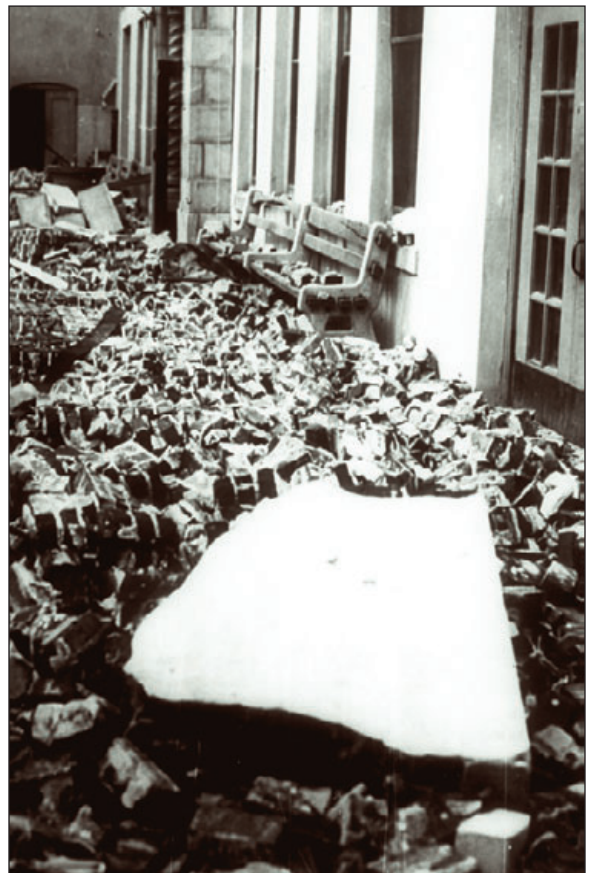
Figure 4-13:
Damage to shop building, Compton Junior High School, Long Beach, CA, 1933

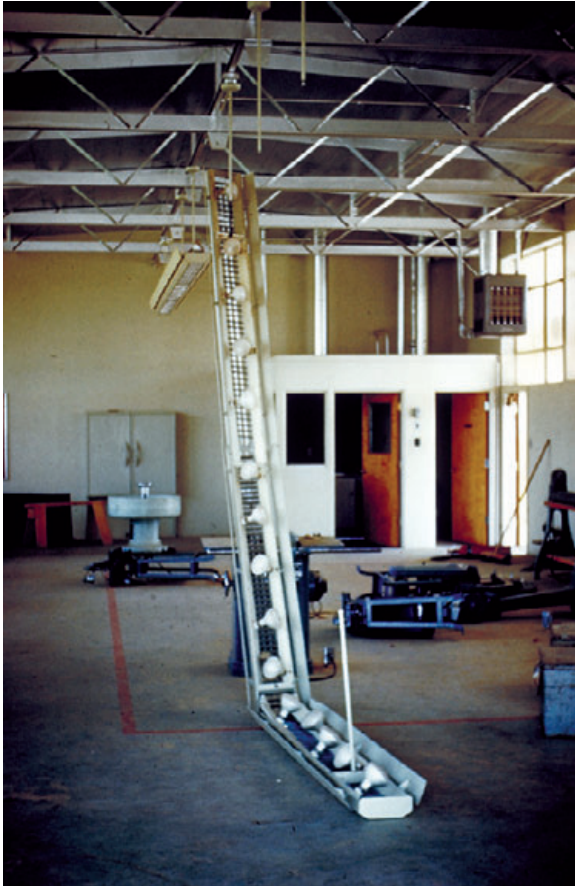
Figure 4-16:
Overturned shop equipment and failed light fixtures, Kern County, CA, 1952

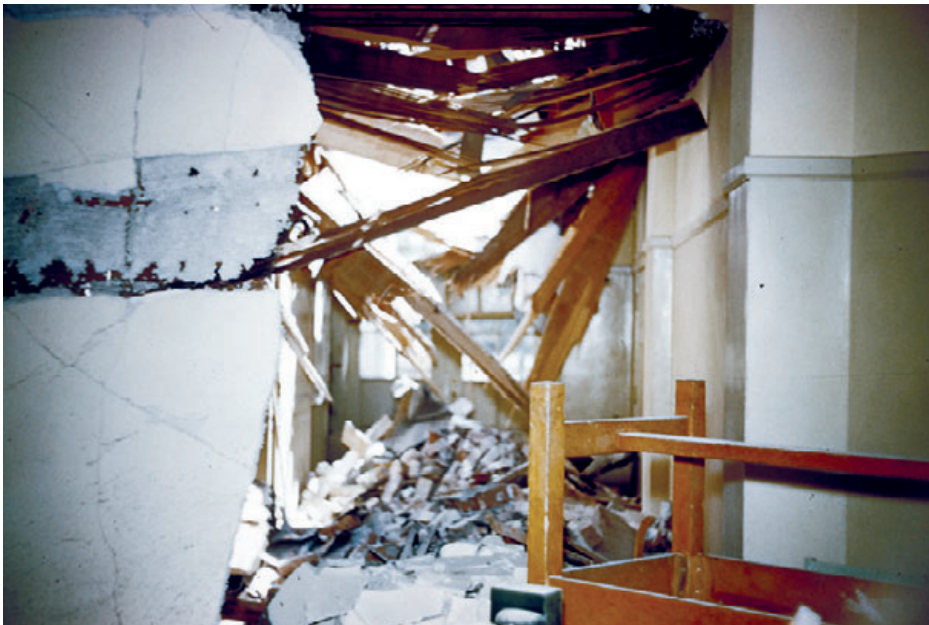
Figure 4-17:
Destroyed exit corridor, Bakersfield, Kern County, CA, 1952

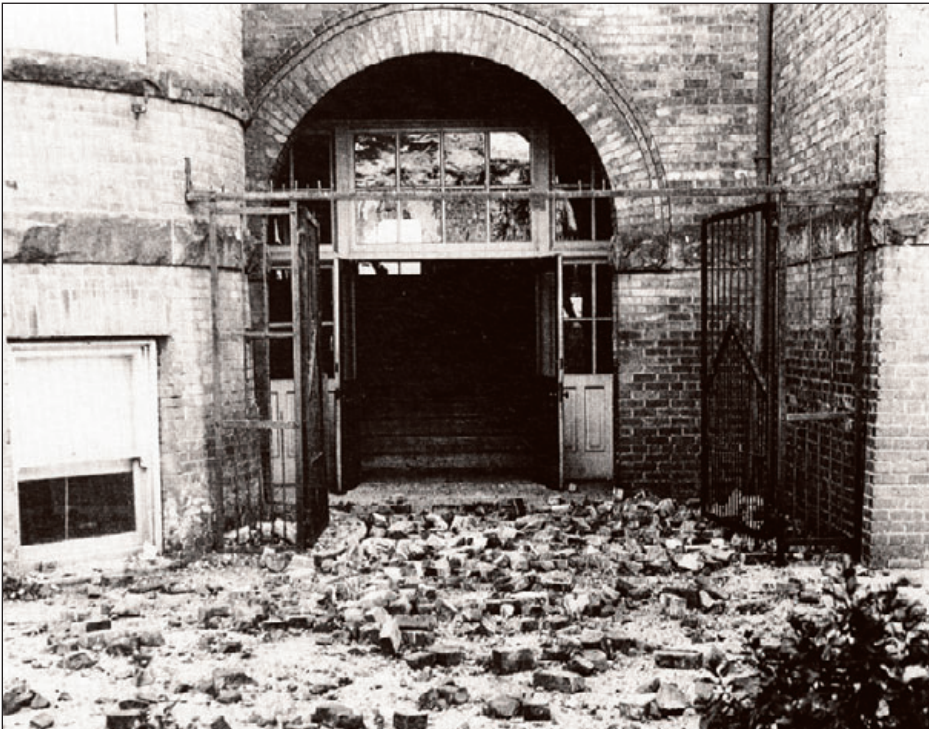
Figure 4-20:
Another dangerous entry collapse, Seattle, WA, 1949

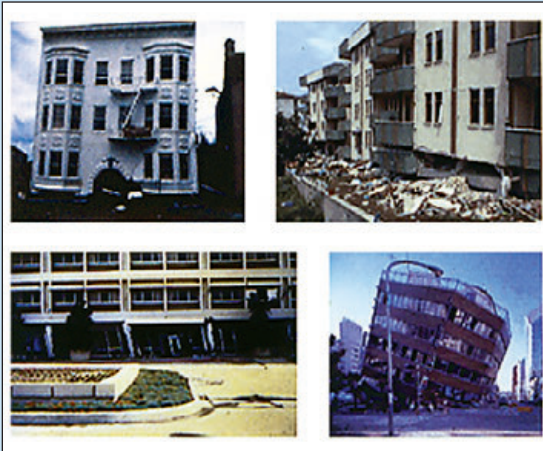
Soft Stories

Typical examples of soft story-induced damage.
