Tornado Protection: *Selecting Refuge Area in Buildings*

Course No: S06-004
Credit: 6 PDH

Selecting Refuge Areas in
Buildings

FEMA P-431, Second Edition / October 2009

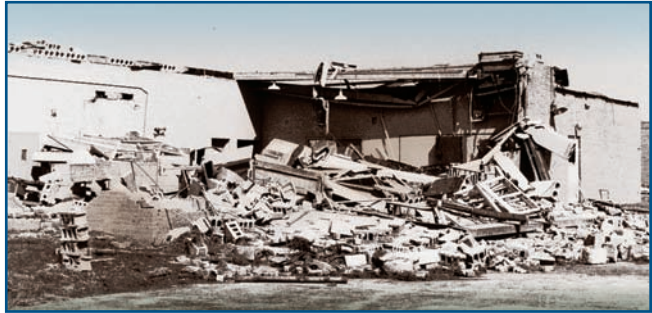
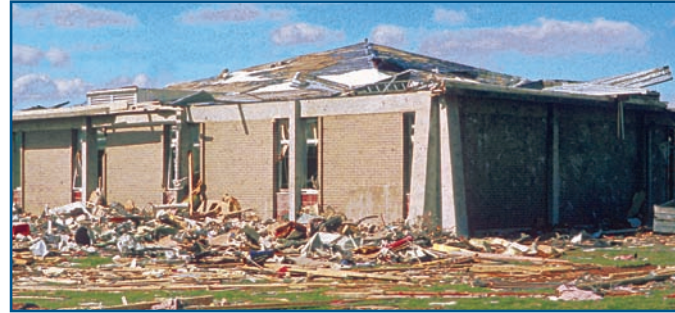
Figure 1-6
Typical tornado rotation.

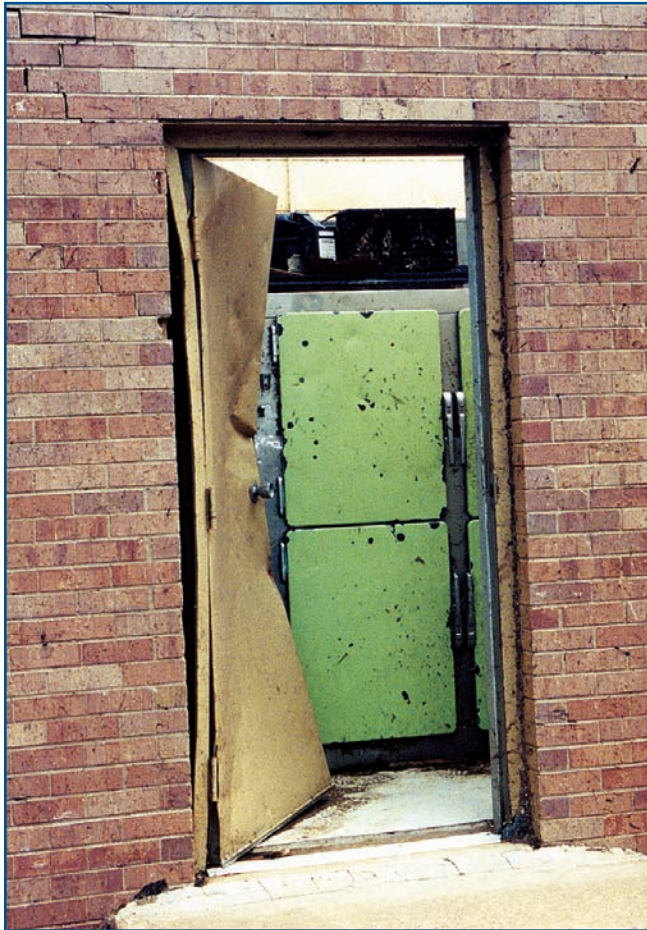
Figure 2-2
Example of damage from a windborne missile. A 2-inch by 6-inch board penetrated a refrigerator.

The extreme winds in tornadoes pick up and carry debris from damaged buildings and objects located in the path of the winds (see Figures 2-2 and 2-3). Even heavy, massive objects such as cars, tractor trailers, and buses can be moved by extreme winds and cause collateral damage to buildings. Light objects become flying debris, or missiles, that can penetrate doors, walls, and roofs; heavier objects can roll and cause crushing-type damage.

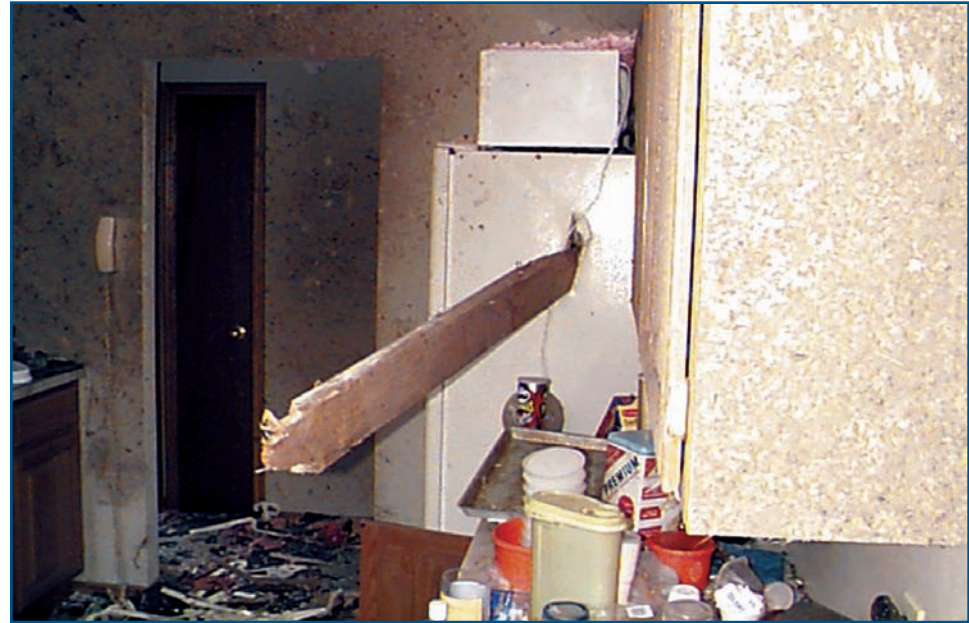
Figure 2-3
Example of severe damage from a windborne missile. This metal door was pushed inward by the impact of a heavy object.

Damage was also caused by the impact of windborne missiles. Figure 2-3, in Chapter 2, shows a steel door that appeared to have been opened by the impact of a heavy object. This door led into an area where the roof was missing. The opening created by this breached door may have allowed wind to enter the building and create internal pressure that increased the load on the building envelope. Figure 3-22 shows damage to a laminated glass window hit by a table.

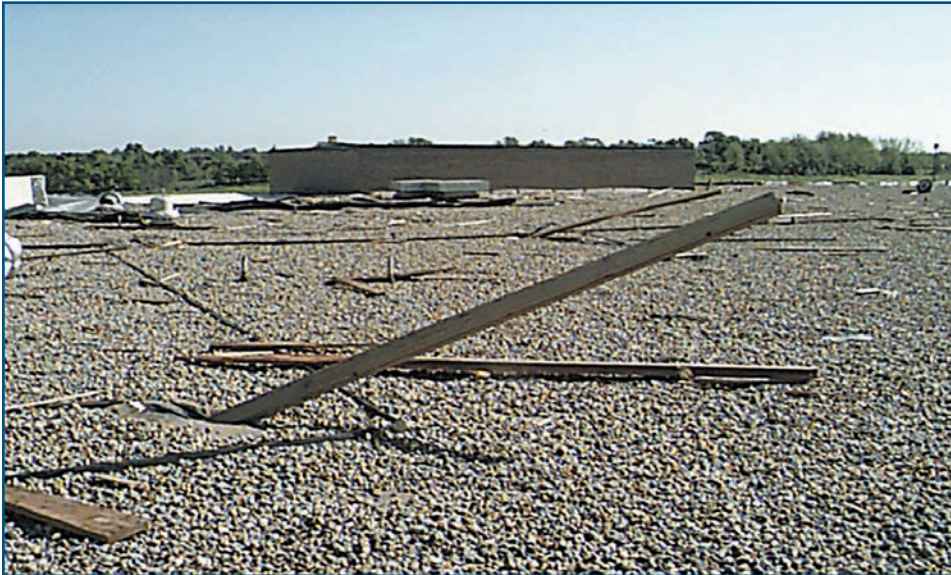
Figure 2-4

Example of damage from windborne missiles. Medium and small missiles penetrating through the roof of a high school. The missile protruding from the roof in the foreground is a double 2-inch by 6-inch wood board. The portion sticking out of the roof is 13 feet long. This missile penetrated a ballasted ethylene propylene diene monomer (EPDM) membrane, approximately 3 inches of polyisocyanurate roof insulation, and the steel roof deck. The missile lying on the roof just beyond it is a 2-inch by 10-inch, 16-foot-long wood board. The missile protruding from the roof in the background is a 2-inch by 6-inch, 16-foot-long wood board.

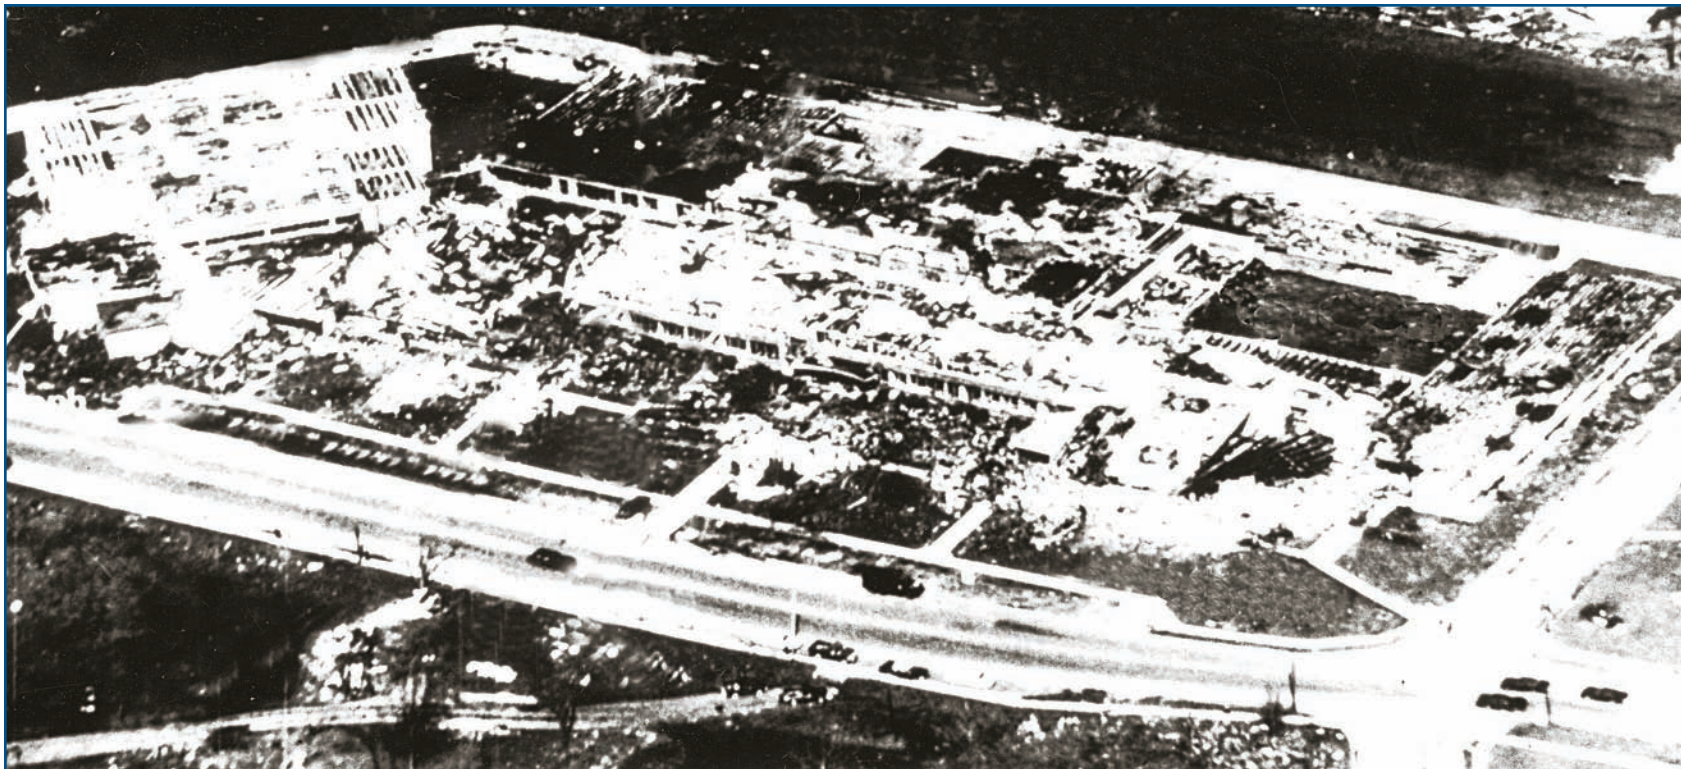
Figure 3-2 Xenia Senior High School, Xenia, Ohio.

The enclosure walls failed on the west and south sides, allowing the winds to enter the building. The roofs collapsed over the three large spans—the auditorium, the boys' gym, and the girls' gym. The lightweight roof over the original two-story building was torn off by the extreme winds.

All **windows** on the west and south sides were blown into the interior. The high single-story, **loadbearing masonry walls** of the **long-span** rooms failed, allowing the roofs to fall in. The unbaffled west entrances allowed the east-west corridors to become **wind tunnels**.

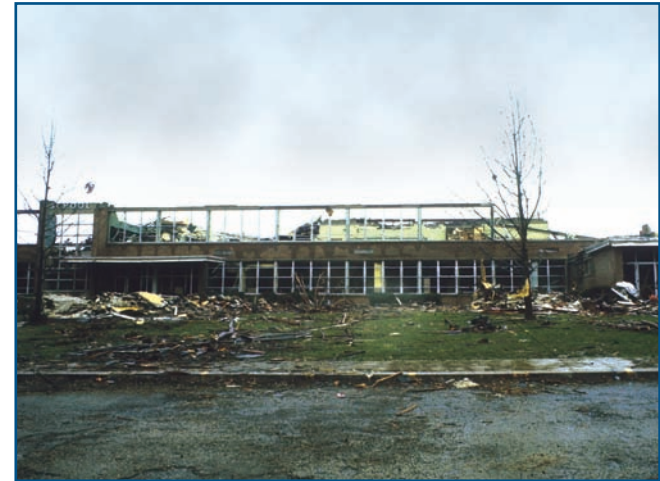
Figure 3-5
Loss of lightweight roof over the original two-story building.

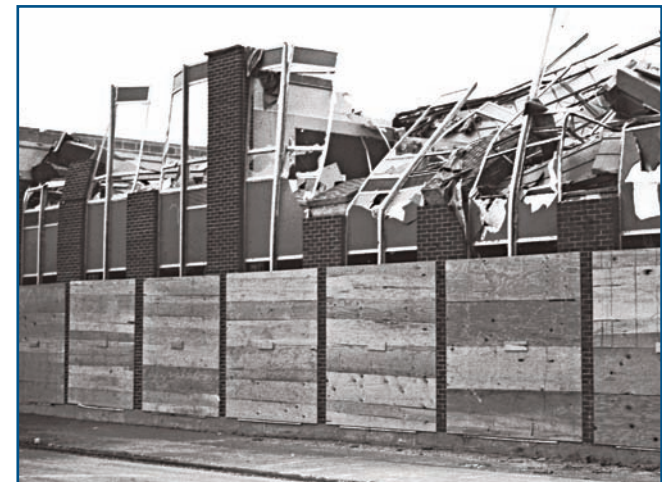
Figure 3-9
Collapsed second floor of St. Augustine Elementary School building.

The tornado winds lifted part of the roof and collapsed the second-floor piers in one wing of the school building (Figures 3-8, 3-9, and 3-10). The wind and windborne debris blew in most of the windows, and windborne debris was found in the classrooms (Figure 3-11). The exterior solid-core wood doors stayed in place and kept the debris out. Wired glass windows near the exterior doors remained intact. The interior doors to the classrooms remained in place although the hinges were damaged. The school was damaged to an extent where demolition was required.

The structural system of **unreinforced masonry piers** collapsed and almost one-third of the second-floor **lightweight roof structure** was lifted. Roof removal occurred over the classrooms as well as over the corridor. Most of the **skylights** in the corridors were removed by wind or broken by windborne debris. Almost all the **windows** on both floors were broken. Windborne debris and broken glass were found in the classrooms.

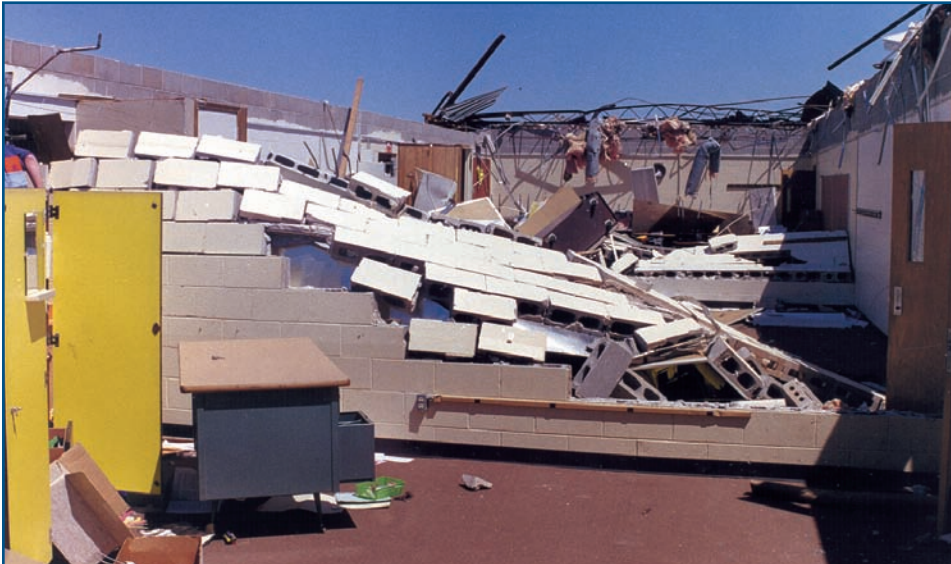
Figure 3-17
Interior and exterior unreinforced masonry walls were damaged when reinforced bond beams failed.

Unreinforced masonry walls failed when the roof system was lifted or removed by tornado winds (Figures 3-17, 3-18, and 3-19). Figures 3-17 and 3-19 show failed interior and exterior walls, respectively. Figure 3-18 shows the separation of the reinforced bond beam (indicated by circles) from the upper part of a corridor wall. The inclusion of clerestory windows in some corridor walls contributed to their failure under loads imposed by tornado winds (Figure 3-20).

Unreinforced masonry walls failed when the reinforced bond beams at the tops of the walls failed.

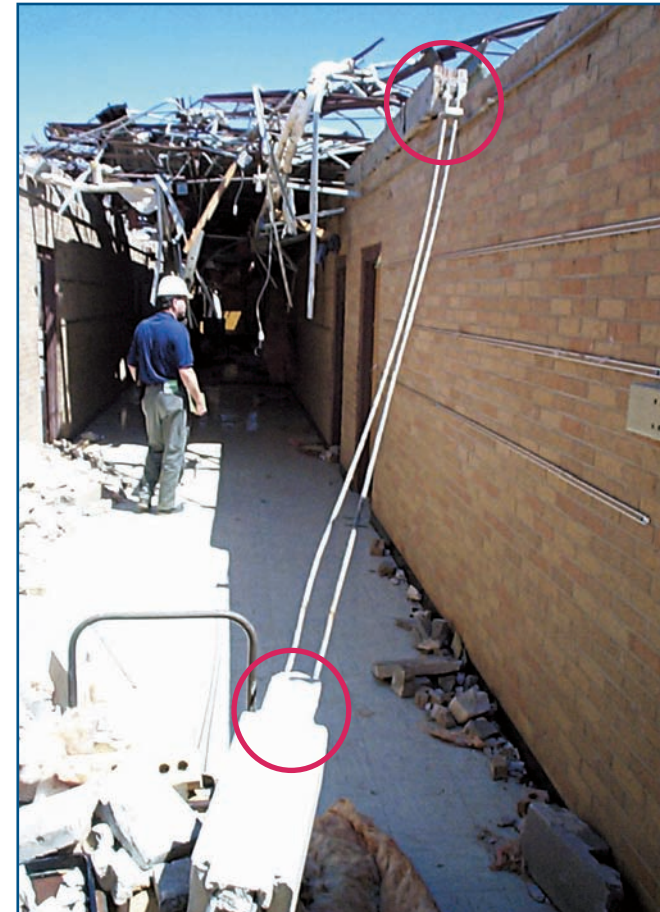
Figure 3-18
Corridor area. Separation of reinforced bond beam (indicated by circles) from supporting wall.

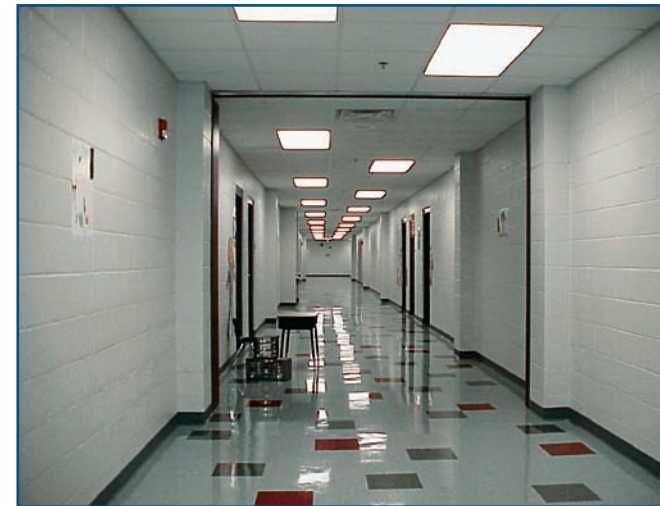
Figure 3-24
Corridor (designated safe area) in reconstructed Kelly Elementary School.

Because the damage to Kelly Elementary School was so great, the school was demolished and completely rebuilt. The new building, although constructed on the same footprint, incorporated several structural improvements specifically designed to provide improved resistance to extreme winds and create refuge areas for the school's occupants. As in the original building, the central corridors of the three wings are the designated refuge areas (Figures 3-23 and 3-24).

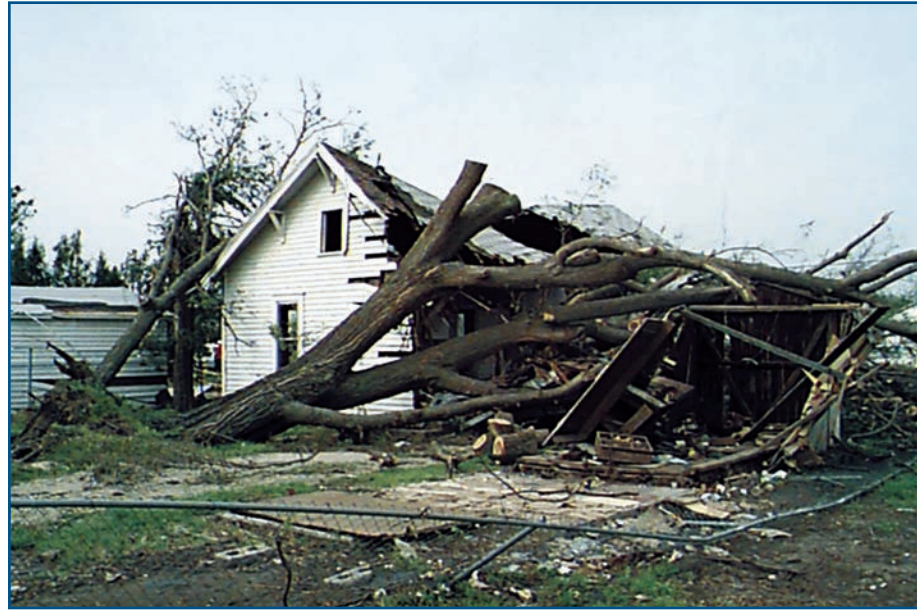
Figure 4-2
Two trees toppled by tornado winds damaged this house in Haysville, Kansas.

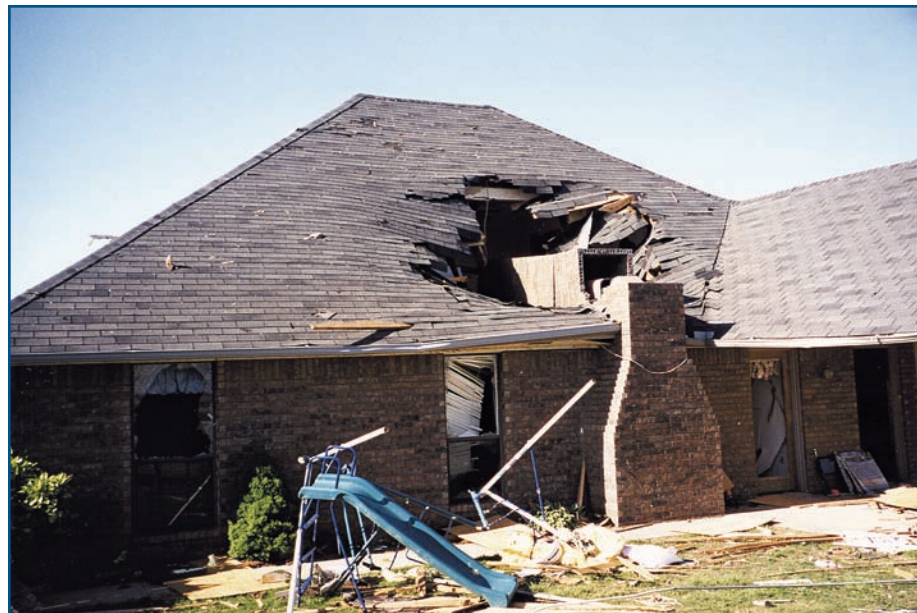
Figure 4-3
Failure of brick chimney under tornado winds damaged the room of this house in Moore, Oklahoma.

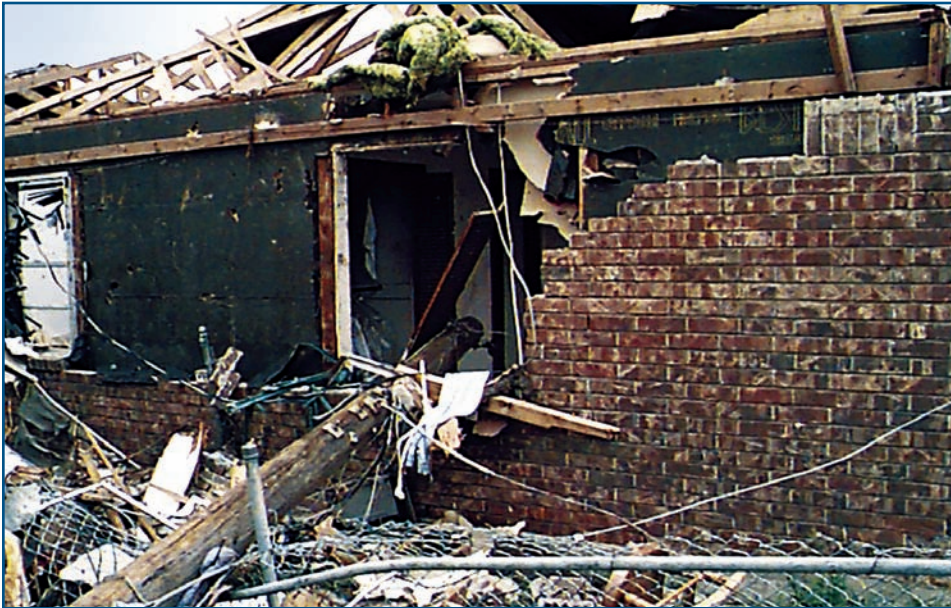
Figure 4-4
This power pole penetrated a window and extended several feet into the house after being blown 40 feet from its original location.

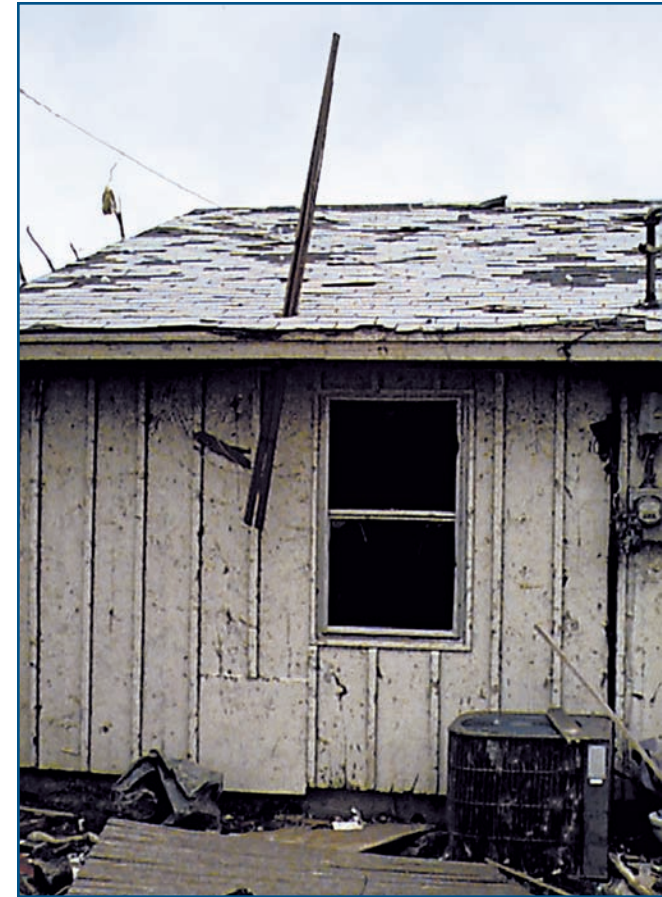
Figure 4-5
This photograph illustrates the importance of overhead protection in refuge areas. The missile shown here fell nearly straight down.

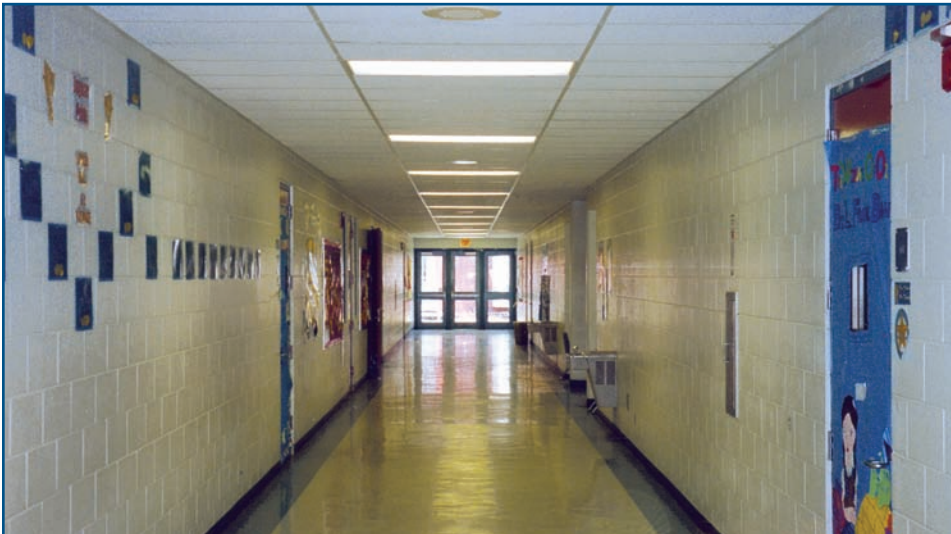
Figure 4-9
Interior central corridor – typical of the corridors in Buildings 200, 400, 600, and 800.

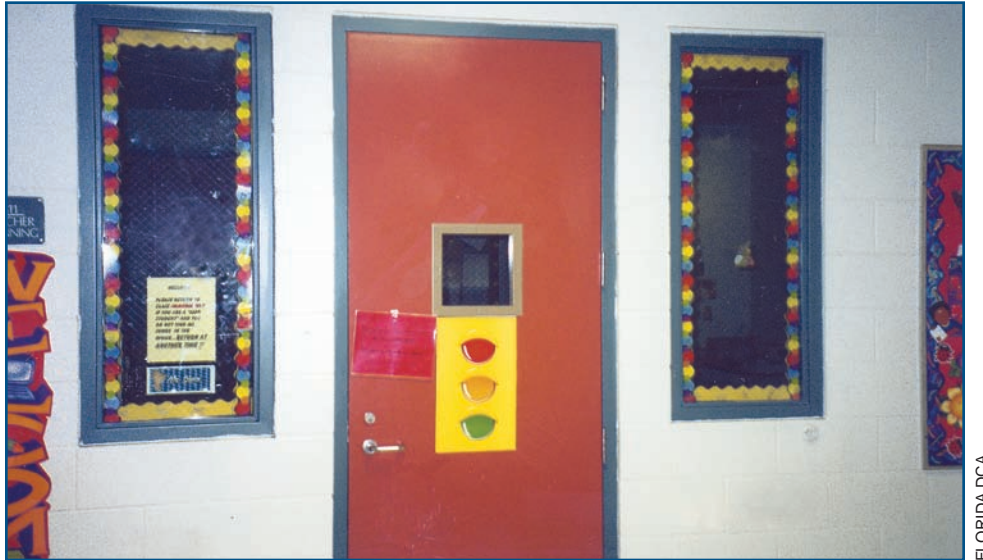
Figure 4-15
Door connecting classroom to corridor – Buildings 200, 400, 600, and 800.

The exterior windows in all eight buildings have aluminum frames and tempered glass. The exterior doors—including the exterior corridor doors in Buildings 200, 400, 600, and 800 (Figure 4-14)—are insulated metal-framed units with large windows. The doors from the corridors to the classrooms in these four buildings are wood with small windows (Figure 4-15).
