## **Steel Bridges: Corrosion Protection**

Course No: S06-009

# Steel Bridge Design Handbook: Corrosion Protection of Steel Bridges

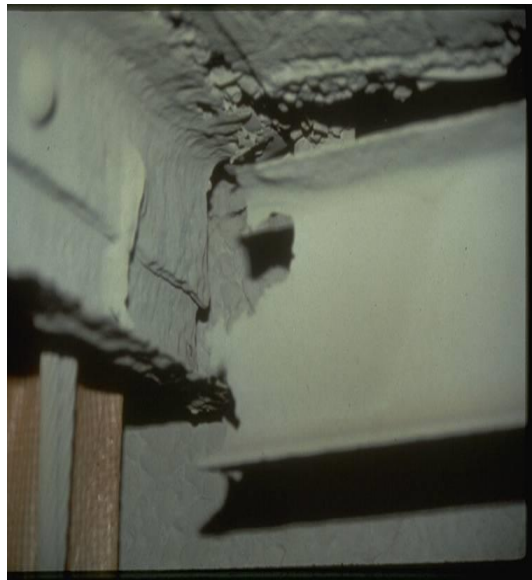
Figure 1. Photo. Photograph of a severed connection due to corrosion.

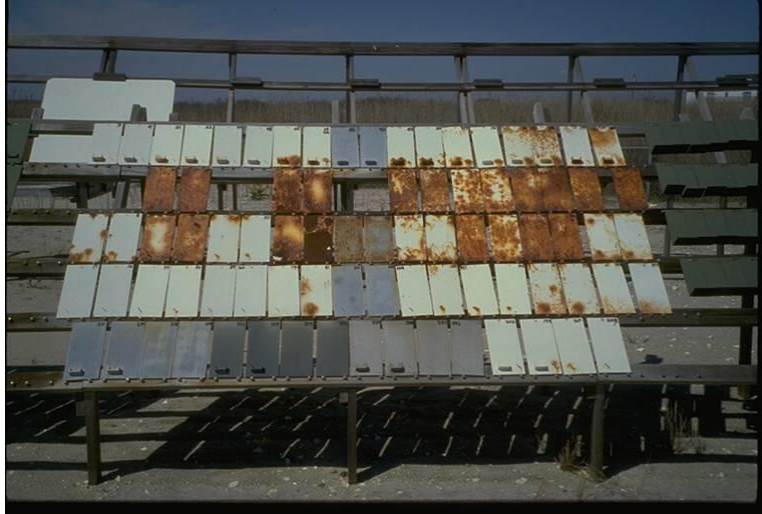
Figure 3. Photo. Testing of various generically similar paint systems shows wide variations in performance.

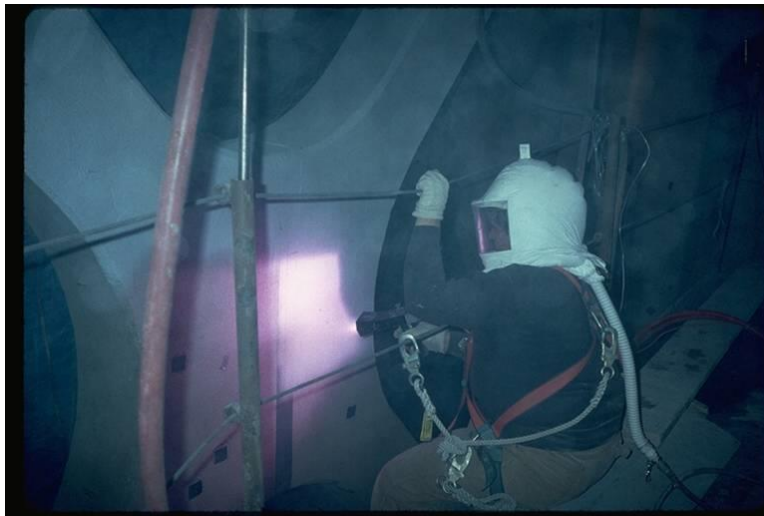
Figure 5. Photo. Metalizing of a bridge member in the field (photo courtesy of R. Kogler).

far the dominant choices for bridge steel are pure zinc, 85 percent zinc/15 percent aluminum alloy, and pure aluminum. Metalized coatings are applied using a heat source to melt a metal feedstock (typically in a wire or powder form) at the tip of a spray gun that uses compressed air to propel the molten metal onto the target steel. The heat source can be either flame or electric arc, similar to the heat sources for welding equipment. Once the molten metal hits the steel surface, it immediately re-solidifies into a solid sacrificial coating. The coating is built up with a series of overlapping “splats” of metal. Achieving proper specified thickness is important to mitigate the possibility of porosity through the coating.<sup>(23)</sup> Figure 4 shows a depiction of this application. Figure 5 illustrates a typical field metalizing application.

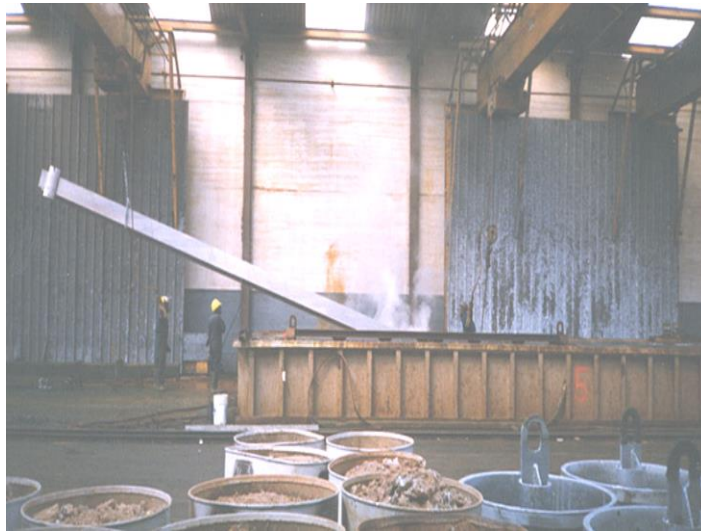
Figure 7. Photo. Hot dip galvanizing kettle with long beam being dipped at one end.

or kettles (as seen in Figures 6 and 7). The final dip in the process is immersing the component into molten kettle of pure zinc, typically at temperatures between 820 and 900 °F. These kettles are typically around 40 feet long, but kettles up to 60 feet long exist. The heat from this zinc dip creates a metallurgical bond between the zinc and steel, and creates a layer of sacrificial zinc. The composition of zinc layer depends on the chemistry of the steel and largely plays into the thickness of the coating, therefore a designer cannot specify a desired coating thickness for a hot-dipped galvanized component. When the silicon level in the steel is between 0.04 and 0.15 percent or above 0.22 percent the steel is considered “reactive”.<sup>(26)</sup> For reactive steels, the entire galvanized layer is zinc/iron intermetallics that can be excessively thick (generally thicker than 10 mils) and also brittle. The other problem with reactive steels is the intermetallic layer can continue to grow, and overall galvanized thickness is controlled by dwell time in the tank, but this can be mitigated by abrasive blasting in lieu of acid pickling. For non-reactive steels, the intermetallics form with a gradient in the zinc/iron ratio being more iron bearing near the steel and decreasing through the thickness to the outer layer that is pure zinc. The nonreactive steels develop a thickness that is on the order of 4 mils thick, and dwell time in the tank does not cause coating thickness to increase. Most of the time, the galvanizer does not know the chemistry of the steel being dipped, and therefore through experience has developed a knowledge of dwell time the piece should be immersed to get a galvanized coating that meets the quality control requirement of ASTM A123 for both reactive and nonreactive steels. ASTM A123 defines the sampling requirements for hot-dipped pieces by which coating thickness is assessed and accepted by.<sup>(27)</sup> For the typical thickness of plate used in bridges, ASTM A123 generally would require a minimum galvanized coating thickness of 3.9 mils or thicker.

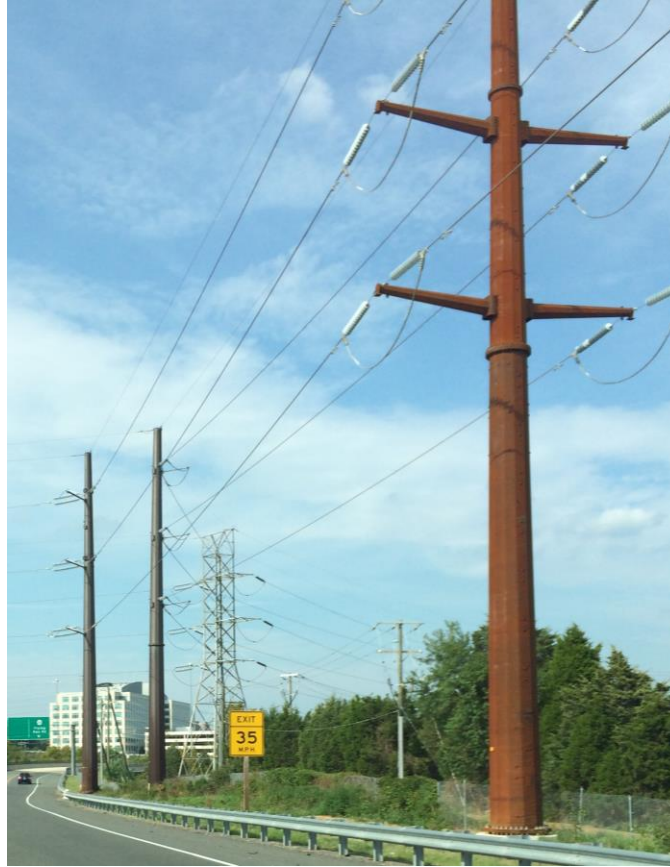
Figure 8. Photo. Different color of rust patina in new transmission tower (close) and older (far).

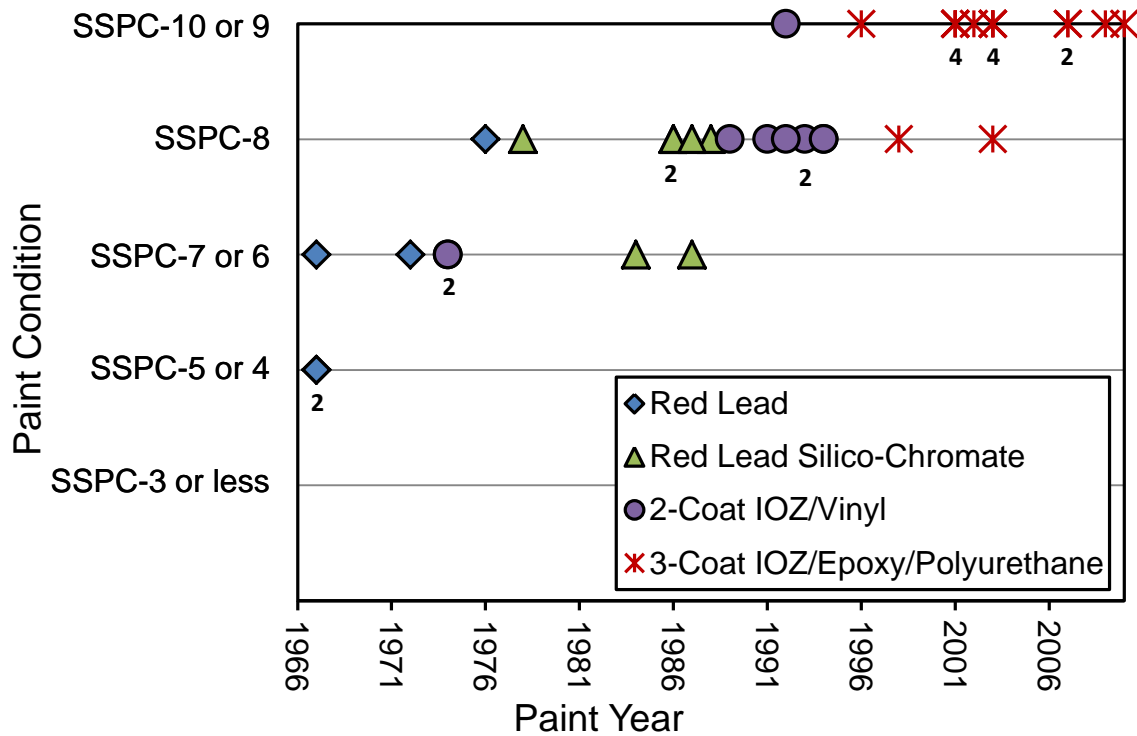
Figure 12. Graph. Condition ratings of original coating systems in Missouri (numbers by data points represent replicates).<sup>(reproduced from 61)</sup>

Missouri conducted an assessment of their current coating practice and surveyed the performance of paint systems from November 2009 to July 2010.<sup>(61)</sup> Figure 12 is reproduced from Missouri’s collected data and shows the performance of coatings that had not received any maintenance throughout their life. Coatings were assessed at beam ends and midspan to the SSPC VIS 2 guidelines. Interestingly, there was a small population of bridges with 20 to 42 years of service with red lead coatings that still only had about one percent rusting. All of the bridges using the conventional zinc-rich 3-coat system were in very good condition, with one being in service for 14 years. One of the major conclusions from the study was that the bridges performing well (regardless of the coating system used), were those that had a deck in good condition, a jointless design, well operating drainage systems, or large deck overhangs.

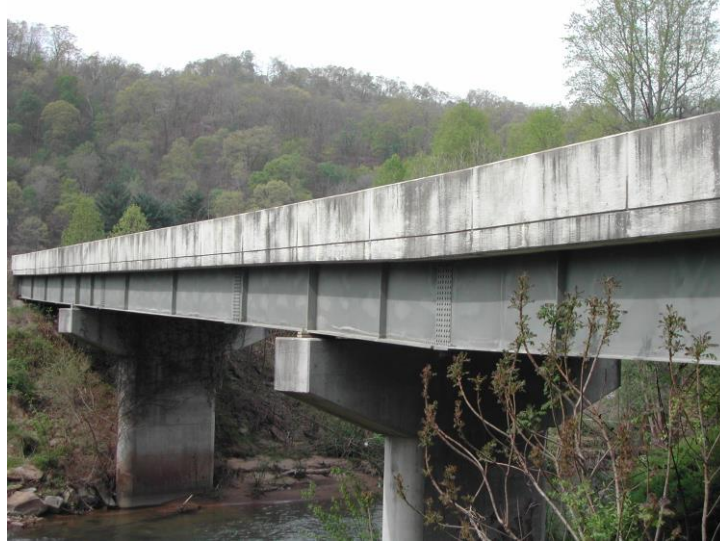
Figure 14. Photo. Bridge in West Virginia with a single-coat inorganic zinc-rich paint system after 25 years.

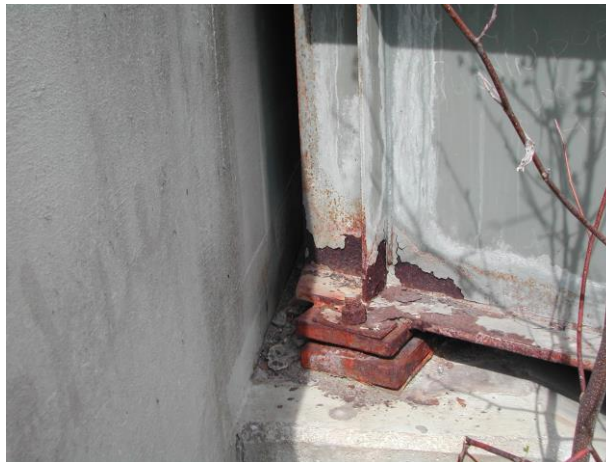
Figure 15. Photo. Deterioration of bearing area beneath a leaking joint with only single-coat inorganic zinc-rich paint.

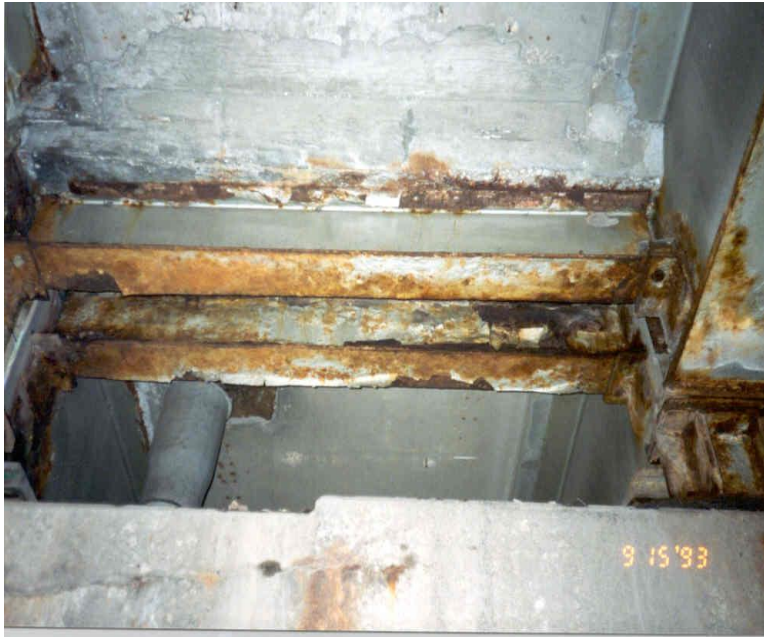
Figure 16. Photo. Steel directly beneath transverse expansion joints that have leaked corrosive runoff from the deck.

debris over time, limiting their effectiveness. Consider use of sealed modular joints in place of multiple single compression seal joints.<sup>(71)</sup> Figure 16 and Figure 17 depict corrosion due to water leakage and entrapment.

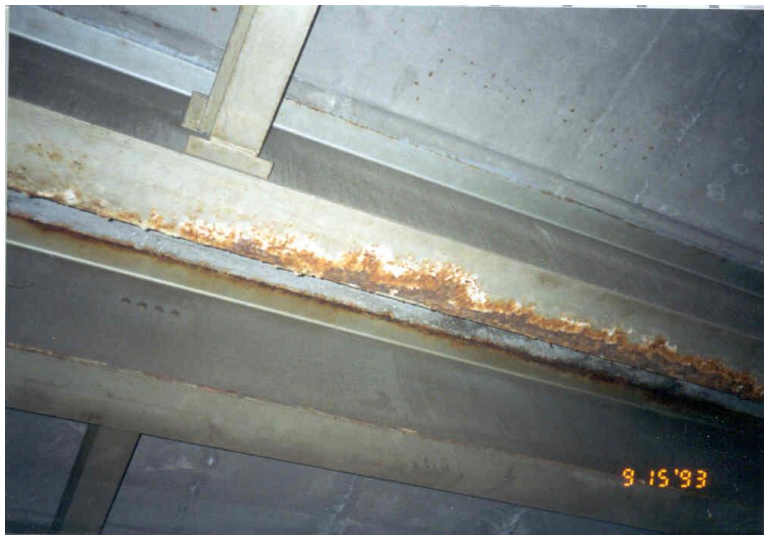
Figure 17. Photo. Steel directly beneath longitudinal expansion joints that have leaked corrosive runoff from the deck.

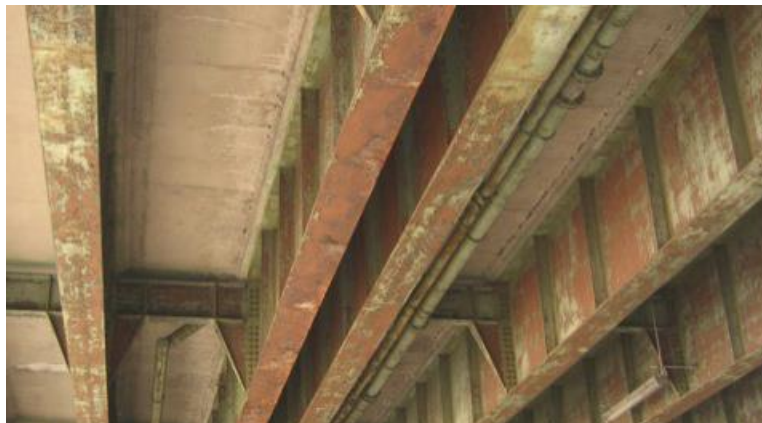
Figure 19. Photo. Closely spaced girders lead to difficult access for maintenance activities.

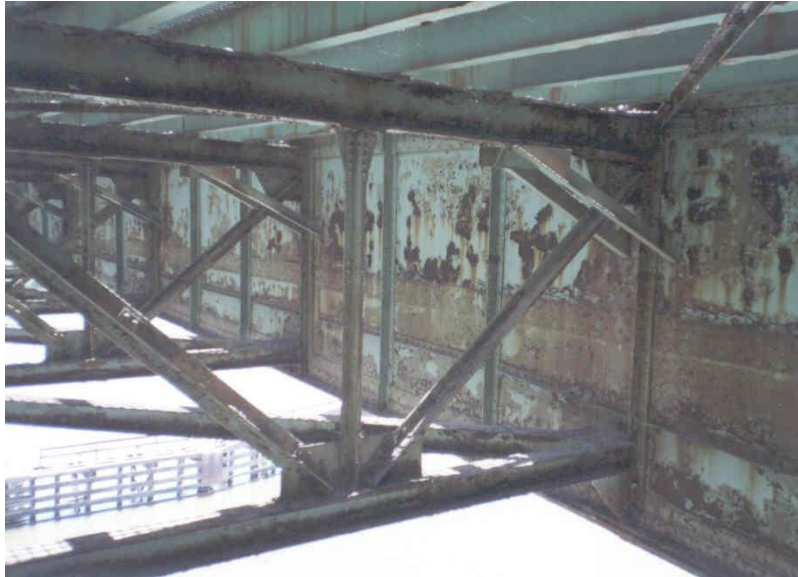
Figure 20. Photo. The area under an open grid deck acting as one large leaking joint.

is shown in Figure 20, in which it can be seen that the majority of the steel coating has failed and active corrosion is occurring.

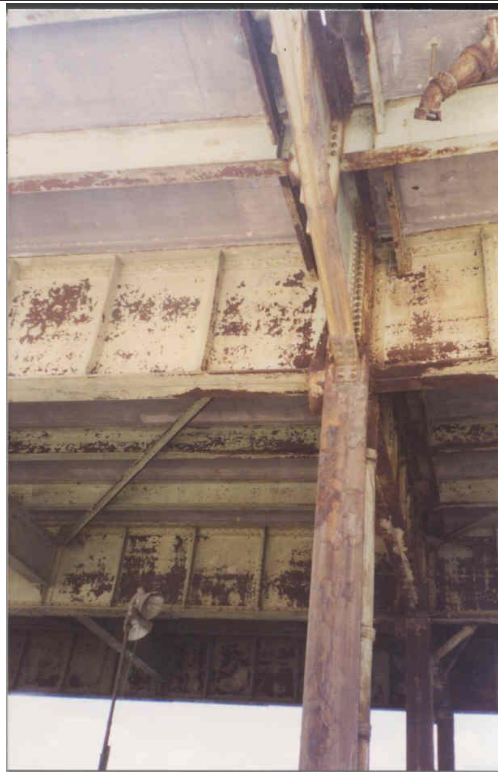
Figure 21. Photo. Missing portion of deck drain downspout.

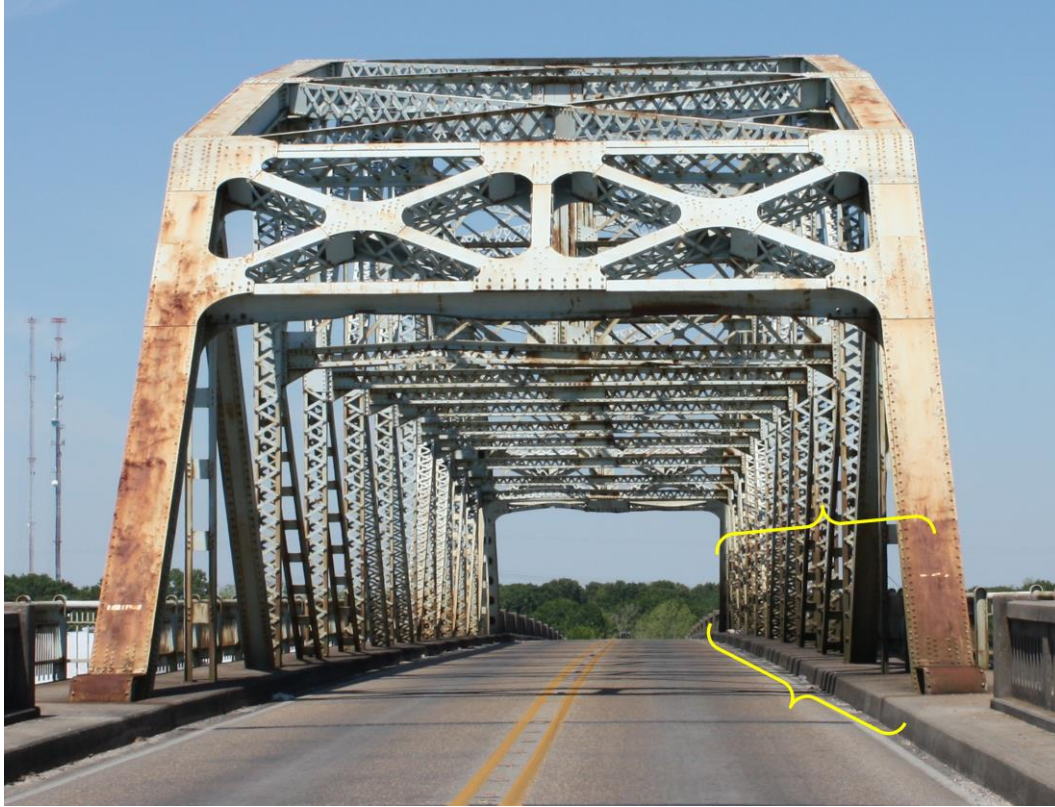
Figure 23. Photo. Through truss showing darkened area in close proximity to the travel lane (i.e. splash zone) that is corroding faster than other parts of the truss outside the splash zone.

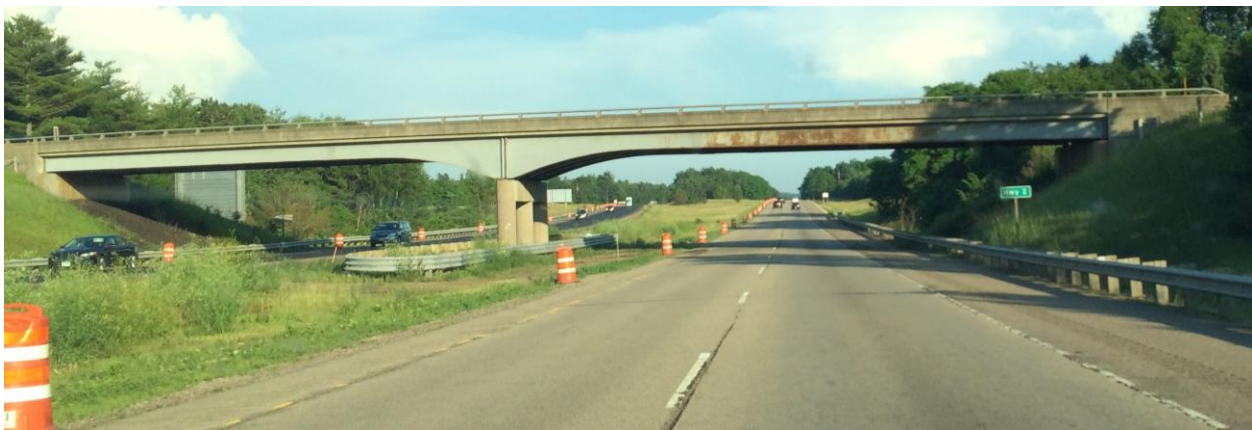
Figure 26. Photo. Accelerated corrosion on the inbound fascia girder of a grade separate structure, particularly over the right travel lane.

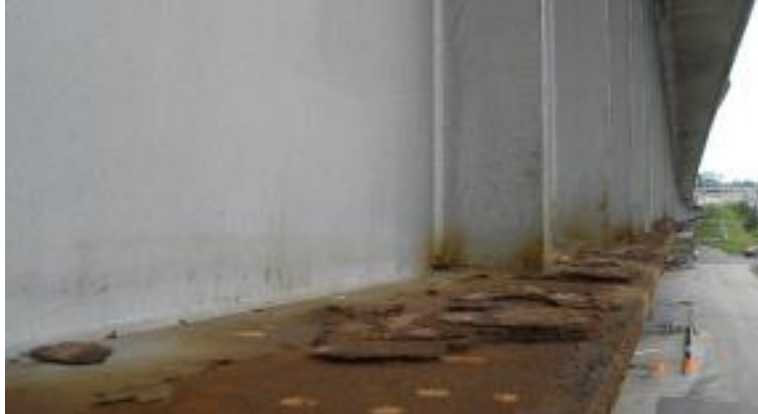
Figure 27. Photo. Corrosion localized to upper surface of lower flange, the rest of the bridge is fine.

Commonly it is observed that the upper surface of I-shaped bottom flanges will corrode before the rest of the I-shape, as seen in Figure 27 and Figure 28. The lower portions of flanged structures corrode early due to higher times of wetness for these parts relative to the rest of the bridge, because they are likely horizontal and can pond water. The higher time of wetness is also caused by preferential condensation on the lower portions of a steel element. While not a recommendation of this handbook, an ideal solution would be to curve the lower flange such that water could not pond on it. This is illustrated in Figure 29 where the right-hand girder in the zoomed in view has a transversely curved lower flange. Certainly, there are logistical issues with the concept; such as how to bend the flange, cutting transverse connection plates to fit, and making bearings to accept the curved surface. However, it illustrates that prevention of ponding water is the goal, but it is not always attainable (unless the entire bridge has a vertical grade). In the case of lower flanges, designing away the problem is not possible and only more durable protection schemes can be specified.

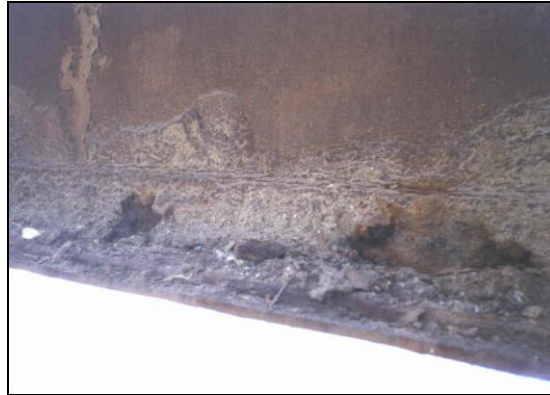
Figure 28. Photo. Heavy corrosion of bottom flange and web due to collection of poulitce.

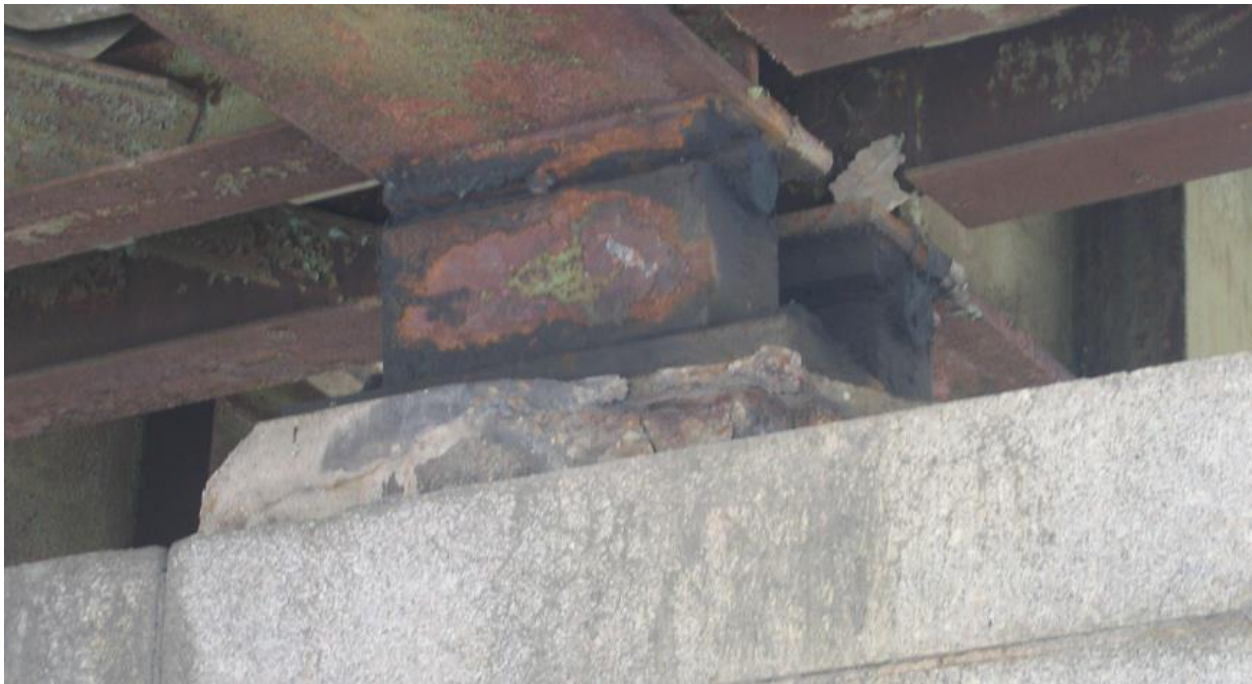
Figure 30. Photo. Corroded bearing.

These elements are difficult and inefficient to paint in the traditional manner. Bearings represent the lowest point on the superstructure, and as such are likely subject to the highest time of wetness, and typically are difficult to protect from corrosion. An example of a corroded bearing is shown in Figure 30. Consideration should be given to galvanize, metalize or fabricate these types of elements from inherently corrosion-resistant alloys.

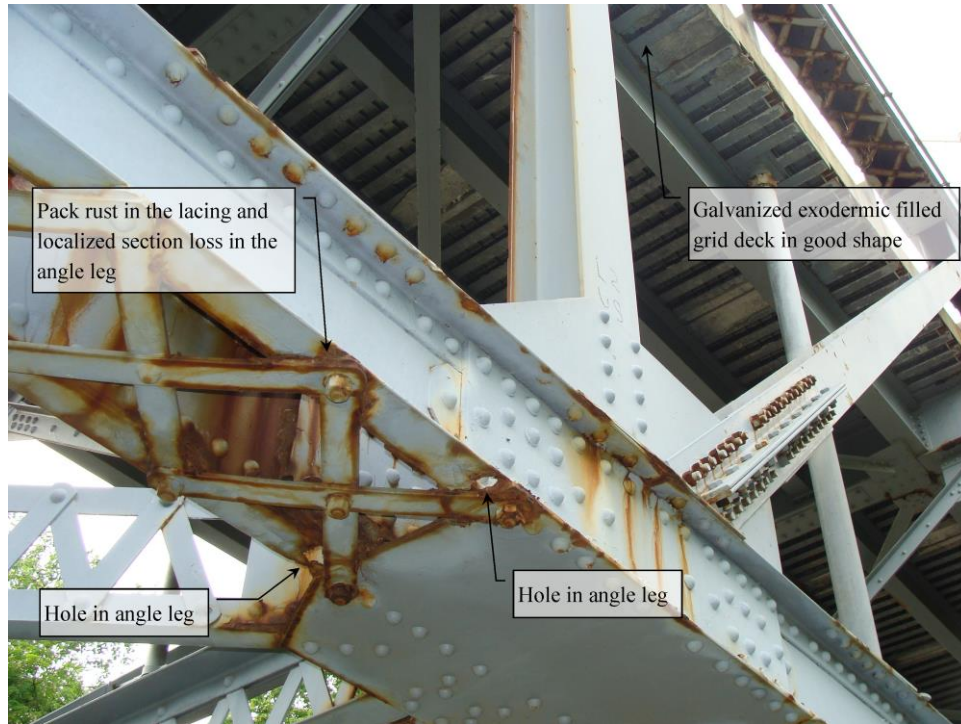
Figure 32. Photo. Annotated picture of riveted lower truss chord connection.

picture from the same truss, but of a lower chord connection. The lower chord elements are tied with lacing, which creates many intersecting surfaces that all show corrosion and pack rust.

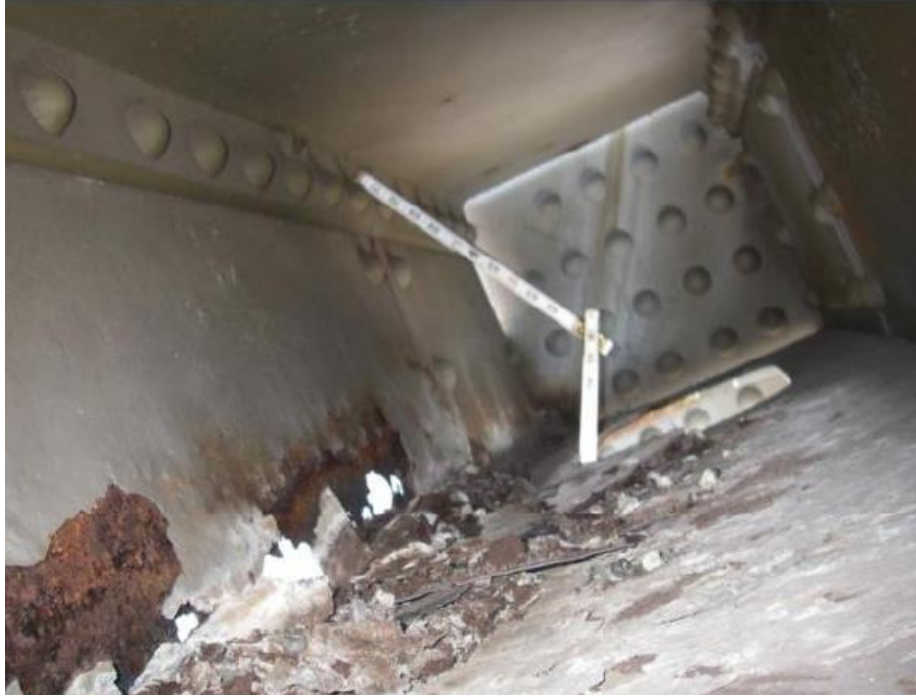
Figure 33. Photo. Inside of built-up box member.

Figure 33 shows the inside of a closed, built-up box member from a truss. The picture was taken through an access hole and not oriented with respect to gravity, but the member was horizontal. Because the member was horizontal, water ponded on the inside atop the bottom box cover plate, and caused through-thickness corrosion in the box web plate over an approximate four-foot length. Small box members also pose maintenance and corrosion remediation challenges due to limited access.

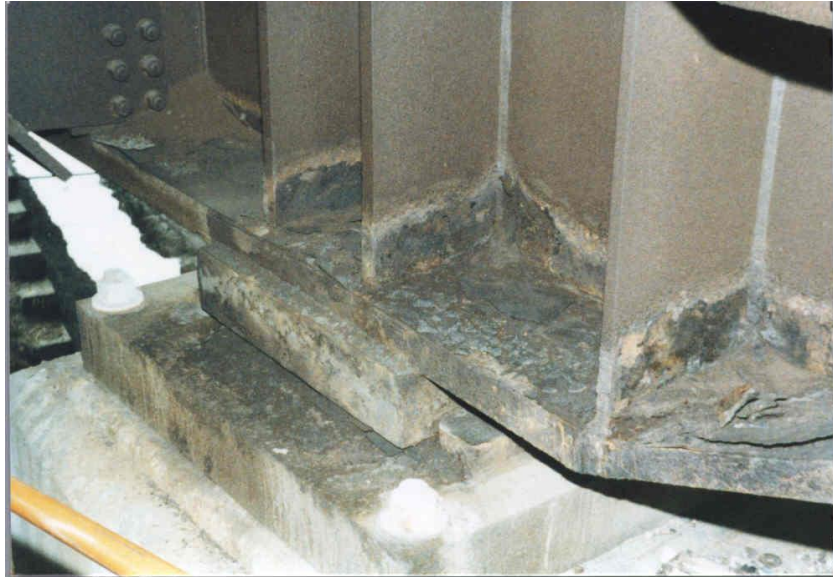
Figure 34. Photo. Girder end on a bearing below a leaking deck joint. Horizontal flange and vertical stiffeners create an excellent trap for debris and moisture.

Water traps are the hardest details to identify in design. Figure 34 illustrates a bearing stiffener detail that was below a leaking joint. Since the flange is horizontal, water can become trapped near each of the stiffeners because it cannot flow away from the area. This also has cascading consequences because as rust product develops in this area, the rust itself begins to hold moisture that further exacerbates the corrosion. Also note in the background of this picture is the connection plate detail bolted to a transverse element; there is an accumulation of dirt and rust between the girder flange and connection plate.

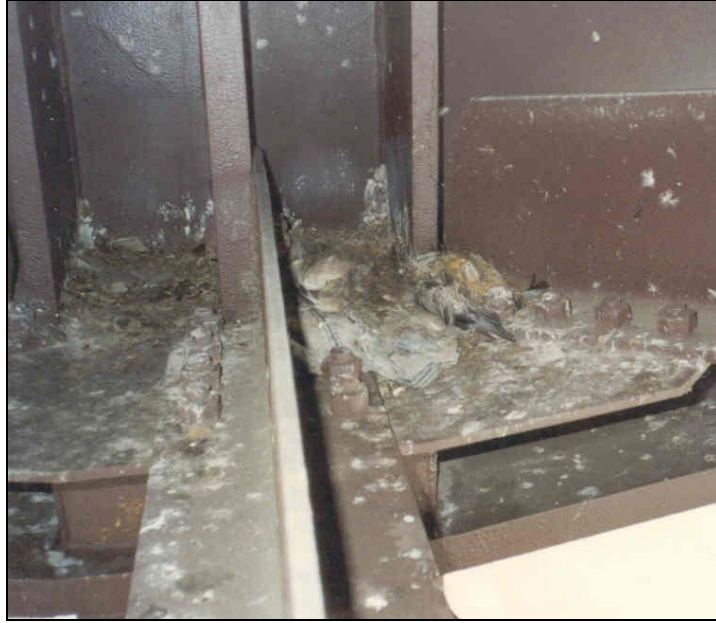
Figure 37. Photo. Debris accumulation at a lateral gusset plate detail.

Figure 37 shows a picture of a lateral gusset plate detail and the accumulation of dirt, bird guano, and even a dead bird. Since the lateral plate is horizontal, poulitice tends to collect on it and not freely drain away, causing localized high times of wetness, leading to corrosion. Figure 38 shows a lateral gusset plate detail that has mostly corroded away because it was perfectly horizontal and ponded water. It is not practical to slope these plates, but drainage holes can be provided to help mitigate any ponding. Where members such as horizontal gusset plates must be used, consider using a high level of corrosion protection (duplex galvanizing/painting or metalizing) for these specific elements.

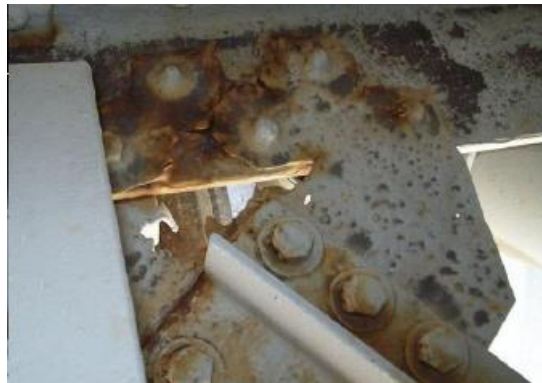
Figure 38. Photo. Corroded lateral gusset plate detail.

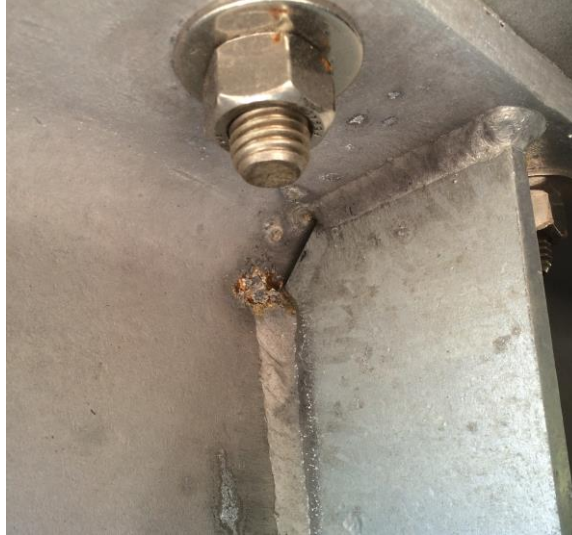
Figure 40. Photo. Connection plate welded to rolled I-beam along with corrosion emanating from unsealed weld.

in opposing directions around a common plane is prohibited, in particular Clause 2.8.8 in D1.5 and Clause 2.9.3.5 in D1.1.<sup>(40, 73)</sup> First, this type of weld is difficult to implement because the welding position has to change and second, there is a high likelihood of undercut when wrapping welds in different directions. Steel bridges always have connection plate details that are unsealed when being welded to the flange because of potential undercut, though wrapping this particular weld has been shown not to be detrimental to fatigue.<sup>(74)</sup> Designers should work with owners to reach consensus about how to handle seal welds as there are consequences to both the long-term corrosion performance and possibly the structural function.
