Repair and Retrofit of Fatigue Cracks in Steel Bridges

Course No: S09-001
Credit: 9 PDH

Gilbert Gedeon, P.E.

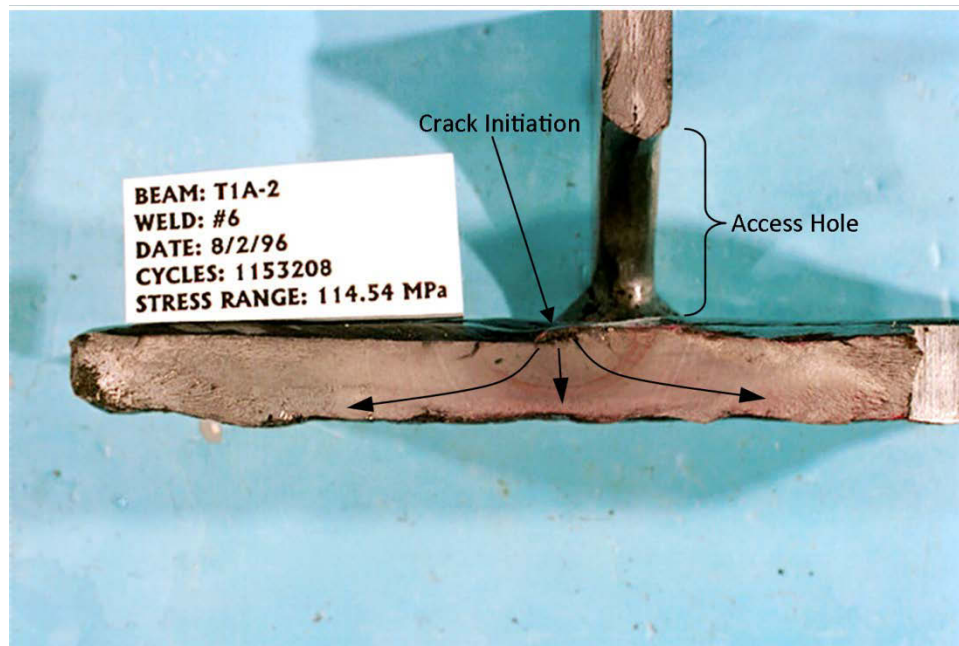
Figure 1. Photo. Typical fatigue crack across a repaired flange butt weld in a welded I-girder test specimen. The arrows show the direction crack growth and the fatigue striations show how the crack grew elliptically through the flange. Photo courtesy of US Coast Guard.[8]

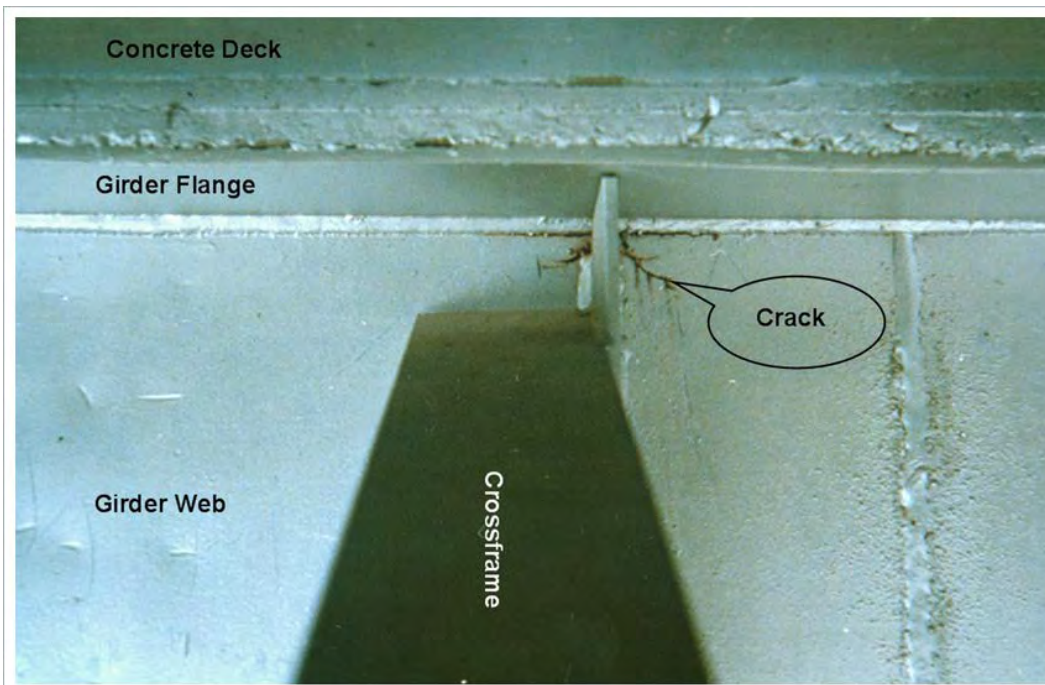
Figure 28. Photo. Typical horseshoe crack originating from web gap. Photo courtesy of Iowa Department of Transportation.

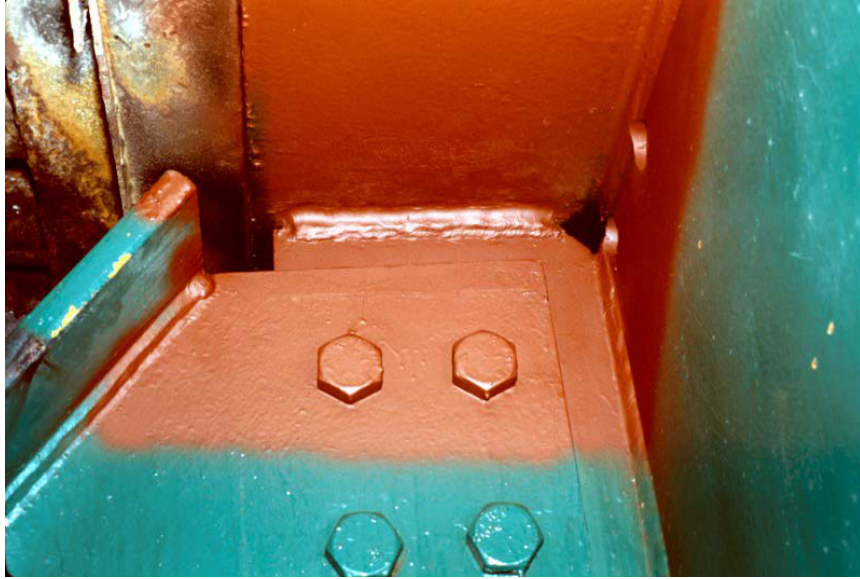
Figure 31. Photo. Retrofitted connection plate detail welded directly to girder flange, Poplar Street Complex in East St. Louis, Missouri. Still in service 20 years after retrofitting [82] Photo courtesy of Wiss, Janney, Elstner Associates.

If the original connection plate was fabricated with a tight fit against the flange, the connection plate can be directly welded to the flange as described above. Often there is a slight gap between the connection plate and flange. In these situations, Figure 33 offers detailing options using additional plates or spacers. Care should be given that the width of the spacer block not be wider (direction in-line with primary bending stress of girder) than 1.5 in. (38.1 mm). Widths greater than this would make the detail less than AASHTO Category C, which is the category of a connection plate-to-girder weld. In situations where the retrofit is to weld a tight-fit connection plate, it may be advantageous to cut back a small portion of the connection plate and use an additional plate as in Figure 33. Contaminants and paint may be present in this tight-fit area, which could adversely affect the weld quality. Removing a small portion of the connection plate allows for the welded area to be cleaned and ground. A generic all-welded retrofit procedure is outlined in Figure 34.

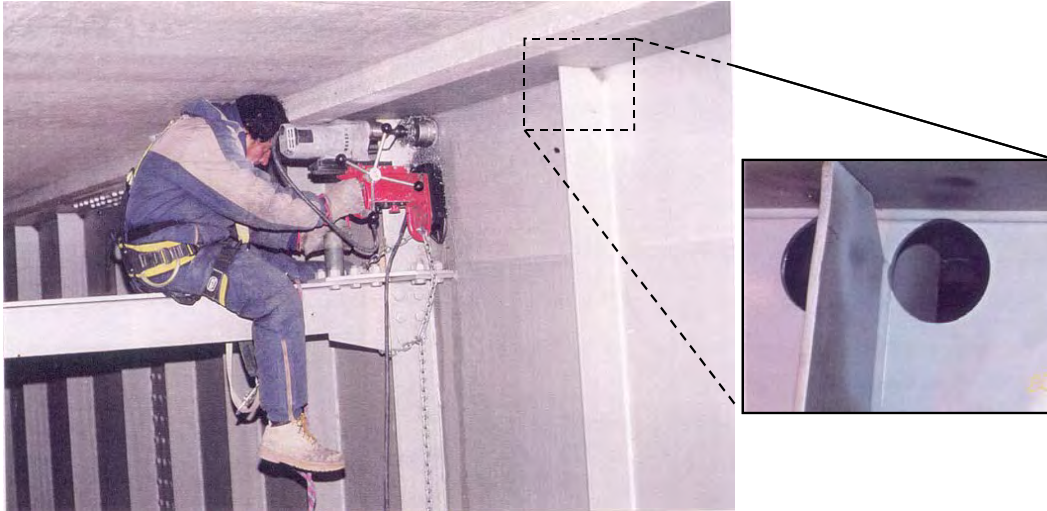
Figure 47. Photo. Implementation of large hole retrofit on I-80 Bridge over Missouri River. Photo courtesy of Iowa Department of Transportation. Photo courtesy of Iowa Department of Transportation.

Instead of cutting a large portion of the connection plate away (which is time-consuming because of extensive grinding and not possible for X-type bracing schemes), large diameter holes can be drilled close to the web-gap area, as opposed to small ones as described in the beginning of this chapter. This retrofit is quicker and easier than bolting or cutting away the connection plate. The large hole also has the ability to remove, intercept, or capture multiple cracks or holes in the vicinity of the web gap, and the large radius prevents crack reinitiation but also softens the web gap by removing a lot of material. A large hole is defined as a diameter equal to or greater than 3.0 in. (76 mm). This type of detail can be seen in Figure 46, and has largely been implemented on bridges in Missouri, Iowa, Illinois, and California.[77,82,86] Iowa has specifically used the retrofit to address the "swiss-cheese" situation shown in Figure 29 to remove multiple holes and crack tips with 3.0-4.0 in. (76-101 mm) holes. This retrofit is most beneficial when cracking is occurring in bearing stiffeners, since they are a reaction point they cannot be cut away to soften the web gap and cannot be stiffened since they are already fully welded to the flange. The hole should be cut on both sides of the connection plate so that it intercepts all welds by a minimum of 0.125 in. (3.2 mm). Figure 47 shows a large hole retrofit being perform showing how the hole intercepts the welds.

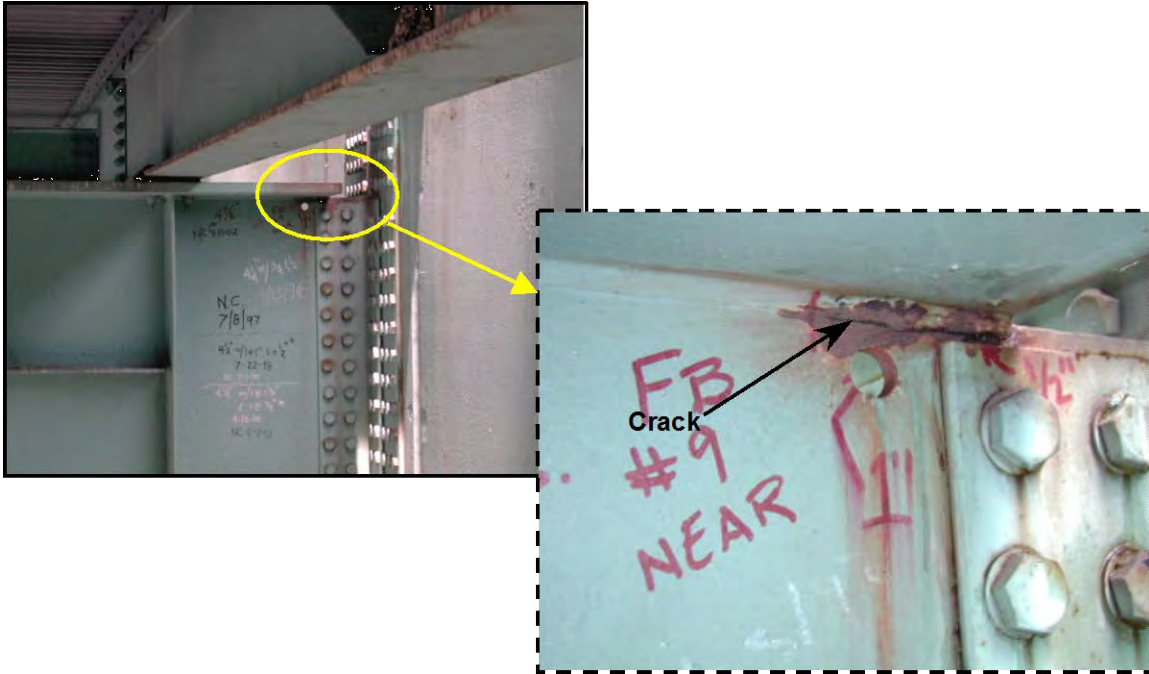
Figure 48. Photo. Cracking in the web gap at a tie girder/floor beam connection on Birmingham Bridge in Pittsburgh, Pennsylvania. Photo taken from Connor et. al.[87]

Though it was not exclusively a tie girder/floor beam cracking problem, a similar retrofit as shown in Figure 51 was used to fix floor beam cracking issues in the Girard Point Bridge outside Philadelphia.[88] The Girard Point Bridge is a truss bridge where the floor beams frame into the vertical truss members. The first retrofit involved flame cutting a U-shape out of the floor beam web to increase the web-gap length. However, data obtained from controlled load testing revealed that the stress ranges were still high enough that cracks could reinitiate. The first repair was modified with the hypothesis that the double angle connection was still restraining the web gap too much. The modification then required a large hole to be drilled in the outstanding legs of the angles, and flame cutting away the extra portion of the angles. The modification then increased the length for the floor beam web to flex over in the longitudinal axis of the floor beam. Truck testing verified the retrofit modification. Both of these retrofits are shown in Figure 53. The retrofit case of the Girard Point Bridge demonstrates the extreme importance of instrumentation and load testing to validate and assess the performance of any retrofit.

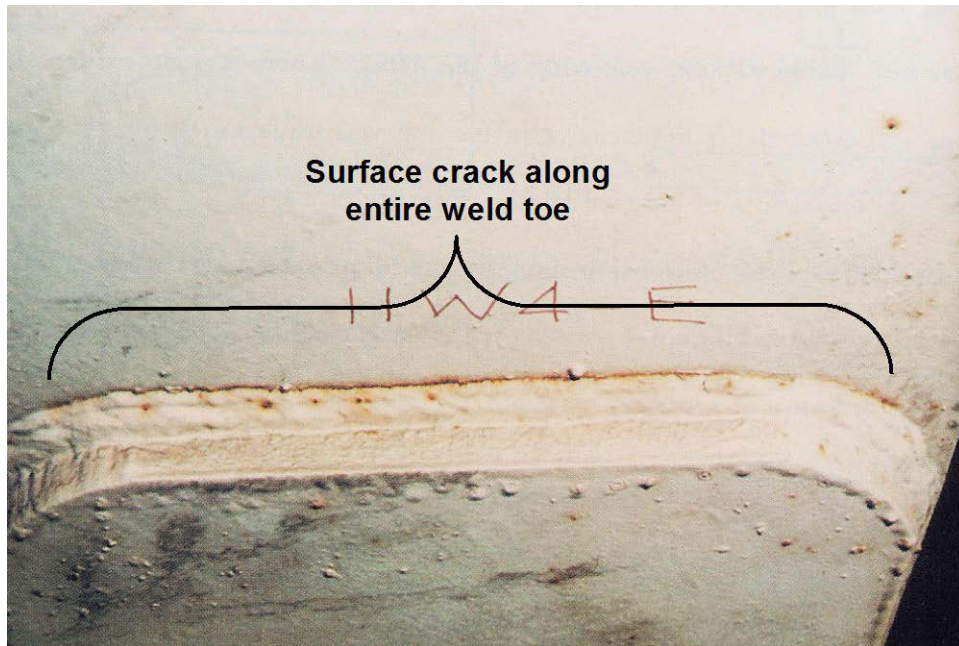
Figure 62. Photo. Cracked coverplate termination of Yellow Mill Pond of the I-95 Connecticut Turnpike.

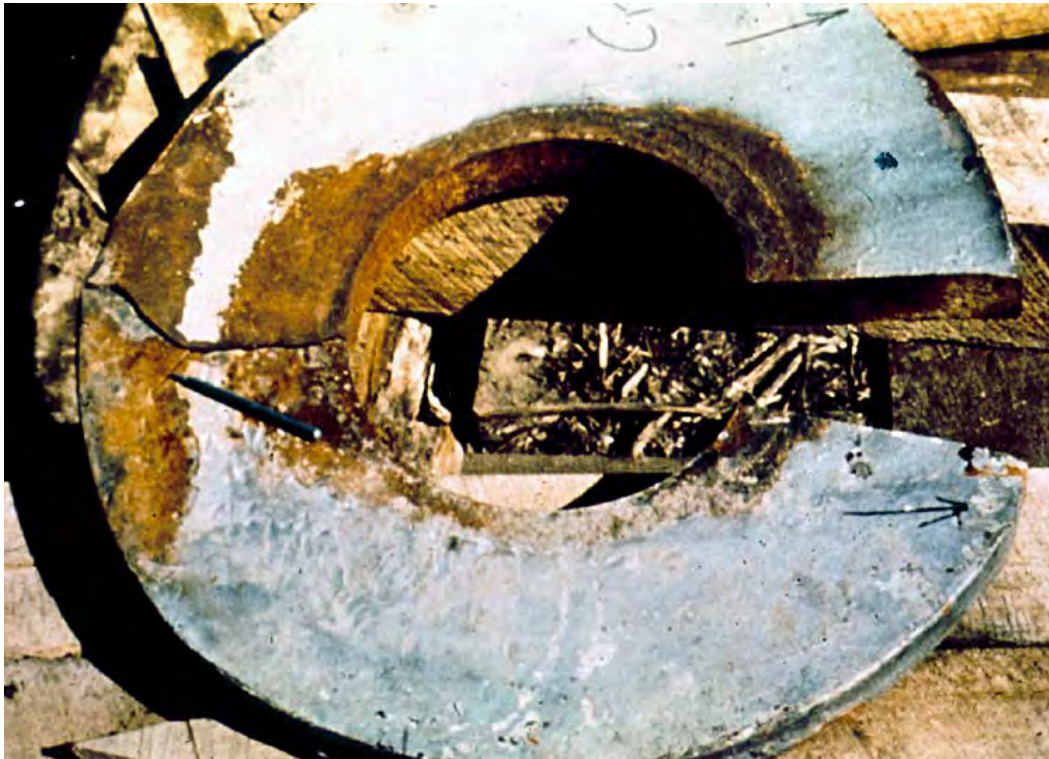
Figure 64. Photo. Fractured eye bar from Point Pleasant Bridge.

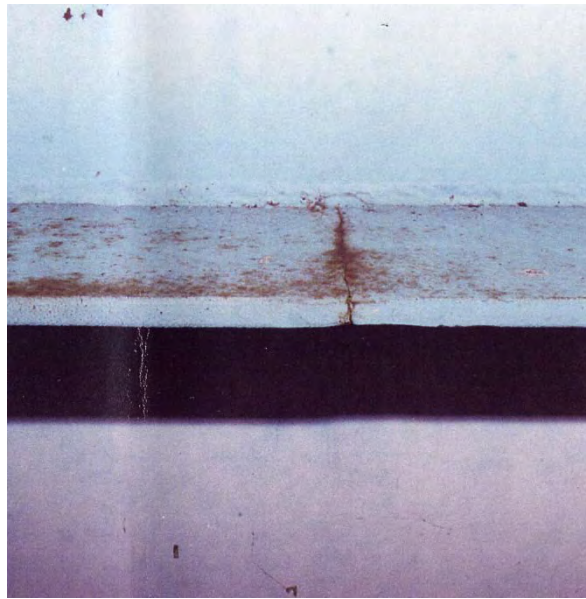
Figure 79. Photo. Cracked butt weld in longitudinal stiffener.

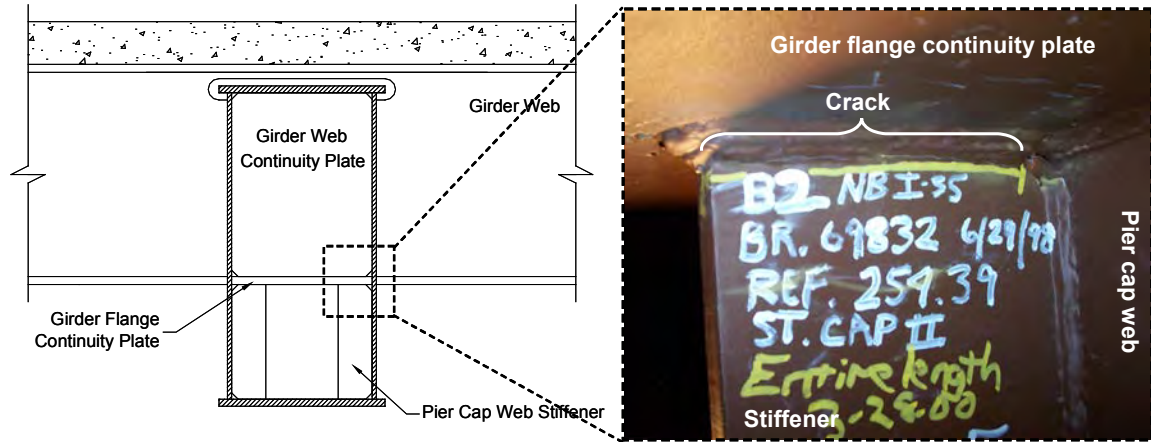
blem, the stiffeners were not welded to the bottom flange (or tension flange) of the pier cap. This caused the lower cell to deform much more than the upper cell, leading to large axial loads in the stiffener, hence cracking along the weld atop the stiffener.

Figure 89. Photo. Picture of MnDOT bridge #69832 in Duluth, Minnesota.

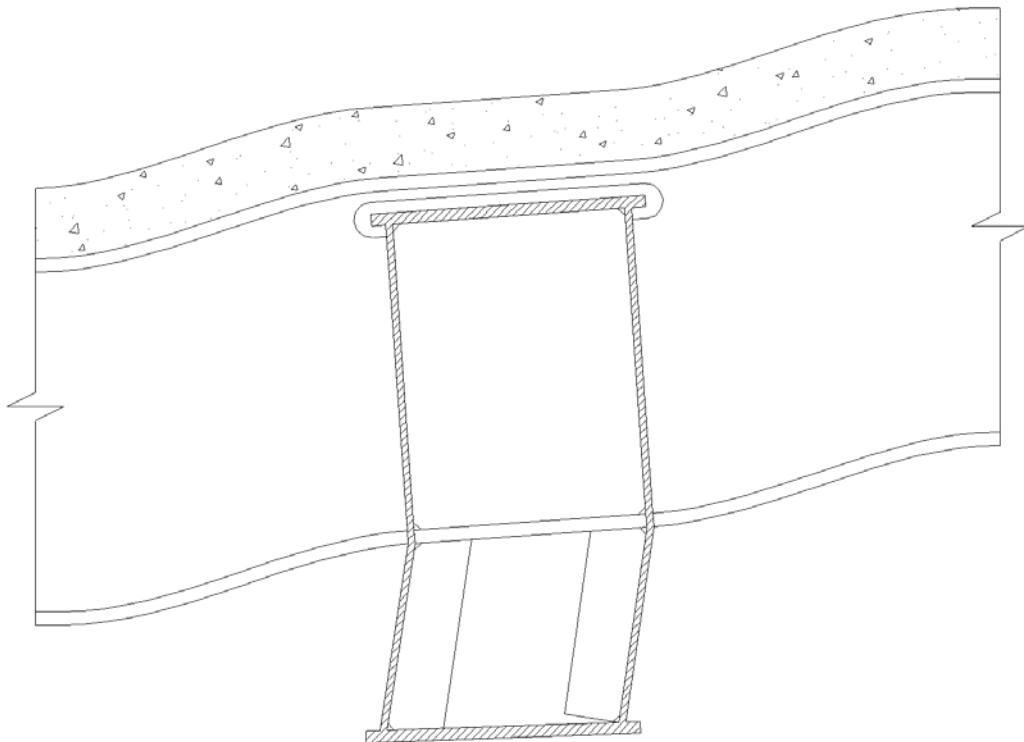
Figure 90. Illustration. Location of cracks in pier cap.
