Taum Sauk Upper Dam Breach FERC No. P-2277

Technical Reasons for the Breach
of December 14, 2005

FERC Independent Panel of Consultants (IPOC)

May 24, 2006

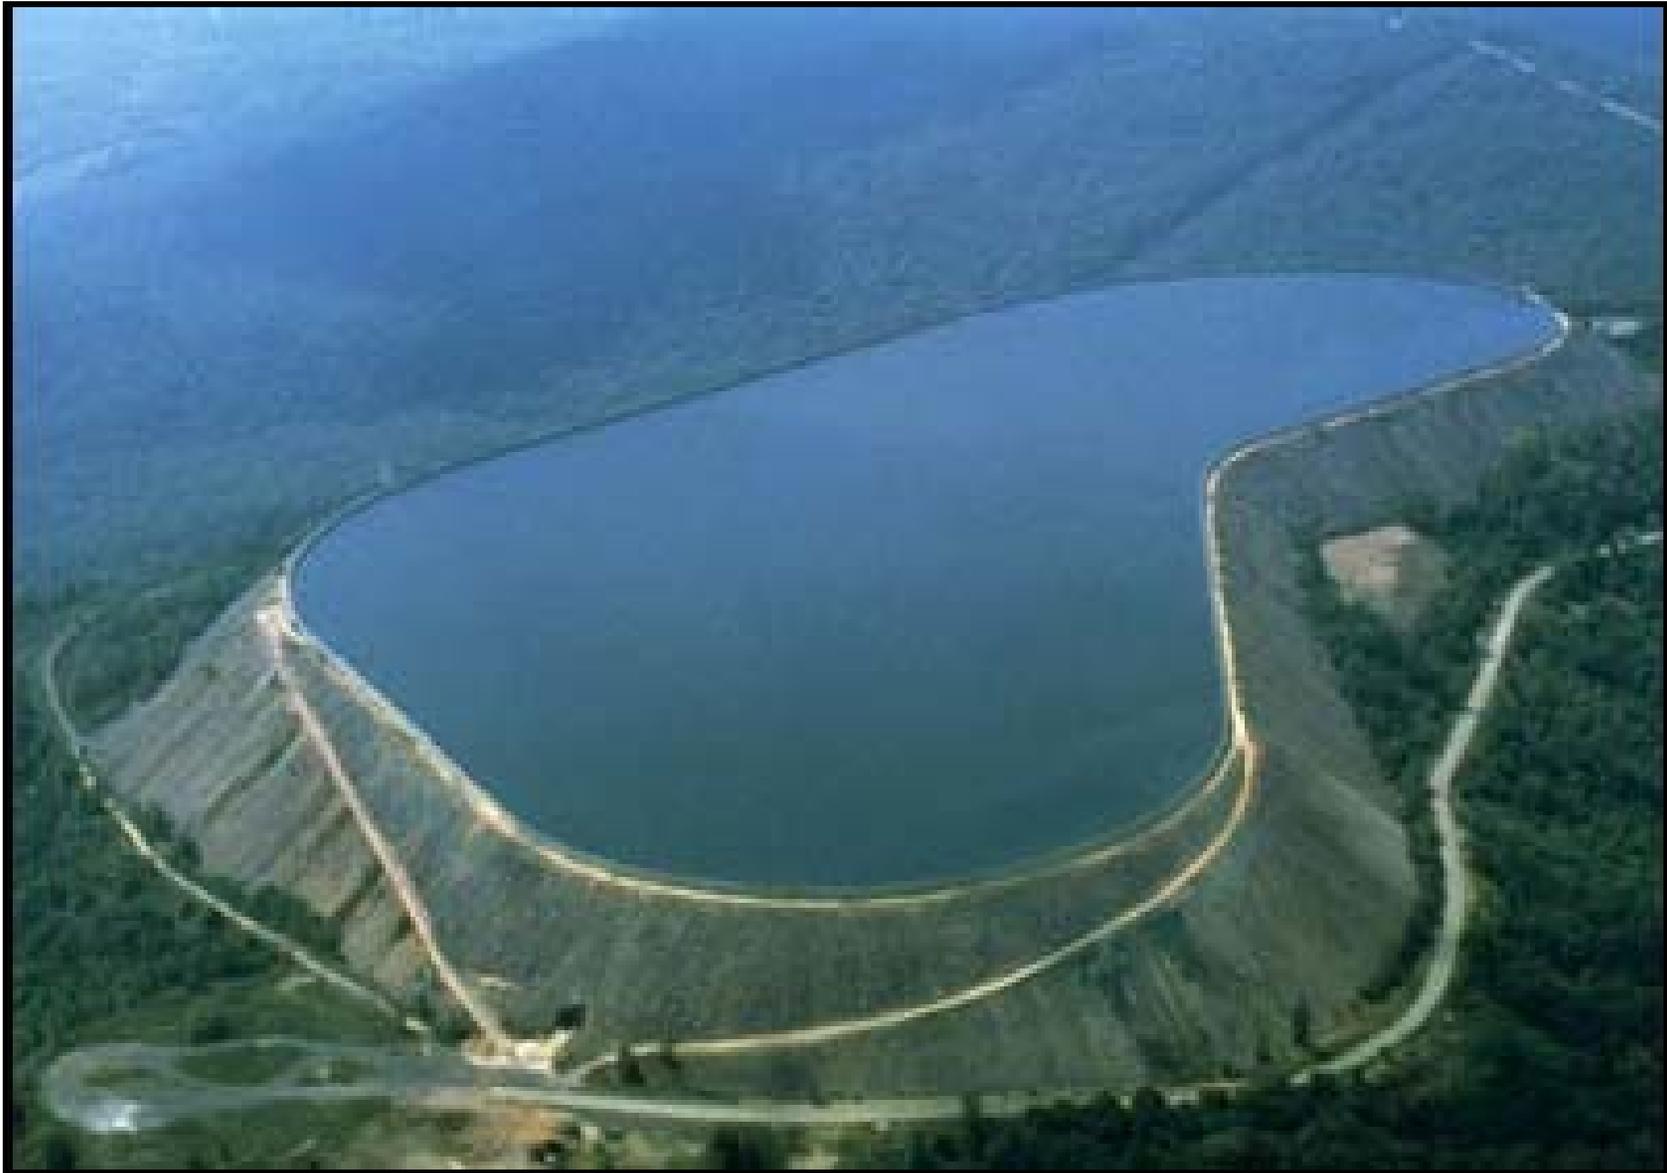
Taum Sauk – Upper Reservoir Full
Figure 1-1

The Upper Dam is a continuous hilltop dike 6,562-ft long forming a kidney-shaped reservoir as shown in Figure 1-1. The dike is a concrete-faced dumped rockfill dam (CFRD) from the foundation level to elevation 1570.0 ft and a rolled rockfill between Elevations 1570 and 1589. The upstream slope is 1.3:1 (horizontal:vertical) and the downstream slope is at the natural angle of repose of the material, approximately 1.3:1, as shown in Figure 2-1. The crest is 12- feet wide. A 10-foot high, 1-foot thick reinforced concrete parapet wall atop the fill extended the crest to elevation 1,599 feet, as originally constructed. Since 1963, the settlements of the rockfill embankment at various points have varied between 1 to 2 feet; the low point at the top of the parapet wall, as surveyed by AmerenUE on November 6, 2004 was elevation 1596.99 feet at Panel 72.

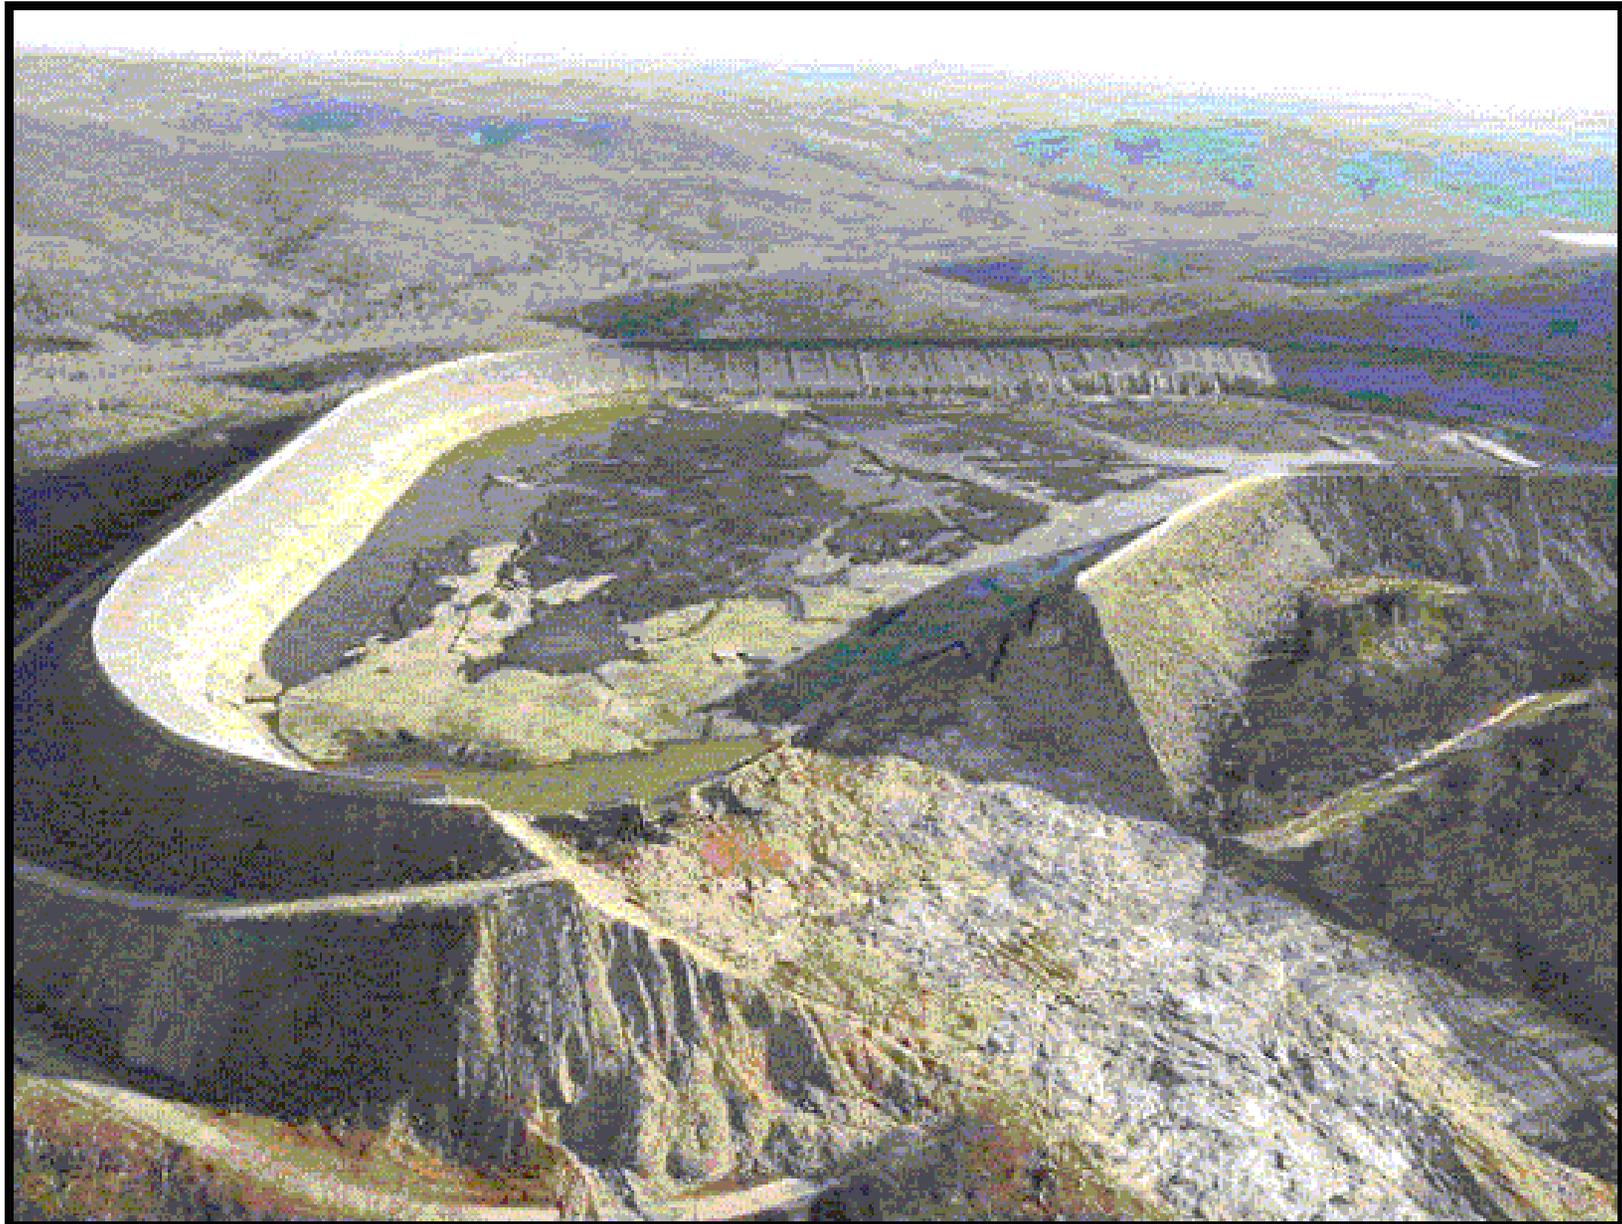
Figure 1-2

Taum Sauk Upper Reservoir Breached

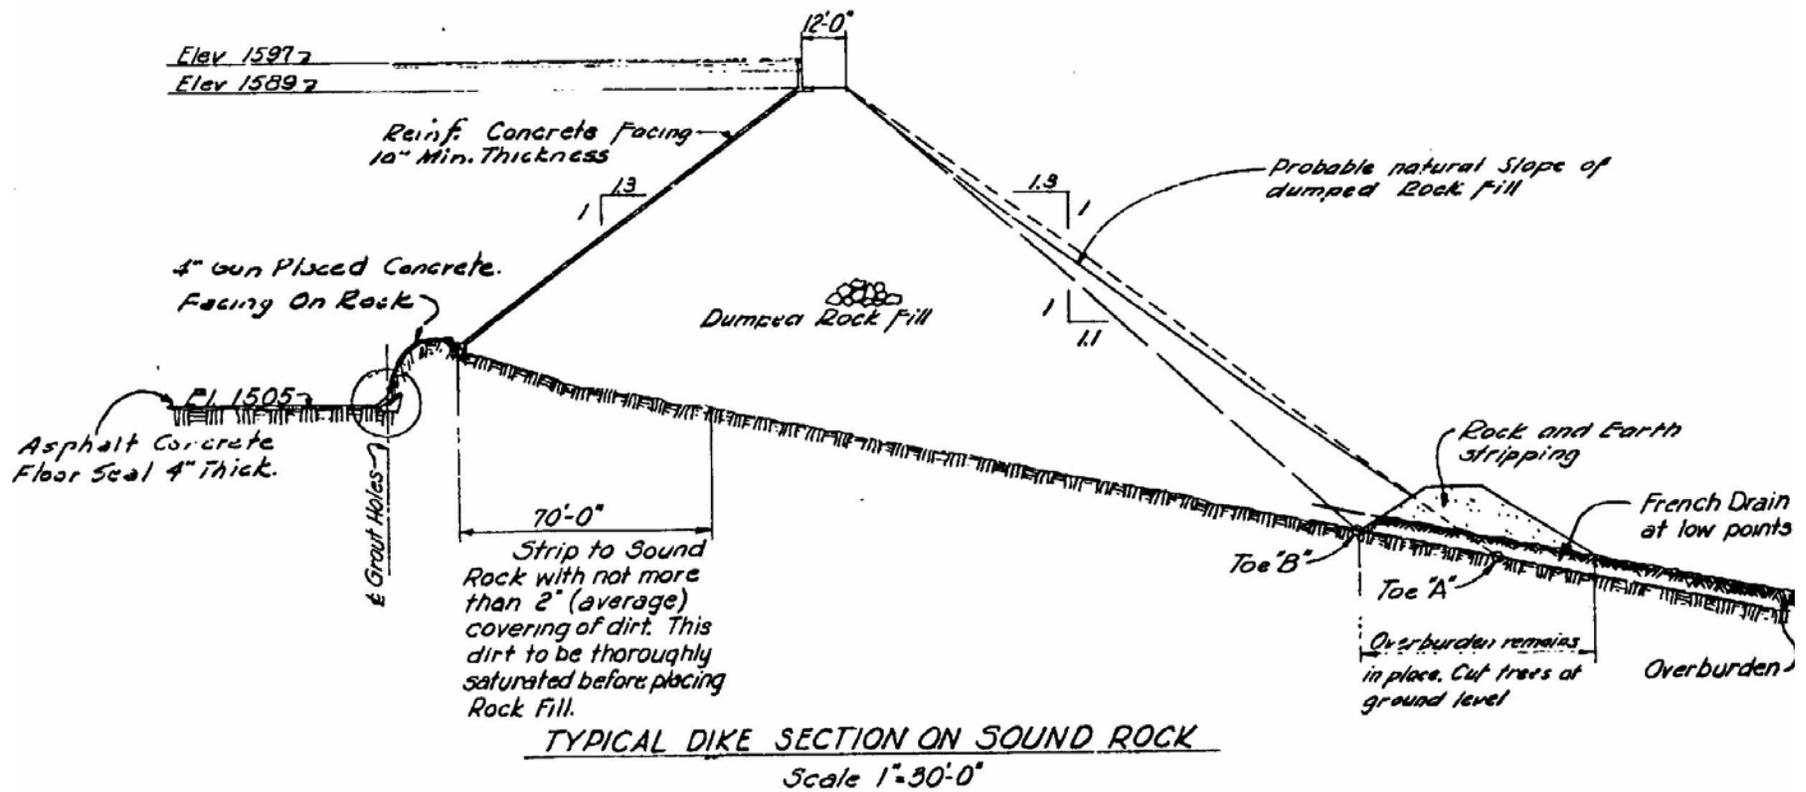
Figure 2-1 Cross section from original design drawings

The pneumatically placed upstream reinforced concrete face slab has a design thickness of 10 inches, and had joints (with copper waterstops) located at the junctures with the parapet wall, the foundation cutoff-slab and with adjacent face panels. The face slab was placed in panels, 60 feet wide at their widest dimension.

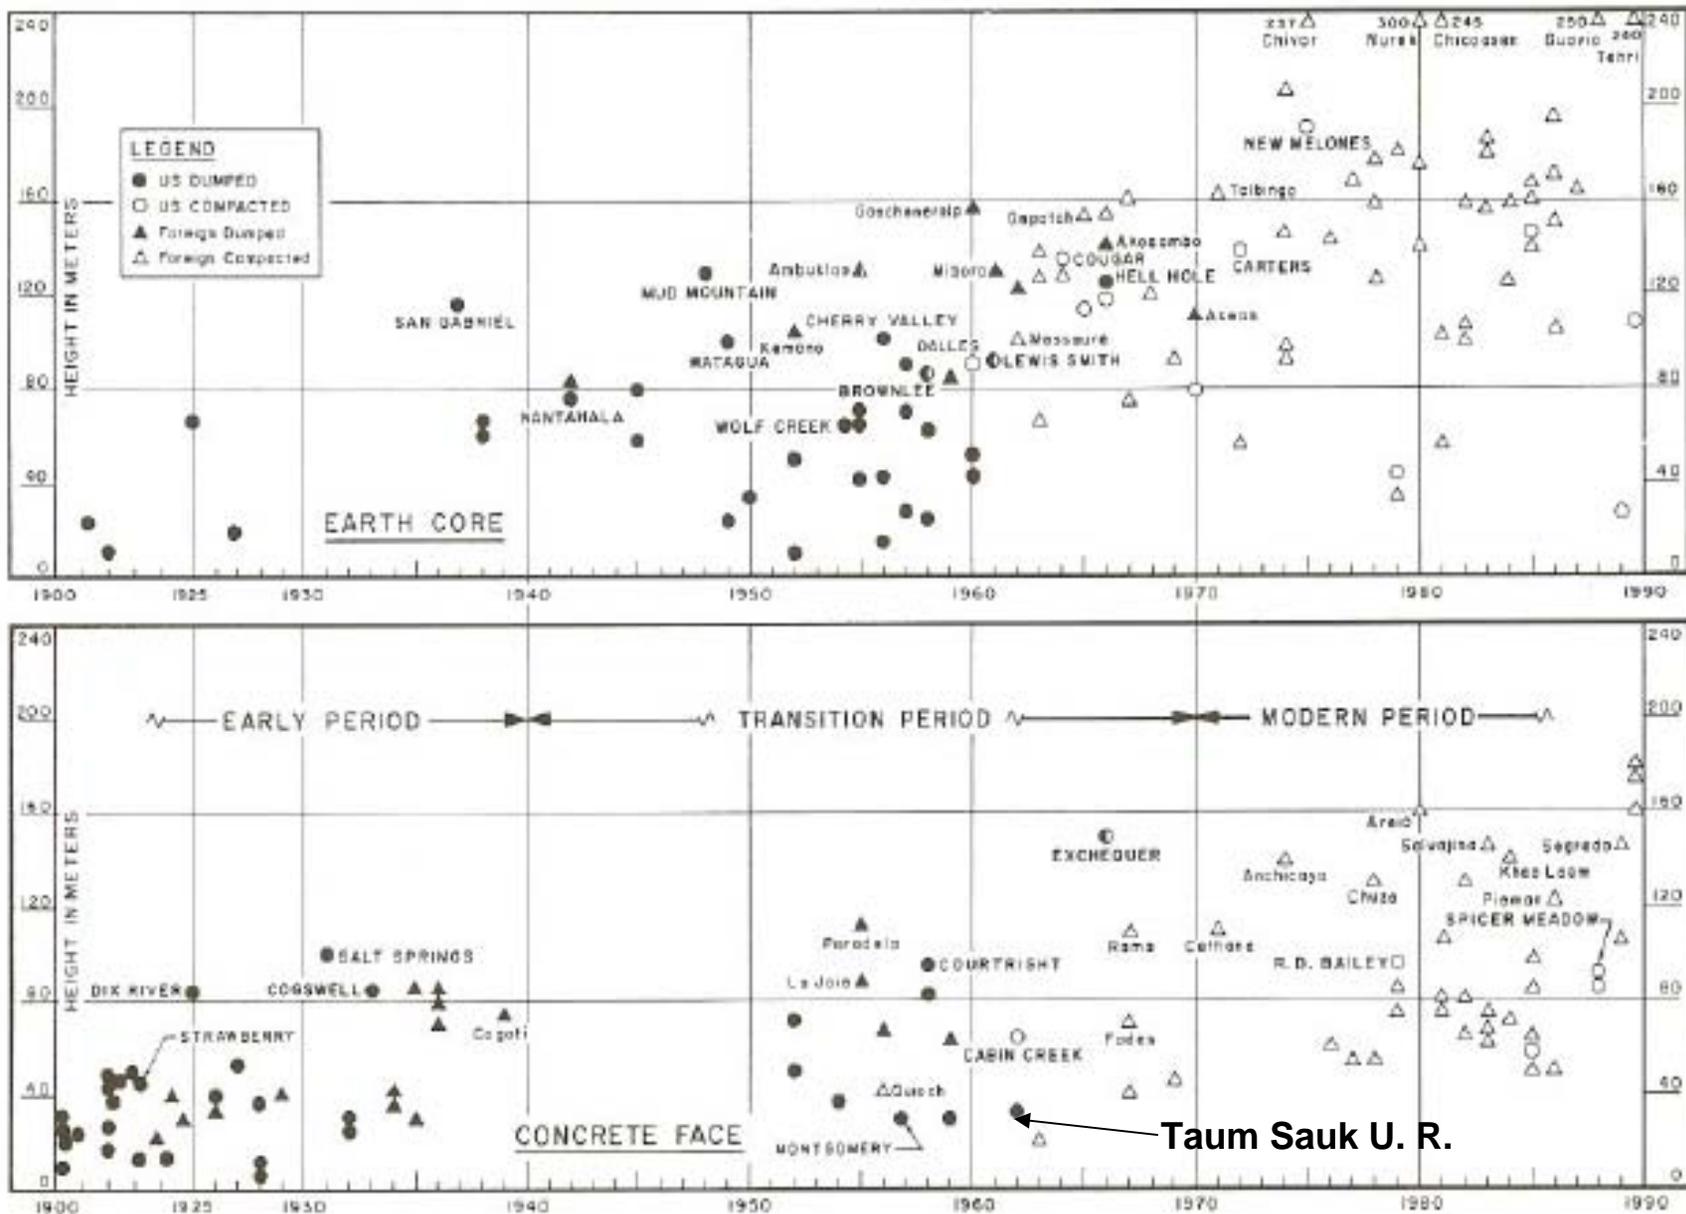
It is noted from Figure 3-1 that nearly 100% of the CFRD's prior to 1963 were dumped and many had cracked face slabs and high leakage. Because of this behavior there were no CFRD's built between 1940 and 1950. As shown on Figure 3-1 Taum Sauk was the last newly constructed dumped rockfill CFRD in the USA; it is also shown in Figure 3-1 that Cabin Creek CFRD was designed at about the same time, but was designed as a compacted rockfill CFRD. Cabin Creek was compacted in 2 ft thick lifts to a height of 70 m (230 ft.) and was an Upper Reservoir Dam for a pumped storage project in Colorado. The maximum section of Cabin Creek Dam is shown in Figure 3-2 which shows an upstream slope of 1.3:1 and a downstream compacted slope of 1.75:1. It is especially important to note that the maximum operating level is 6 ft below the rockfill crest of the dam, and 9 ft below the top of a 3 ft high parapet wall on the crest of the dam. The differences in the Taum Sauk and Cabin Creek CFRD designs represent differences in risk tolerances for different engineering firms and individual consultants during the same time frame taking into account the state of the art for CFRD design in the middle 1960's. It should also be noted that Cabin Creek Dam was overtopped by pumping, but did not fail.

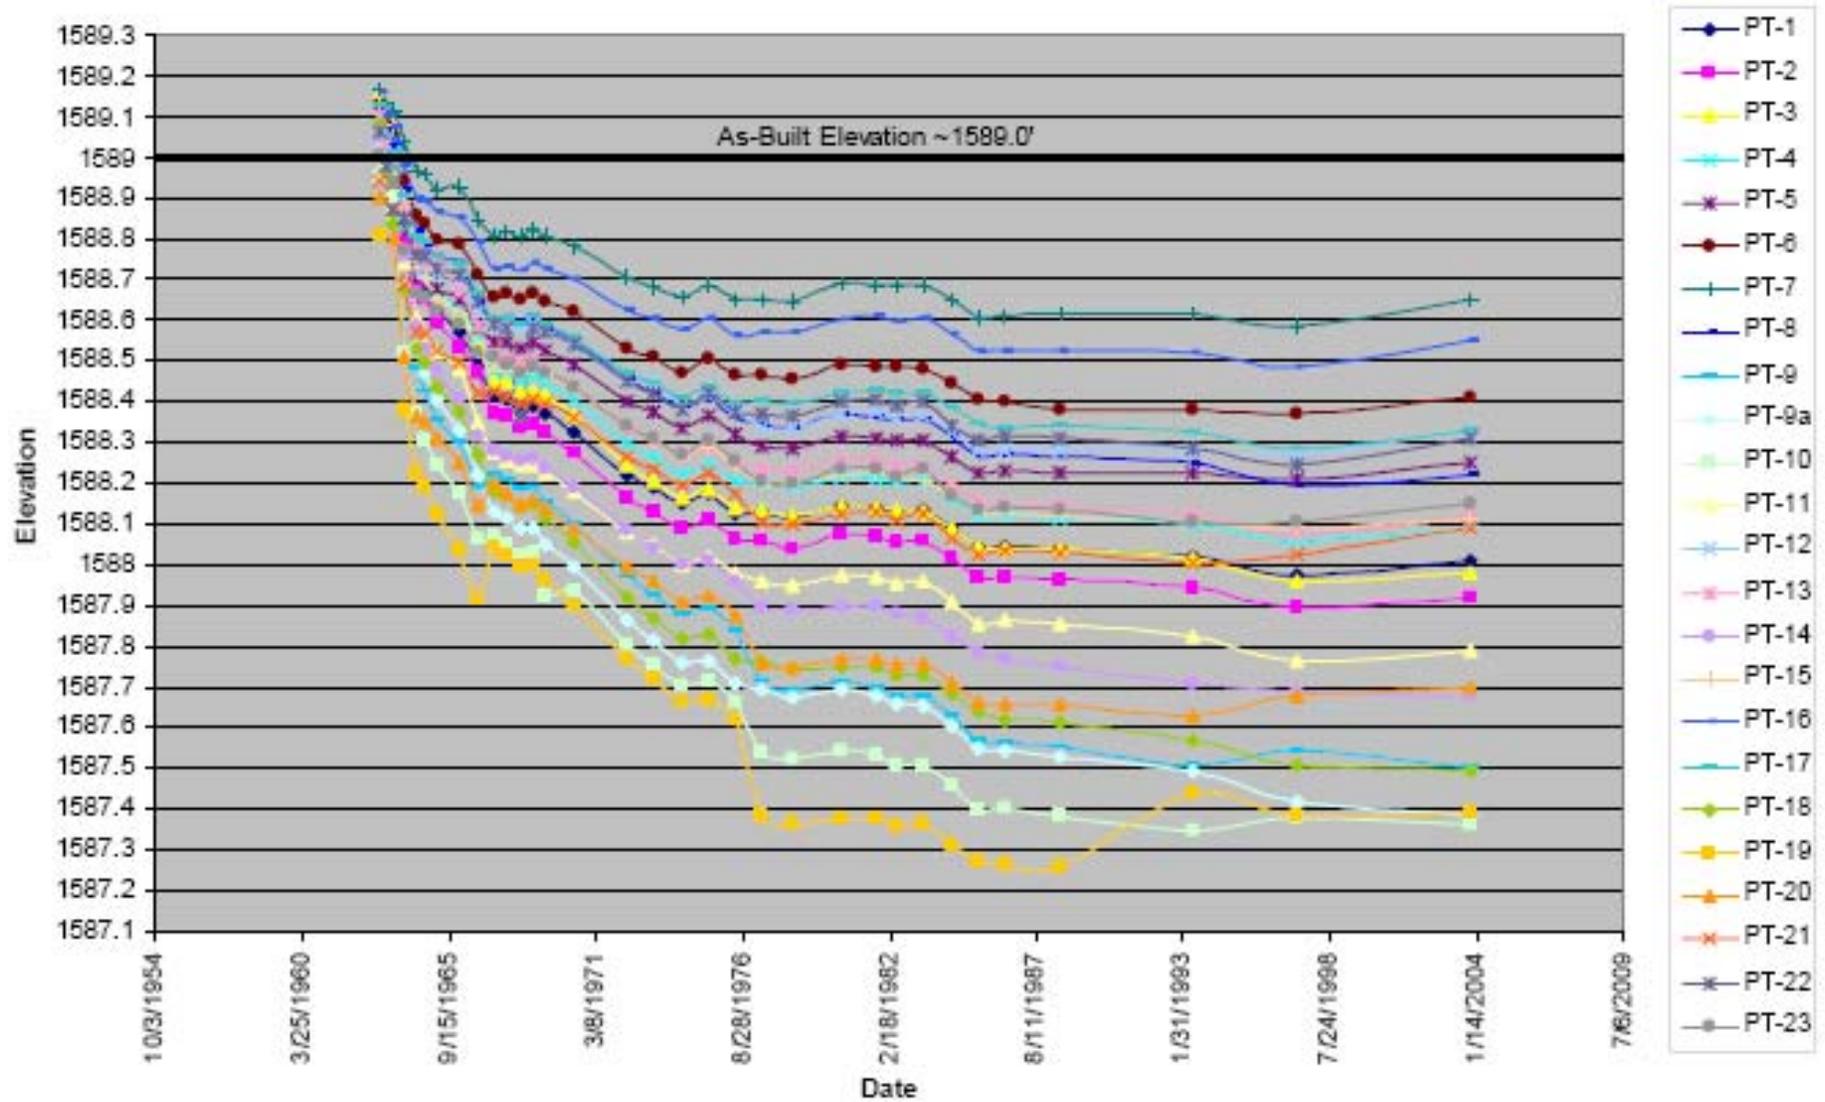
If it is noted that the original survey pins 18 and 19 (Figure 3-4) correspond to Panels 90 and 95 within the breach area and it is shown on Figure 3-3 that the 2004 elevation of Pin 18 and Pin 19 are 1587.5 and 1587.4, respectively. Then

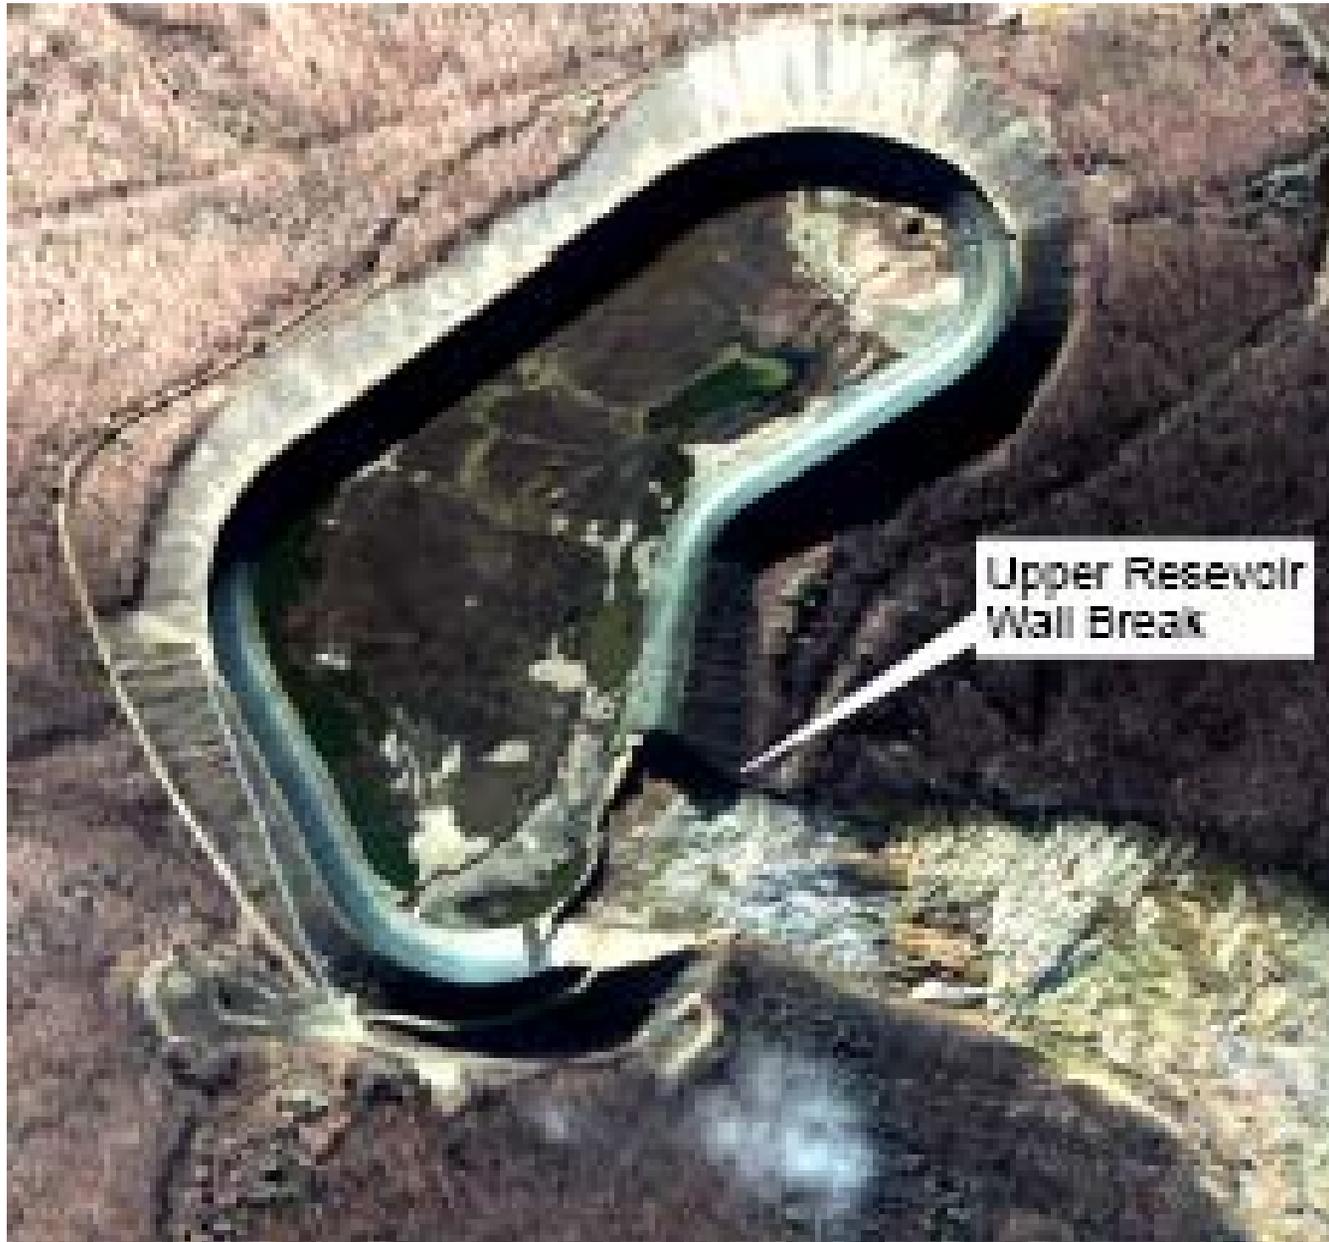
Figure 6-1

Taum Sauk
Upper Reservoir
Breach 12/14/05

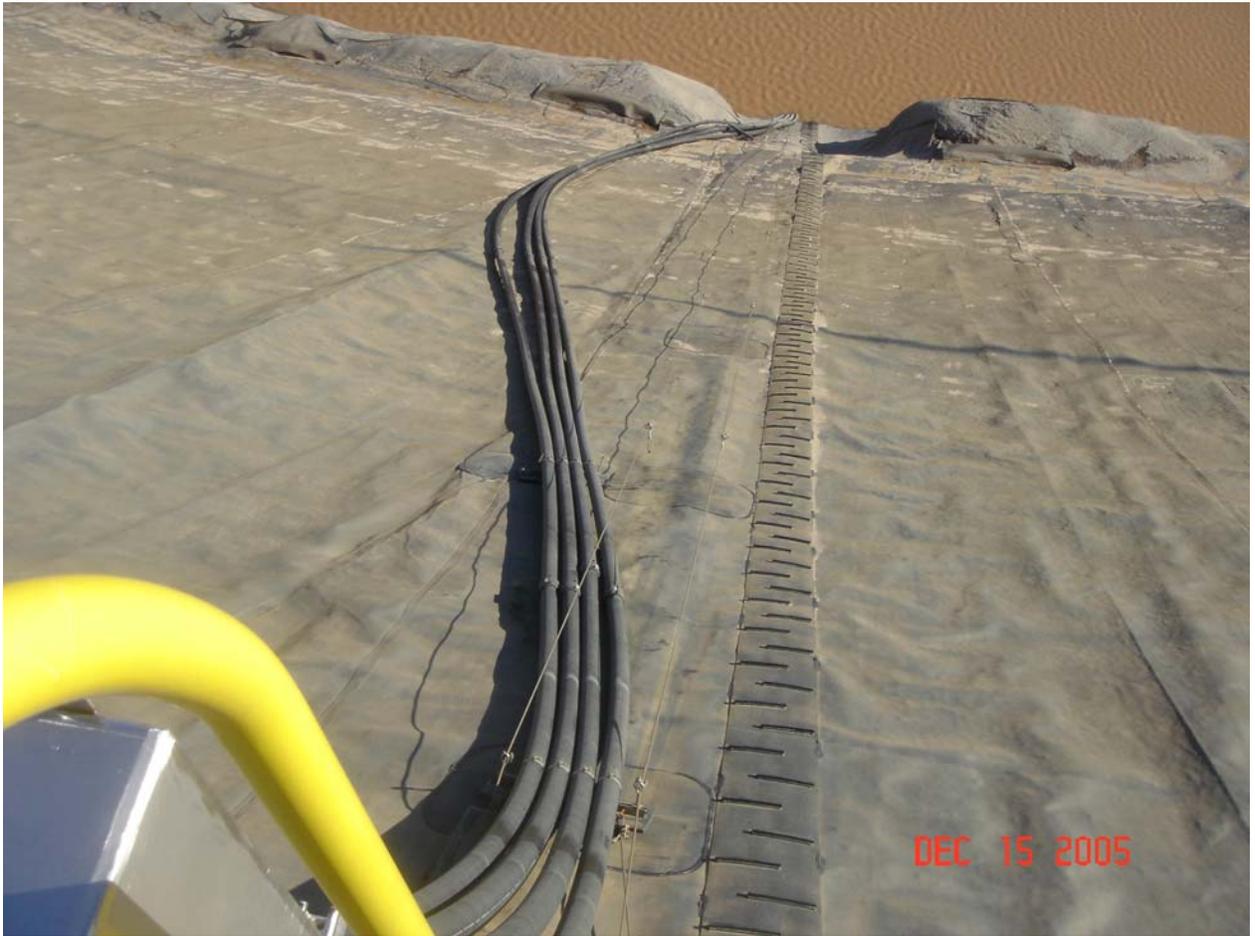
Figure 7-4

A visual examination of the pressure transducer protective pipes, Figures 7-3 through 7-5, shows that the protective pipes had moved from their straight alignment in the lower elevation of the reservoir. Since the transducer cables remained fixed at their instrument box on the parapet wall (Figure 7-6), any movement of the protective pipes from their initial straight alignment would produce an upward movement of the pressure transducer and a corresponding negative error in the water level reading. That is, the reported water level would be less than the actual level.

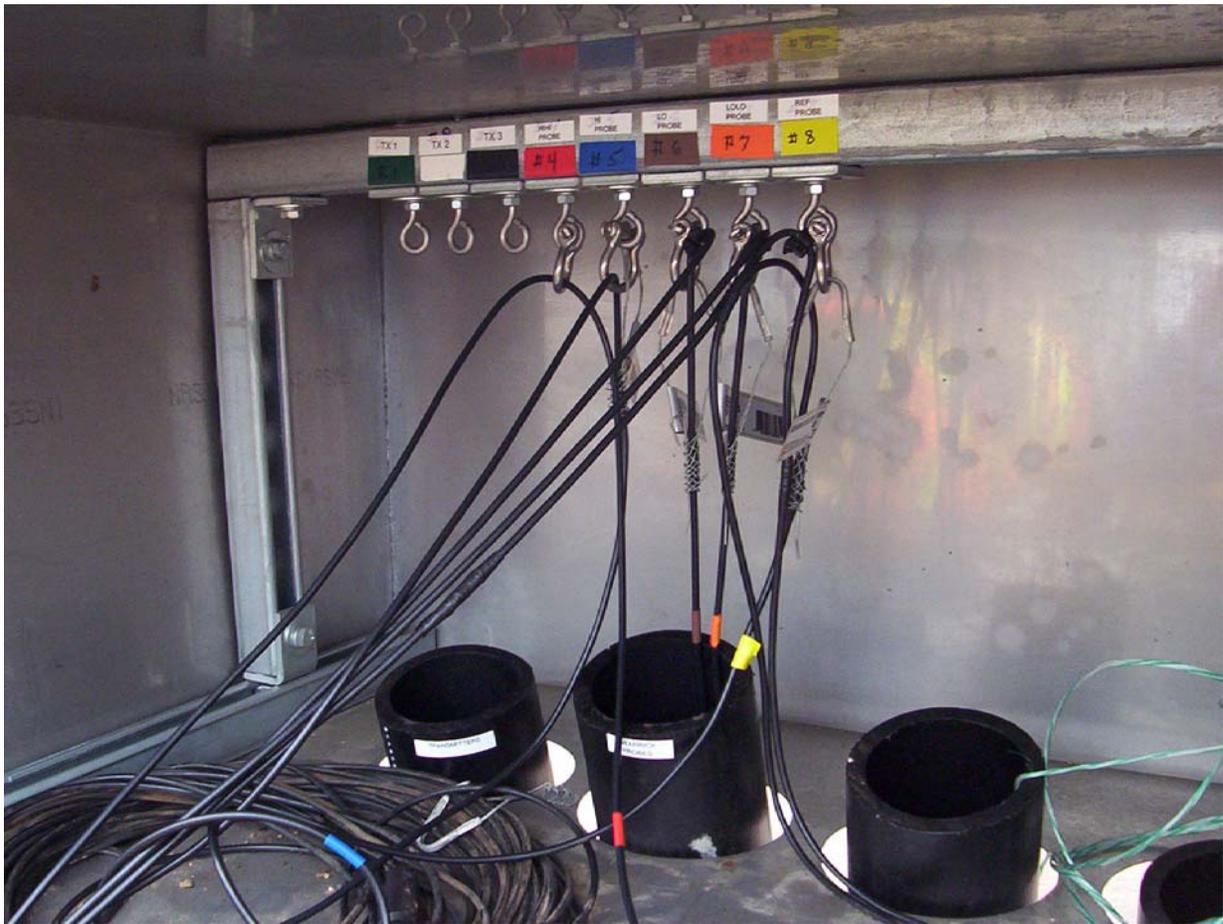
Figure 7-6

**Upper ends of protective pipes
with instrument cables in enclosure on parapet.
Pressure transducers use left pipe
and conductivity probes use the second pipe from left.**

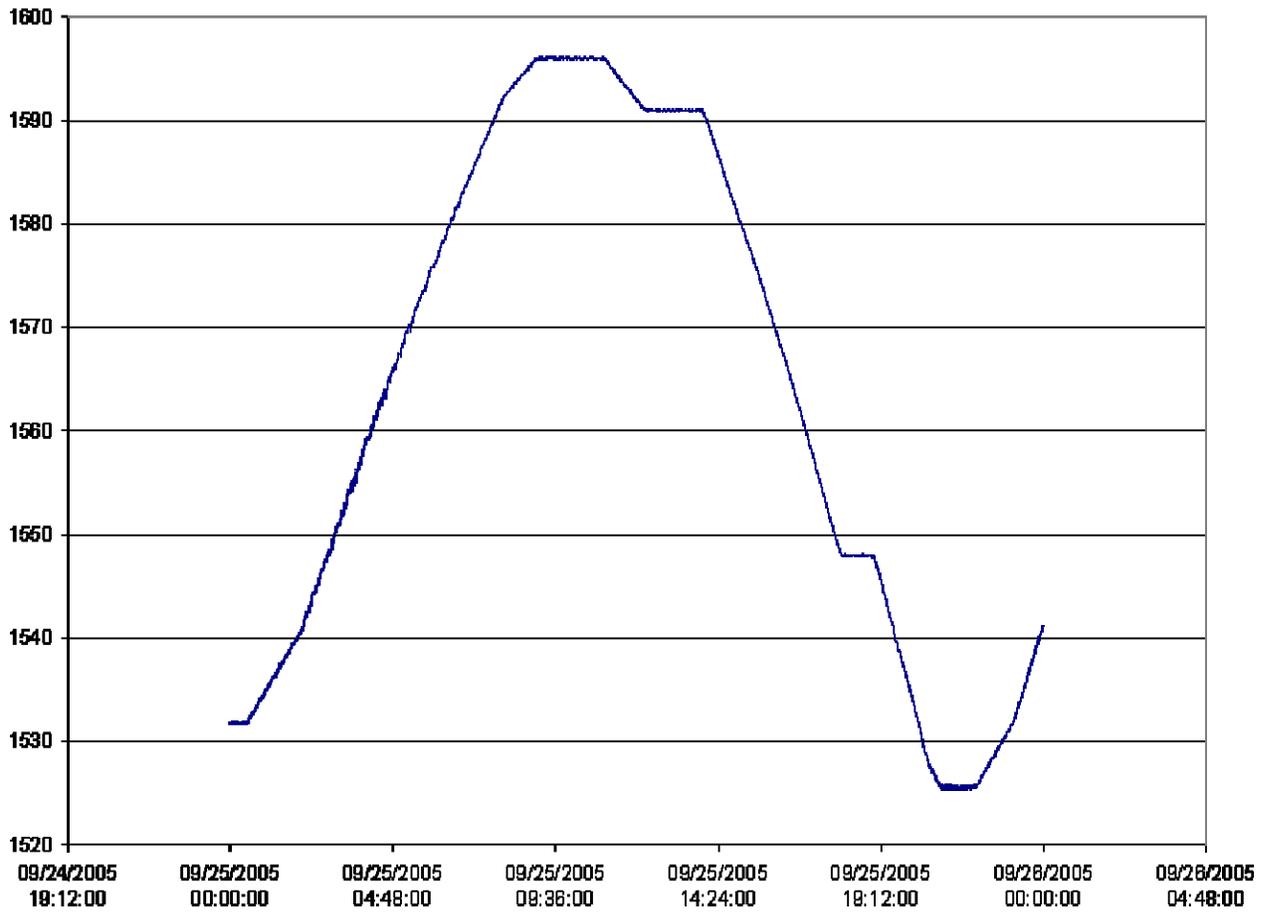
Figure 7-9

Figures 7-9 through 7-11 show upper reservoir water level readings taken during and prior to the Hurricane Rita event.

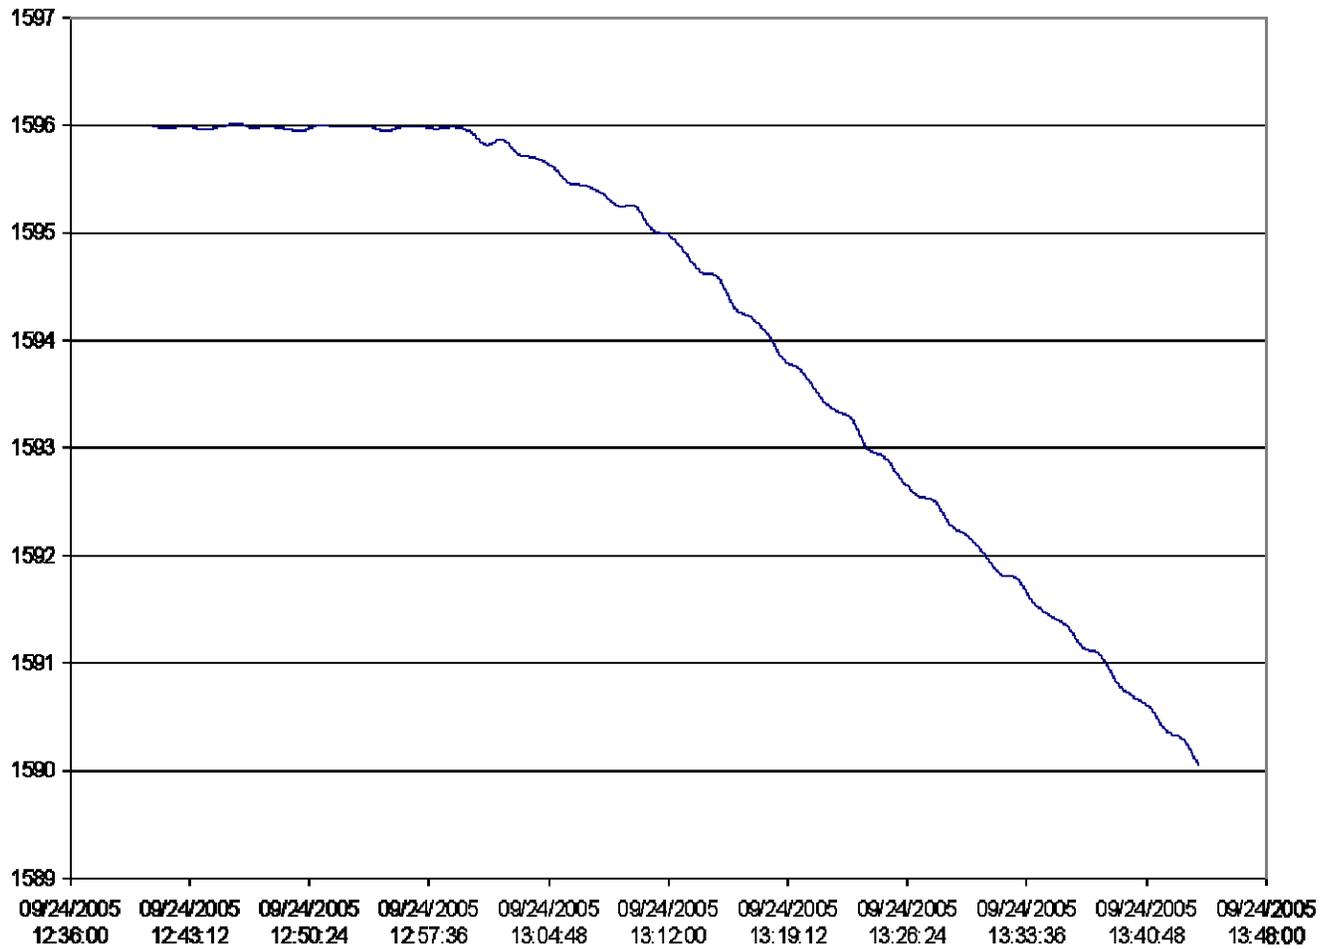
Figure 7-11

Generation start on day prior to Hurricane Rita. Note smaller level variations compared to next day.

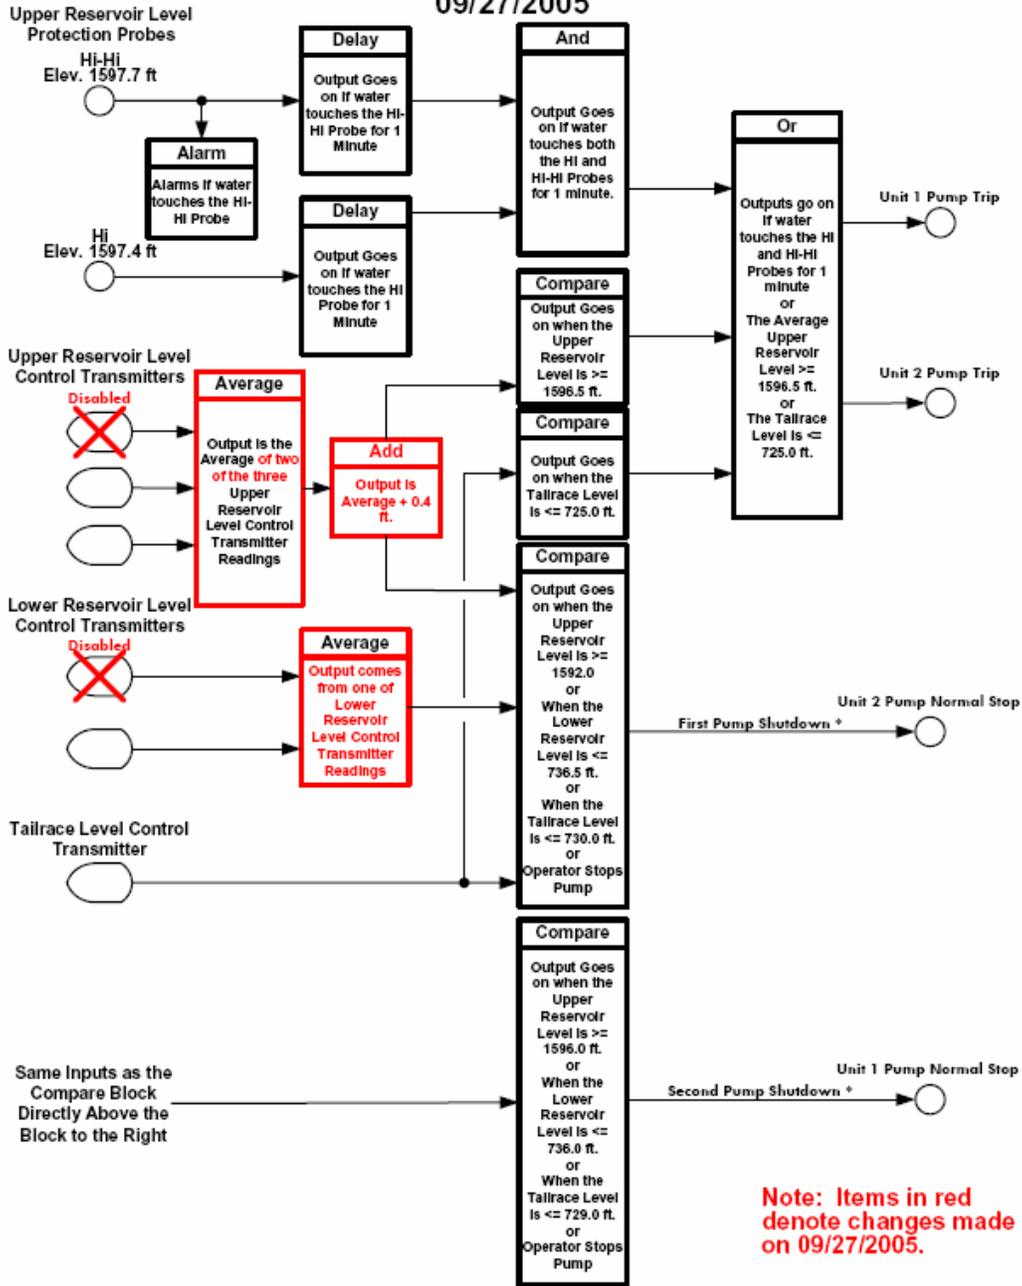
Figure 7-12 (09/27/2005) shows the disabling of one upper reservoir pressure transducer and one lower reservoir pressure transducer and the addition of the 0.4 feet offset in the upper reservoir level indication.
