Taum Sauk Upper Dam Breach FERC No. P-2277

Technical Reasons for the Breach
of December 14, 2005

FERC Independent Panel of Consultants (IPOC)

May 24, 2006

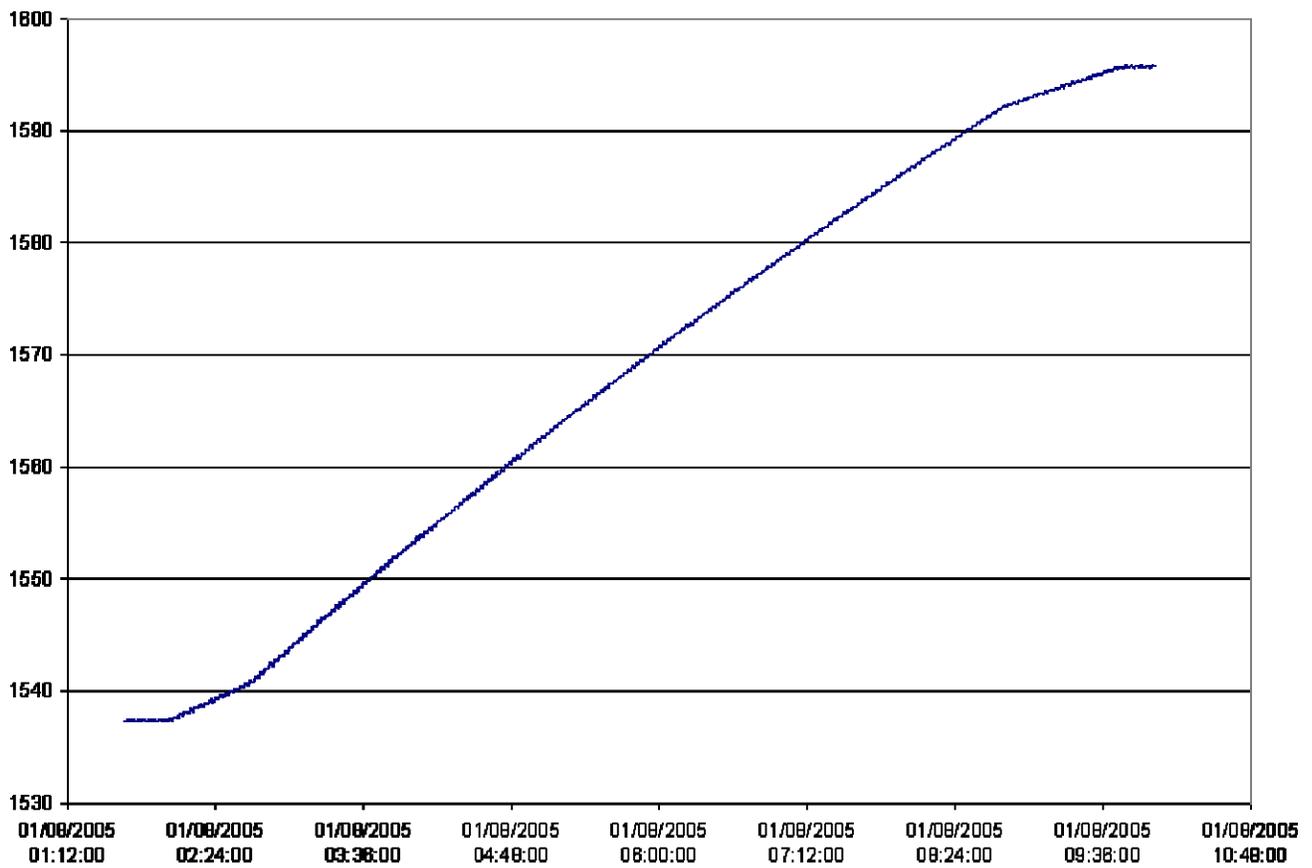
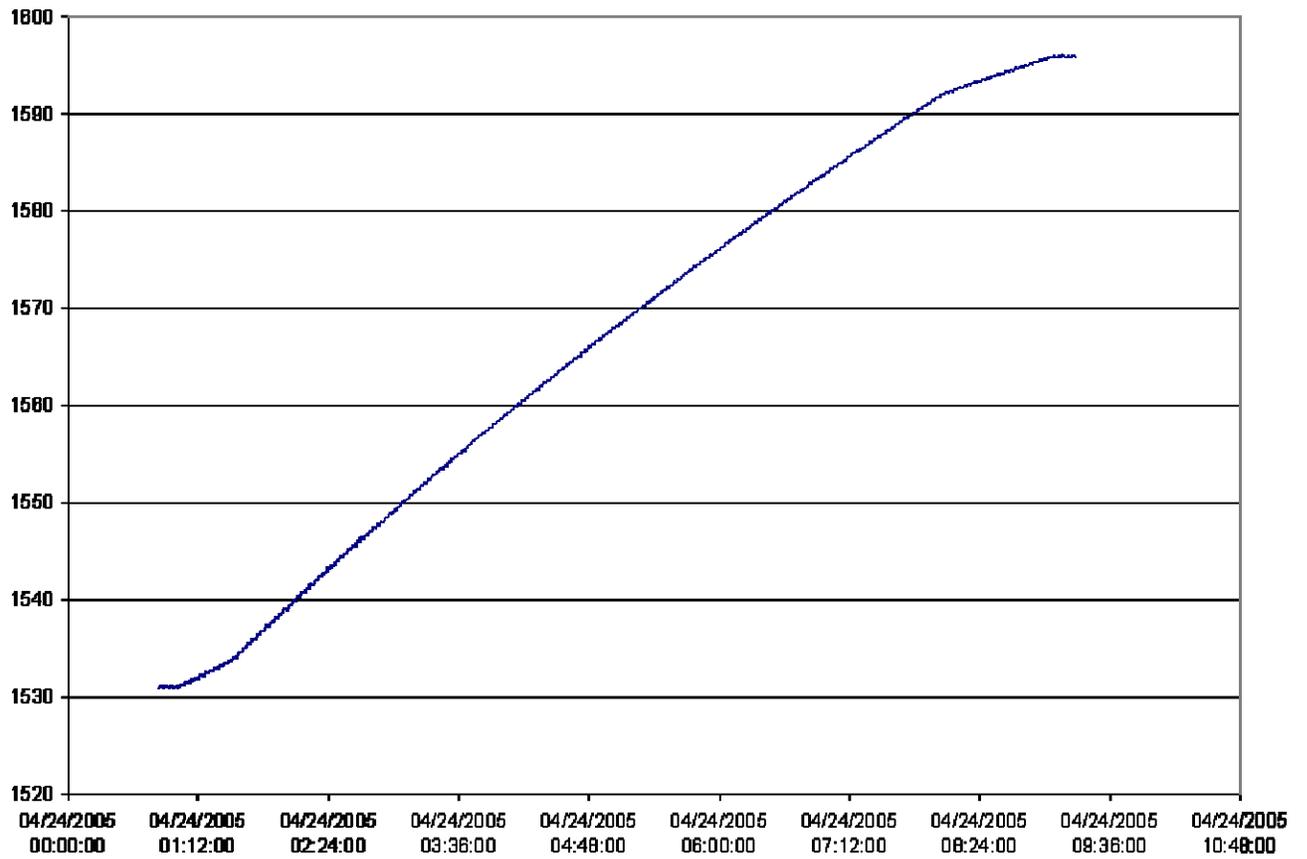
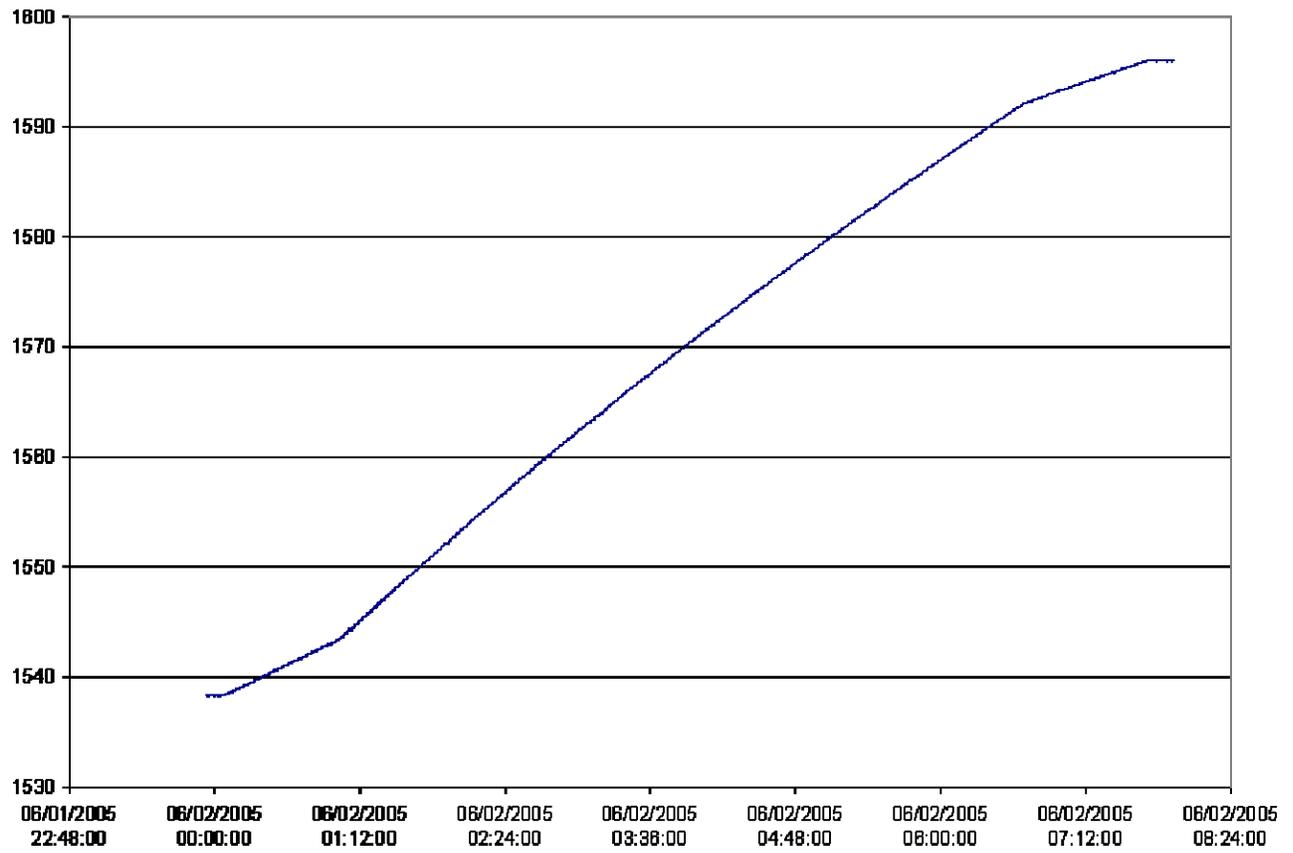
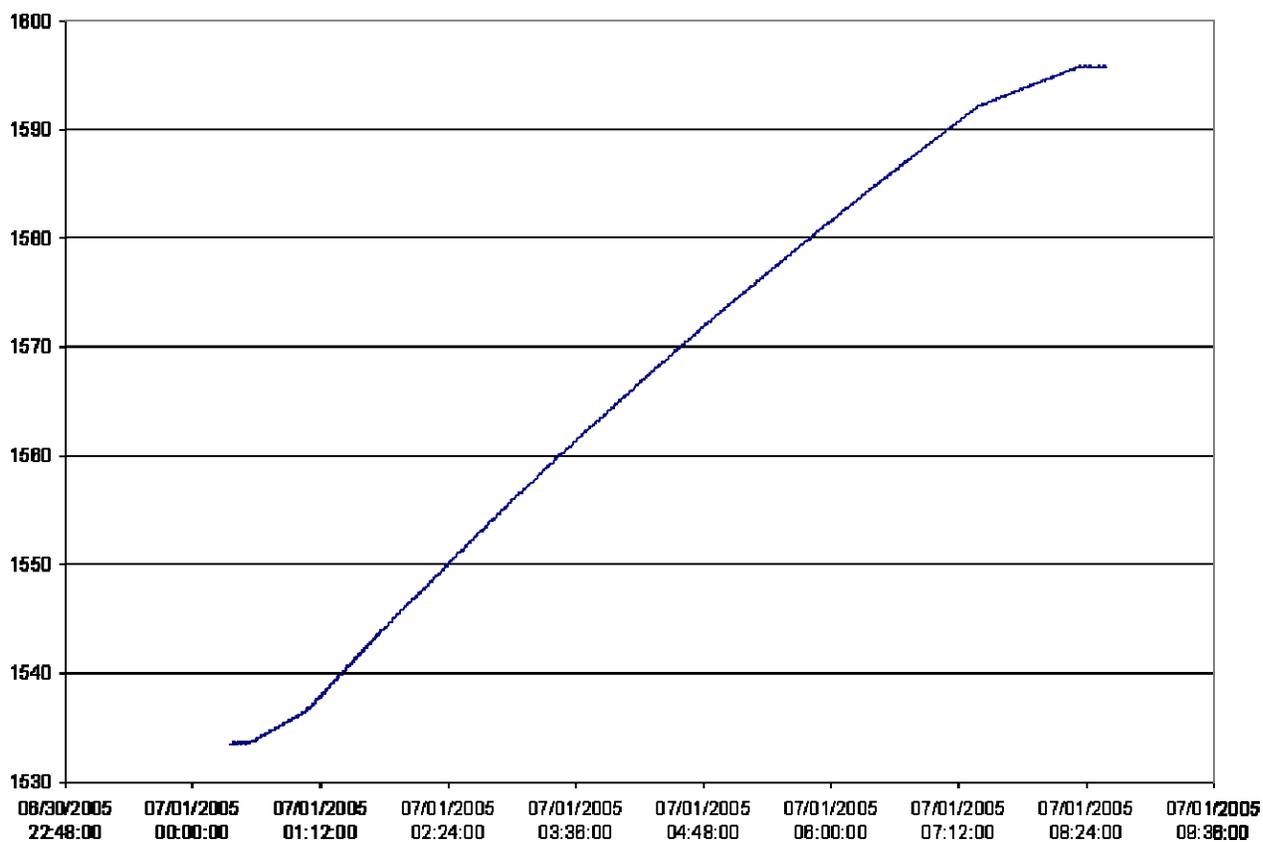
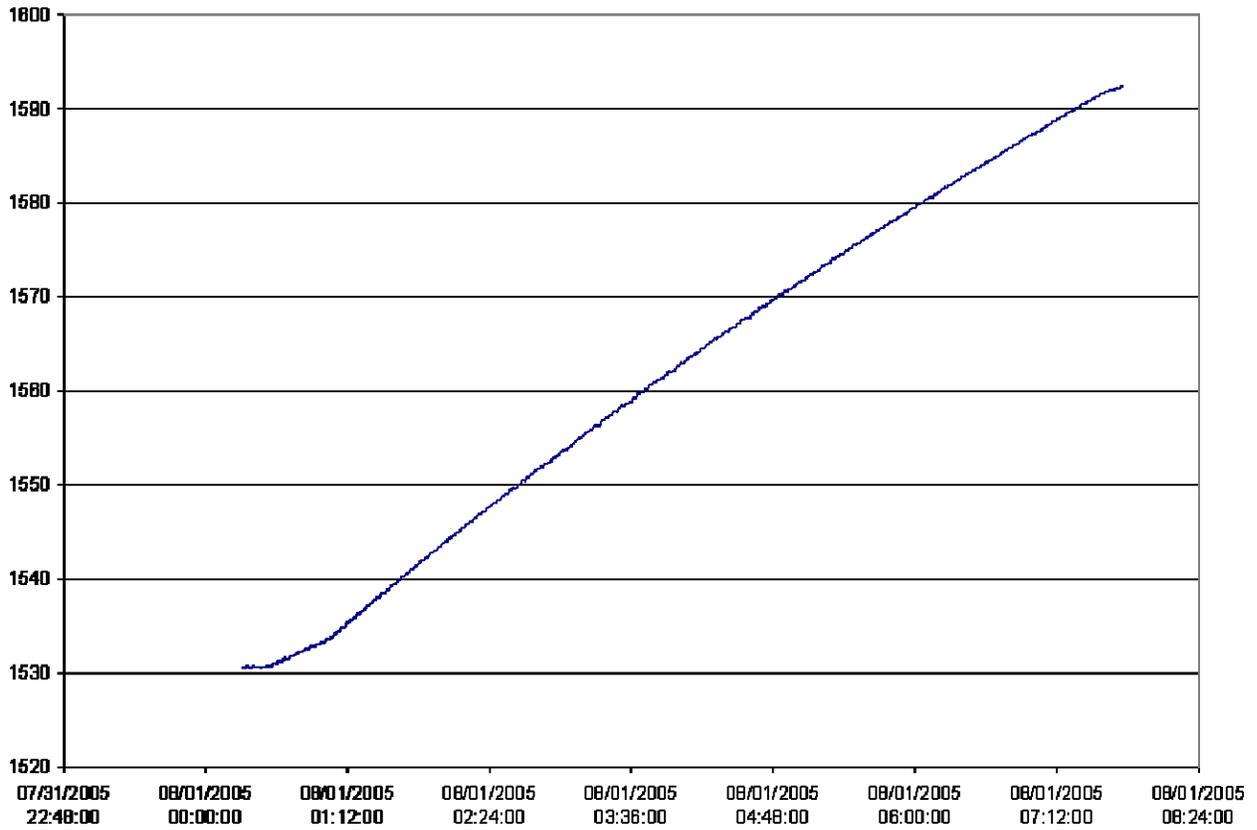
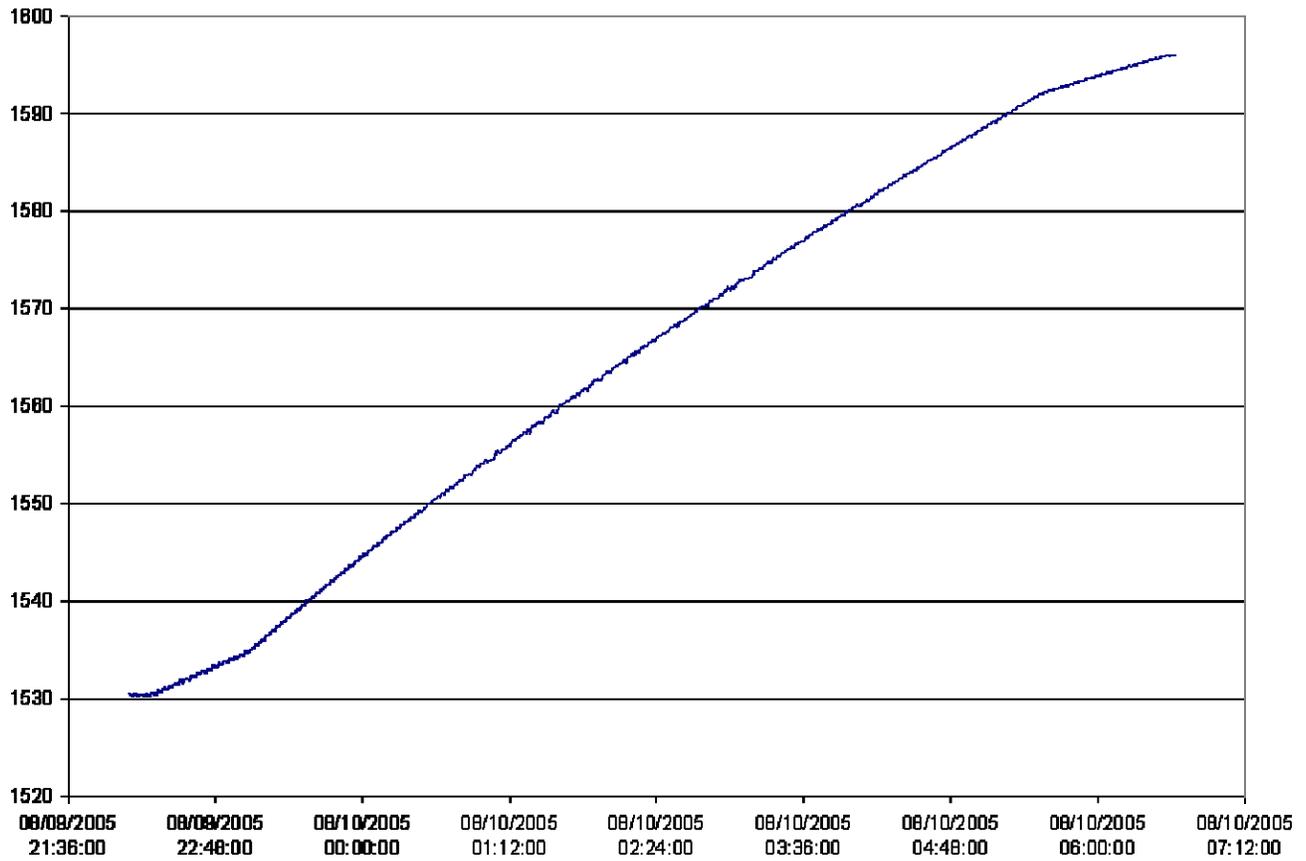
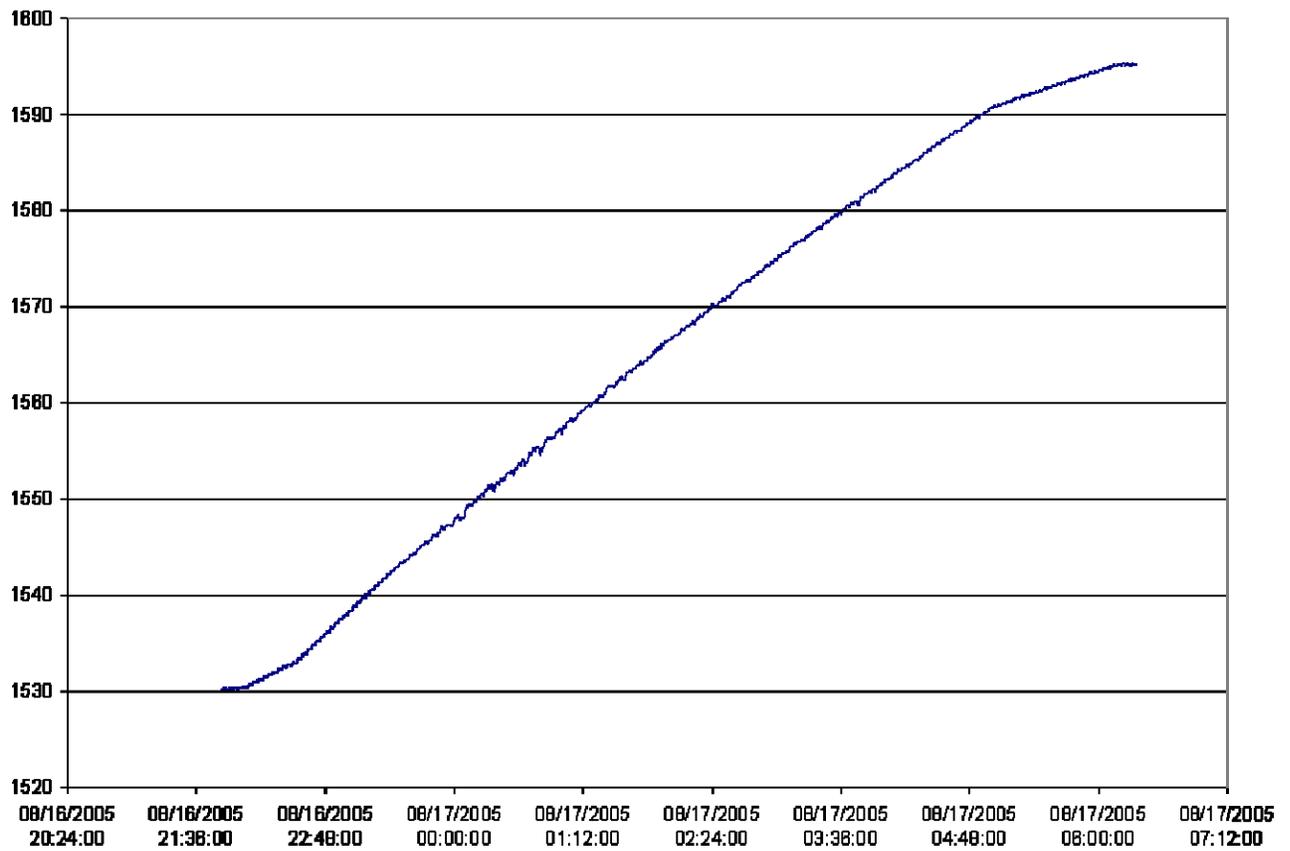
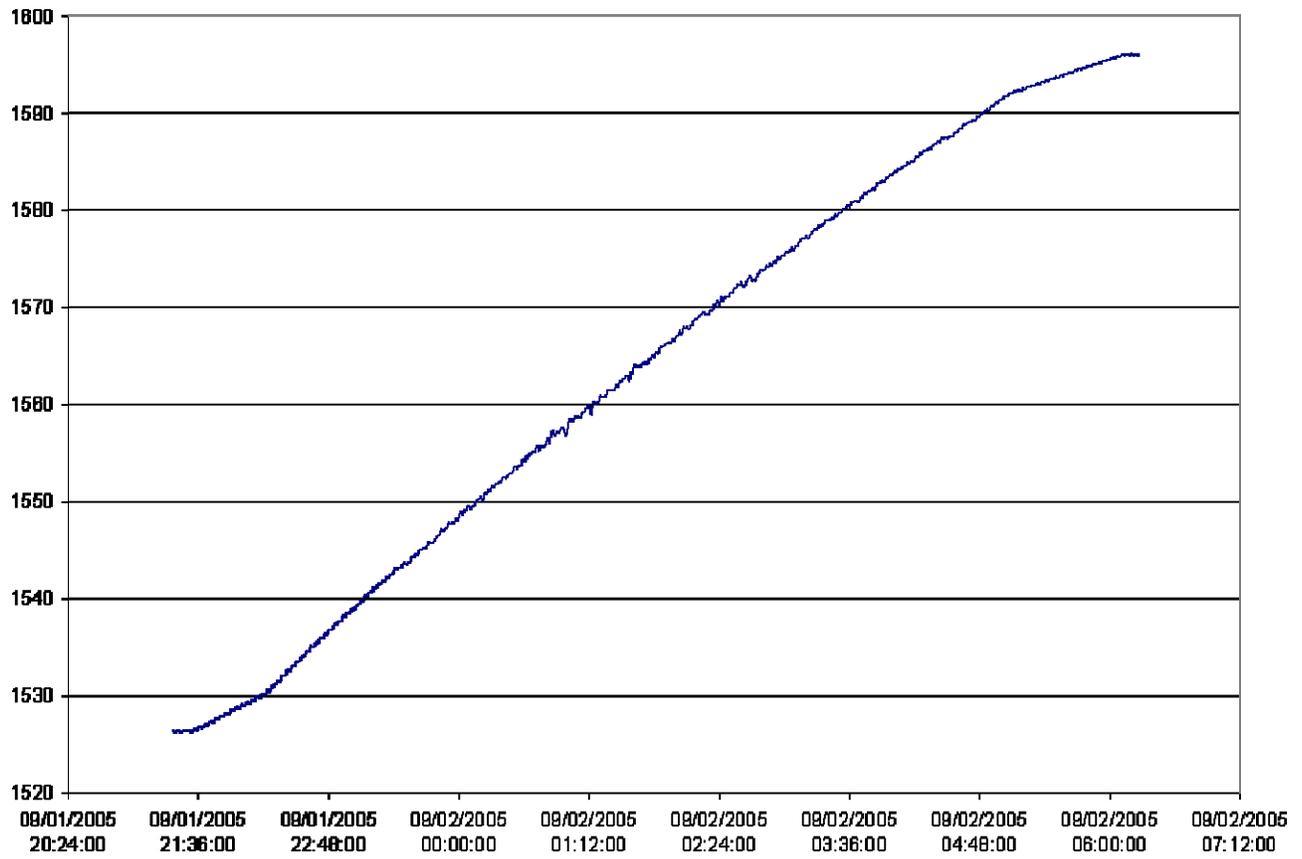
A review of two pump operations during 2005 shows that the upper reservoir water level indications are reasonably stable until early August. Figures 7-15 through 7-22 are examples of these levels from the pressure transducers. Beginning in early August, the water level plots begin to show the erratic behavior that increased until December 14, 2005.

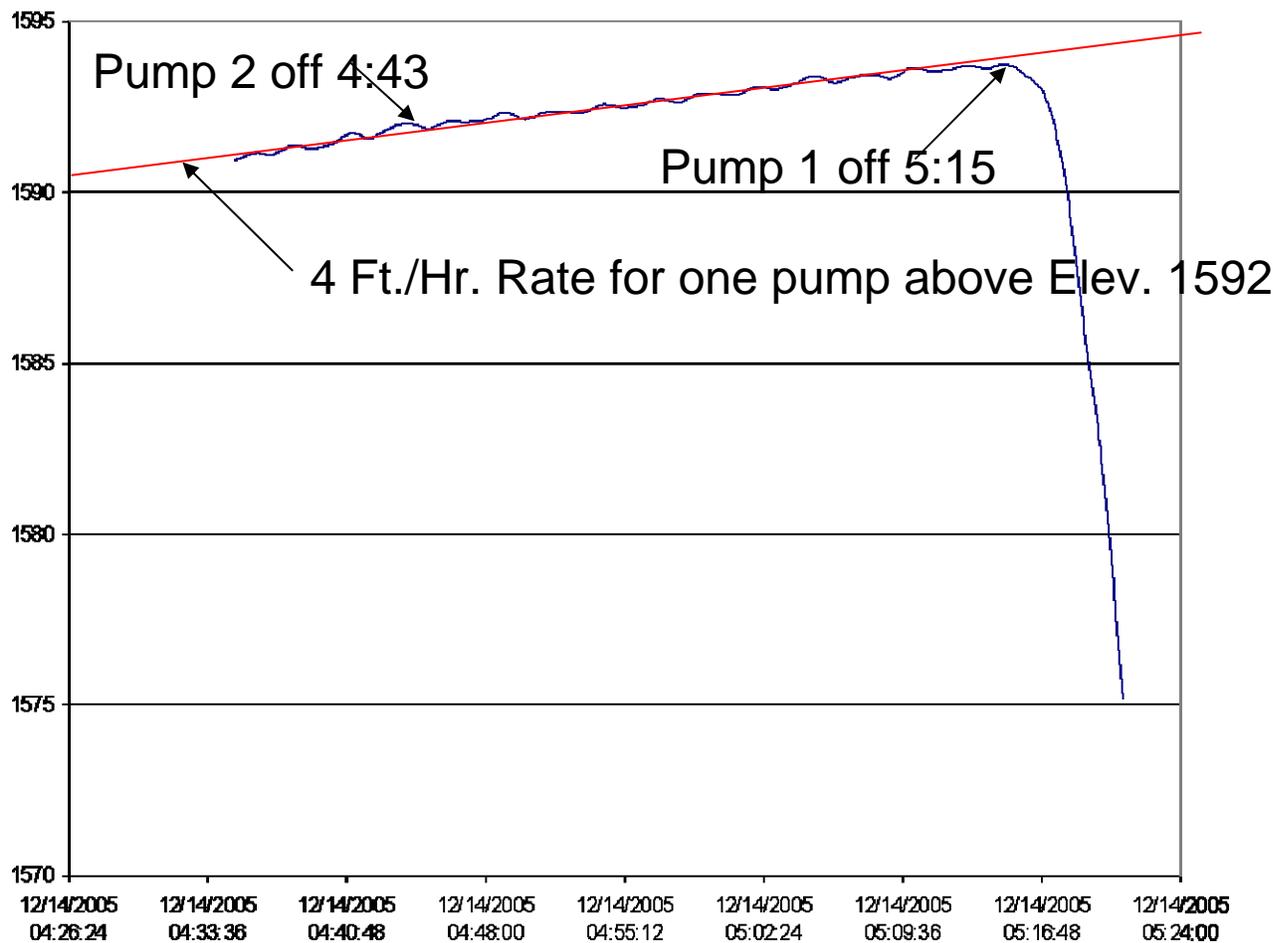
Figure 7-25 shows indicated upper reservoir water levels around the time of the breach on December 14, 2005. A trend line has been added to show the calculated rate of rise for one pump operation at the maximum reservoir level. Note that the measured water level rate of rise matches the calculated trend line very closely to within a few minutes of the rapid drop in level. This suggests that the breach occurred very quickly after shut down of the second pump.

With a 15 minute per foot rate of rise for one pump and a minimum parapet elevation of 1597 at panel 72, more than 15 minutes would have been required to raise the water level from Elev. 1597 to Elev. 1598 since overtopping would have been occurring at panel 72 and other locations. Figure 7-25 does not show such a long period of reduced rate of rise prior to the breach. Therefore, the water level could not have reached as high as Elev. 1598.

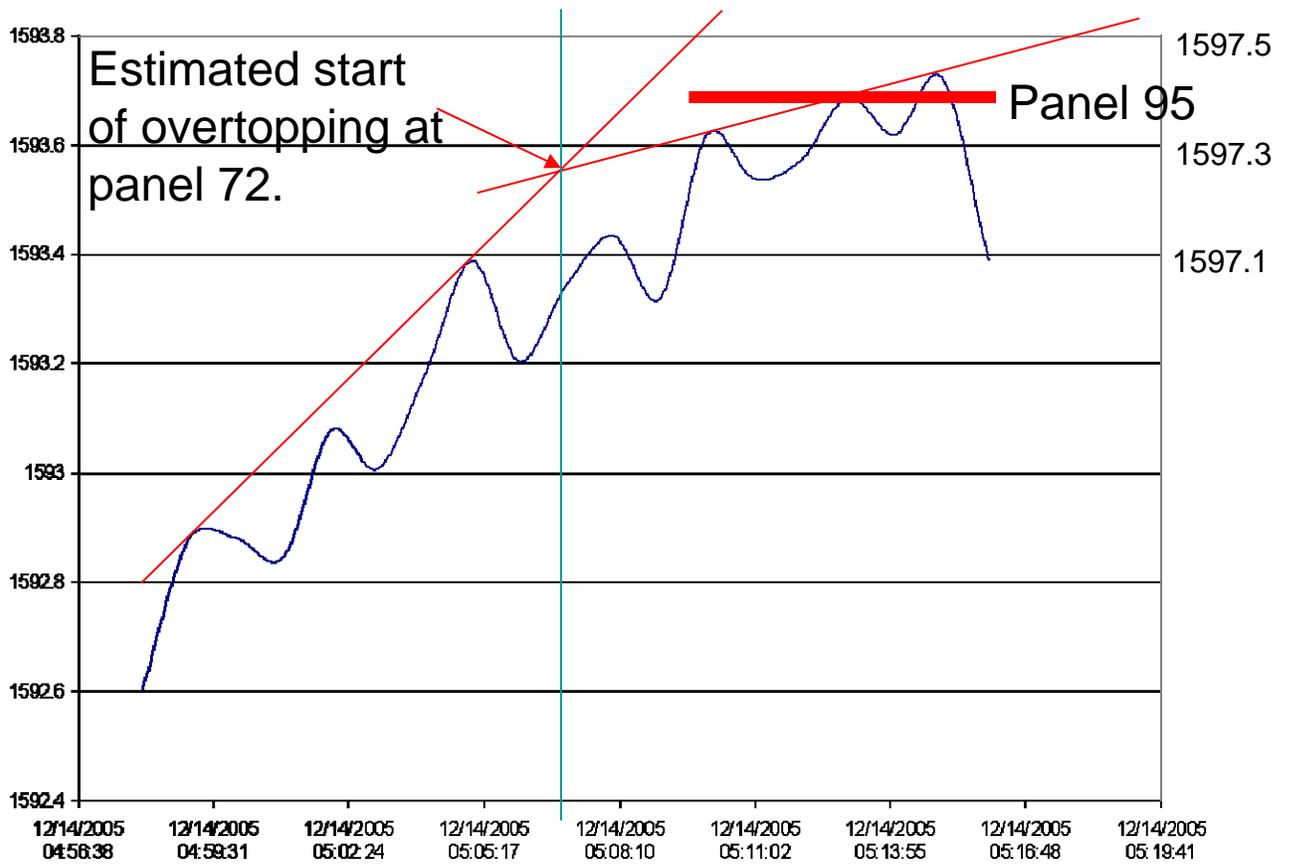
Figure 7-26 is an enlargement of Figure 7-25 with two trend lines added. The left trend line represents rising water level prior to overtopping and the right trend line represents a reduced rate of level rise associated with beginning of overtopping. The lines intersect at about 5:07 AM suggesting that the actual level was around

Water level indications (left scale)
and adjusted (right scale) prior to breach event.

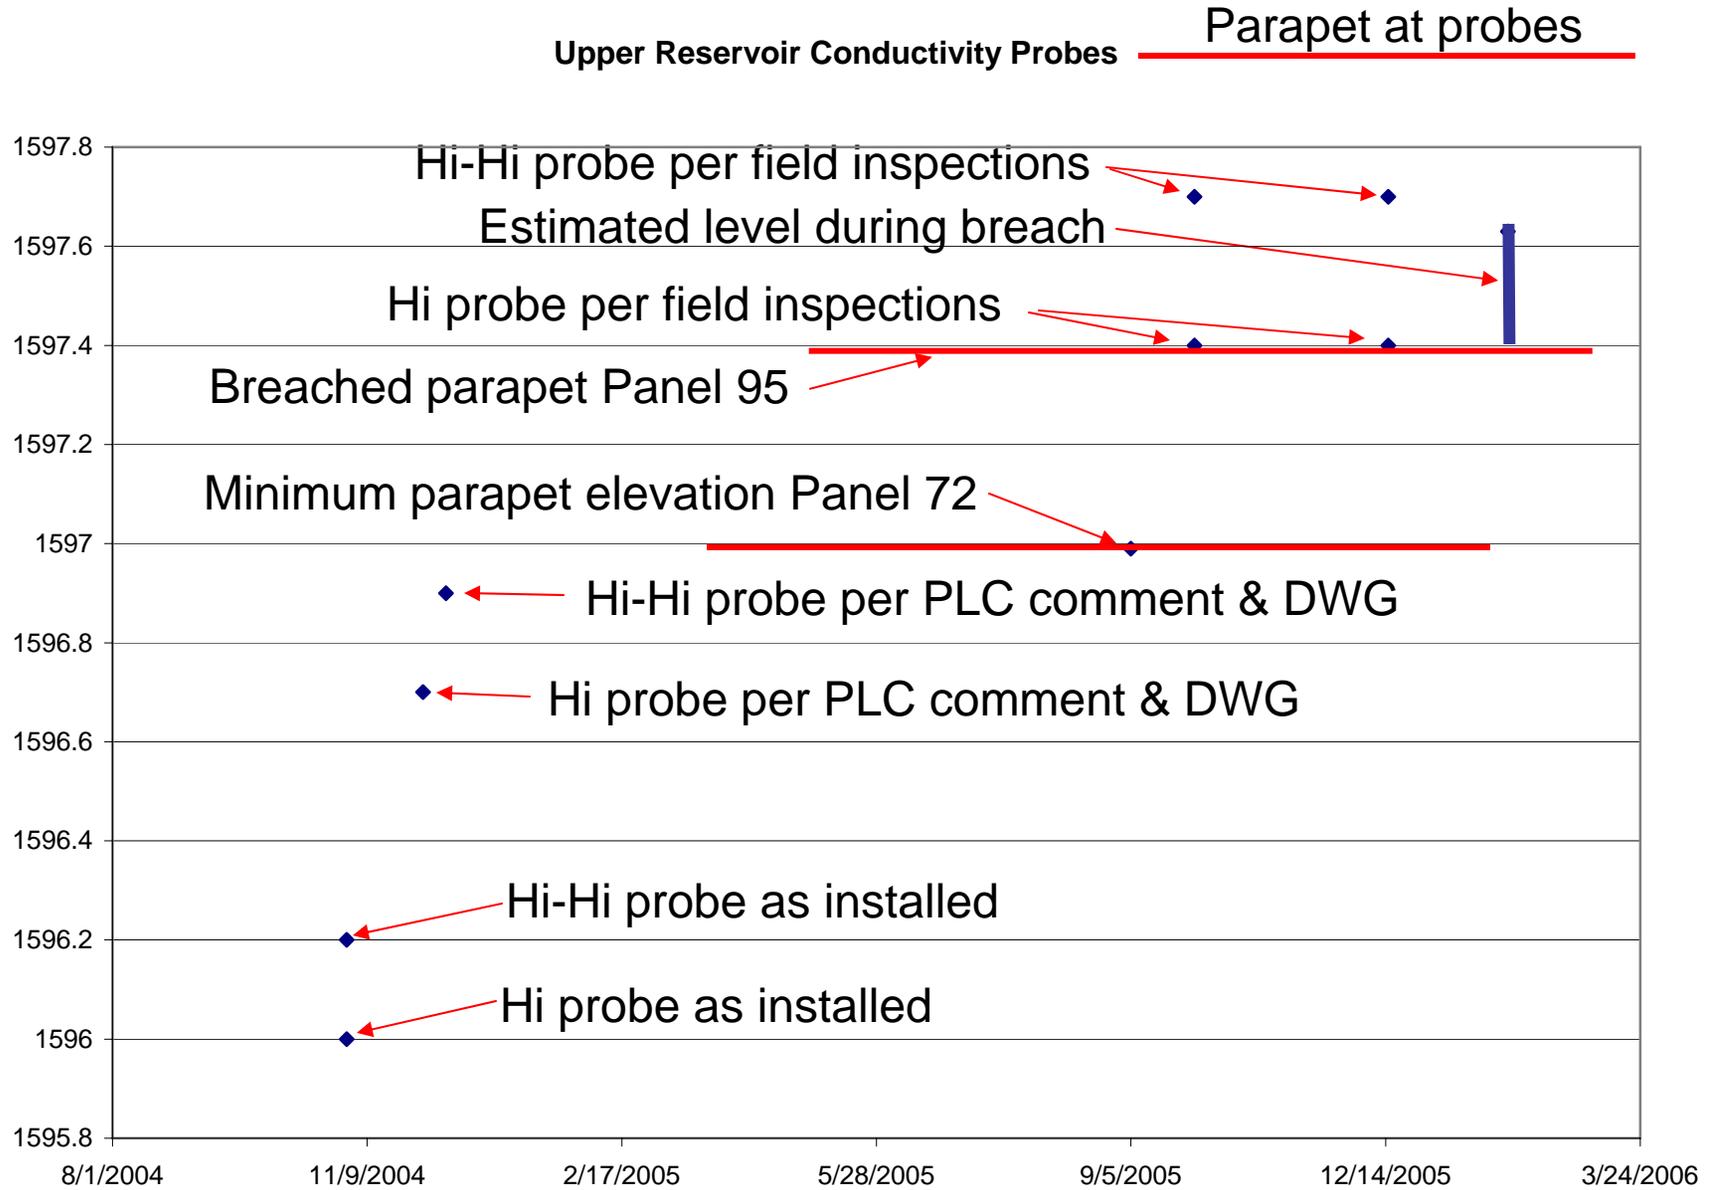
Figure 7-30 shows a maximum water level of about Elev. 1597.4 based on indexing the pressure transducer record to Elev. 1597 when the rate of rise decreased during one pump operation.
