Ethical Issues from the Kansas City Hyatt Hotel Collapse

Course No: LE2-001

J. Paul Guyer, P.E., R.A., Fellow ASCE, Fellow AEI

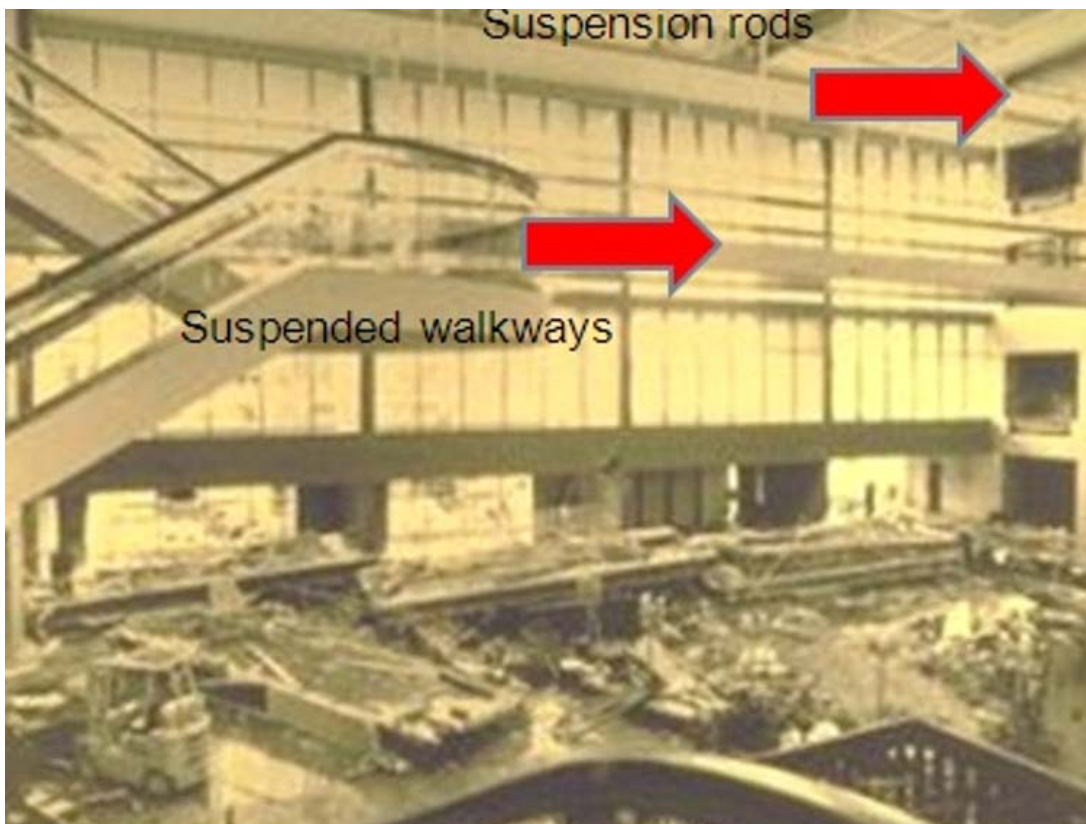
Figure 5
Suspended Walkways at the Atrium Lobby

The structural failure occurred at two of the three suspended walkways that traversed from one side to the other of the atrium lobby. Walkways that failed were directly in line with each other and crossed from one side to the other at the second and fourth floors. The third walkway, at the third floor, was offset from the other two and was not involved in the failure.

The fourth floor walkway failed, collapsed onto the second floor walkway, both crashed to the lobby floor, and 114 people were killed and 200 injured.
