# **Ethical Issues from the Kansas City Hyatt Hotel Collapse**

Course No: LE2-001

J. Paul Guyer, P.E., R.A., Fellow ASCE, Fellow AEI

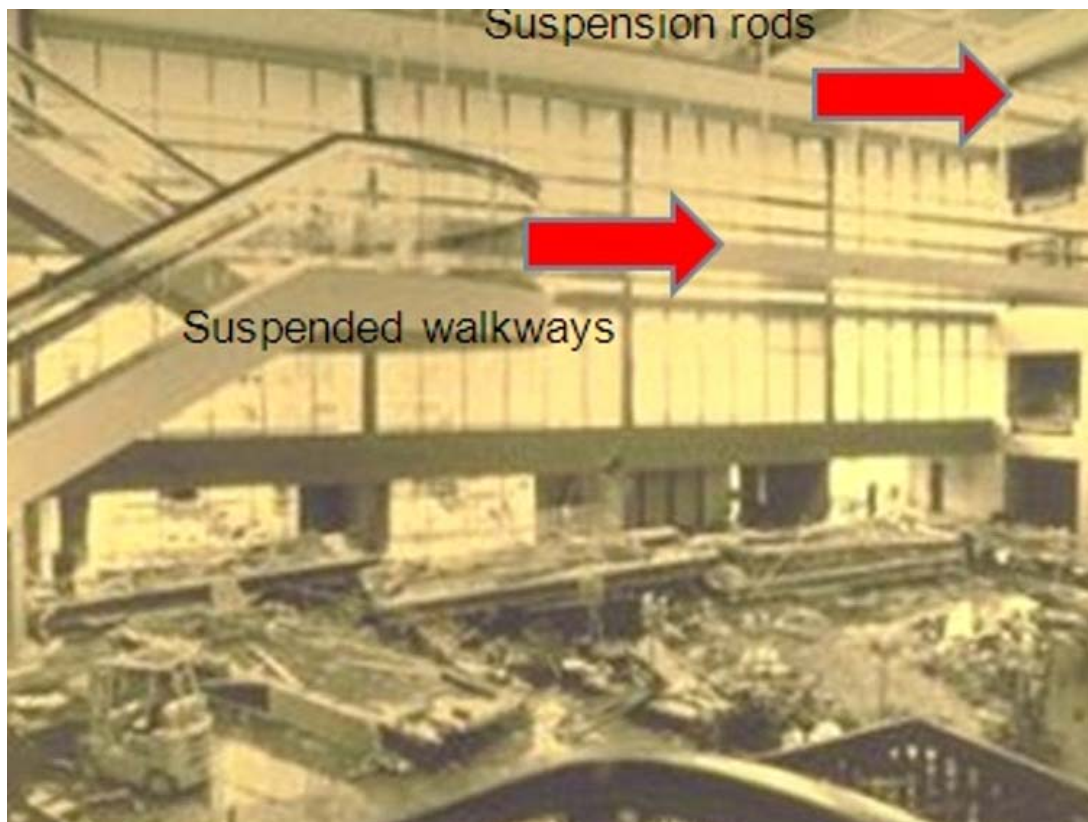
Figure 5  
Suspended Walkways at the Atrium Lobby

The structural failure occurred at two of the three suspended walkways that traversed from one side to the other of the atrium lobby. Walkways that failed were directly in line with each other and crossed from one side to the other at the second and fourth floors. The third walkway, at the third floor, was offset from the other two and was not involved in the failure.

The fourth floor walkway failed, collapsed onto the second floor walkway, both crashed to the lobby floor, and 114 people were killed and 200 injured.
