Bridge Inspection (Part 2): Abutments and Wingwalls (BIRM)

Course No: S02-007

Inspection Procedures and Locations for Abutments

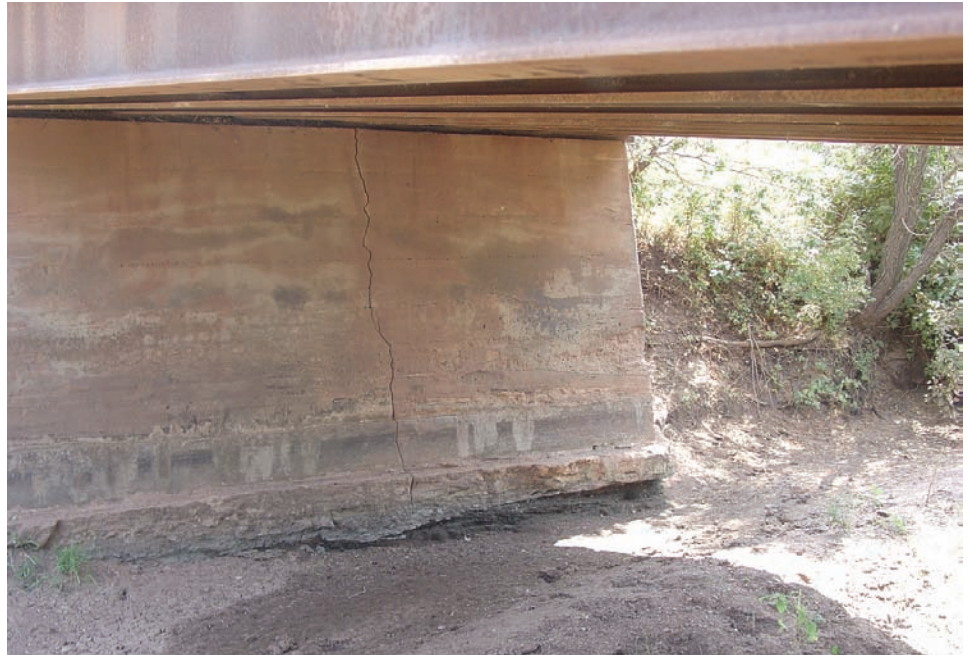
Figure 10.1.24 Crack in Abutment due to Settlement

- Inspect the joint opening between the end of the approach slab and the deck. In some cases, pavement expansion or approach fill expansion could conceivably cause vertical movement in the approach slab.
- Investigate existing and new cracks for signs of settlement (see Figure 10.1.24).
- Examine the superstructure alignment for evidence of settlement (particularly the bridge railing and deck joints).
- Check for scour and undermining around the abutment footing or foundation.
- Inspect the joint that separates the wingwall and abutment for proper alignment.

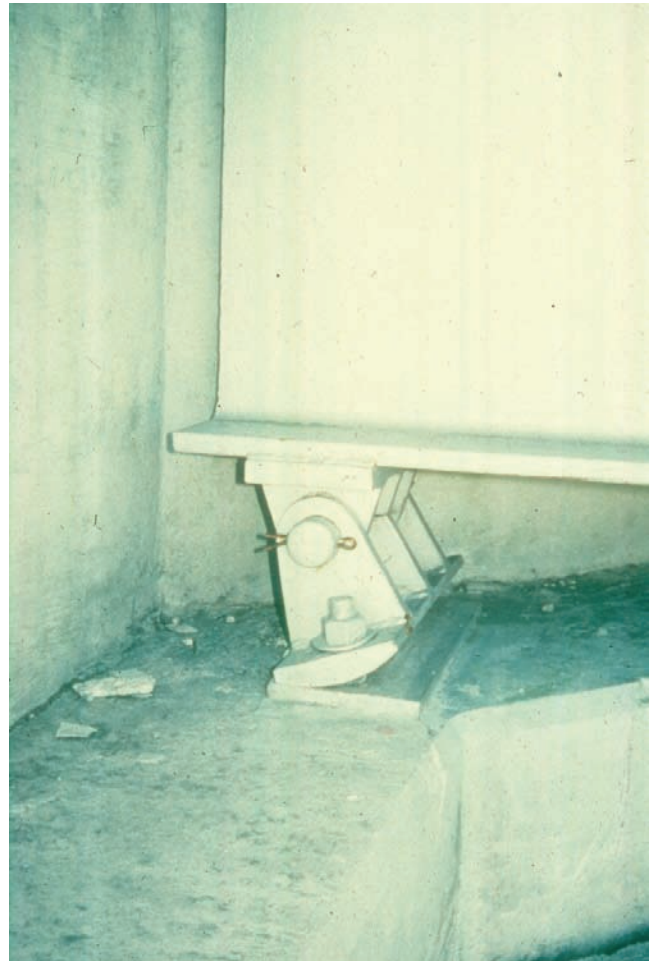
Figure 10.1.26 Excessive Rocker Bearing Displacement Indicating Possible Lateral Displacement of Abutment

- Inspect the general alignment of the abutment.
- Check the bearings for evidence of lateral displacement (see Figure 10.1.26).
- Examine the opening in the construction joint between the wingwall and the abutment.
- Investigate the joint opening between the deck and the approach slab (see Figure 10.1.27).
- Check the approach roadway for settlement.
- Check the distance between the end of the superstructure and the backwall.
- Examine for clogged drains (approach roadway, weep holes, and substructure drainage).
- Inspect for erosion, scour or undermining of the embankment material in front of the abutment (see Figure 10.1.28).

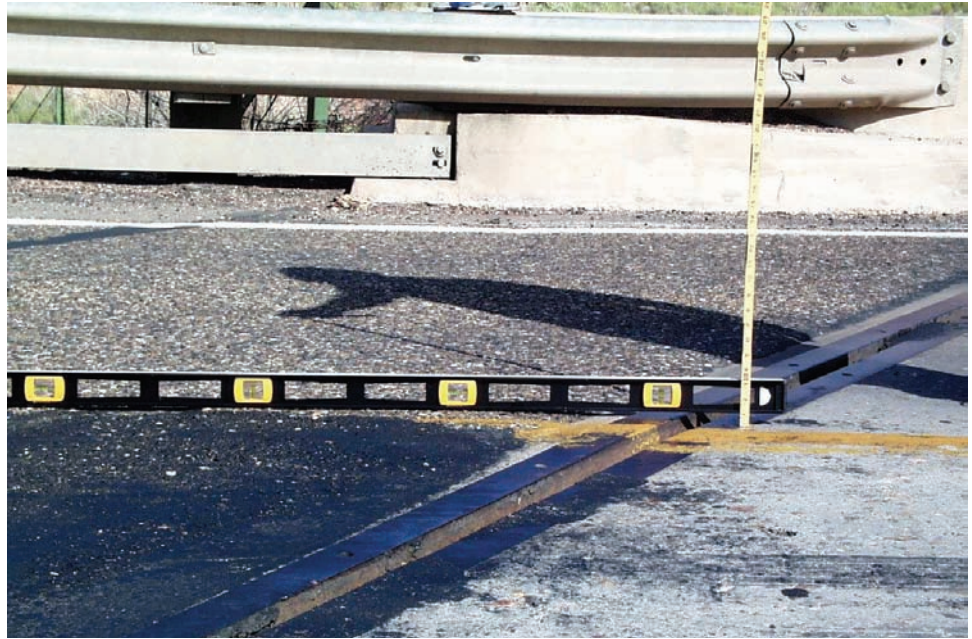
Figure 10.1.27 Depressed Approach Slab due to Rotating Abutment

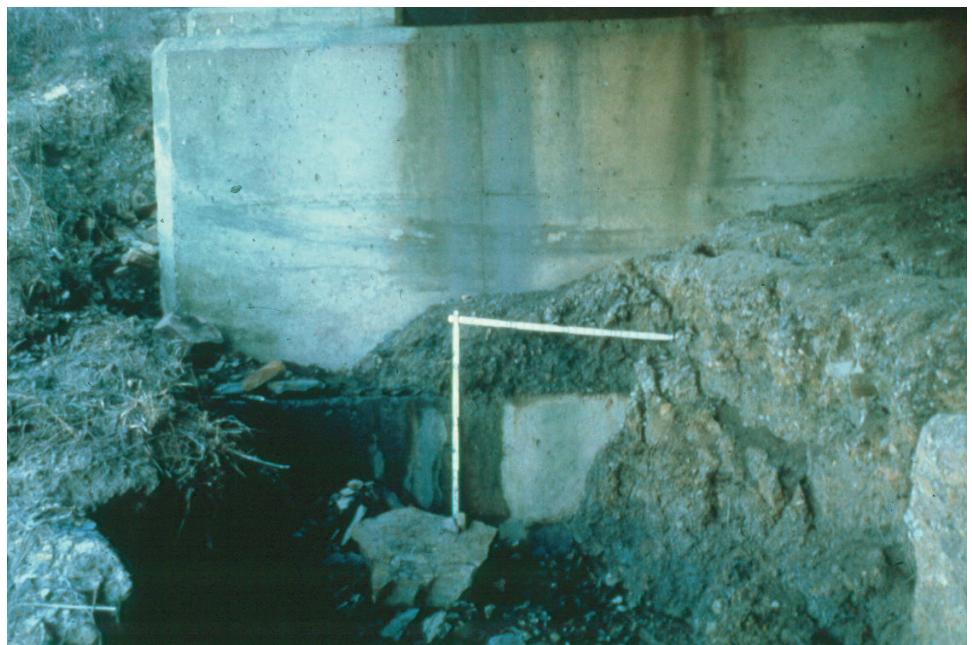
Figure 10.1.28 Erosion at Abutment Exposing Footing

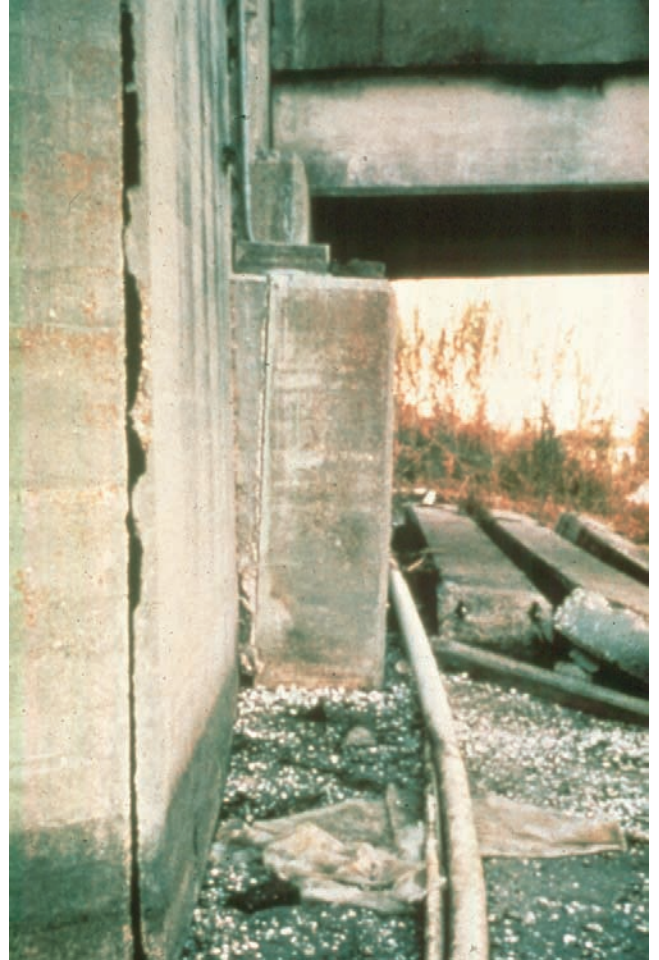
Figure 10.1.30 Rotational Movement at Abutment

- Check the vertical alignment of the abutment using a plumb bob or level; keep in mind that some abutments are constructed with a battered or sloped front face (see Figures 10.1.30 and 10.1.31).
- Examine the clearance between the beams and the backwall.
- Inspect for clogged drains or weep holes.
- Investigate for unusual cracks or spalls.
- Check for scour or undermining around the abutment footing. See Topic 11.2 for a detailed description of scour and undermining. See Topic 11.3 for a detailed description of underwater inspection.

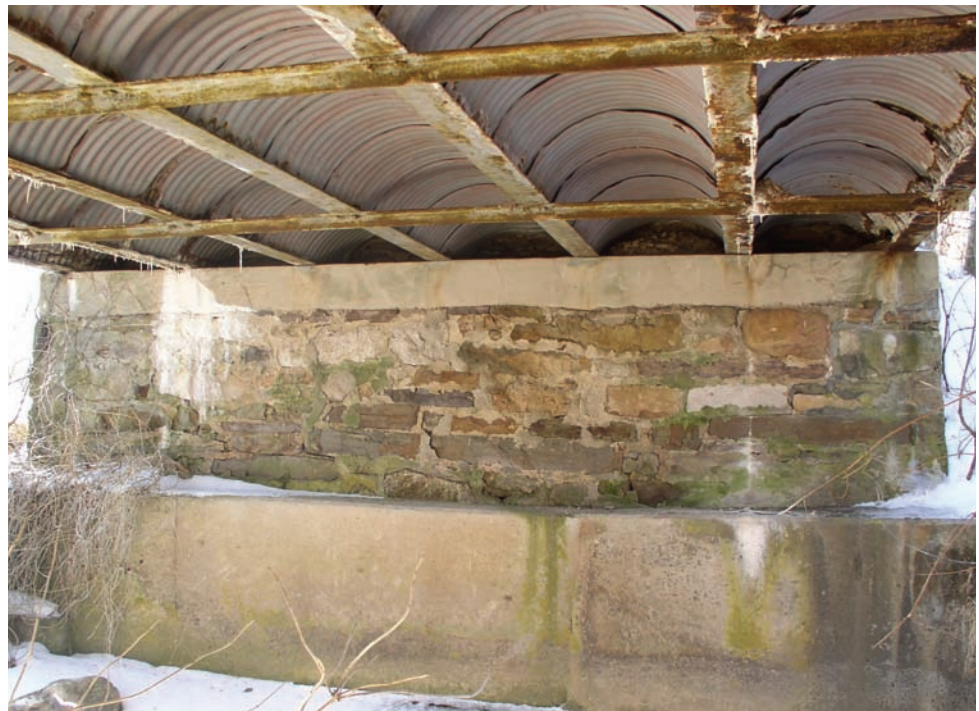
Figure 10.1.32 Cracking in Bearing Seat of Concrete and Stone Abutment

- Examine the bearing seats for cracking and spalling, particularly near the edges; this is particularly critical where concrete beams bear directly on the abutment seat (see Figure 10.1.32).
- Inspect for the presence of debris and standing water on the bearing seats.
- Investigate for deteriorated concrete in areas that are exposed to roadway drainage, particularly below the joint between the backwall and the deck (see Figure 10.1.33).
- Check the backwall for cracking and possible movement.
- Examine the construction joint between the backwall and the abutment stem.
- Inspect stone masonry for mortar cracks or loss of mortar in the joints (see Figure 10.1.34).
- Examine stone masonry for vegetation, water seepage through cracks, loose or missing stones, weathering, split, spalled, loose or missing blocks.

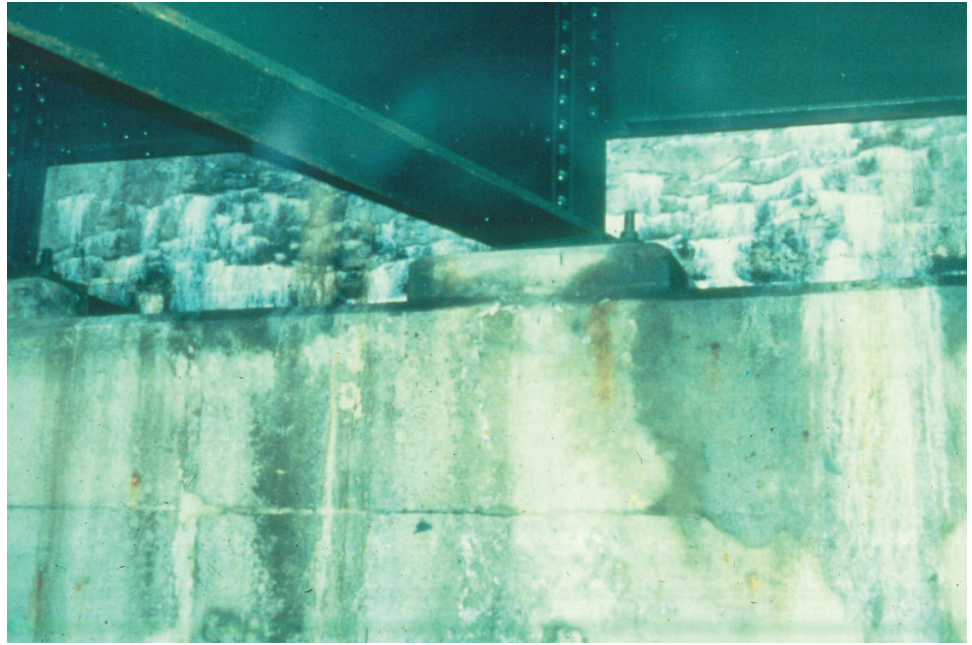
Figure 10.1.33 Deteriorated Concrete in Abutment Backwall

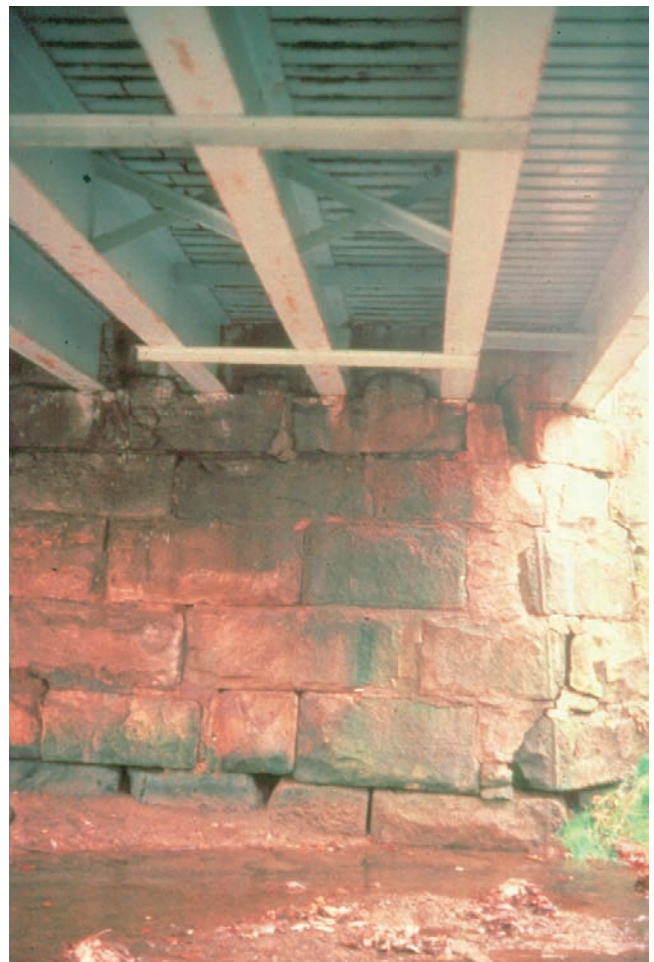
Figure 10.1.34 Deteriorated Stone Masonry Abutment

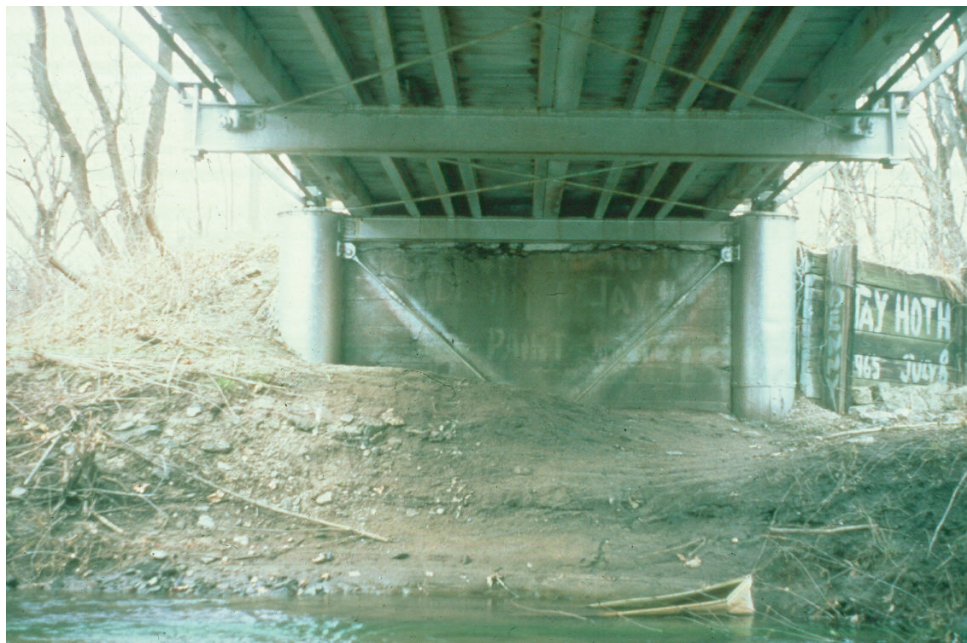
Figure 10.1.35 Steel Abutment

Although a steel abutment is uncommon (see Figure 10.1.35), the following items should be inspected if one is encountered:

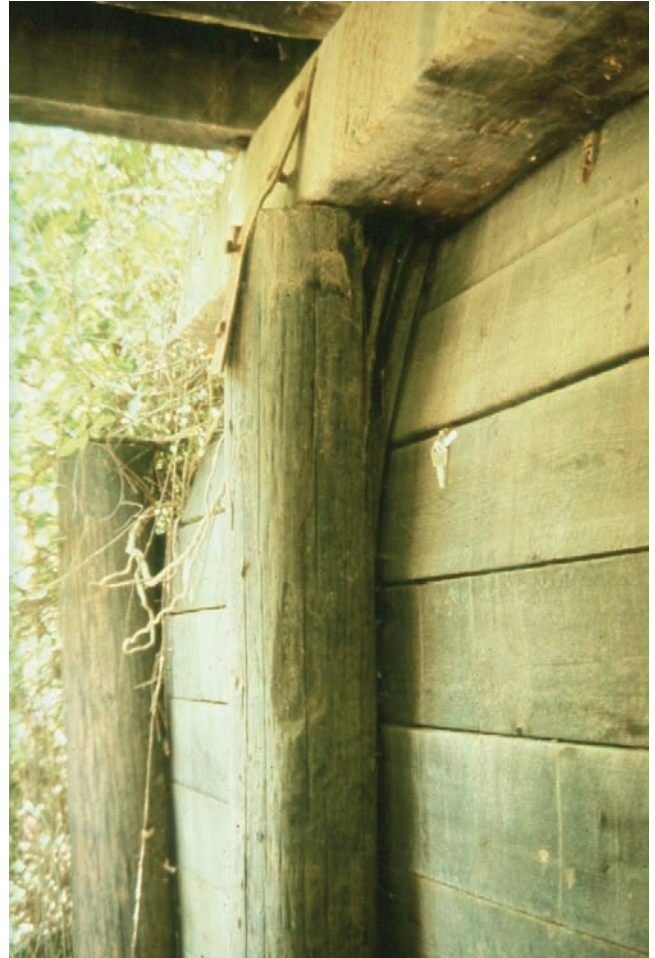
Figure 10.1.36 Local Failure in Timber Pile due to Lateral Movement of Abutment

- Examine bearing seat for accumulated dirt and debris and prolonged exposure to moisture.
- Inspect for decay, insect damage, and crushing of the cap beam.
- Investigate for local failures in lagging or piles due to lateral movement (see Figure 10.1.36).
- Check crib timbers, timber lagging, and piles for splits, cracks, decay, insect damage, fire damage, and chemical attack (see Figure 10.1.37).
- Inspect for scour around the piles (see Figure 10.1.38).
- Examine piles very closely for decay at or near the ground line or

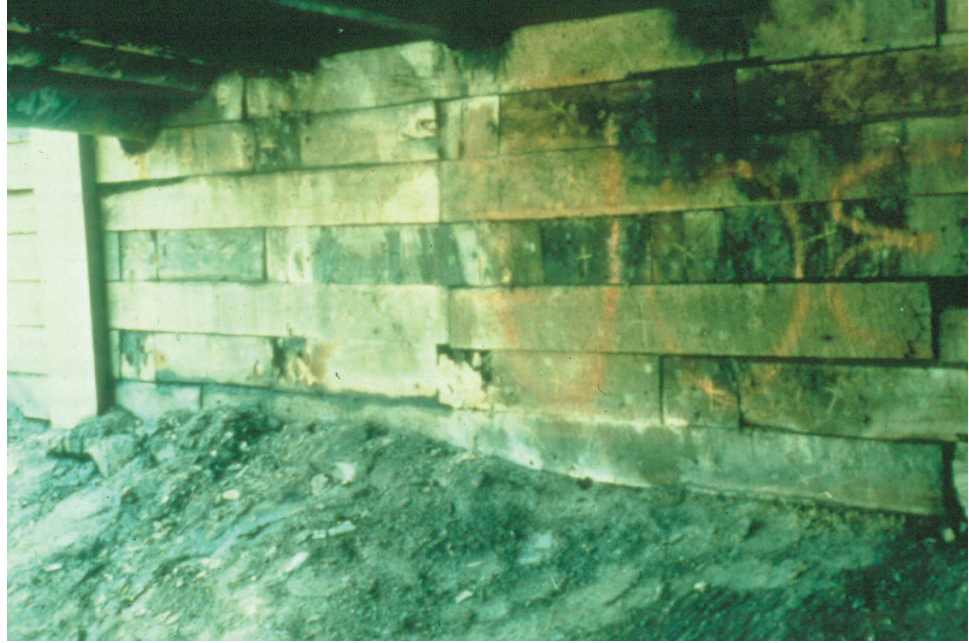
Figure 10.1.37 Decay in Lagging of Timber Crib Abutment

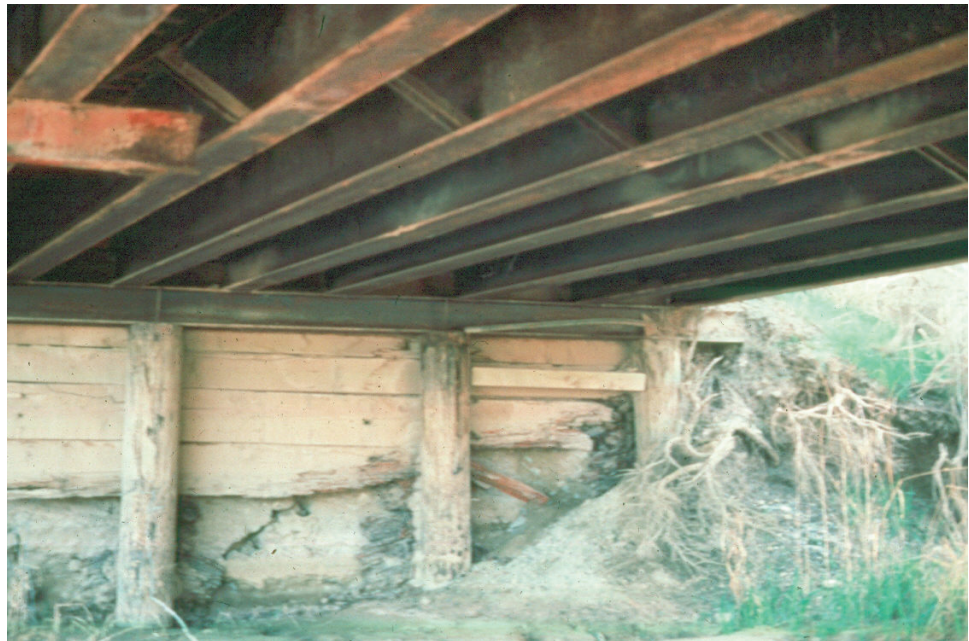
Figure 10.1.38 Decayed Lagging and Scour at a Timber Pile Bent Abutment

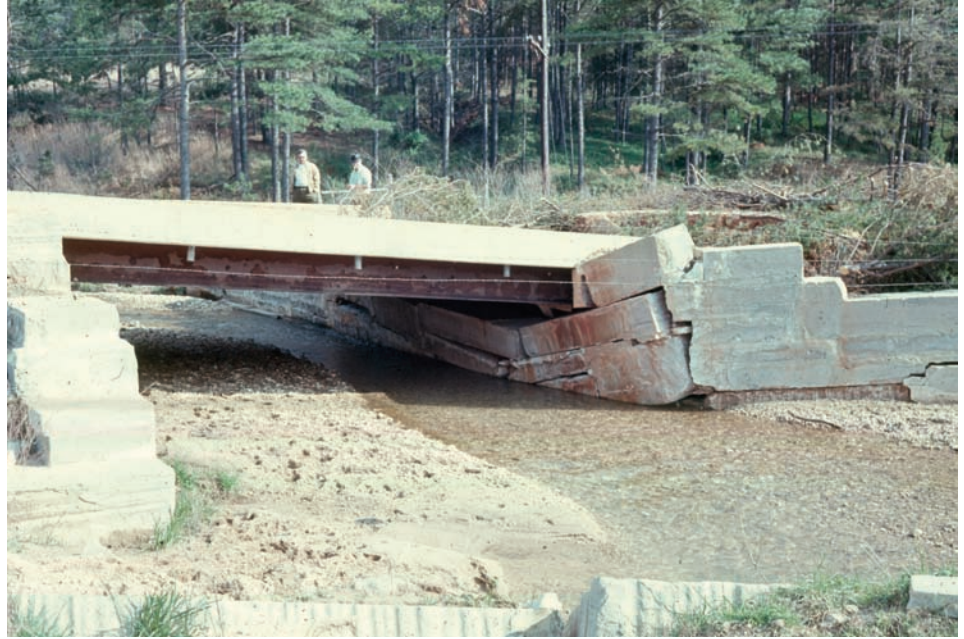
Figure 10.1.39 Abutment with Undermining due to Scour

Scour and Undermining Scour is the removal of material from a streambed as a result of the erosive action of running water (see Figure 10.1.39). Scour can cause undermining or the removal of supporting foundation material from beneath the abutments when streams or rivers flow adjacent to them. Refer to Topic 11.2 for a more detailed description of scour and undermining.

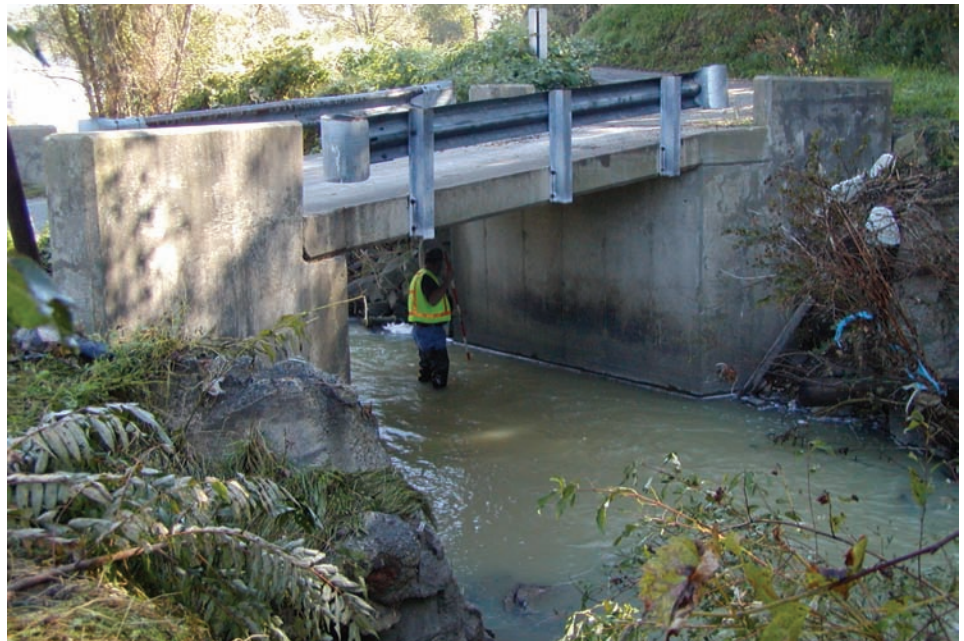
Figure 10.1.40 Inspector Checking for Scour

Inspection for scour should include probing around the abutment footing for signs of undermining (see Figure 10.1.40). Sometimes silt loosely fills in a scour hole and offers no protection or bearing capacity for the abutment footing.

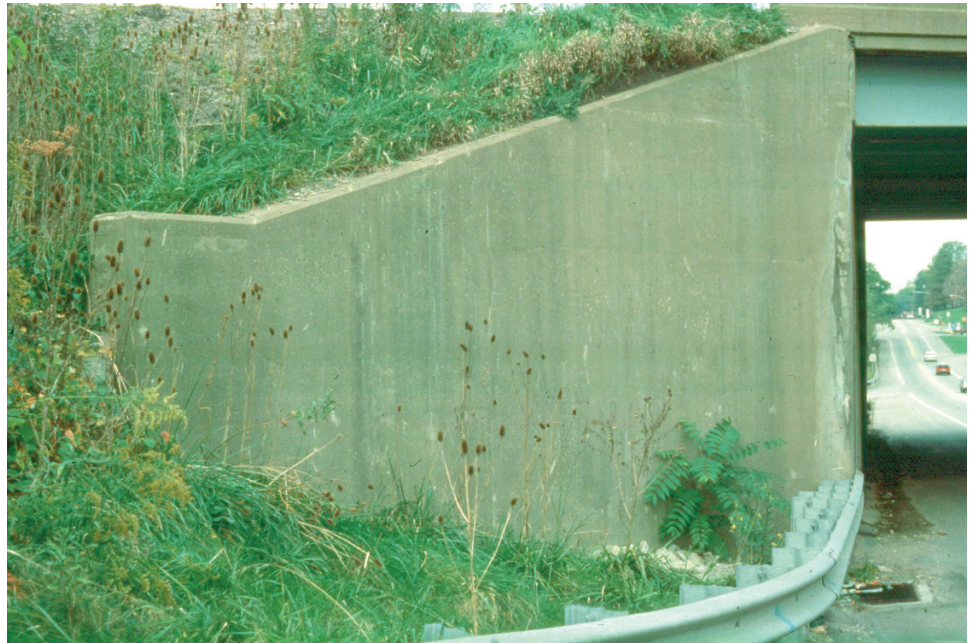
Figure 10.1.41 Typical Wingwall

Wingwalls are located on the sides of an abutment and enclose the approach fill. Wingwalls are generally considered to be retaining walls since they are designed to maintain a difference in ground surface elevations on the two sides of the wall (see Figure 10.1.41).

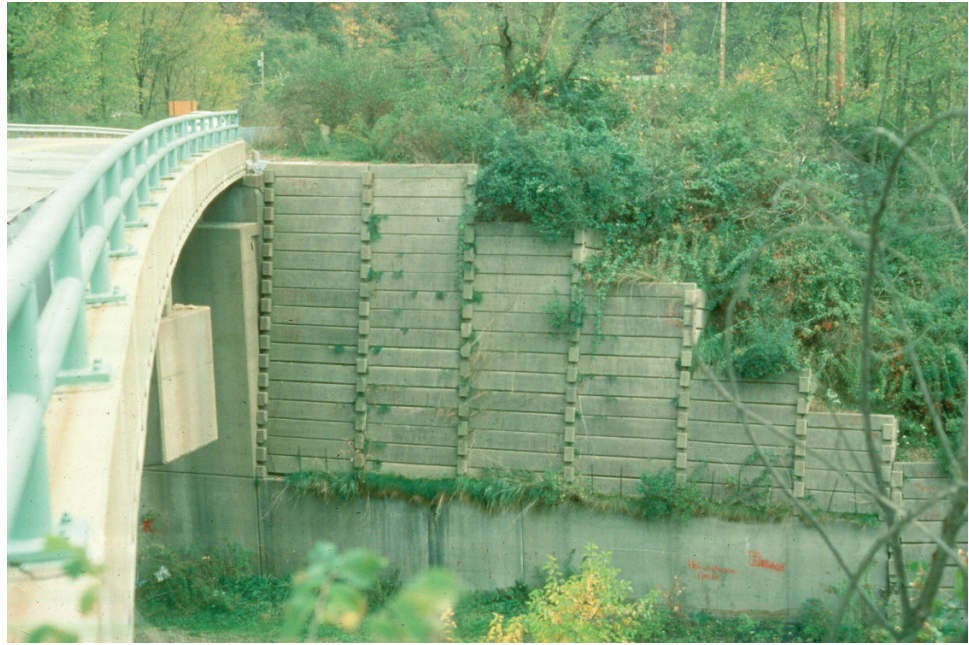
Figure 10.1.42 Straight Wingwall

- **Straight** - extensions of the abutment wall (see Figure 10.1.42)
- **Flared** - form an acute angle with the bridge roadway (see Figure 10.1.43)
- **U-wings** - parallel to the bridge roadway (see Figure 10.1.44)

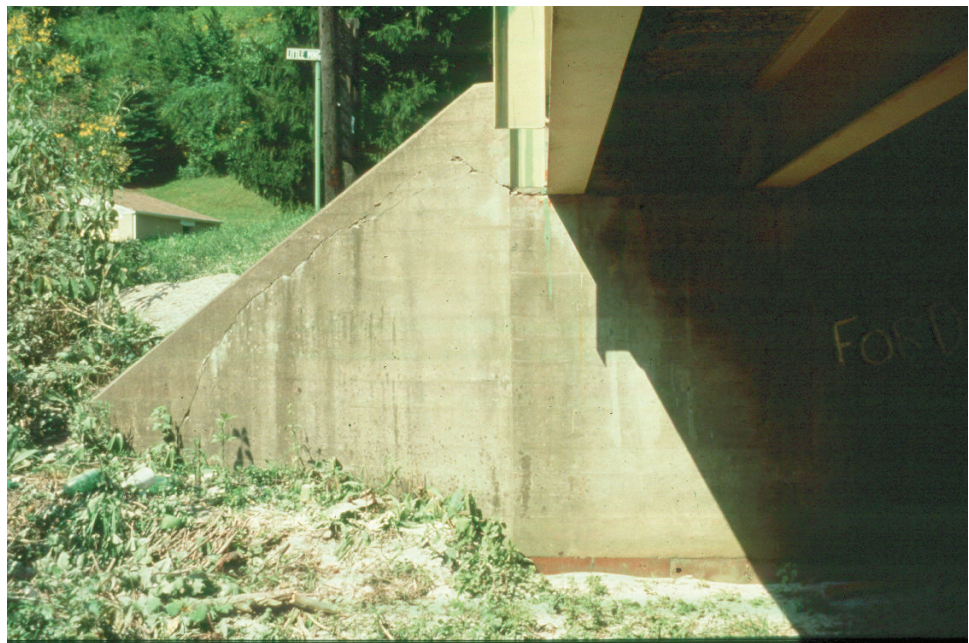
Figure 10.1.43 Flared Wingwall

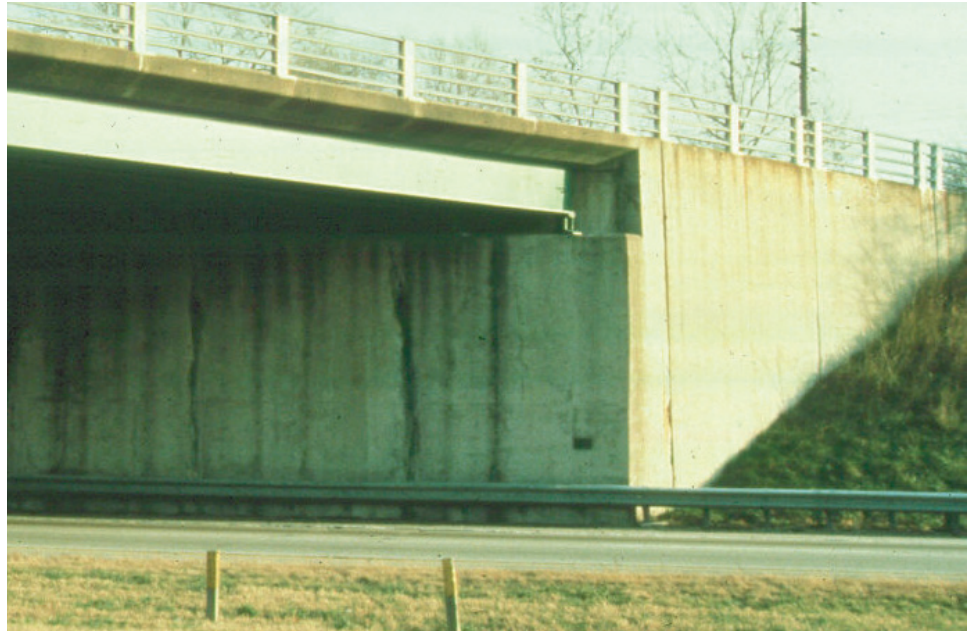
Figure 10.1.44 U-wingwall

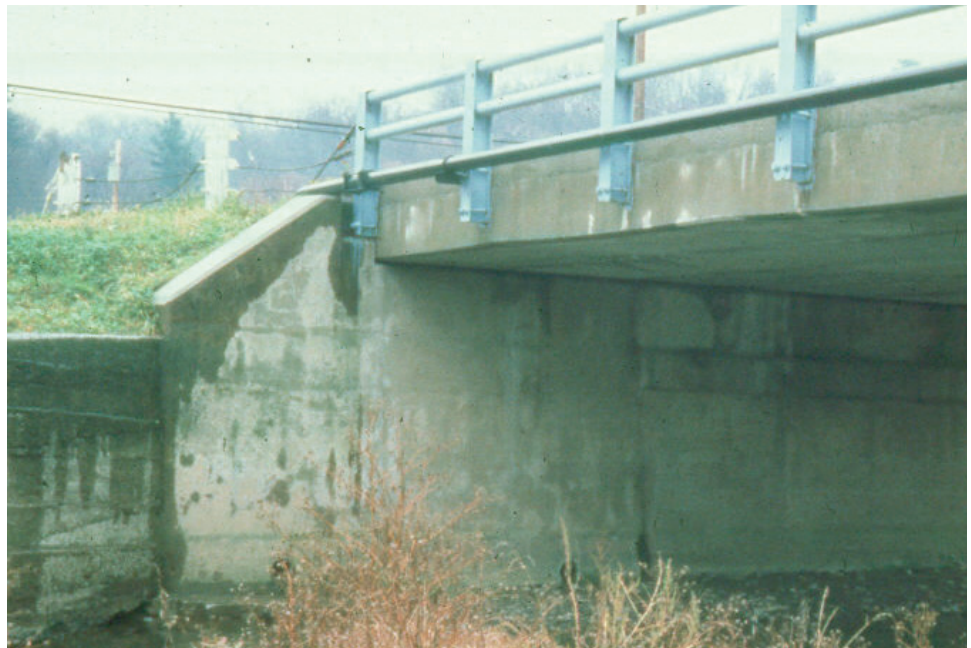
Figure 10.1.45 Integral Wingwall

- **Integral** - constructed monolithically with the abutment (see Figure 10.1.45) normally cast-in-place concrete
- **Independent** - constructed separately from the abutment; usually an expansion or mortar joint separates them from the abutment stem (see Figure 10.1.46)

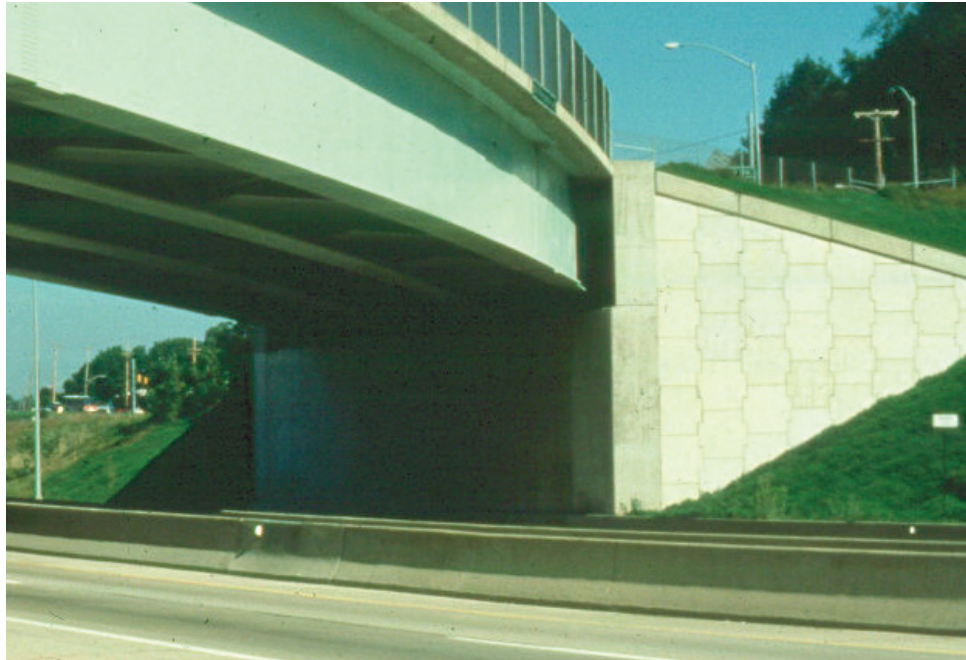
Figure 10.1.46 Independent MSE Wingwall

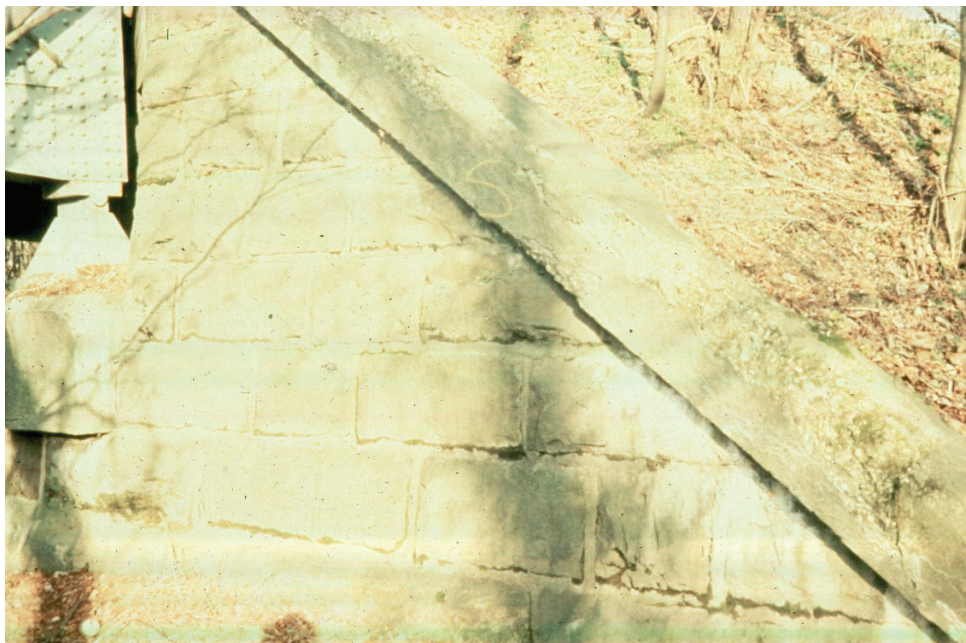
Figure 10.1.47 Masonry Wingwall

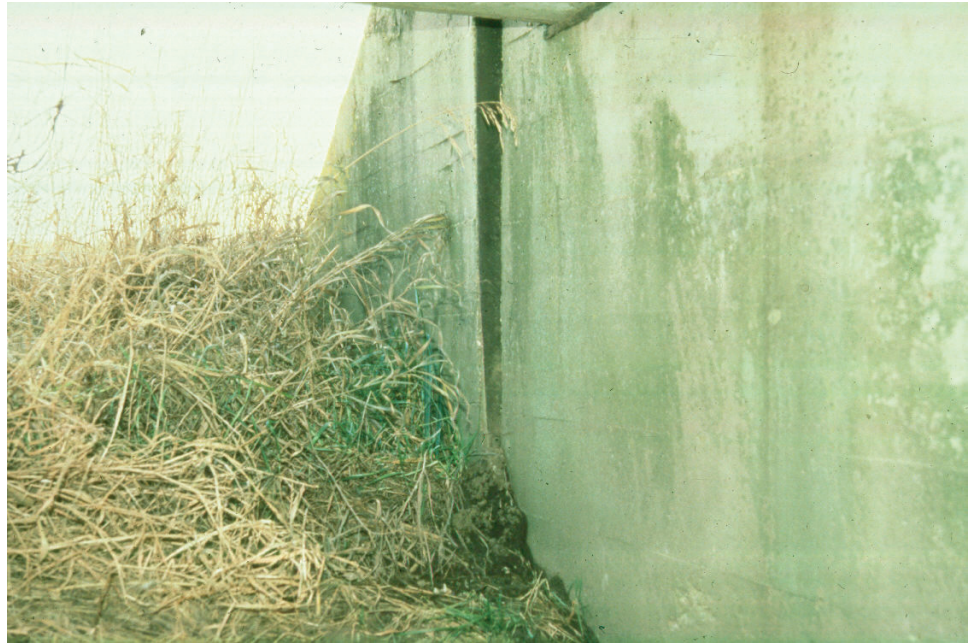
Figure 10.1.49 Rotational Movement at Concrete Wingwall

- Vertical movement
- Lateral movement
- Rotational movement (see Figure 10.1.49)
- Material defects (see Figure 10.1.50)
- Scour/undermining (see Figure 10.1.51)
- Drainage systems
- Areas subjected to high stresses
- Areas exposed to traffic

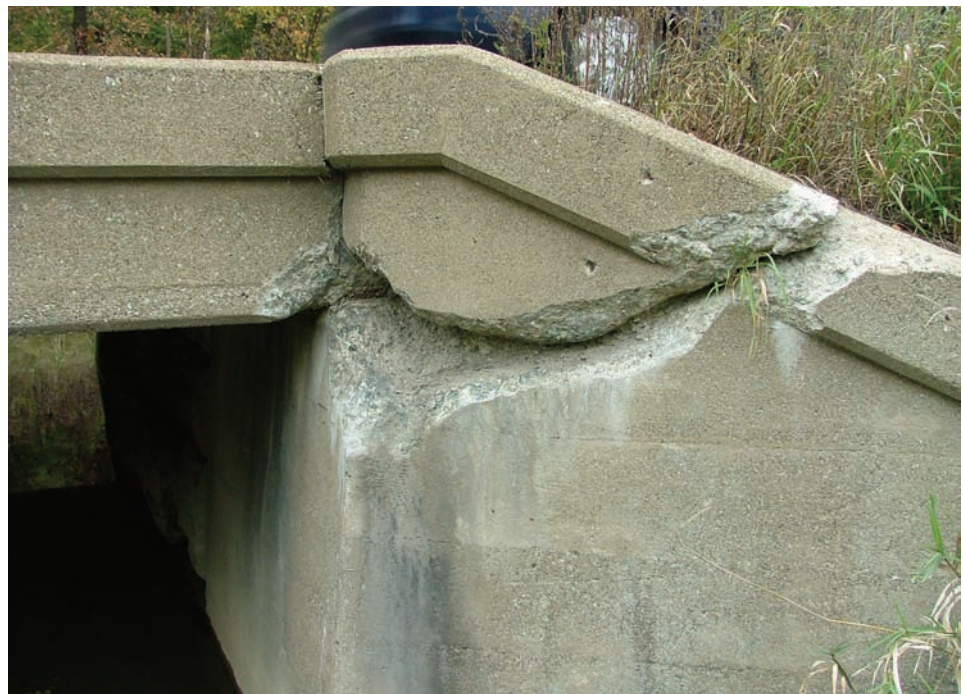
Figure 10.1.50 Deteriorated Concrete Wingwall

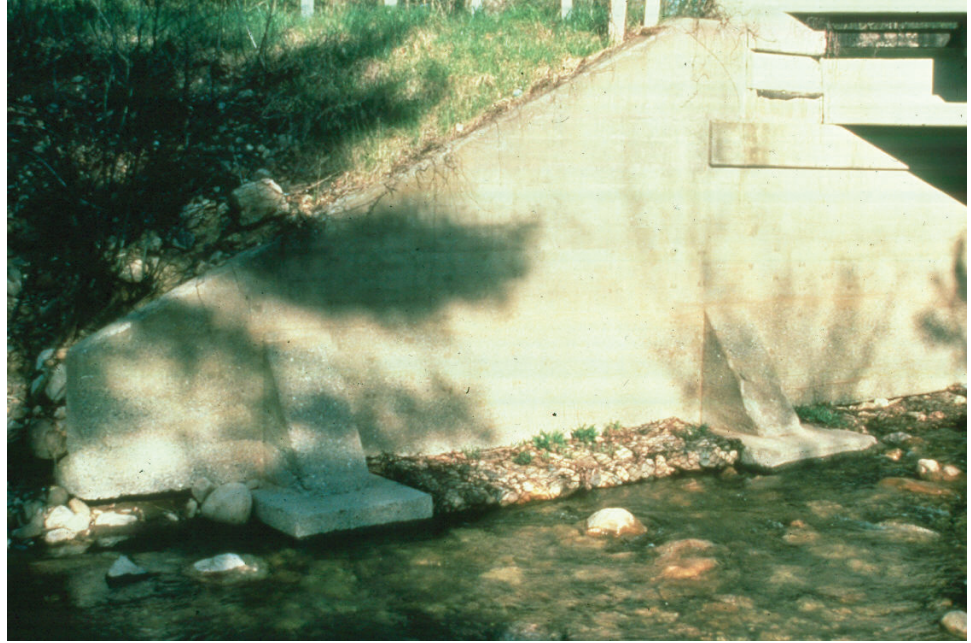
Figure 10.1.51 Scour and Possible Undermining of Concrete Wingwall

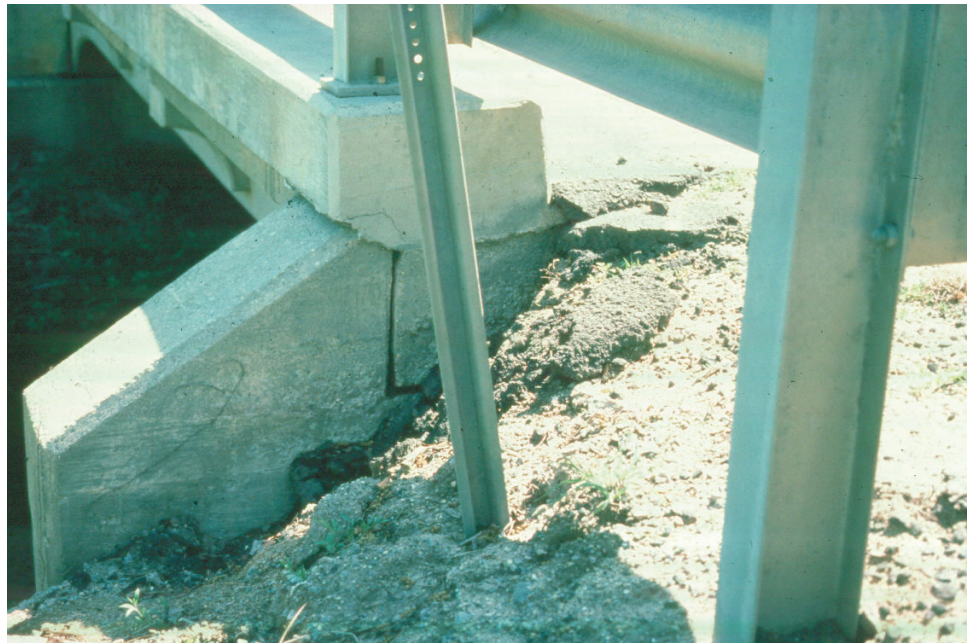
Figure 10.1.52 Roadway Shoulder Erosion Behind Wingwall

Material defects to look for include shoulder erosion, cracks, concrete deterioration, stone masonry deterioration, timber decay, and steel buckling (see Figures 10.1.52 to 10.1.55).

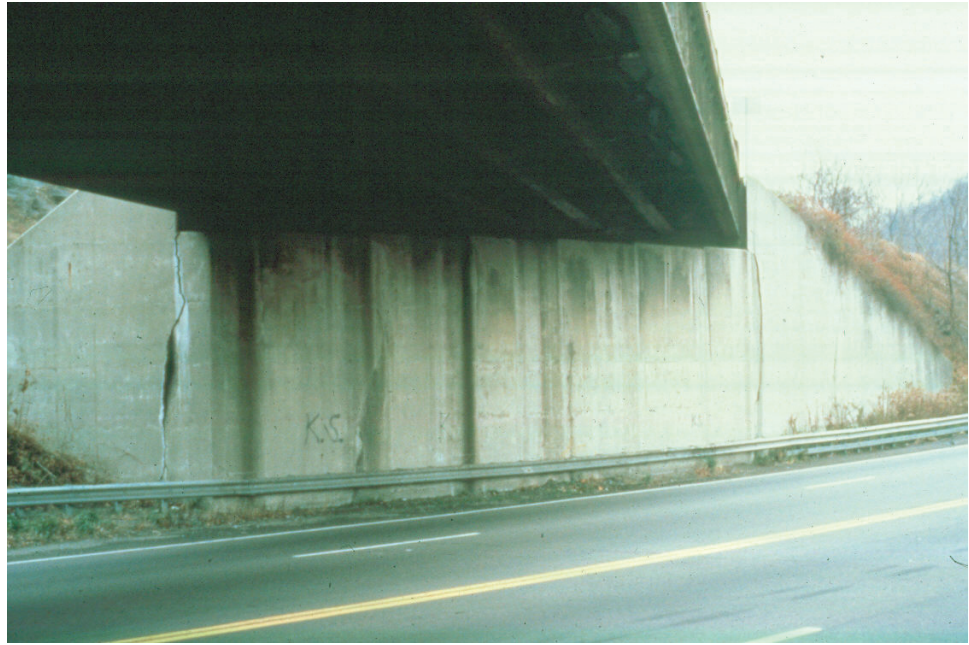
Figure 10.1.53 Settlement Cracks at Integral Concrete Wingwalls

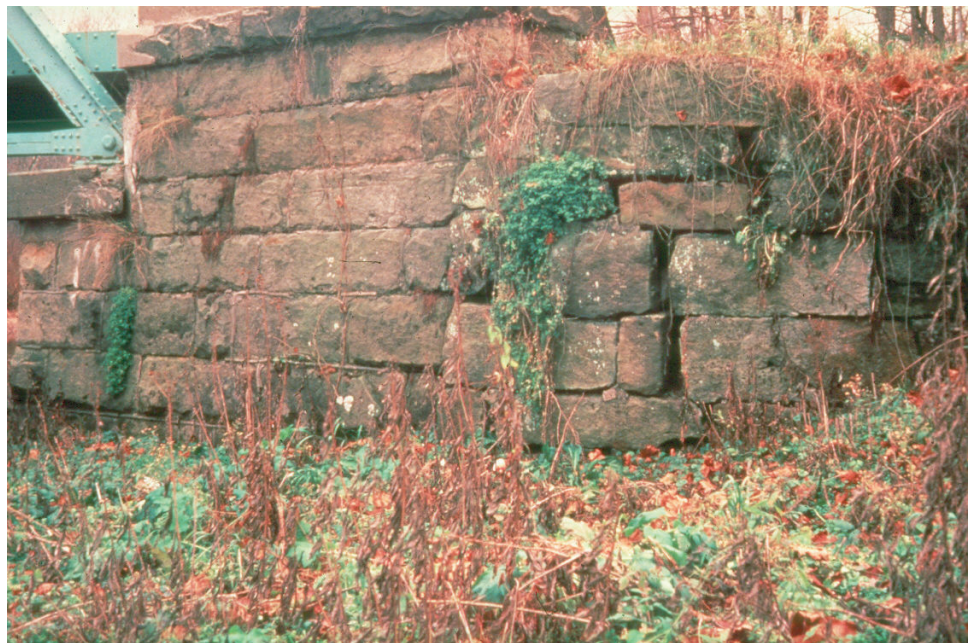
Figure 10.1.54 Deteriorating Stone Masonry Wingwall

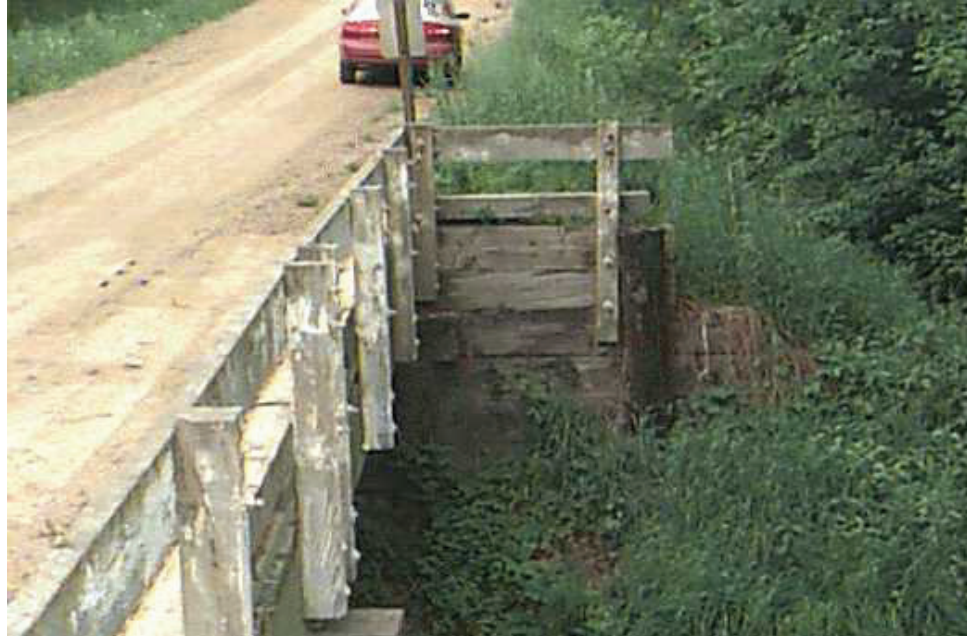
Figure 10.1.55 Timber Wingwall
