Impact of Plants on Earthen Dams

Course No: C08-014

This course was adapted from the “FEMA”, Publication No “54”, which is in the public domain.

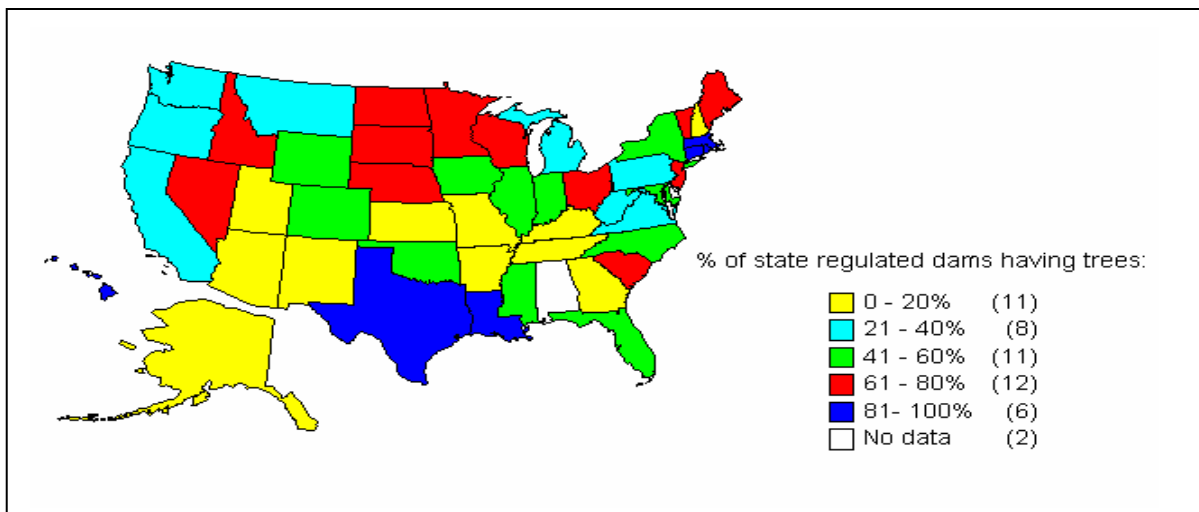
Figure 1. Estimated percentages of state-regulated dams having trees.

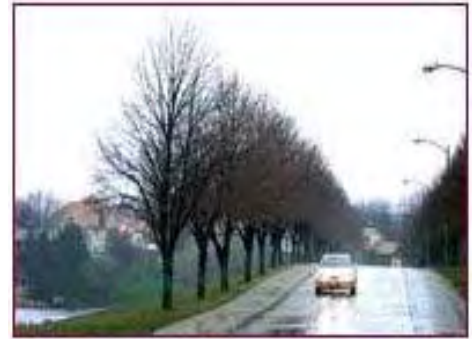
Figure 2. Example dam with problematic trees in Nebraska.

Of the 48 states that responded to the above seven questions (Alabama and Delaware did not reply), all state dam safety officials indicated that they consider trees and plant growth on dams to be a safety problem. One eastern state dam safety engineer goes so far to say that trees are probably the major problem that he has to deal with. He notes further that most of the trouble occurs because owners (and some engineers) do not recognize trees as problems and become complacent as trees slowly grow into serious problems. Both state and federal officials agree that trees have no place on dams. Federal agencies like the Corps of Engineers, U. S. Bureau of Reclamation, and TVA, which own, operate and maintain their own dams, do not allow trees to grow on their structures. Figure 2 shows a problem dam in Nebraska where tree roots have been reported to penetrate the chimney drain and thus affect the

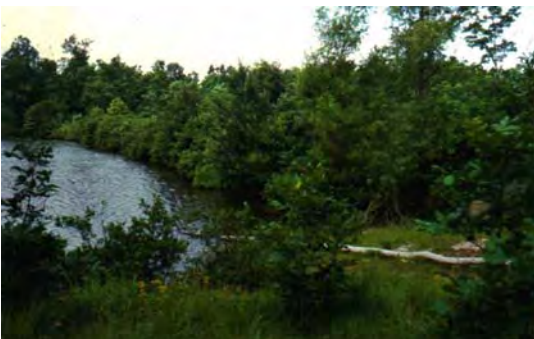
Figure 3. Example dam with inspection-hindering trees in Tennessee.

The problem most commonly noted by state officials is that trees, woody vegetation, briars, and vines interfere with effective safety inspections. Figure 3 illustrates this problem for a dam located in Tennessee.

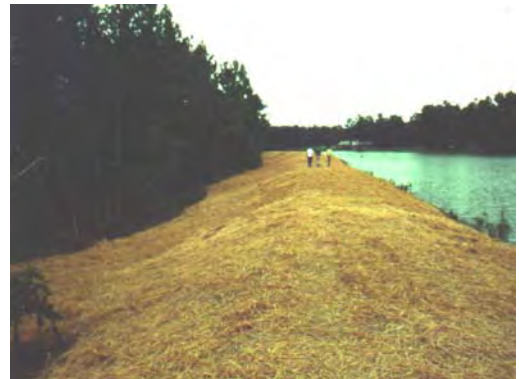
Figure 7. Completed remediation job after removing stumps, seeding, fertilizing & mulching.

Figures 6 and 7 illustrate extensive efforts necessary to restore a heavily wooded earthen dam to a desirable vegetated and maintained condition.

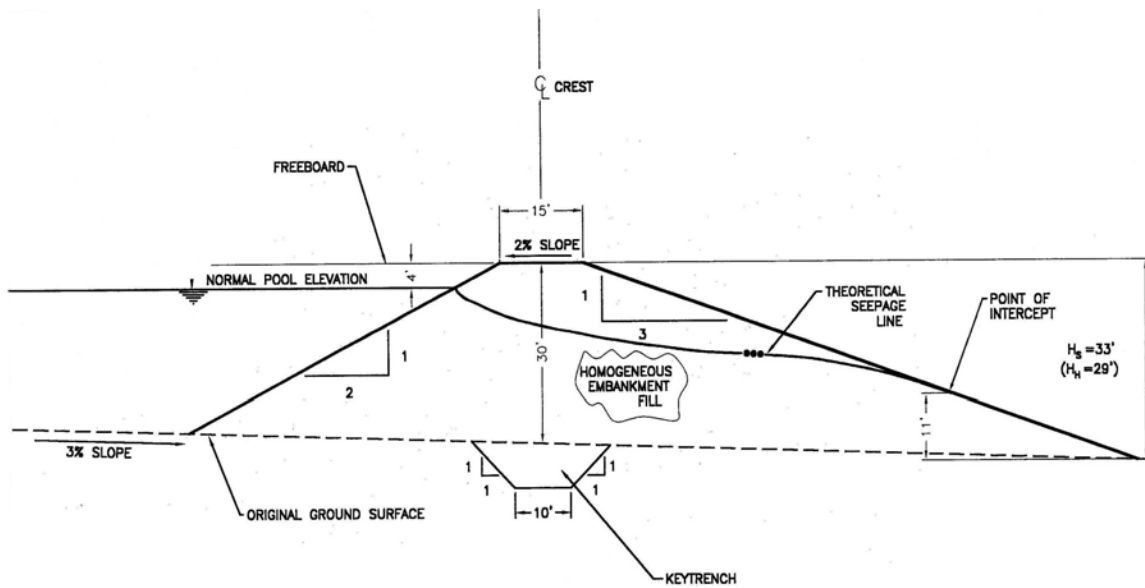
**TYPICAL EMBANKMENT SECTION
WITHOUT TOE DRAIN SYSTEM**

The configuration of the example earthen dam consists of an upstream slope of 2:1 (horizontal to vertical), a crest width of fifteen feet, and a 3:1 (horizontal to vertical) downstream slope. The dam has a freeboard of four feet making the hydraulic height of the dam about 29 feet. The dam is founded on relatively impervious (compared to the embankment fill soil) material with a down gradient slope of about three percent. The example earthen dam section has a key trench directly below the centerline of the dam crest that has a bottom width of ten feet and side slopes of 1:1 (horizontal to vertical). The dam crest has a two-percent slope toward the impounded lake and the upstream slope has no protection system against tree and woody vegetation growth or wave erosion. The embankment of the example earthen dam is assumed to be homogeneous. Figure 1 is a representation of the example earthen dam configuration with the theoretical seepage line intercepting the downstream slope at about one-third the hydraulic height of the dam.

Rule-of-Thumb: *The phreatic surface intercepts the downstream slope of a homogeneous earthen dam at a vertical distance of about one-third the hydraulic height above the toe of the downstream slope, provided there is no internal drainage system in the dam embankment.*

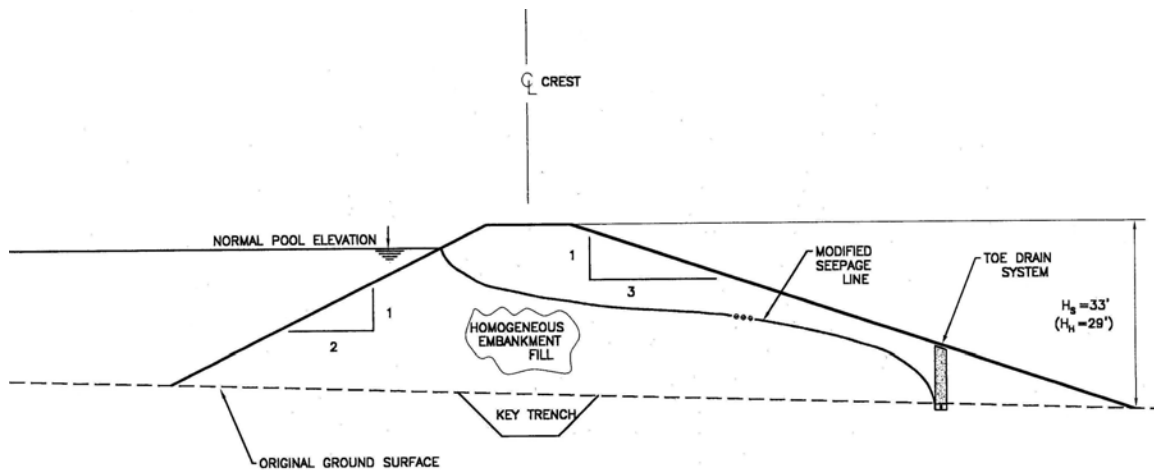
TYPICAL EMBANKMENT SECTION
WITH TOE DRAIN SYSTEM

Figure 2 illustrates the example earthen dam with an embankment subdrain system located within the downstream embankment slope. The subdrain or embankment drain system is located at about the point of interception of the seepage line with the downstream slope if there was no embankment toe drain system within the downstream slope. As a result of the presence of the embankment subdrain system, the seepage line through the dam embankment has been modified (lowered) from the location of the theoretical seepage line for a homogeneous earthen dam embankment. The seepage line within an earthen dam is often mistakenly considered to have a permanent location.

However, the location of the seepage line is continually changing as a result of many influential factors. Fluctuations in the pool elevation, seasonal and long-term climatological conditions, and the growth of trees and woody vegetation in close proximity to the seepage line are some of the factors that influence changes in the location of the phreatic surface within an earthen dam embankment.

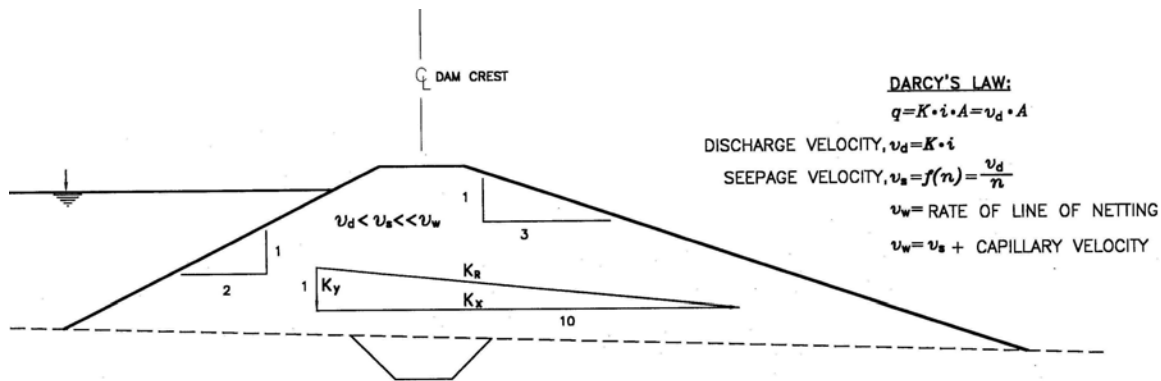
TYPICAL EMBANKMENT SECTION
WITH CONSIDERATION OF K AND v_s .

Figure 4 is an illustration of the example earthen dam with relationships between various soil water flow velocities and permeabilities. First, consider the relationship between the vertical and horizontal permeability of a compacted homogeneous embankment soil.

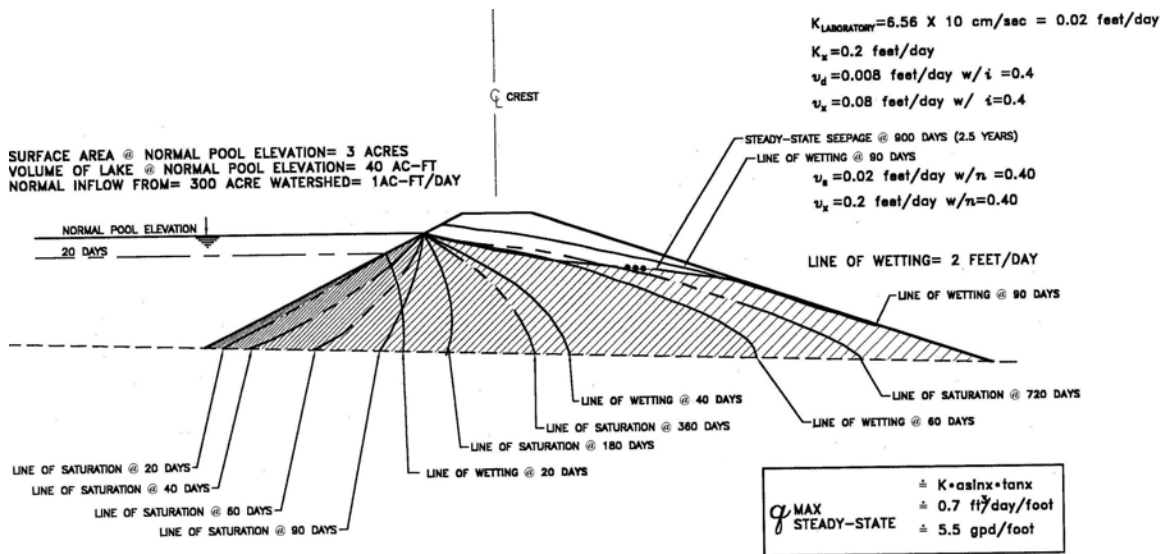
Figure 5

**PROGRESSION OF EMBANKMENT WETTING & SATURATION
WITHOUT CONSIDERATION OF VEGETATION**

Applying this factor to the previous comparison between seepage velocity and discharge velocity, one finds that the wetting velocity is about 25 times greater than the discharge velocity. Based upon the foregoing discussion of earthen dam embankment wetting, saturation, and steady-state seepage velocities, consider the illustration in Figure 5. This figure illustrates embankment wetting, saturation, and steady-state seepage during the early years of the design life of an earthen dam. Assume that laboratory testing indicates that embankment soils of the example dam embankment have a permeability or hydraulic conductivity value of 0.02 foot per day. The discharge velocity would be about 0.008 foot per day with a hydraulic gradient of about 0.4 resulting in a horizontal discharge velocity of about 0.08 foot per day. The associated seepage velocity would be about 0.02 foot per day with a soil porosity of about 40 percent and the horizontal seepage velocity would be about 0.2 foot per day. The velocity of the line of wetting or the wetting velocity would be about 2.0 feet per day.

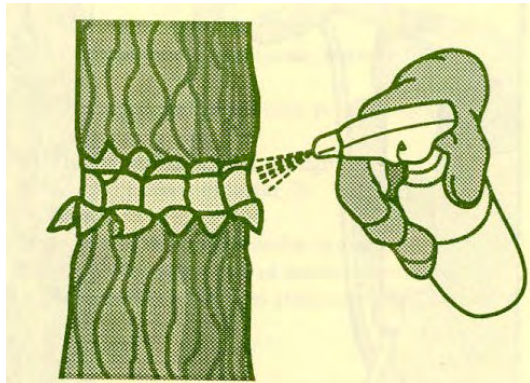
Figure 5a. Frill cut application.

Vanquish
Weedone
Chopper
Pathway
Tordon
Arsenol

Some of these techniques and herbicides used are illustrated in Figures 5a – 5f. The U. S. Department of Agriculture (SCS, now NRCS) published a useful methods, treatment points, and time of treatment guidelines for controlling trees and brush on dams, including some of the applications listed in Figure 4 (USDA, 1988). Table 4 summarizes the USDA recommendations. With the exception of Krenite, which is applied to the foliage, 2,4-D is the only approved herbicide for poisoning trees on dams. 2, 4-D is manufactured by several companies and is sold under several trade names. In all cases, the user is cautioned again to follow the manufacturer’s instructions and should consider the manufacturer’s label instructions to supercede recommended instructions in the USDA table.

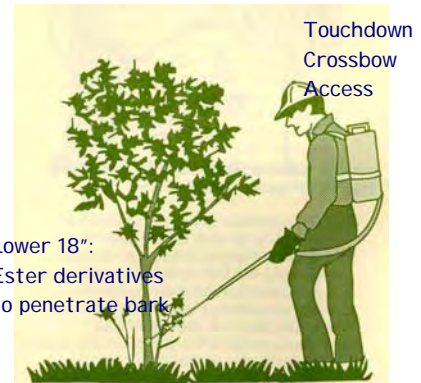
Figure 5b. Basal bark spraying.

Touchdown
Crossbow
Access

Lower 18":
Ester derivatives
to penetrate bark

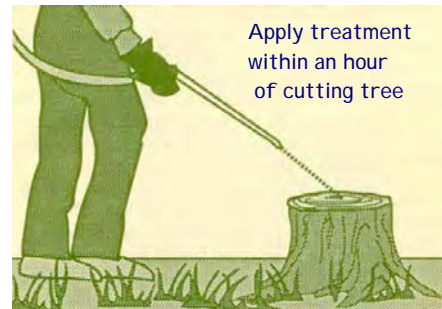
Figure 5d. Cut-stump application.

Apply treatment
within an hour
of cutting tree

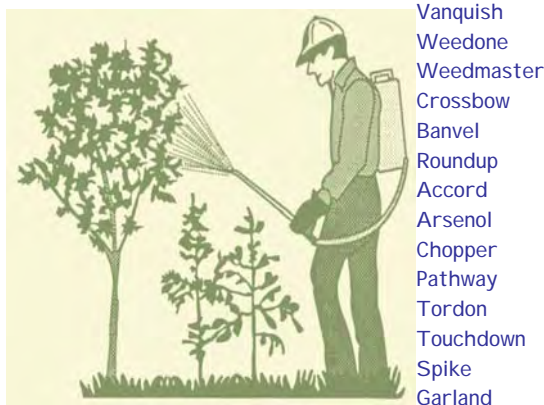
Figure 5e. Backpack foliar application on dam.

Vanquish
Weedone
Weedmaster
Crossbow
Banvel
Roundup
Accord
Arsenol
Chopper
Pathway
Tordon
Touchdown
Spike
Garland

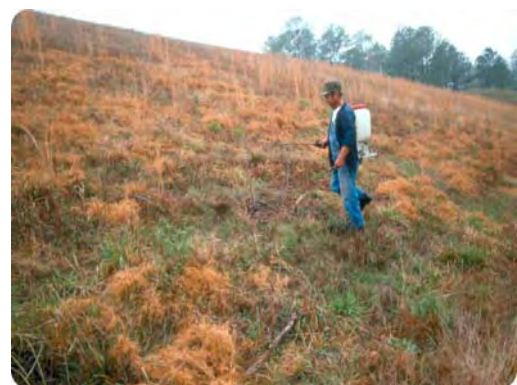
Figure 5. Applications and techniques for different herbicidal deliveries to trees and brush, with example commercially-available herbicides listed.

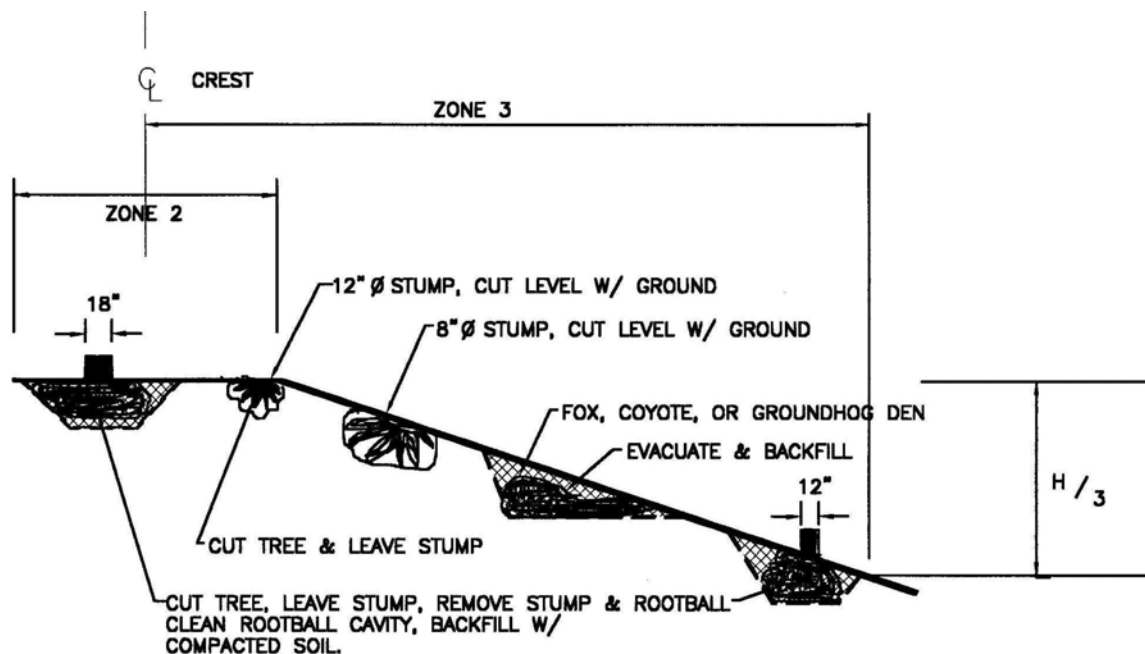
ZONE 2 & 3 REPAIR PROCEDURES

Potential problems associated with tree and woody vegetation growth on earthen dams in identified Zones 2 and 3 are illustrated with dam remediation design procedures in Figure 5. Potential problems illustrated for Zone 2 include the growth of mature trees having stump diameters greater than twelve inches. Mature trees having stump diameters greater than eight inches are illustrated at various locations throughout Zone 3 and in the overlap area of Zones 2 and 3.

Two dam remediation design procedures are illustrated in Figure 5 for removal of trees of various sizes. This illustration implies that trees located in the overlap area of Zones 2 and 3 having stump diameters less than about twelve inches could be cut flush with the ground and left in place for future treatment of the decayed stump and rootball system. However, removal of all stumps, rootballs and root systems is always the better and more conservative approach to removal of mature trees. Subsequent to cutting of trees having stump diameter less than about twelve inches in the overlap area of Zones 2 and 3, the surface of the stump can be treated with a protective coating similar to polyurethane that will prolong the decaying process. Conversely, the referenced illustration indicates that any trees in Zone 2 upstream of the overlap area of Zones 2 and 3 having stump diameters of twelve inches or greater should be treated by total removal of the tree, stump, rootball, and root system. The suggested dam remediation design and construction procedure suggested for complete removal of trees, stumps, rootballs, and root systems in Zones 2 and 3 consists of the following activities:

Figure 5 further illustrates that trees located in Zone 3 that have stump diameters greater than about eight inches should be treated by total removal. The removal procedure should be the same as previously described for larger trees in Zone 2. Trees having stump diameter of less than about eight inches could be cut flush with the ground and treated with a waterproofing sealant similar to polyurethane to prolong the stump and rootball decaying process. Again, complete removal of the stumps, rootballs, and root systems of all mature trees is a better and more conservative method of remediation.

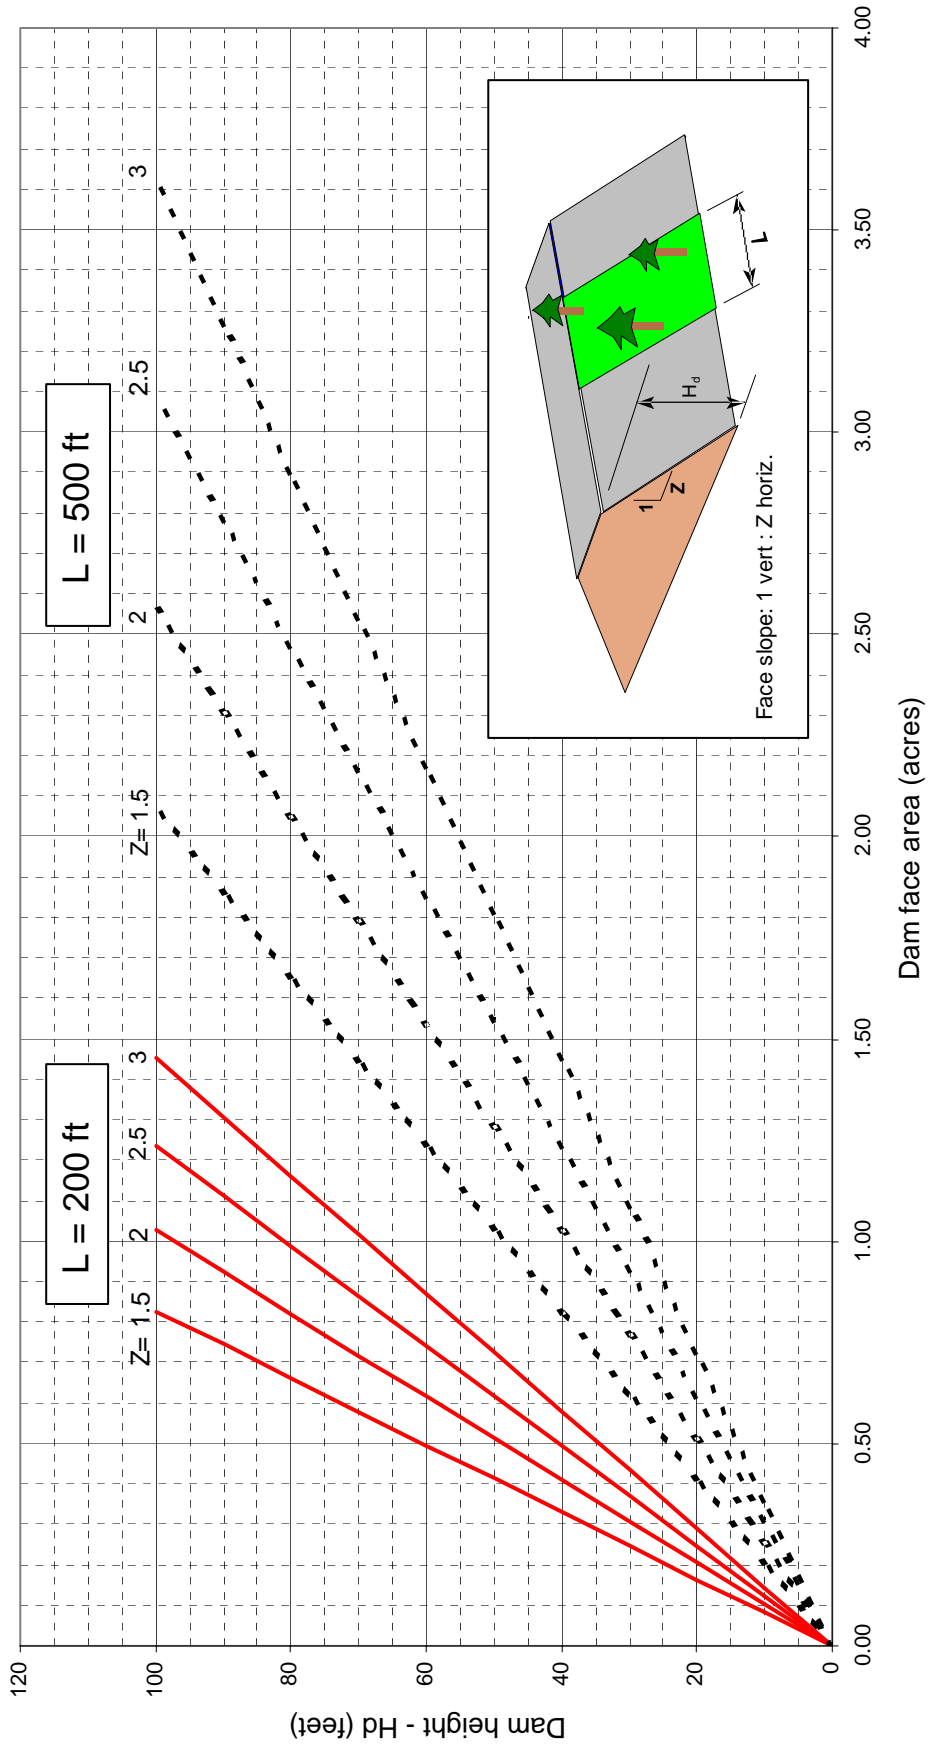
Chart 1. Dam face area for different geometries

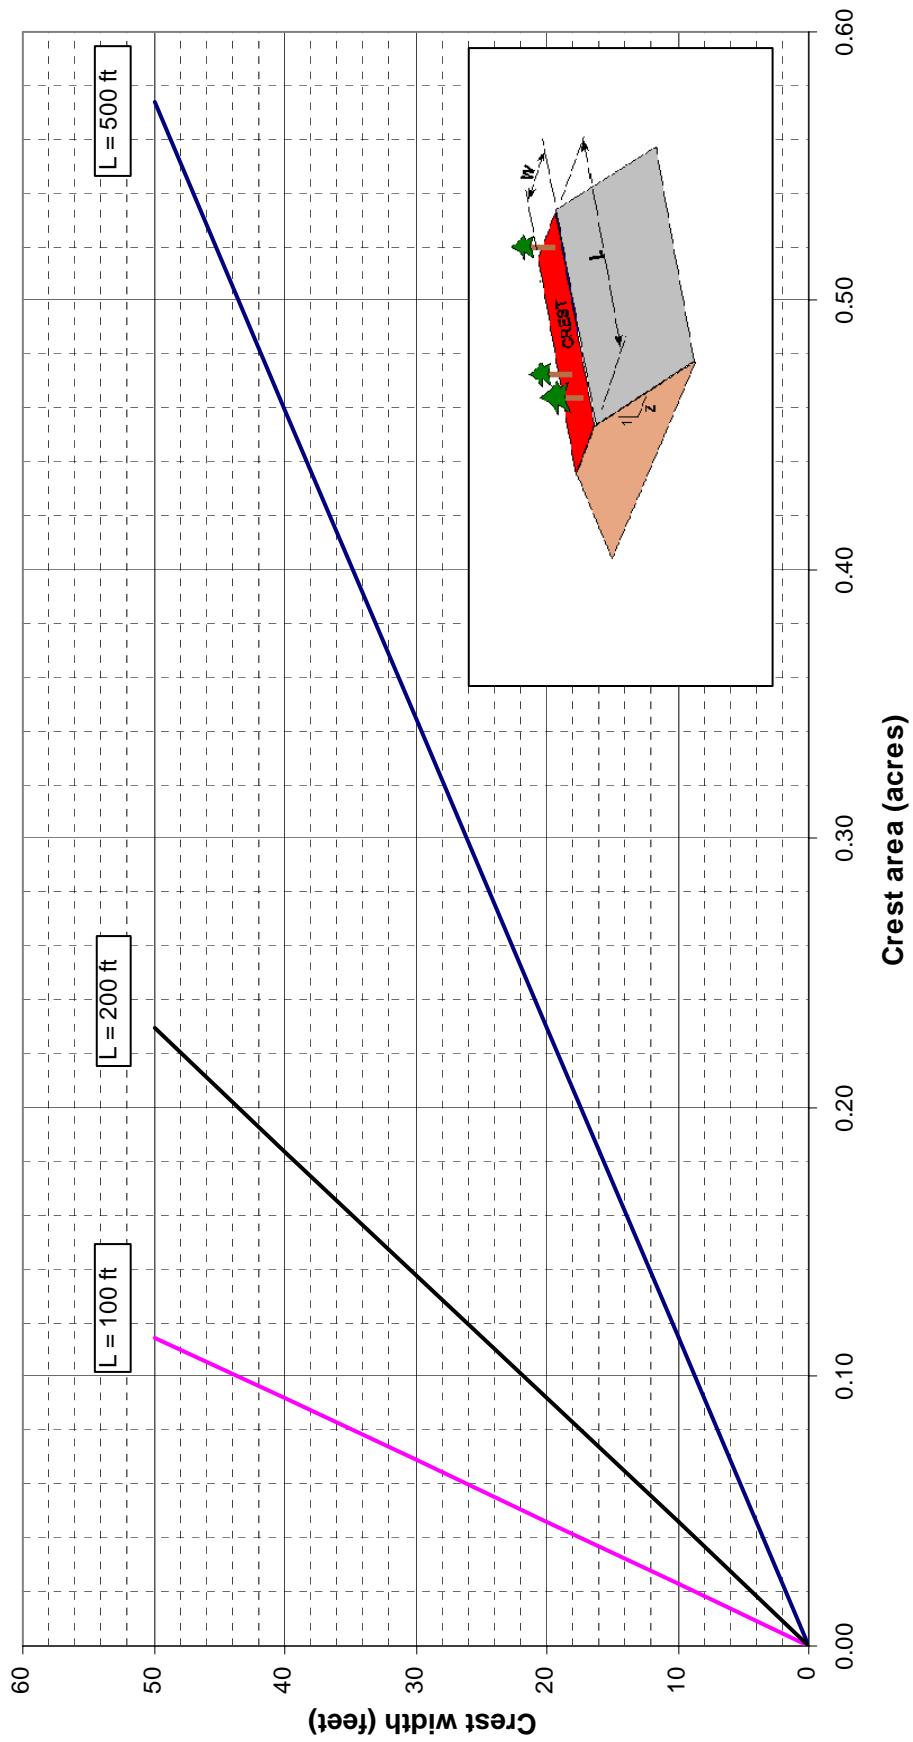
Chart 2. Dam crest area by width and length

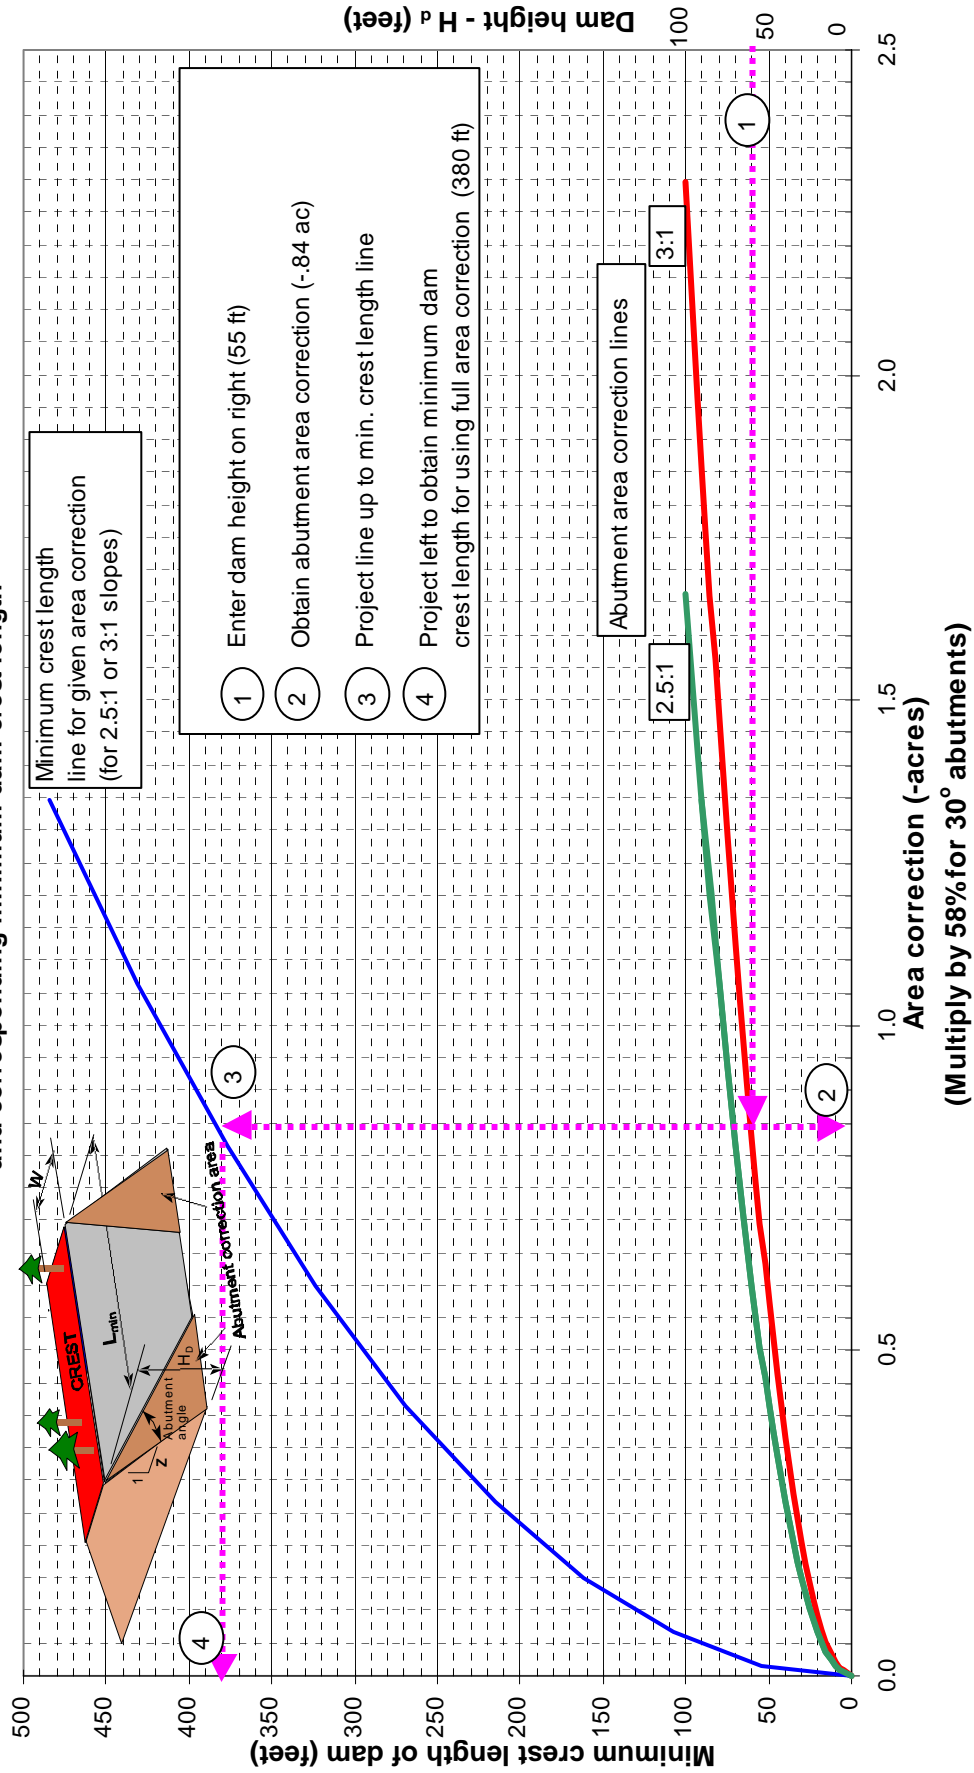
Chart 3. Abutment area corrections vs. dam height for 2.5H:1V & 3H:1V side slopes, with 45° abutment angle and corresponding minimum dam crest length
