Impact of Plants on Earthen Dams

Technical Manual for Dam Owners

Impacts of Plants on Earthen Dams

FEMA 534 / September 2005

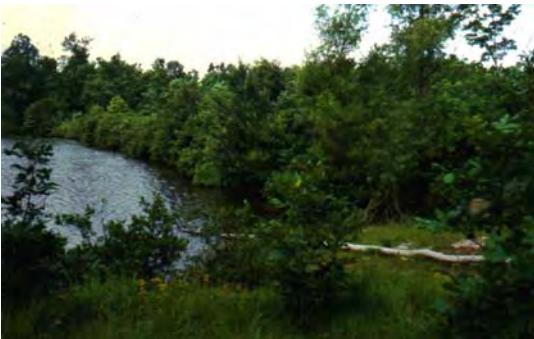
Figure 3. Example dam with inspection-hindering trees in Tennessee.

The problem most commonly noted by state officials is that trees, woody vegetation, briars, and vines interfere with effective safety inspections. Figure 3 illustrates this problem for a dam located in Tennessee.

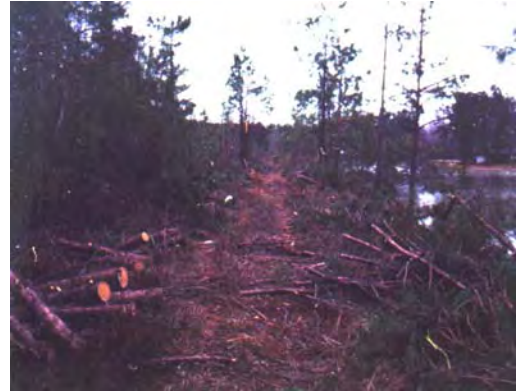
Figure 6. Trees cut prior to removing stumps and roots from dam.

Figures 6 and 7 illustrate extensive efforts necessary to restore a heavily wooded earthen dam to a desirable vegetated and maintained condition.

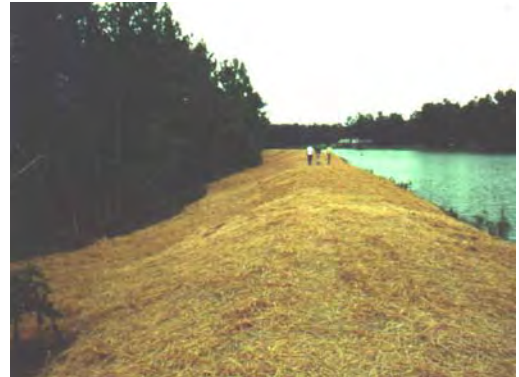
Figure 7. Completed remediation job after removing stumps, seeding, fertilizing & mulching.

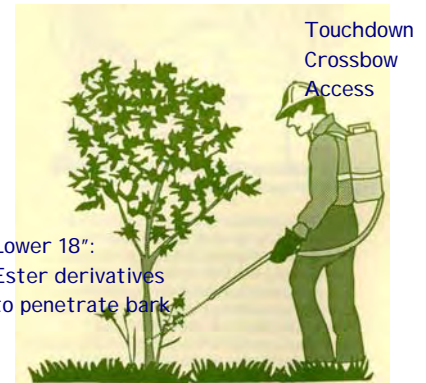
Touchdown
Crossbow
Access

Lower 18":
Ester derivatives
to penetrate bark

Figure 5b. Basal bark spraying.

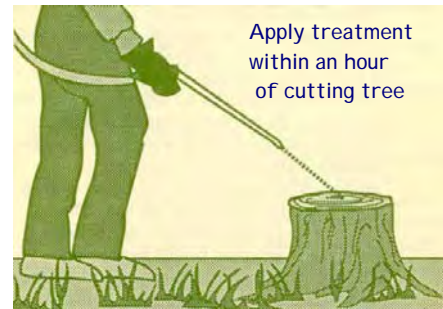
Apply treatment
within an hour
of cutting tree

Figure 5d. Cut-stump application.

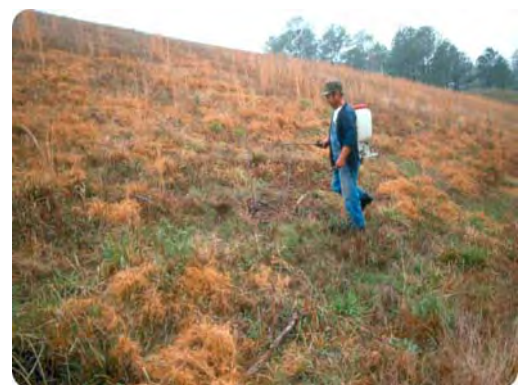
Figure 5. Applications and techniques for different herbicidal deliveries to trees and brush, with example commercially-available herbicides listed.

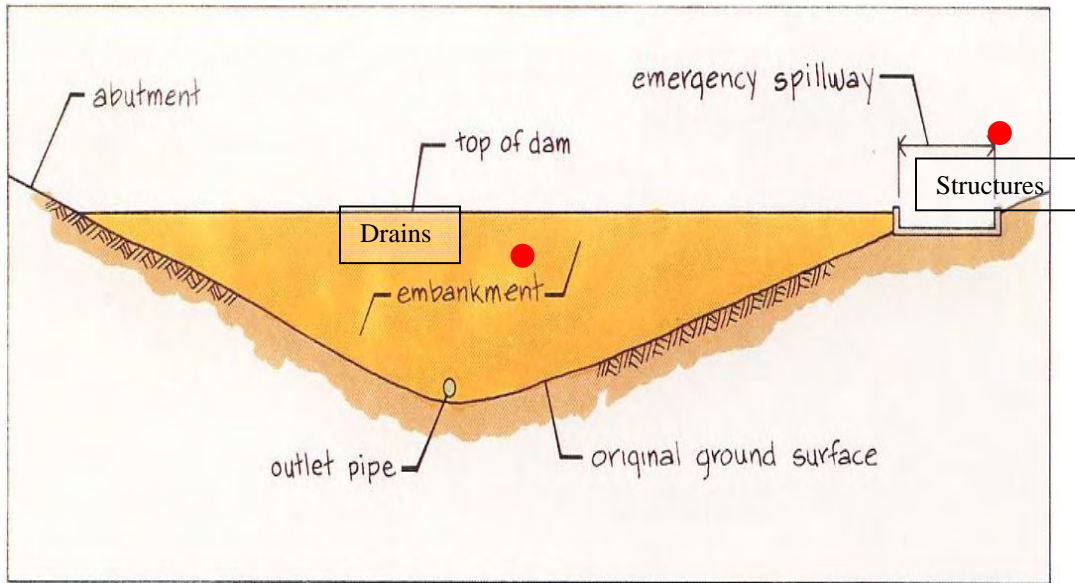
Figure 6. Tree clearance zones for embankment dams and dikes.

3. **Root exclusion zones** utilizing soil structure changes, soil compaction, water/aeration, stress, anaerobic conditions, soil injections and slurries, soil additives, and chemicals to prevent roots from colonizing the soil structure areas due to applied physical or chemical changes to the soil. Changing the soil structure, pore space volume or drainage/aeration matrices can generate a soil environment that roots cannot effectively grow and sustain. A variety of physical- or chemical-based soil altering materials (i.e., soil injected clay slurry or cement solutions) can be effective, at least over the short term if adequate soil volume is treated. Compacting soils appear to be a very good way to prevent root colonization. High density soils increase the resisting strength of these soils to root penetration and deprive the roots from needed oxygen and available water. Certain types of clay soils, freeze-thaw cycles, biological activity, and poor soil compaction can, over time, produce root-accessible pore space. Soil or infrastructure building material additives that neutralize or sterilize the available minerals and nutrients such as nitrogen gas, sulphur, sodium, zinc, borate, salts, or herbicides may produce serious environmental consequences, short-lived results, and non-targeted damage potential. Other methods or additives may be cost-prohibitive. See Figure 6 at end of chapter for root clearance zones.

8. **Creating avoidance zones** to separate tree growth from earthen dam embankments and dam appurtenances where root damage may be critical thus establishing biological-free zones that reduce potential problems. This method simply recognizes that there are places where trees are acceptable and other places, namely dams, where they are not (see Figure 6).

The reader is referred to the USDA guideline for detailed discussion on each of the six treatment methods listed in the above table. These methods can be applied to establish tree and woody plant clearance or avoidance zones on and around dams as illustrated in Figure 6.

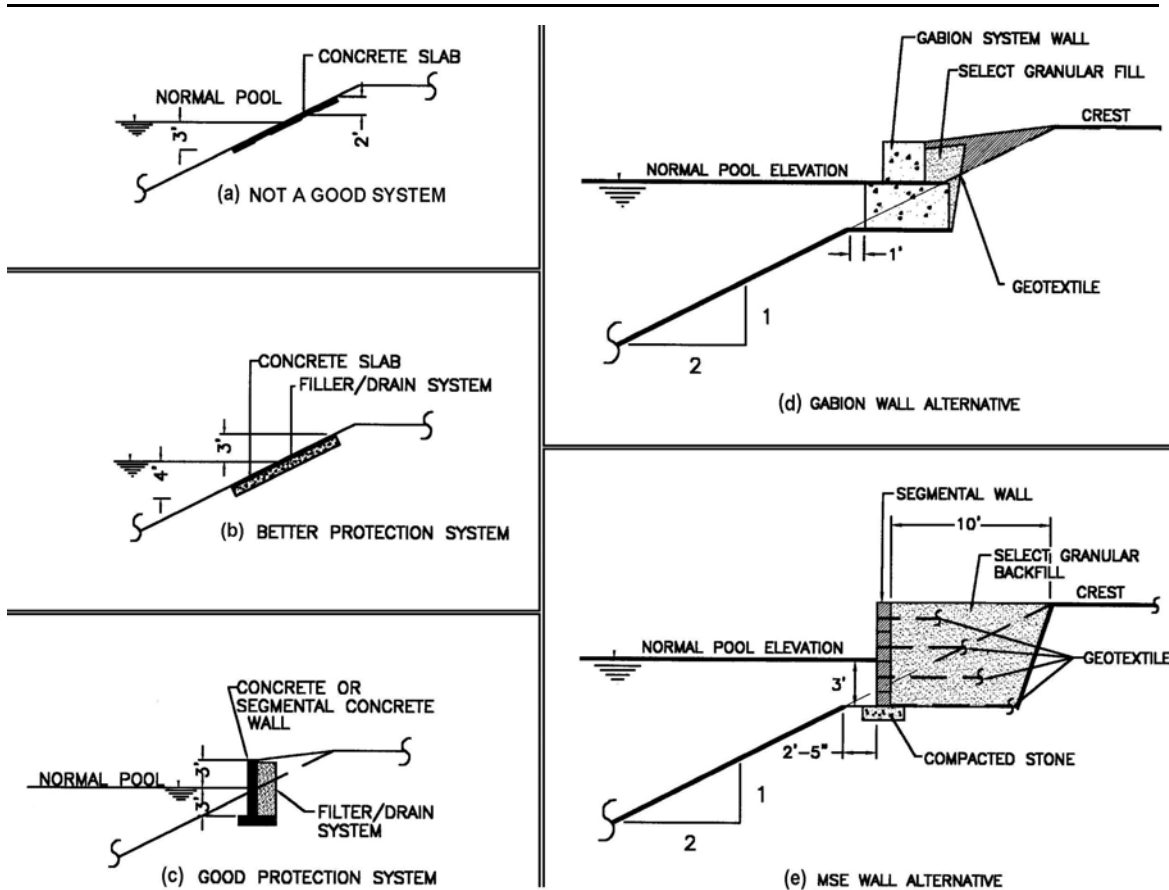
Figure 4

Figures 4(a) through 4(c) illustrate various configurations of rigid (concrete) upstream embankment slope protection systems. Figure 4(a) illustrates a concrete slab being placed directly on the upstream slope from about three feet below to about two feet above normal pool elevation. While this system is somewhat limited relative to the area of protection, the most critical aspect of this system is that it provides no filtration and/or drainage system beneath the concrete slab. Continual wave action and the buildup of hydrostatic pressures beneath the concrete slab will eventually result in downward movement of the slab. Figure 4(b) illustrates a better dam remediation design utilizing a concrete slab slope protection system. This slope protection system has been improved over the original system by covering a larger area of the upstream slope and by providing a filter system beneath the concrete slab protection system. The author is of the opinion

NOTE: Reinforced concrete wall and slab systems constructed on the upstream slope must always be provided with filtration/drainage systems to reduce the potential for development of excessive hydrostatic pressures and internal erosion and scour of soil from beneath the structures. The referenced figures are presented for illustrative purposes and should not be used for actual dam remediation design without proper design analyses to confirm any indicated dimensions of the drawings.

Dam remediation design techniques necessary to address potential problems illustrated in Figure 2 are illustrated in Figures 3 and 4. Dam remediation construction typically requires lowering of the normal pool elevation and/or complete drawdown of the retained reservoir. This is particularly true for dam remediation construction in Zone 1. The normal pool elevation should be lowered as far ahead of the scheduled dam remediation construction as practicable.

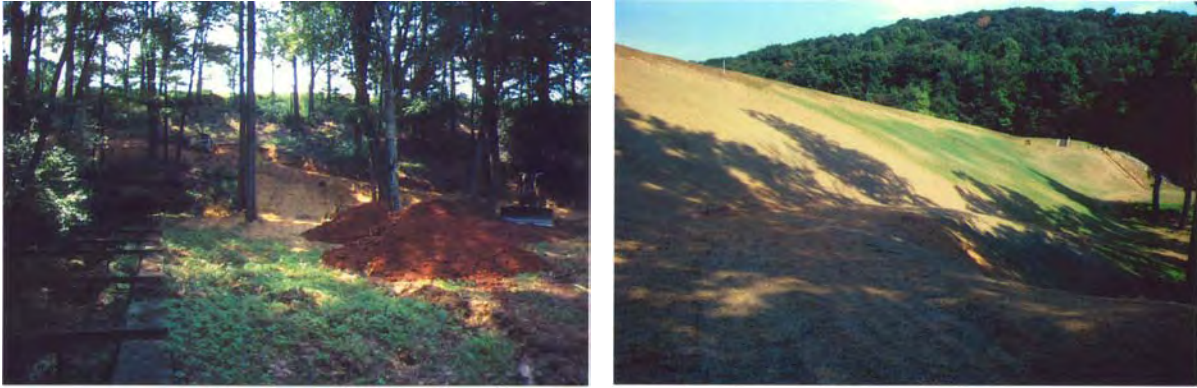
Figure 1. Restored Downstream Slope on Fishing Creek Dam, Maryland (1991-92)

State and federal dam safety officials and other dam safety experts agree that trees have no place on dams. Federal agencies and some states do not allow trees to grow on dams. However, it is estimated that about a third of the nation's 77,000 inventoried dams have sufficient woody vegetation to hinder effective dam safety inspections (ASDSO, 2000; Tschantz, 2000). Most states require dam owners to remove trees and undesirable vegetation, but the cost of clearing and grubbing trees and restoring the dam embankment slopes and crest is often cost prohibitive for many dam owners, usually running into thousands of dollars. It would seem that regular control of woody vegetation and maintaining the surface on an earthen is relatively inexpensive, compared to removing trees on and repairing damage from neglected dams such as shown in Figure 1.

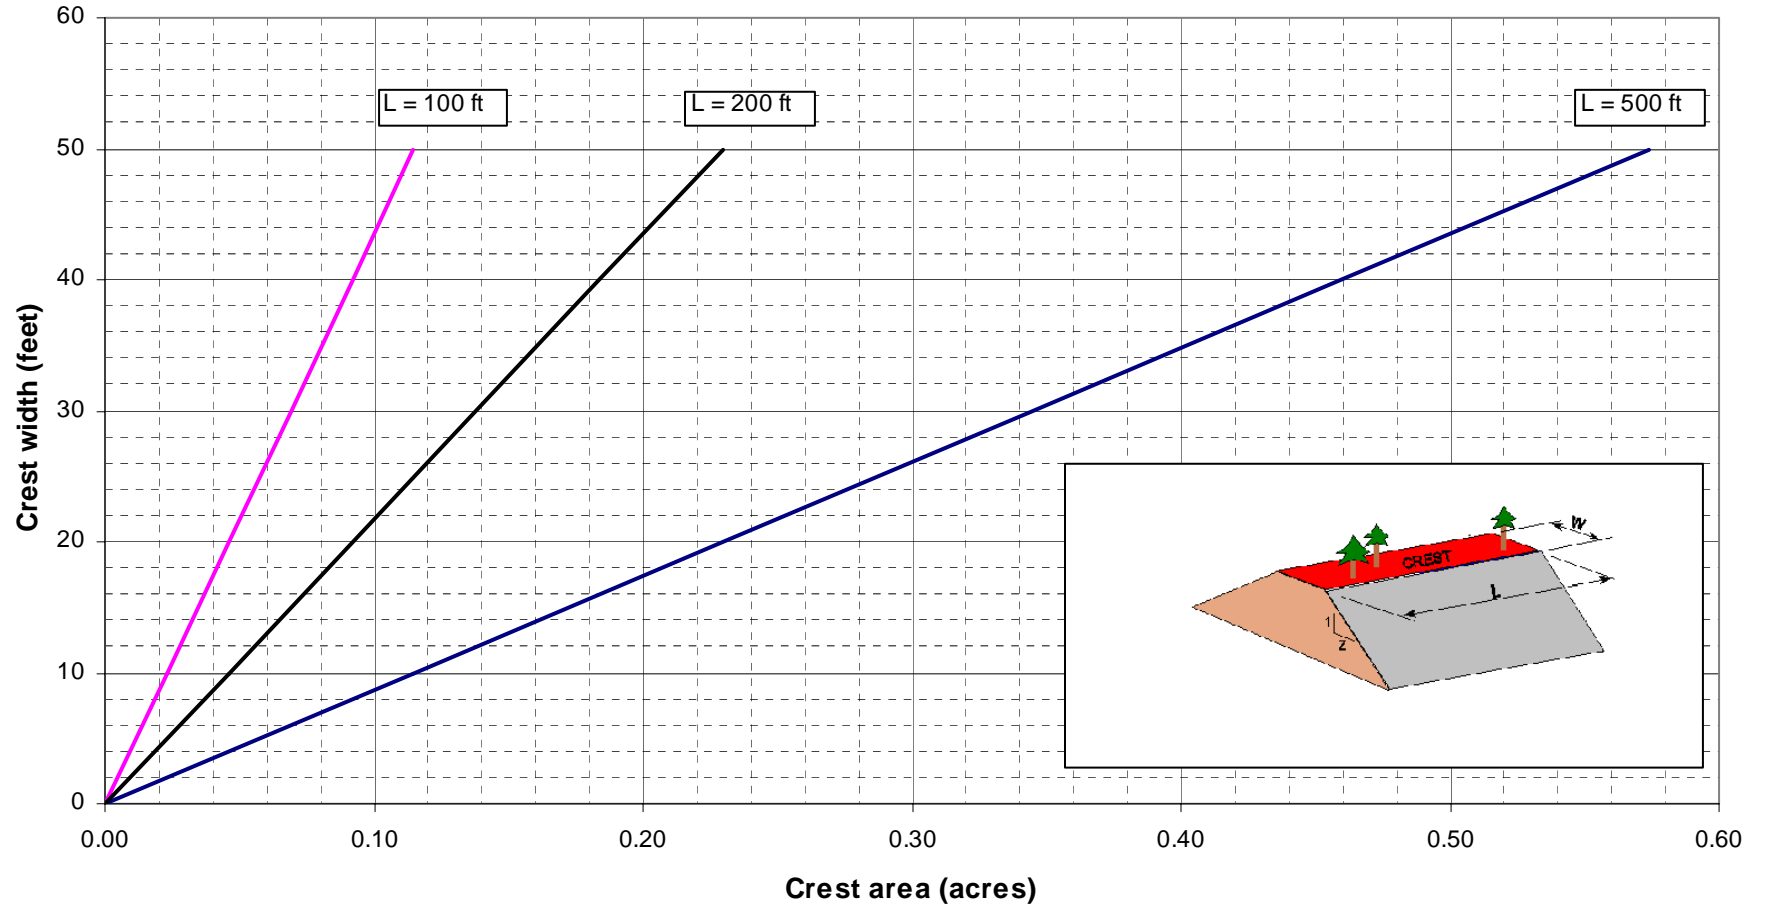
Chart 2. Dam crest area by width and length
