Coastal Construction: Maintaining the Building

Course No: S01-007
Credit: 1 PDH

14 Maintaining the Building

This chapter provides guidance on maintaining the building structure and envelope.

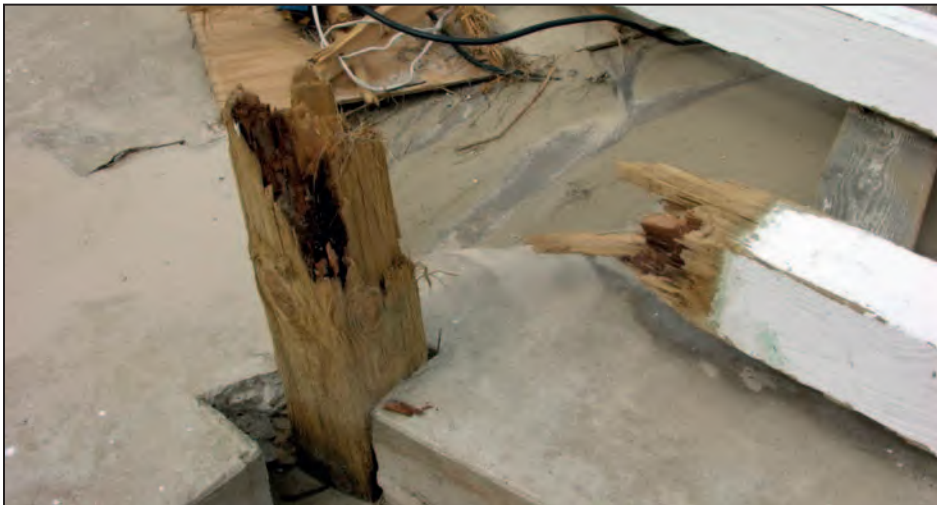
Figure 14-1.
Pile that appears acceptable from the exterior but has interior decay

acceptable condition but is weakened by interior decay, which can be determined only through a detailed inspection. This post failed under the loads imposed by a natural hazard event.

For maximum performance of a building in a coastal area, the building structure and envelope (i.e., exterior doors, windows, skylights, exterior wall coverings, soffits, roof systems, and attic vents) must not be allowed to deteriorate. Significant degradation by corrosion, wood decay, termite attack, or weathering increases the building's vulnerability to damage from natural hazards. Figure 14-1 shows a post that appears on the exterior to be in

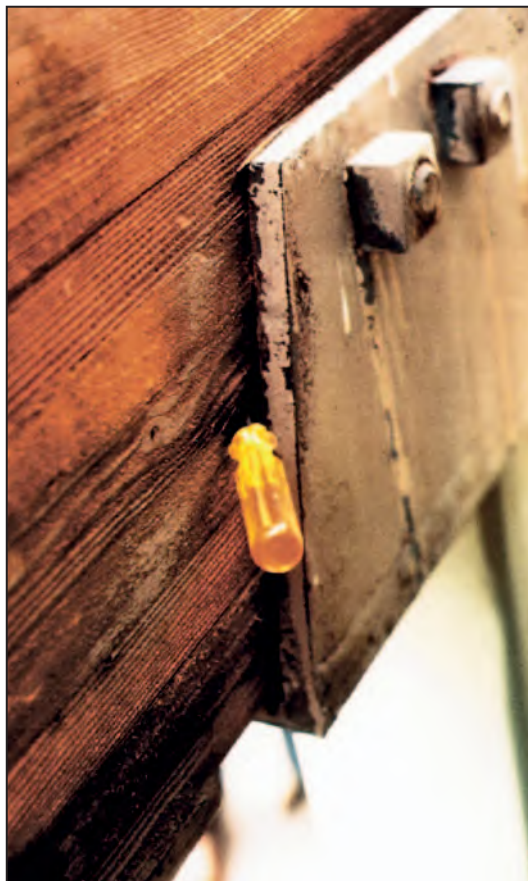
Figure 14-2.
Wood decay behind a
metal beam connector

There are many sources of exterior moisture from outside the home in the coastal environment. Whenever an object absorbs and retains moisture, the object may decay, mildew, or deteriorate in other ways. Figure 14-2 shows decay behind the connection plate on a beam.

Connectors should be designed to shed water to prevent water from accumulating between the connector and the material the connector is attached to. Trapped moisture increases the moisture content of the material and potentially leads to decay. Moisture is most likely to enter at intersections of materials where there is a hole in the building envelope (e.g., window, door) or where two surfaces are joined (e.g., roof to wall intersection). If properly installed, the flashings for the openings and intersections should not require maintenance for many years. However, flashings are frequently not properly installed or installed at all, creating an ongoing moisture intrusion problem.

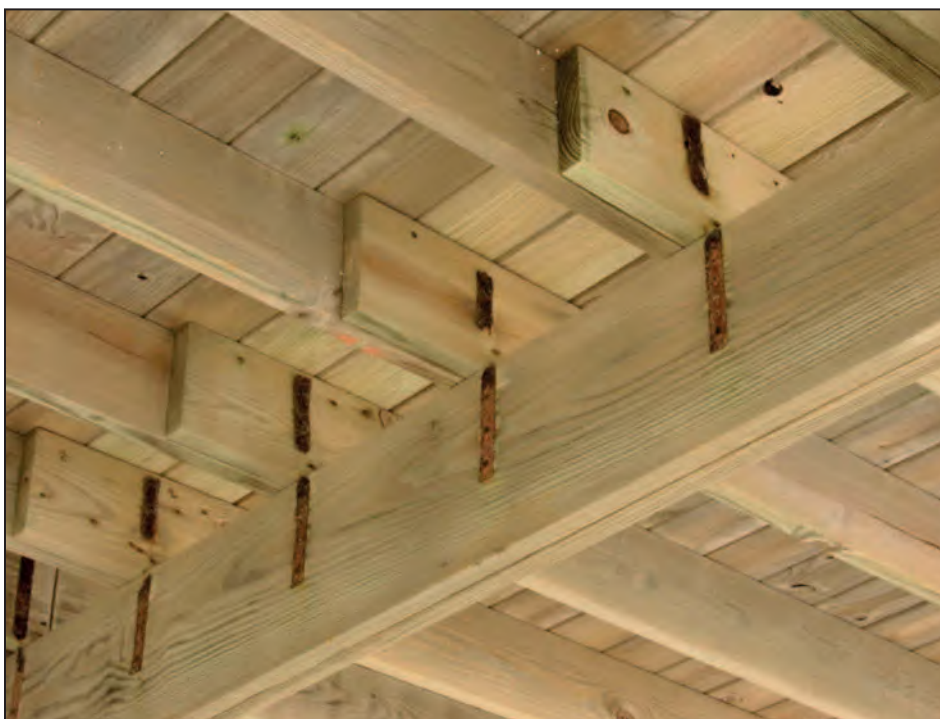
Figure 14-3.
Severely corroded deck connectors

been consumed and the corrosion rate of the unprotected steel can be expected to accelerate by up to a factor of 50 times. Figure 14-3 illustrates severe corrosion under an exterior deck.

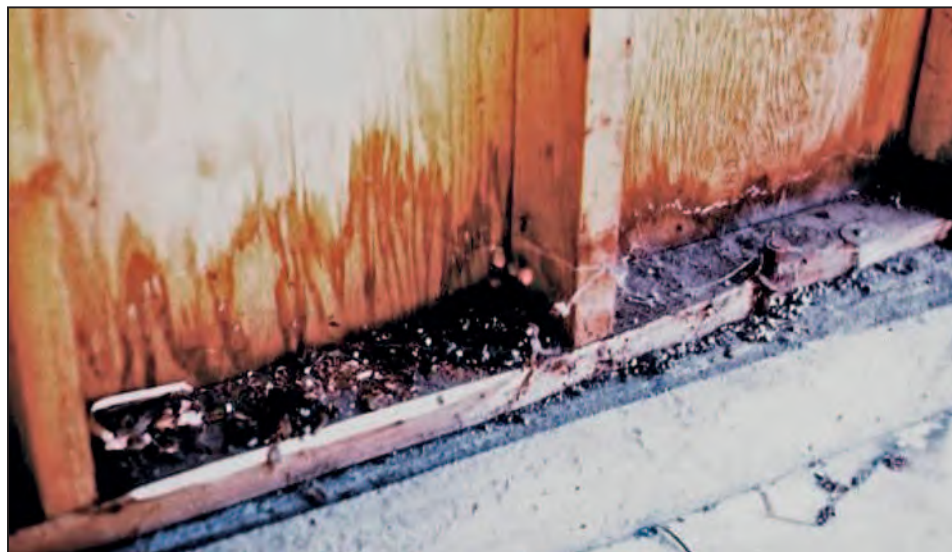
Figure 14-4.
Deteriorated wood sill
plate

Shearwall sill plates bearing directly on continuous footings or concrete slabs-on-grade, if used in coastal construction, are particularly susceptible to decay in moist conditions. Figure 14-4 shows a deteriorated sill plate. Even if the decay of the preservative-treated sill plate is retarded, the attached untreated plywood can easily decay and the shearwall will lose strength. Conditions that promote sill and plywood decay include an outside soil grade above the sill, stucco without a weep screed at the sill plate, and sources of excessive interior water vapor. Correcting these conditions helps maintain the strength of the shearwalls.
