## **Coastal Construction: Designing the Building Envelope**

Course No: S04-018  
Credit: 4 PDH

# 11 Designing the Building Envelope

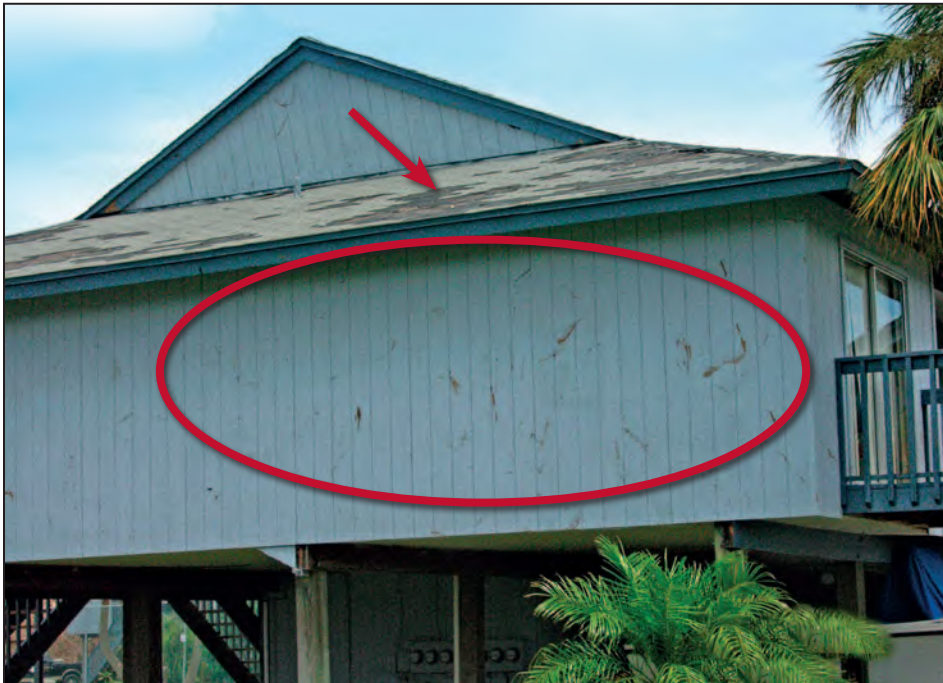
**Figure 11-2.** Numerous wind-borne debris scars on the wall of this house and several missing asphalt shingles. Estimated wind speed: 140 to 150 mph. Hurricane Charley (Florida, 2004)

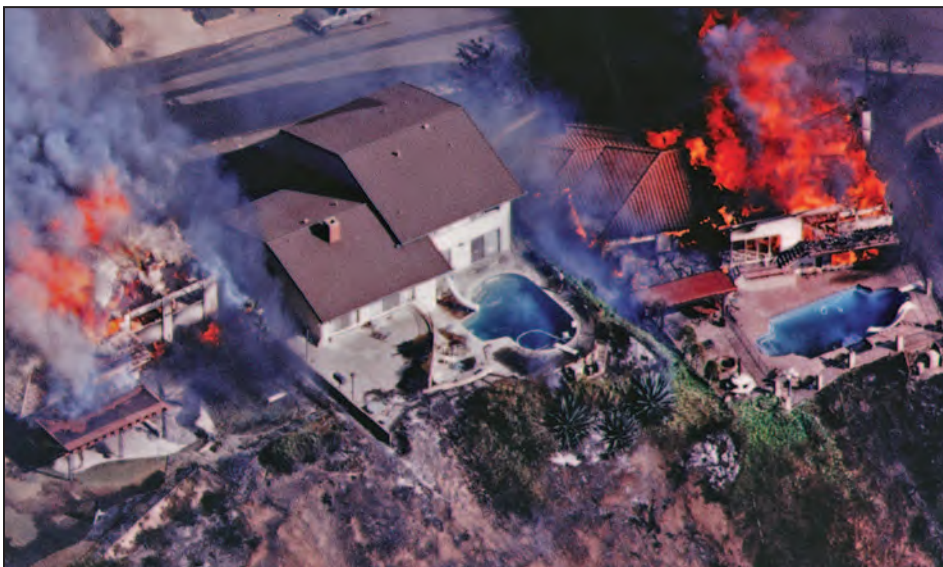
**Figure 11-3.** House that survived a wildfire due in part to fire-resistant walls and roof while surrounding houses were destroyed  
SOURCE: DECRA ROOFING SYSTEMS, USED WITH PERMISSION

A building's susceptibility to wildfire depends largely on the presence of nearby vegetation and the characteristics of the building envelope, as illustrated in Figure 11-3. See FEMA P-737, *Home Builder's Guide to Construction in Wildfire Zones* (FEMA 2008), for guidance on materials and construction techniques to reduce risks associated with wildfire.

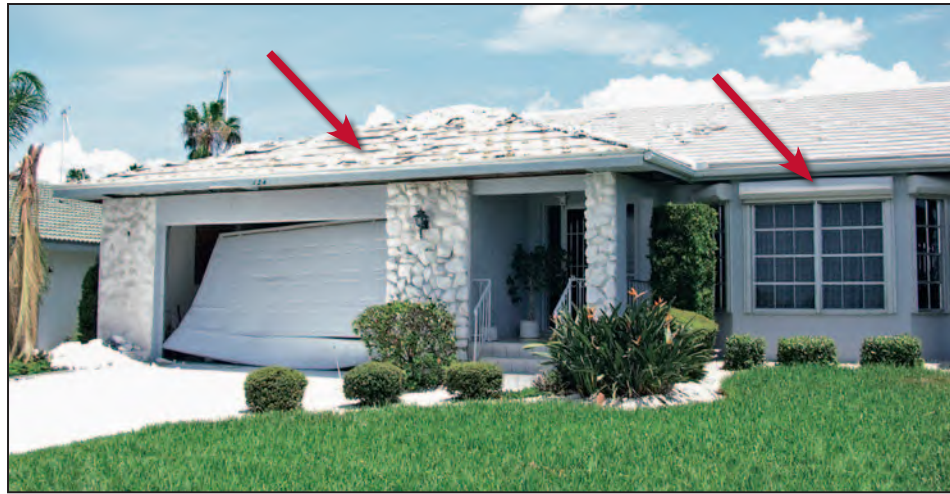
**Figure 11-6.** Garage door blown from its track as a result of positive pressure. Note the damage to the adhesive-set tiles (left arrow; see Section 11.5.4.1). This house was equipped with roll-up shutters (right arrow; see Section 11.3.1.2). Estimated wind speed: 140 to 160 mph. Hurricane Charley (Florida, 2004)

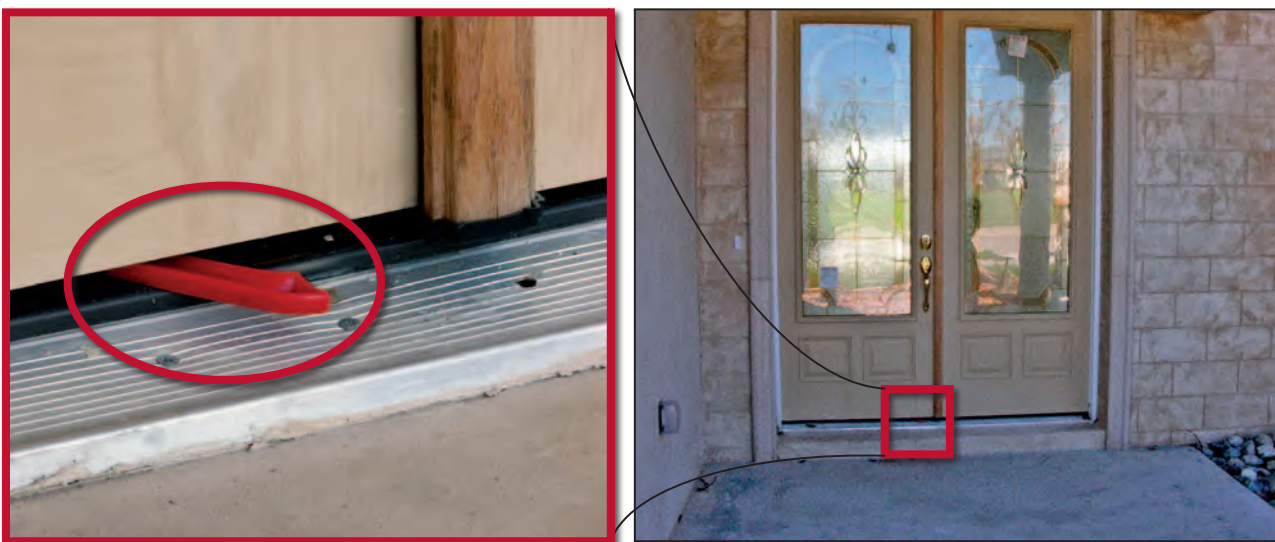
Figure 11-7.

A 3/8-inch gap between the threshold and door (illustrated by the spatula handle), which allowed wind-driven rain to enter the house. Estimated wind speed: 140 to 160 mph. Hurricane Charley (Florida, 2004)

Figure 11-7 shows a pair of doors that successfully resisted winds that were estimated at between 140 and 160 mph. However, as shown in the inset, a gap of about 3/8 inch between the threshold and the bottom of the door allowed a significant amount of water to be blown into the house. The weatherstripping and thresholds shown in Fact Sheet 6.1 in FEMA P-499 can minimize water entry.

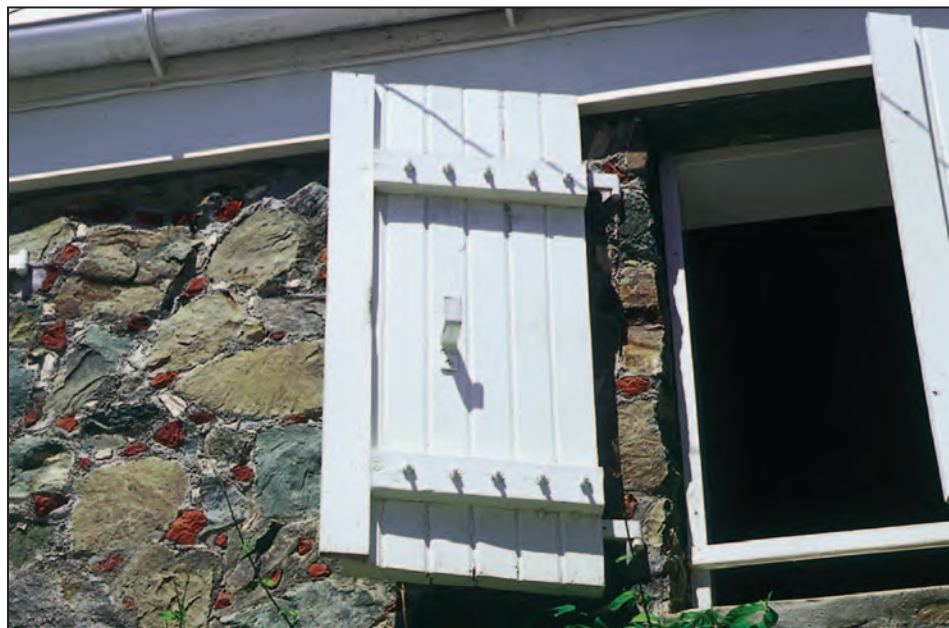
**Figure 11-9.**  
Very old building  
with robust shutters  
constructed of  
2x4 lumber, bolted  
connections, and heavy  
metal hinges. Hurricane  
Marilyn (U.S. Virgin  
Islands, 1995)

In windstorms other than hurricanes and tornadoes, the probability of a window or skylight being struck by debris is extremely low, but in hurricane-prone regions, the probability is higher. Although the debris issue was recognized decades ago, as illustrated by Figure 11-9, wind-borne debris protection was not incorporated into U.S. codes and standards until the 1990s. In order to minimize interior damage, the IBC and IRC, through ASCE 7, prescribe that exterior glazing in wind-borne debris regions be impact-resistant (i.e., laminated glass or polycarbonate) or protected with an impact-resistant covering (shutters). ASCE 7 refers to ASTM E1996 for missile (debris) loads and to ASTM E1886 for the test method to be used to demonstrate compliance with the ASTM E1996 load criteria. Regardless of whether the glazing is laminated glass, polycarbonate, or protected by shutters, glazing is required to meet the positive and negative design air pressures.

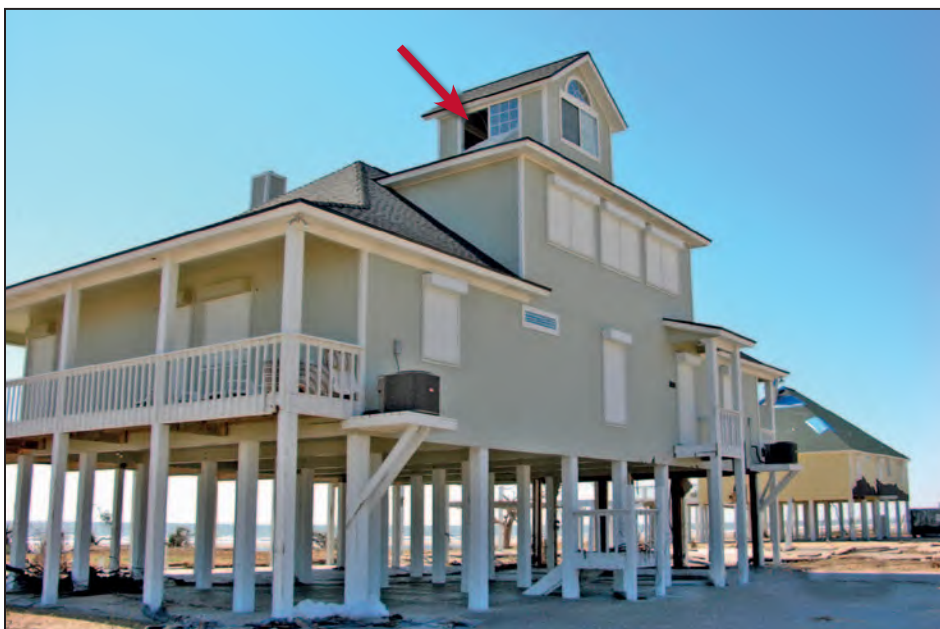
**Figure 11-10.**  
Unprotected cupola  
window that was broken.  
Estimated wind speed:  
110 mph. Hurricane Ike  
(Texas, 2008)

Because hurricane winds can approach from any direction, when debris protection is specified, it is important to specify that all exterior glazing be protected, including glazing that faces open water. At the house shown in Figure 11-10, all of the windows were protected with roll-up shutters except for those in the cupola. One of the cupola windows was broken. Although the window opening was relatively small, a substantial amount of interior water damage likely occurred.

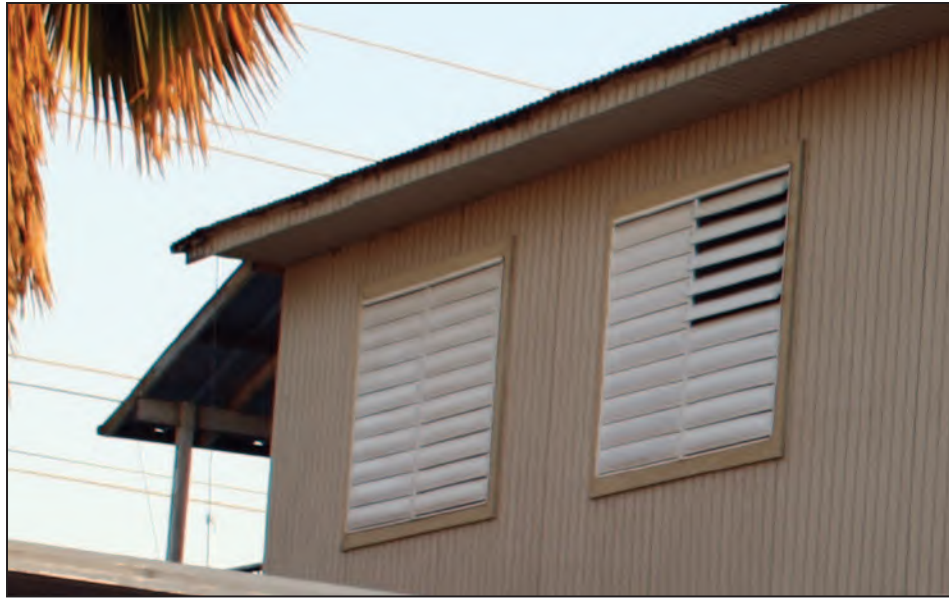
Figure 11-14.  
House in Puerto Rico with  
metal jalousie louvers

In tropical climates such as Puerto Rico, some houses have metal jalousie louvers in lieu of glazed window openings (see Figure 11-14). Metal jalousies have the appearance of a debris-resistant shutter, but they typically offer little debris resistance. Neither the UBC nor IRC require openings equipped with metal jalousie louvers to be debris resistant because glazing does not occur. However, the louvers are required to meet the design wind pressure.

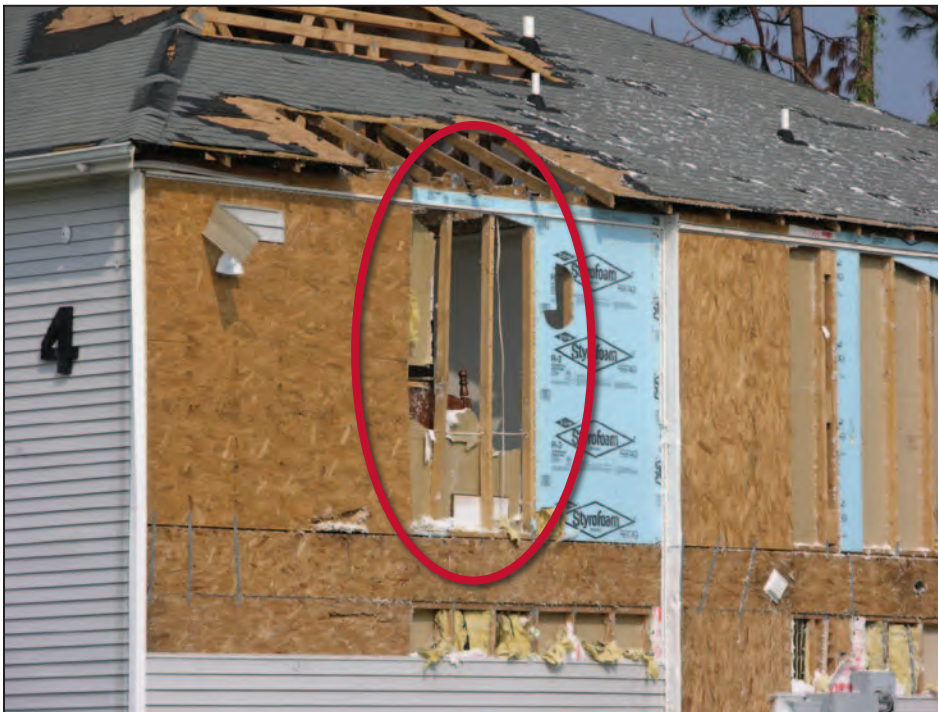
**Figure 11-15.** Blown-off vinyl siding and foam sheathing; some blow-off of interior gypsum board (circle). Estimated wind speed: 130 mph. Hurricane Katrina (Mississippi, 2006)

other siding or panel materials (see Figure 11-15). Problems with aluminum and fiber cement siding have also occurred (see Figure 11-16).

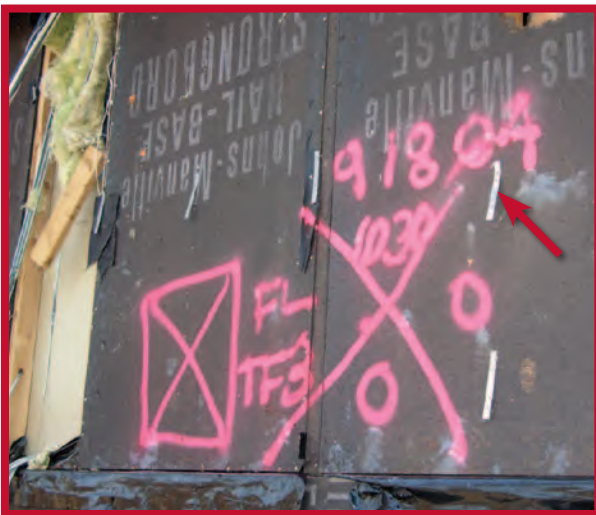
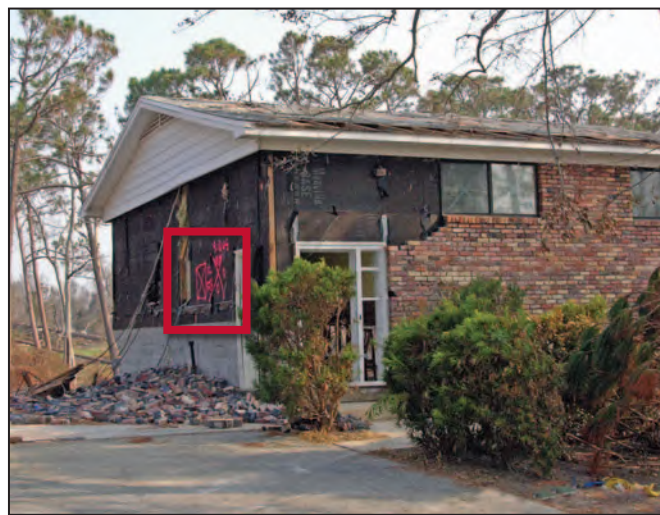
Figure 11-17.  
Four brick veneer failure modes; five corrugated ties that were not embedded in the mortar joints (inset). Hurricane Ivan (Florida, 2004)

Blow-off of brick veneer has occurred often during high winds. Common failure modes include tie (anchor corrosion), tie fastener pull-out, failure of masons to embed ties into the mortar, and poor bonding between ties and mortar, and poor-quality mortar. Four of these failure modes occurred at the house shown in Figure 11-17. The lower bricks were attached to CMU and the upper bricks were attached to wood studs. In addition to the wall covering damage, roof sheathing was blown off along the eave.

A key to the successful performance of brick veneer is attachment with a sufficient number of properly located ties and proper tie fasteners (based on design loads and tested resistance). Fact Sheet 5.4, *Attachment of Brick Veneer in High-Wind Regions*, in FEMA P-499 provides guidance on specifying and installing brick veneer in high-wind regions.

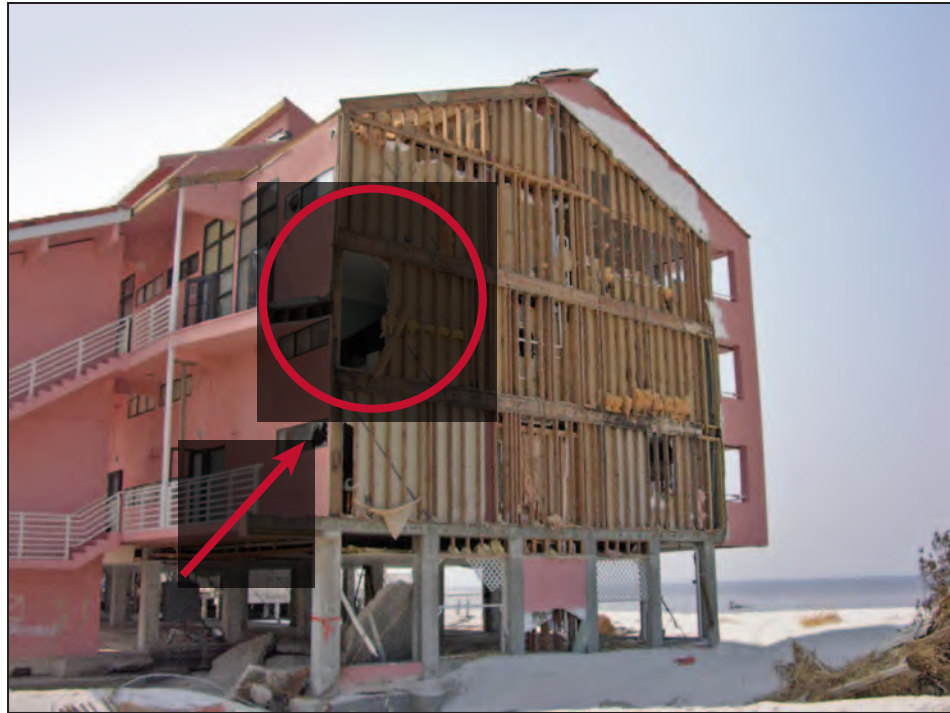
Figure 11-19. Blown-off EIFS, resulting in extensive interior water damage; detachment of the gypsum board or stud blow off (circle); two windows broken by debris (arrow). Estimated wind speed: 105 to 115 mph. Hurricane Ivan (Florida, 2004)

At the residence shown in Figure 11-19, the synthetic stucco was installed over molded expanded polystyrene (MEPS) insulation that was adhered to gypsum board that was mechanically attached to wood studs. Essentially all of the gypsum board blew off (the boards typically pulled over the fasteners). The failure was initiated by detachment of the gypsum board or by stud blow off. Some of the gypsum board on the interior side of the studs was also blown off. Also, two windows were broken by debris.

Several of the studs shown in Figure 11-19 were severely rotted, indicating long-term moisture intrusion behind the MEPS insulation. The residence shown in Figure 11-19 had a barrier EIFS design, rather than the newer drainable EIFS design (for another example of a barrier EIFS design, see Figure 11-21). EIFS should be designed with a drainage system that allows for dissipation of water leaks.

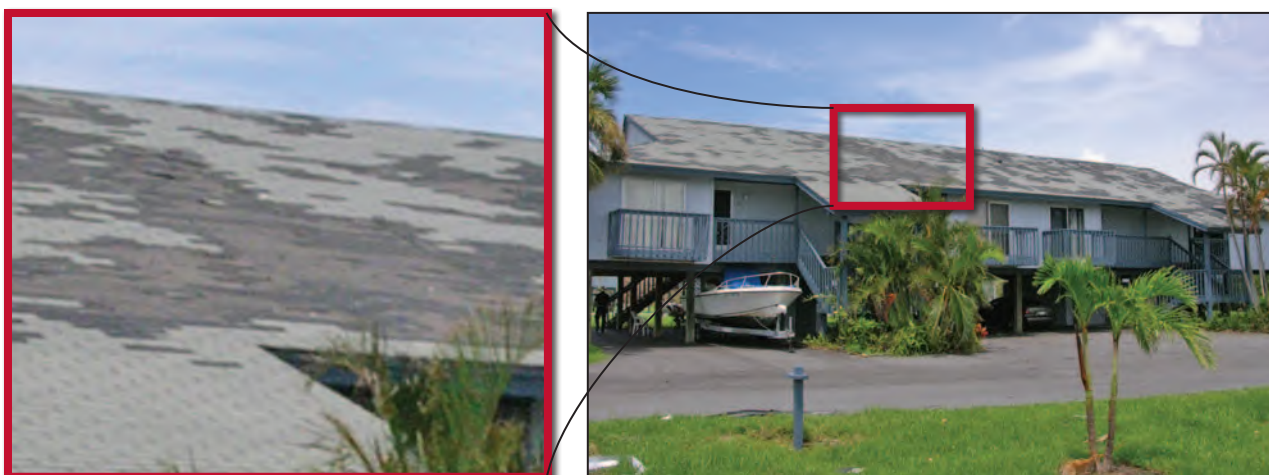
Blow-off of several newer shingles on a roof that had been re-covered by installing new asphalt shingles on top of old shingles (newer shingles are lighter and older shingles are darker). Hurricane Charley (Florida, 2004)

At the residence shown in Figure 11-23, new asphalt shingles had been installed on top of old shingles. Several of the newer shingles blew off. Re-covering over old shingles causes more substrate irregularity, which can interfere with the bonding of the self-seal adhesive of the new shingles.

When reroofing in high-wind areas, the existing roof covering should be removed rather than re-covered so that the roof deck can be checked for deterioration and adequate attachment. See Figure 11-23. Also see Chapter 14 in this Manual.

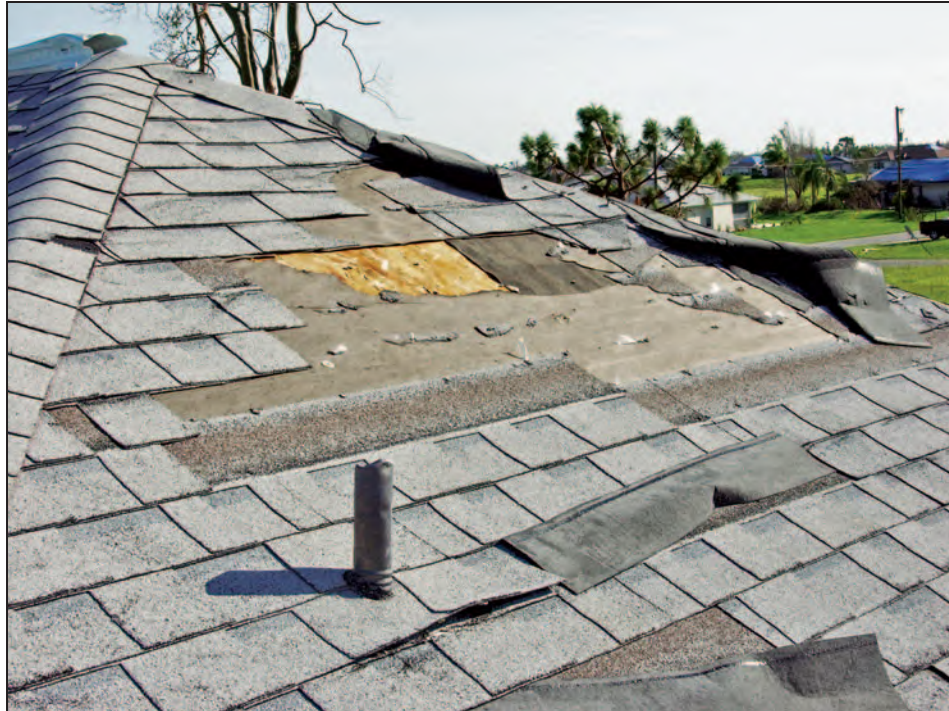
Figure 11-24.  
Small area of sheathing that was exposed after loss of a few shingles and some underlayment. Estimated wind speed: 140 to 160 mph. Hurricane Charley (Florida, 2004)

If shingles blow off, water infiltration damage can be avoided if the underlayment remains attached and is adequately sealed at penetrations. Figures 11-24 and 11-25 show houses with underlayment that was not effective in avoiding water leakage. Reliable

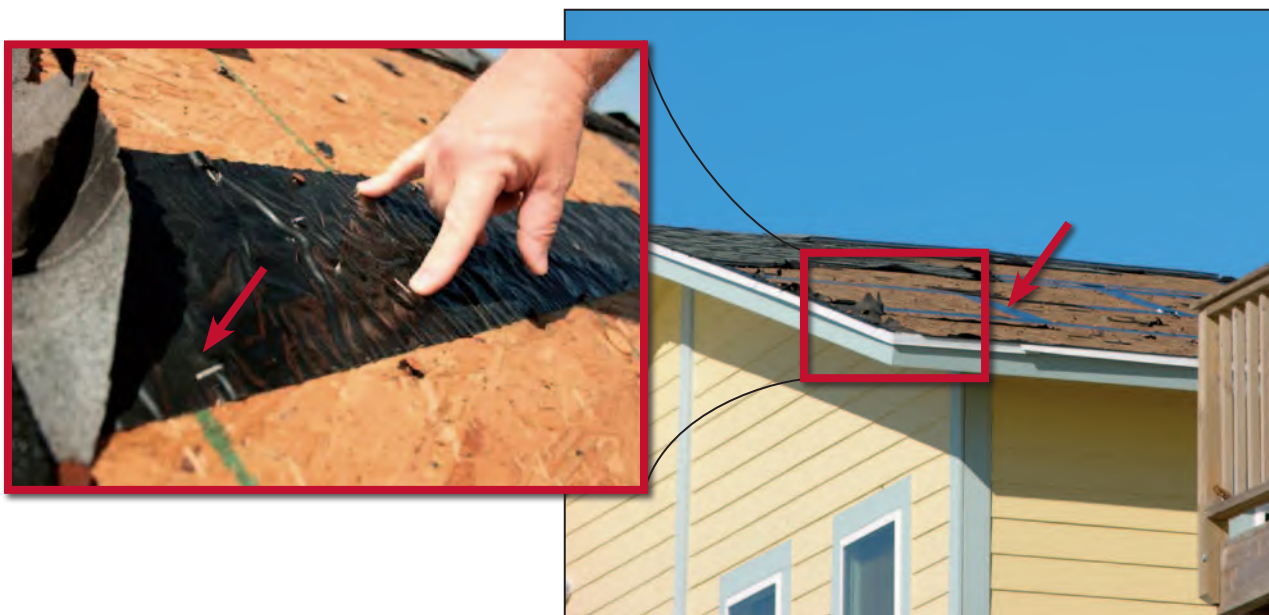
**Figure 11-28.** House that used enhanced underlayment Option 3 with taped sheathing joints (arrow). The self-adhering modified bitumen tape (inset) was stapled because of bonding problems. Estimated wind speed: 110 mph. Hurricane Ike (Texas, 2008)

Figure 11-28 shows a house that used Option 3. The self-adhering modified bitumen tape at the sheathing joints was intended to be a third line of defense against water leakage (with the shingles the first line and the felt the second line). However, as shown in the inset at Figure 11-28, the tape did not provide a watertight seal. A post-storm investigation revealed application problems with the tape. Staples (arrow, inset) were used to attach the tape because bonding problems were experienced during application. Apparently, the applicator did not realize the tape was intended to prevent water from leaking through the sheathing joints. With the tape in an unbonded and wrinkled condition, it was incapable of fulfilling its intended purpose.

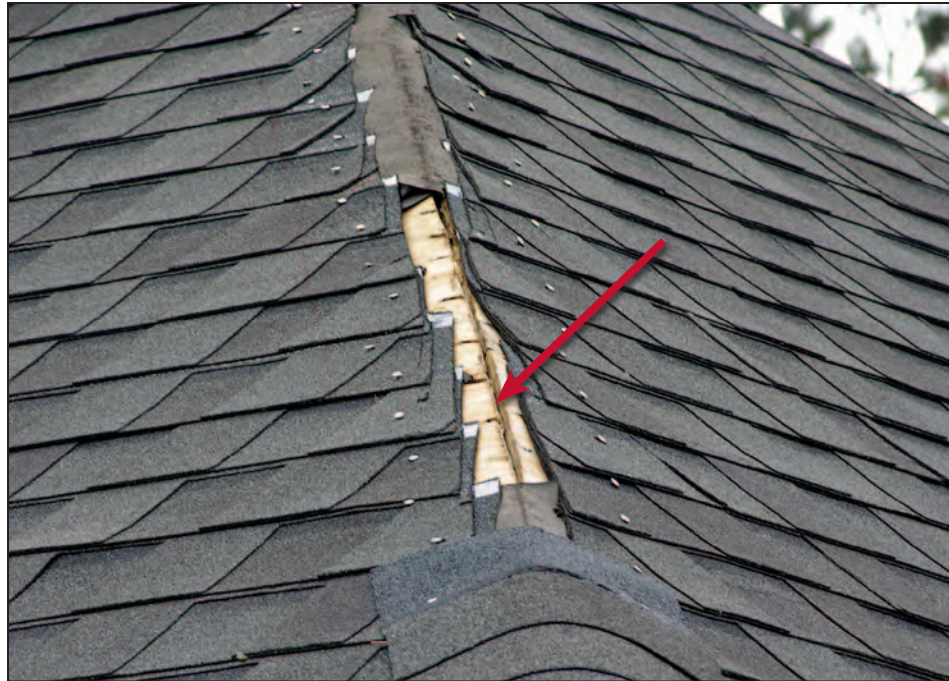
Figure 11-29. Underlayment that was not lapped over the hip; water entry possible at the sheathing joint (arrow). Estimated wind speed: 130 mph. Hurricane Katrina (Mississippi, 2005)

In addition to taping the sheathing joints in the field of the roof, the hip and ridge lines should also be taped unless there is a continuous ridge vent, and the underlayment should be lapped over the hip and ridge. By doing so, leakage will be avoided if the hip or ridge shingles blow off (see Figure 11-29). See Section 11.6 for recommendations regarding leakage avoidance at ridge vents.

Shingle blow-off is commonly initiated at eaves (see Figure 11-30) and rakes (see Figure 11-31). Blow-off of ridge and hip shingles, as shown in Figure 11-29, is also common. For another example of blow-off of ridge

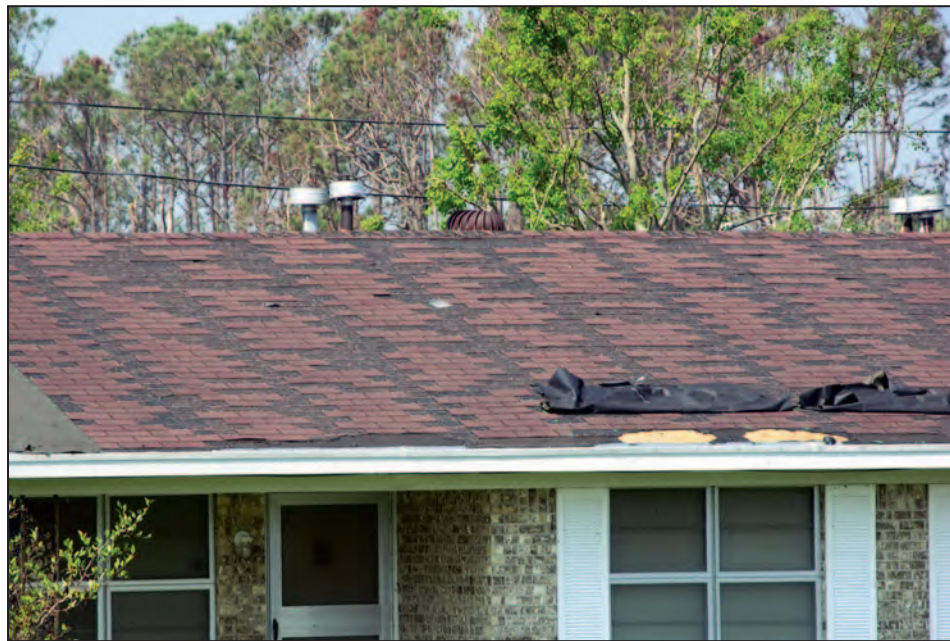
**Figure 11-38.**  
Shingles that unzipped at the band lines because the raking method was used to install them. Estimated wind speed: 135 mph. Hurricane Katrina (Mississippi, 2005)

Shingle damage is also sometimes caused by installing shingles via the raking method. With this method, shingles are installed from eave to ridge in bands about 6 feet wide. Where the bands join one another, at every other course, a shingle from the previous row needs to be lifted up to install the end nail of the new band shingle. Sometimes installers do not install the end nail, and when that happens, the shingles are vulnerable to unzipping at the band lines, as shown in Figure 11-38. Raking is not recommended by the National Roofing Contractors Association or the Asphalt Roofing Manufacturers Association.

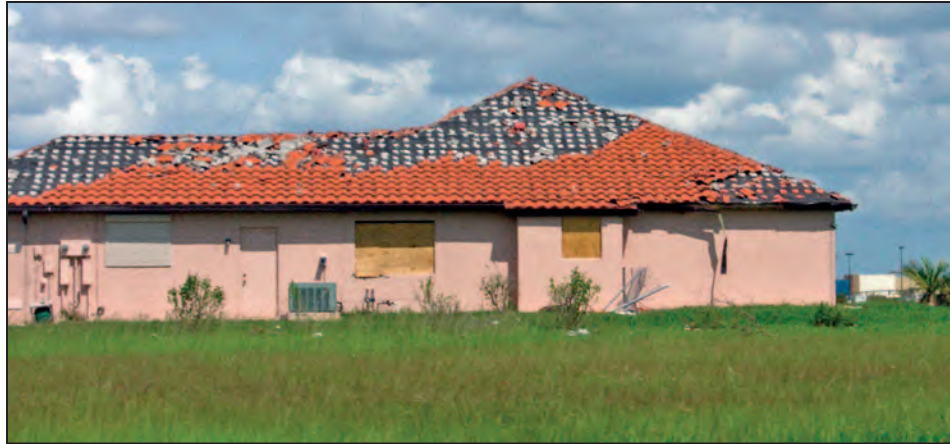
Figure 11-42.  
Extensive blow-off  
of mortar-set tiles.  
Hurricane Charley  
(Florida, 2004)

Damage investigations have revealed that mortar-set systems often provide limited wind resistance (Figure 11-42).<sup>17</sup> As a result of widespread poor performance of mortar-set systems during Hurricane Andrew (1992), adhesive-set systems were developed. Hurricane Charley (2004) offered the first opportunity to evaluate the field performance of this new attachment method during very high winds (see Figures 11-43 and 11-44).

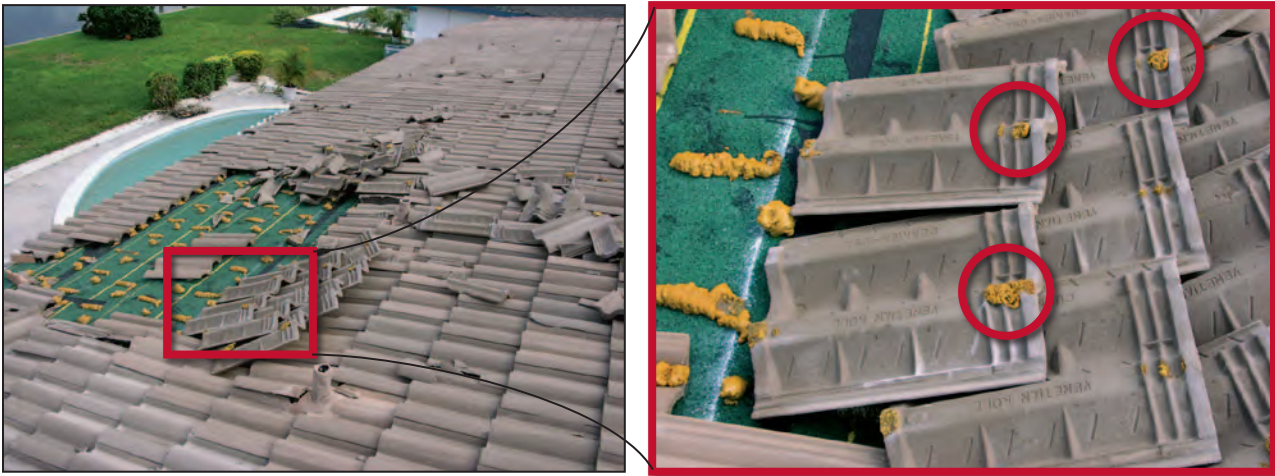
Figure 11-43.  
Blown-off adhesive-set tile. Note the very small contact area of the foam at the tile heads (left side of the tiles) and very small contact at the nose (circles). Estimated wind speed: 140 to 160 mph. Hurricane Charley (Florida, 2004)

Figure 11-43 shows a house with adhesive-set tile. There were significant installation problems with the foam paddies, including insufficient contact area between the patty and the tile. As can be seen in Figure 11-43, most of the foam failed to make contact with the tile. Some of the foam also debonded from the mineral surface cap sheet underlayment (see Figure 11-44).

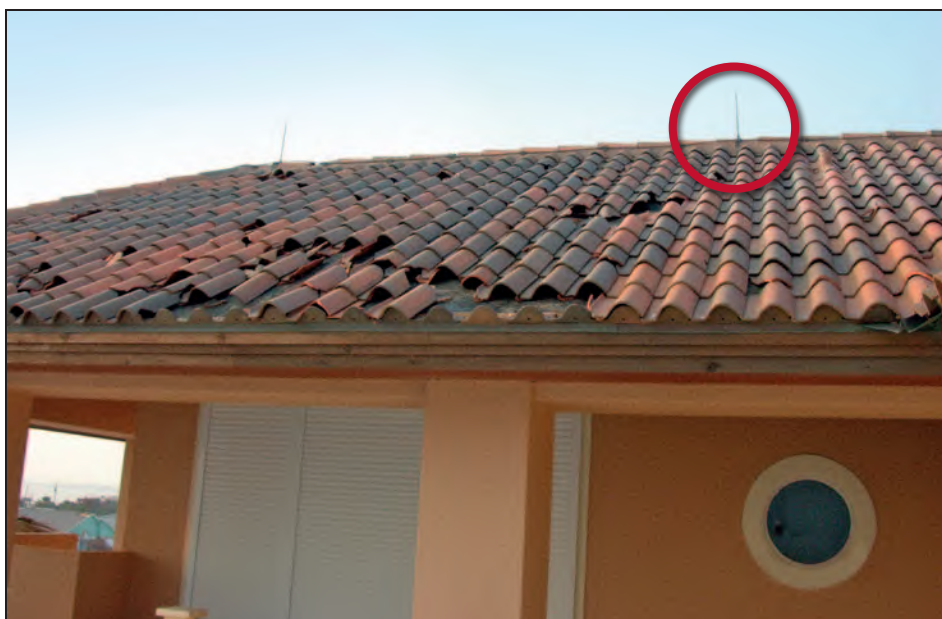
**Figure 11-48.**  
The fastener heads on this mechanically attached tile roof had corroded; air terminals (lightning rods) in a lightning protection system (circle). Hurricane Ivan (Alabama, 2004)

At houses on the coast, fasteners and clips that are used to attach tiles are susceptible to corrosion unless they are stainless steel. Figure 11-48 shows a 6-year-old tile roof on a house very close to the ocean that failed because the heads of the screws attaching the tile had corroded off. Stainless steel straps, fasteners, and clips are recommended for roofs within 3,000 feet of an ocean shoreline (including sounds and back bays).

The house in Figure 11-48 had a lightning protection system (LPS), and the LPS conductors were placed under the ridge tile. Conductors are not susceptible to wind damage if they are placed under the tile and the air terminals (lightning rods) are extended through the ridge.

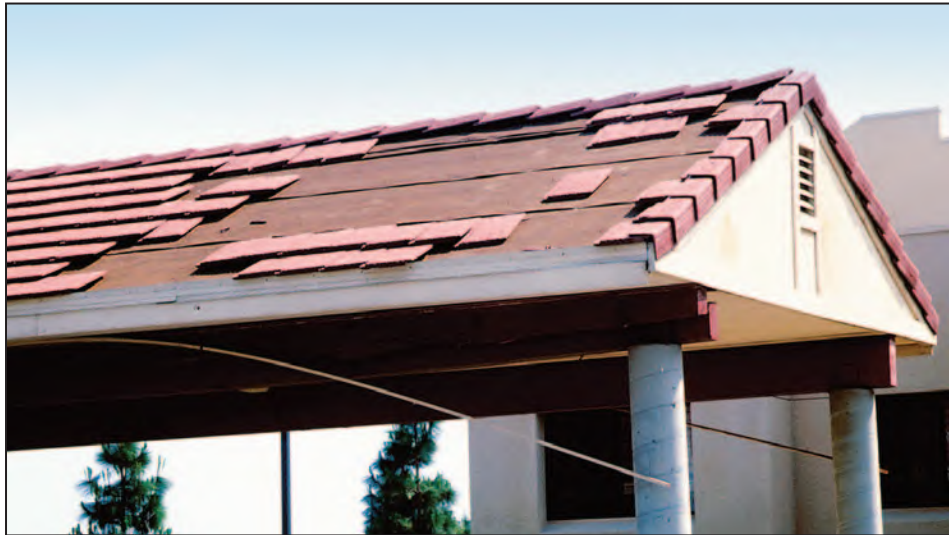
Figure 11-50.  
Tiles that were nailed  
to thin wood sheathing.  
Northridge Earthquake  
(California, 1994)

- Tiles nailed only at the head may or may not perform well. If they are attached with a smooth-shank nail into a thin plywood or OSB sheathing, pullout can occur. Figure 11-50 shows tiles that were nailed to thin wood sheathing. During the earthquake, the nose of the tiles bounced and pulled out the nails. Specifying ring-shank or screw-shank nails or screws is recommended, but even with these types of fasteners, the nose of the tile can bounce, causing enlargement of the nail hole by repeated pounding. To overcome this problem, wind clips near the nose of the tile or a bead of adhesive between the tiles at the headlap should be specified.

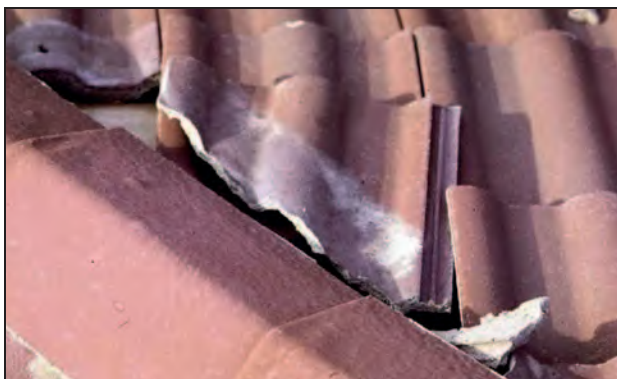
Figure 11-51.  
Tile that slipped out from under the hip tiles.  
Northridge Earthquake (California, 1994)

- When tiles are cut to fit near hips and valleys, the portion of the tile with the nail hole(s) is often cut away. Figure 11-51 shows a tile that slipped out from under the hip tiles. The tile that slipped was trimmed to fit at the hip. The trimming eliminated the nail holes, and no other attachment was provided. The friction fit was inadequate to resist the seismic forces. Tiles must have supplemental securing to avoid displacement of these loose tiles.

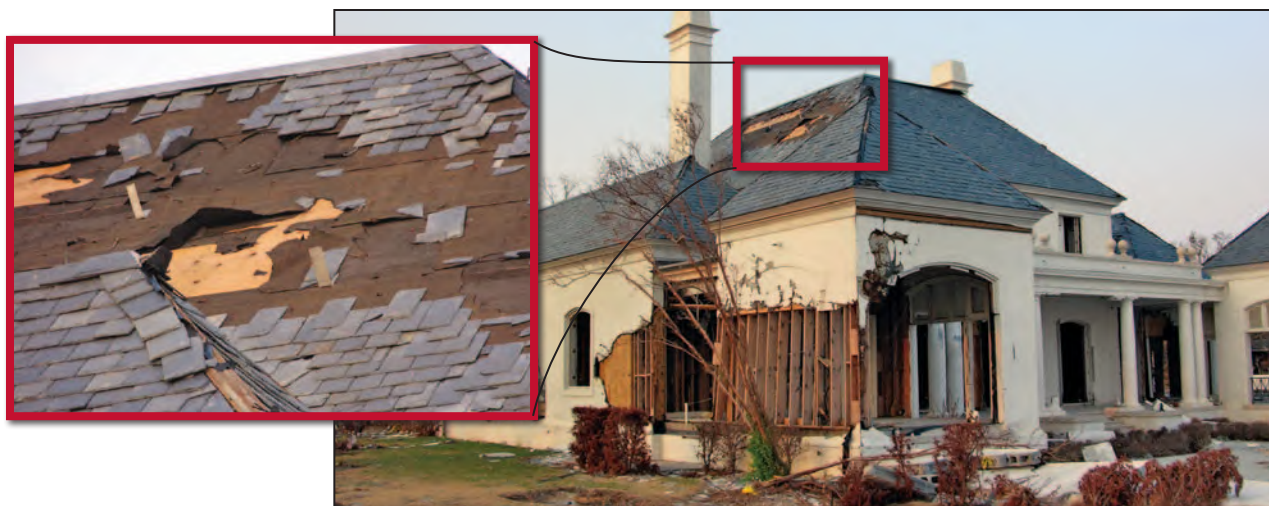
Figure 11-53.

Damaged slate roof with nails that typically pulled out of the deck. Some of the slate broke and small portions remained nailed to the deck. Estimated wind speed: 130 mph. Hurricane Katrina (Mississippi, 2005)

Because of limited market share of slate in areas where research has been conducted after high-wind events, few data are available on its wind performance. However, as shown in Figure 11-53, wind damage can occur.
