Protocols for the Assessment and Repair of Bridge Foundations

Course No: S08-006
Credit: 8 PDH

This course was adapted from the US Department of Transportation - Federal Highway Administration, Publication No. FHWA HIF-17-044, “Protocols for the Assessment and Repair of Bridge Foundations”, which is in the public domain.

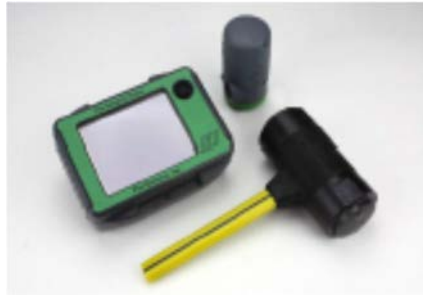
Figure 5-3: Pile Integrity Tester (Pile Dynamics, Inc.)

Pulse Echo – The pulse echo method, which employs a small hand-held hammer to create a compression wave in the foundation element, as shown by Figure 5-3, can be used on all types of solid section foundation elements (concrete, concrete filled pipes, drilled shafts, timber), but has limited application to unfilled steel pipes or H-piles. A compression wave from a hammer strike applied to the exposed pile or shaft head is reflected from the toe, or in some cases, a change in the cross-sectional area or material quality of the foundation element, and returns to the head of

the pile or shaft at a time interval relative to the wave speed for the foundation material type. Data from the test can be used to evaluate pile integrity and physical dimensions of both length and cross sectional area. Likens (2015) indicated that the length to diameter ratio (L/D) may be limited to about 30, less in strong soils or possibly greater than 50 in weaker soils. The method conforms to ASTM D5882 “Standard Test Method for Low Strain Impact Integrity Testing of Deep Foundations,” and was successfully used in South Carolina to quickly assess in-situ pile lengths relative to scour impacts, as discussed in Section 3.2.11.

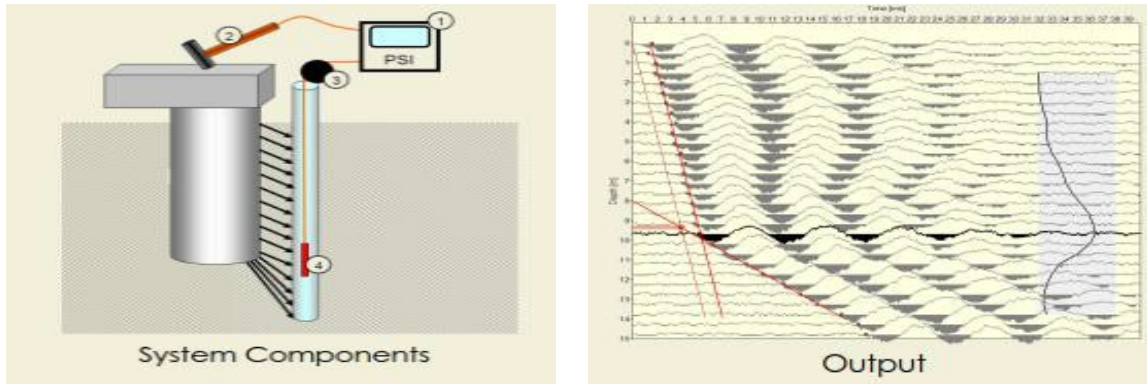
Figure 5-5: Parallel Seismic Test Method (PileTest)

- Parallel Seismic – The Parallel Seismic Method is the sonic analog to the electromagnetic induction coil test method. A PVC cased borehole is installed alongside of the foundation element and hammer strikes on the foundation relative to geophone receivers suspended in the borehole are used to assess first arrival (compression) wave speeds. The method depends upon the borehole being deeper than the pile or shaft toe in order to detect a change in the compression wave speed arrival, as shown by Figure 5-5. Access to the pile head is not essential to the parallel seismic method.

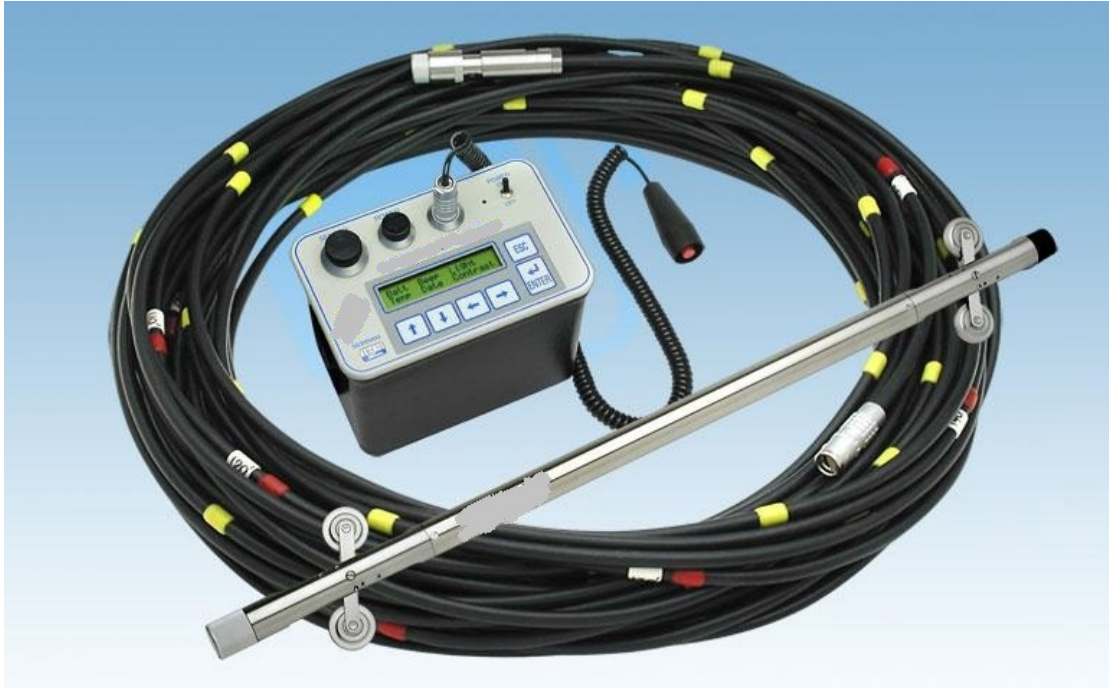
Figure 5- 9: Inclinator Probe (Slope Indicator Company)

- Inclinometers – Concurrent with boring investigation, inclinometer casings can be installed in SPT boreholes if lateral ground movement is relevant to the failure condition, such as a landslide or lateral squeeze related failure. Inclinometer casing is special purpose, with grooved tracks to accommodate the inclinometer probe. Casing is available in various diameters, the larger diameters, such as SINCO 85 mm, being more suitable for use where failure is in progress and large ground movements may be occurring. Periodic inclinometer readings will enable detection of shear zones, and establish whether movement is constant, accelerating, or responding to remedial measures.

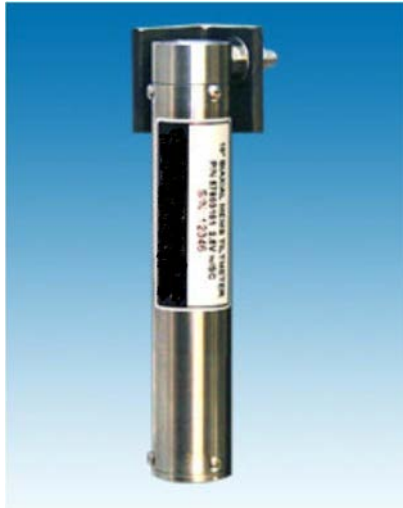
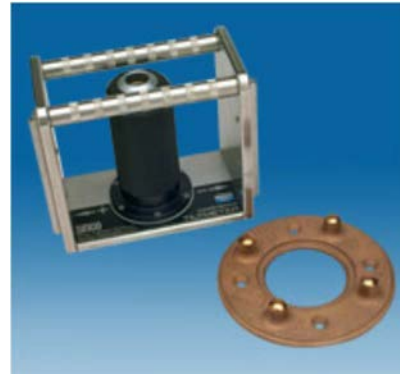
Figure 5-10: Tiltmeters: (a) Permanent (b) Portable (Slope Indicator Company)

- Tiltmeters – Tiltmeters are used to monitor changes in the inclination of a structure. They are commercially available as both permanently mounted and portable units. The permanently mounted units, as shown in Figure 5-10a, can be attached almost anywhere on a structure with an L-bracket. Readings can be obtained on-site using a portable readout device. An automated data logger can also be used to monitor readings remotely. Portable tiltmeters, as shown in Figure 5-10b, can be used on multiple face mounted tiltplates.

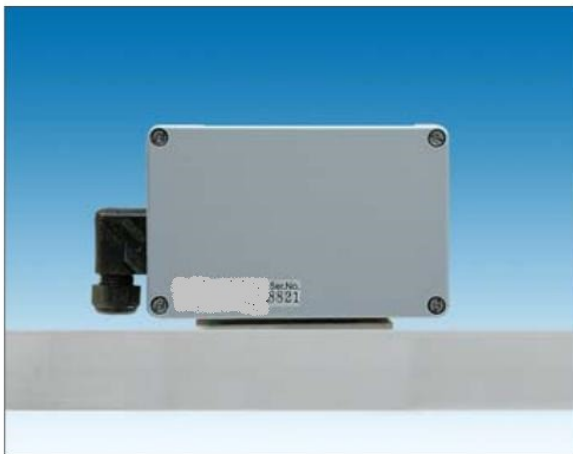
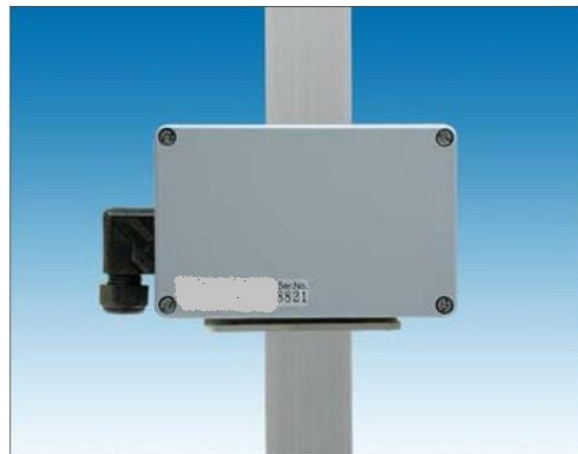
Horizontal Beam Sensor

Vertical Beam Sensor

Figure 5-11: Beam Sensors (Slope Indicator Company)

Beam Sensors – Similar to tiltmeters, beam sensors are high resolution electrical instruments that are mounted on horizontal or vertical beams to monitor differential movement and rotation in structures.

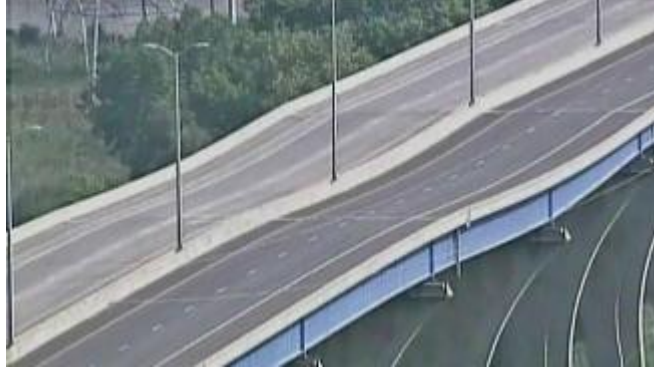
Figure A-2: Sagging Leo Frigo Memorial Bridge (Thompson, 2013)

On September 25, 2013, Pier 22 suddenly settled approximately 2 feet between 3:00 and 3:45 AM. The bridge was closed after motorists called 911 early that morning to alert authorities about the resulting dip in the bridge deck. The vertical displacement of the 400-foot-long span of the bridge deck is shown in Figure A-2 (Phelps, 2013; WisDOT, 2015)

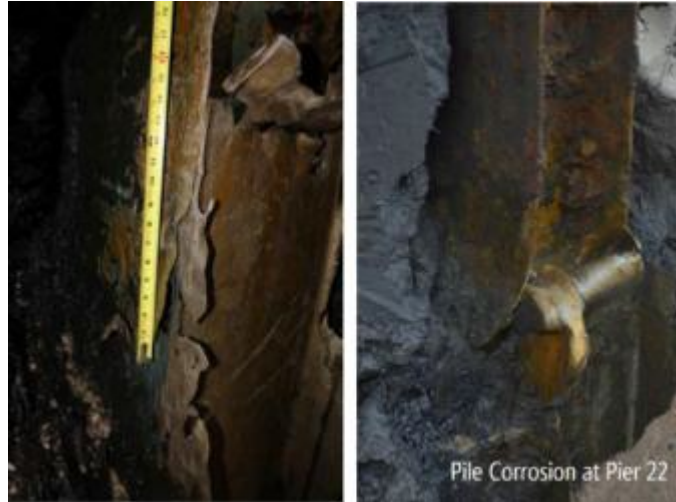
Figure A-3: Pile Corrosion at Pier 22 (Source: Wisconsin DOT)

Subsurface explorations began on September 28 to investigate the cause of the sudden settlement. Robotic survey instrumentation was also installed to monitor any additional movement of the pier. Investigations revealed corrosion and subsequent buckling of the deteriorated steel H-piles supporting Pier 22 caused the observed settlement. Figure A-3 shows pile corrosion found under Pier 22. Pile corrosion was also found underneath Piers 21, 23, and 25. Investigations determined that the composition of industrial byproduct fill placed in the area of the corroded piles prior to construction interacting with groundwater led to accelerated steel pile corrosion. The porous fly ash fill had high levels of chlorides and sulfides and low resistivity, leading to increased corrosion. A clay layer underlying the fill also led to high differential oxygen levels and chemical concentrations, providing a corrosive environment. Microbial activity also likely played a role in increasing corrosivity. The problem was not detected earlier as checking for pile corrosion is not part of regular bridge inspections. (Phelps, 2013; WisDOT, 2015)

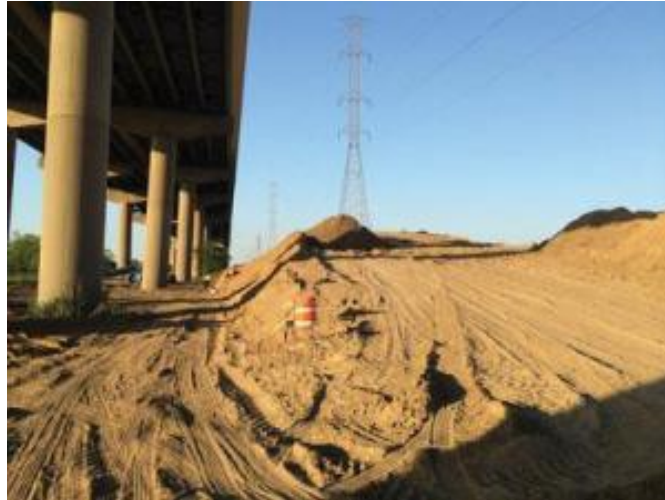
Figure A-6: Tilting bridge piers and adjacent soil stockpile (O'Shea, 2015)

The bridge was closed on June 2, 2014 after it was observed that 60-foot-high piers on the northbound side were tilting toward the east (Moffitt and Shelly, 2015). The damage was observed by a geotechnical engineer who was working for a third party and was on site to investigate whether a soil stockpile on adjacent private property had caused damage to an underground petroleum pipeline. The stockpile was adjacent to the northbound side of the interstate, specifically in the area of bridge piers 11 through 14. These piers were tilted as much as four percent out of the vertical alignment, resulting in an 18-inch difference in elevation between the median barriers. Subsequent investigations found that the stockpile had caused the bridge foundation failure by inducing lateral loads and deformations (lateral squeeze) into the thick soft clay layer, resulting in lateral displacements of the piles of up to two feet. Figure A-6 shows the soil stockpile adjacent to tilting piers. (Mohammad and Armfield, 2015; Burke and Montgomery, 2014)

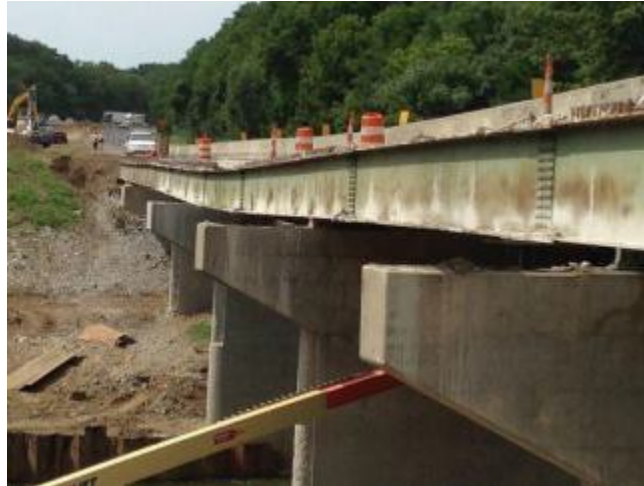
Figure A-8: Post-Failure View, I-65 Bridge, Lafayette, Indiana (McCoy, 2015)

Repairs to Pier 3 consisted of 12 high-strength, small-diameter steel micropiles installed through the pier's footing to a depth of 67 feet and a steel-reinforced concrete block installed around the existing bridge pier to transfer pier loads to the micropiles. A test micropile was installed near Pier 3 first to verify load capacity. To help mitigate the influence of artesian pressure, low mobility grout was injected during the drilling process. After the piles were installed, the bridge deck was jacked back up to its original position and steel supports were installed (McCoy, 2015). When the structure was jacked up, the contractor used H-piles for temporary support to facilitate rocker bearing restoration. The H-piles were available on-site, facilitating the quick implementation of this emergency repair. Figure A-8 shows the I-65 bridge deck following the failure. (INDOT, 2015; McCoy, 2015)

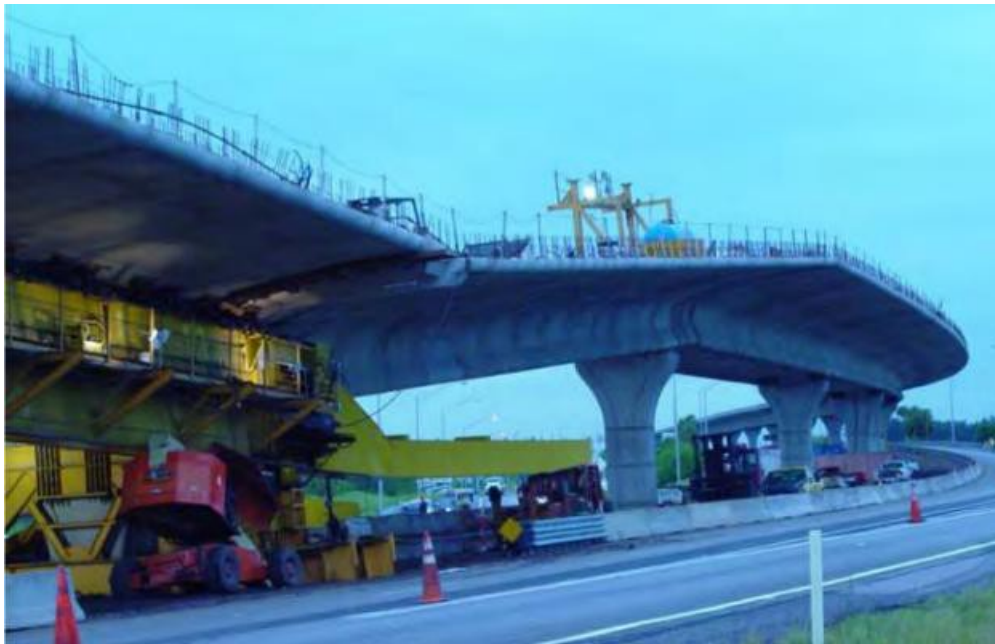
Figure A-10: Collapse of Pier 97 in April, 2004 (Graham et al., 2014)

In April 2004, approximately 14 months into construction of the elevated lanes, Pier 97 suddenly settled 11 feet (Samuel, 2009). The photograph in Figure A-10 shows the damage from the sudden settlement.

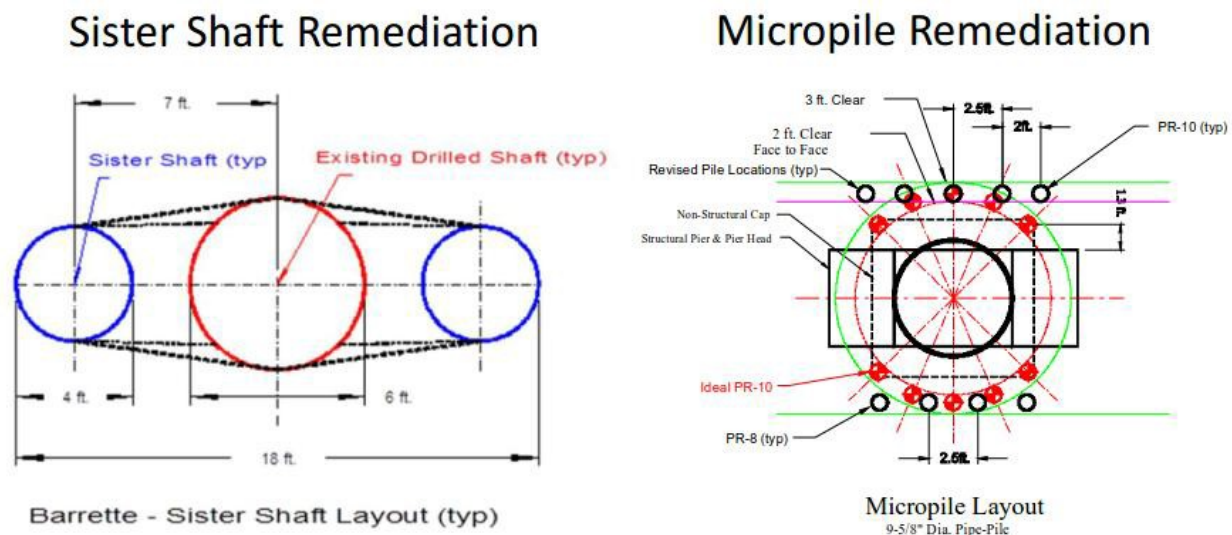
Figure A-11: Remediation techniques selected (Dapp et al., 2013)

Repairs were paid for by the owner, Tampa Hillsboro (Toll) Expressway Authority (THEA), but subsequently were the subject of a claim by THEA for recovery of these costs. Specific information about procurement of the repair work was not found in reviewed literature. Depending on geological conditions, the insufficient piers were either retrofitted with micropiles or drilled shafts. Four to ten micropiles, depending on soil conditions, were installed to augment existing foundations at 87 of the piers. Two 4-foot diameter “sister” drilled shafts were installed for support at each of the remaining 67 drilled shafts that needed remediation. Post-tensioned foundation caps were used to connect the existing foundation with the new drilled shafts. Figure A-11 shows schematics of the two different types of remediation. Multiple borings at each pier were taken and correlated to results from full scale dynamic testing previously done for recently constructed piers to determine if/how much additional support was needed (Samuel, 2009; Graham et al., 2014).

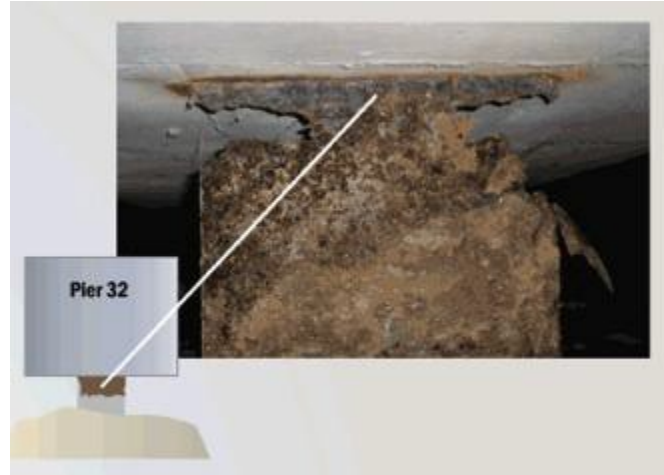
Figure A-14: Pile corrosion under Pier 32 (Paint Square, 2013)

In November of 2013, during a scheduled bridge inspection, Minnesota Department of Transportation (MnDOT) inspectors discovered pile corrosion near the connection to Pier 32 of the southbound bridge, where the bridge is just 4 feet off the ground. Figure A-14 shows the observed damage. Excessive moisture and poor drainage were thought to be the causes of the corrosion. Another potential contributor is the high chloride content from salt washing off of the bridge deck during winter, increasing corrosivity. The entire bridge was closed on November 18, 2013 in order to better assess the condition of piles. (Kraker, 2013; Paint Square, 2013)

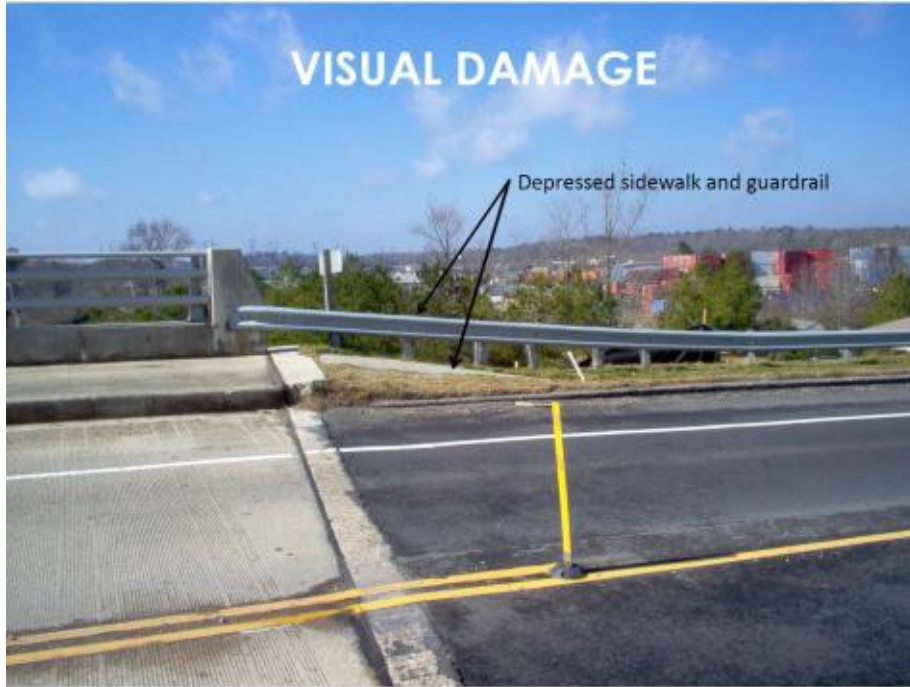
Figure A-16: Damage from Settlements (DeStephen, 2015)

Settlements of 2.5 feet to 3.5 feet were expected from approach embankment loading during the original construction of the bridge. Since eighty percent of this settlement was expected to occur over 3 months, so the embankments were constructed and allowed to settle for 3 months before bridge construction began. However, by 2000, additional settlements of up to 2.5 to 3 feet had occurred at the approach embankments after the end of the bridge construction. Figure A-16 shows sagging of the approach at the surface from excessive embankment settlements. A study conducted in 2003 concluded that original analyses did not properly calculate anticipated settlements or account for downdrag effects on the foundation piles. Up to 22 more inches of consolidation of the soft clay layer under the existing embankment load was possible. Damage to the bridge from settlement included cracked beams, buckling of slope protection, and cracked wing walls. Investigation into the abutment foundations indicated that the piles supporting the abutment were severely damaged. Figure A-17 shows the tensile failure of a pile due to downdrag and the void beneath the abutment foundation. (DeStephen, 2015)

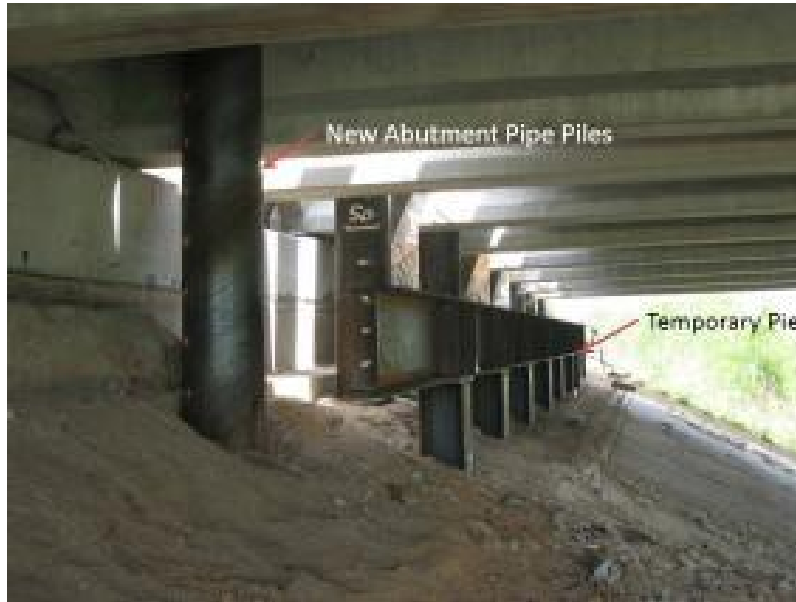
Figure A-18: Repairs and New Foundations (DeStephen, 2015)

was decided to reconstruct the bridge abutments while the piers and bridge spans were left in place. Sixteen-inch diameter steel pipe piles were installed as new foundations for the abutments. The piles were coated to reduce friction. Temporary shoring and steel H-piles were used to support the structure during abutment reconstruction. Square access holes were cut in the bridge deck to install the piles. Figure A-18 shows the temporary and permanent foundation elements replacing the original pre-stressed concrete piles. (DeStephen, 2015)
