Underwater Inspection of Bridge Substructures Using Imaging

Course No: S12-001
Credit: 12 PDH

This course was adapted from the Department of Transportation, Publication No. DOT-FHWA-HIF-18-049, “Underwater Inspection of Bridge Substructures Using Imaging Technology”, which is in the public domain.

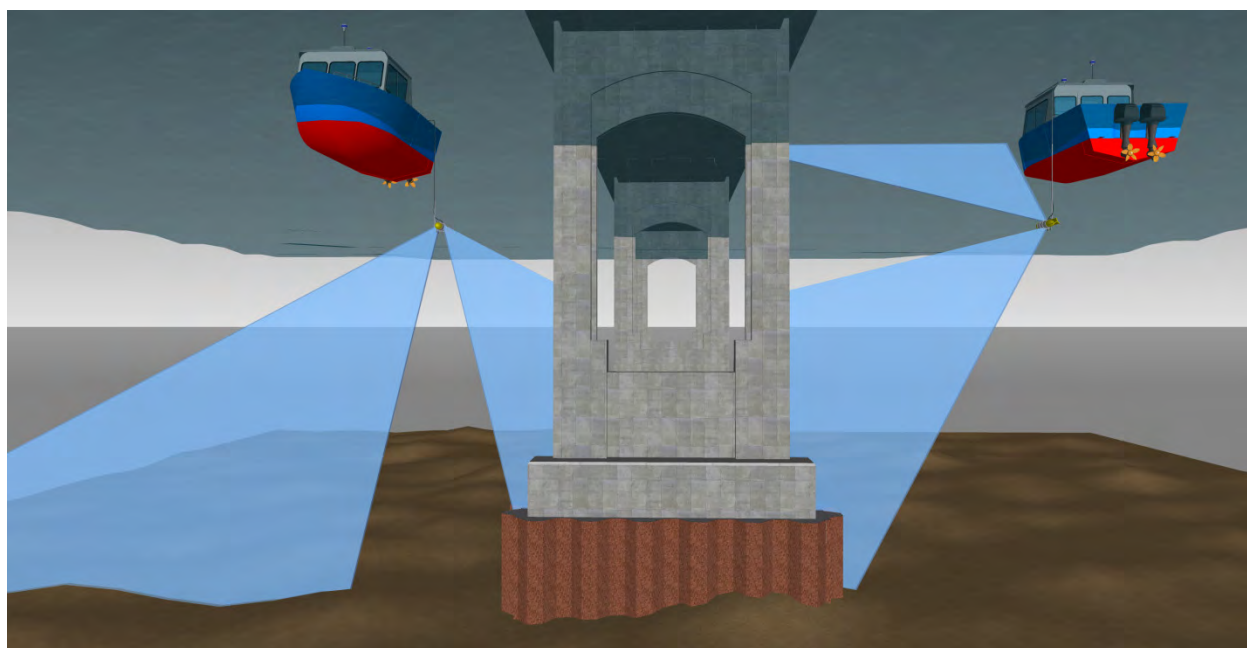
The primary limitation of side-scan sonar is the difficulty generating images of the vertical components of submerged structures. It is possible to image vertical components of bridge substructures if the transducers are rotated 90 degrees and pole-mounted. The quality of the image that results is largely dependent on operator ability to maintain a close and constant distance to the pier face and maintain a constant speed past the bridge pier.⁽¹³⁾ Figure 14 demonstrates the beam pattern that a side-scan sonar produces when being utilized for bottom scanning and when rotated 90 degrees for imaging vertical surfaces.

Figure 14. Graphic. Side-scan sonar mounting positions for structural imaging (right) and bottom scanning (left).

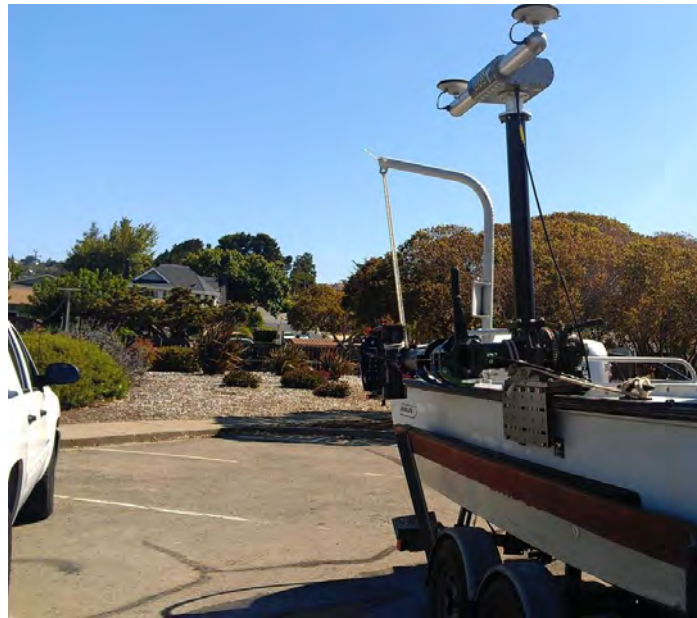
Figure 21. Photo. 3D real-time multibeam sonar mounted on the boat.

Setup and mounting of the equipment is shown in figure 21.

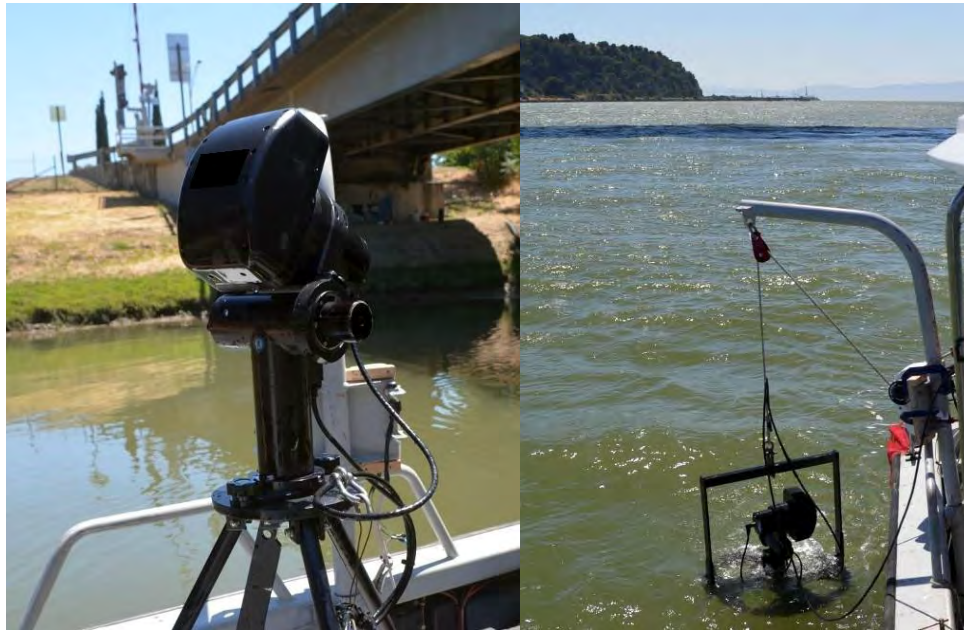
A. Tripod.

B. Heavy plate.

Figure 23. Photo. Stationary mounting methods.

In addition, a 3D mechanical multibeam scanning sonar was used by inspection team B. This unit requires stationary mounting, usually on the water body bed. A tripod and a heavy-plate mounting were both used in this study as shown in figure 23. The 3D mechanical multibeam scanning unit had a beam pattern of 1 degree by 1 degree with a 0.18 degree spacing. The mechanical step size was a minimum of 0.4 degrees.

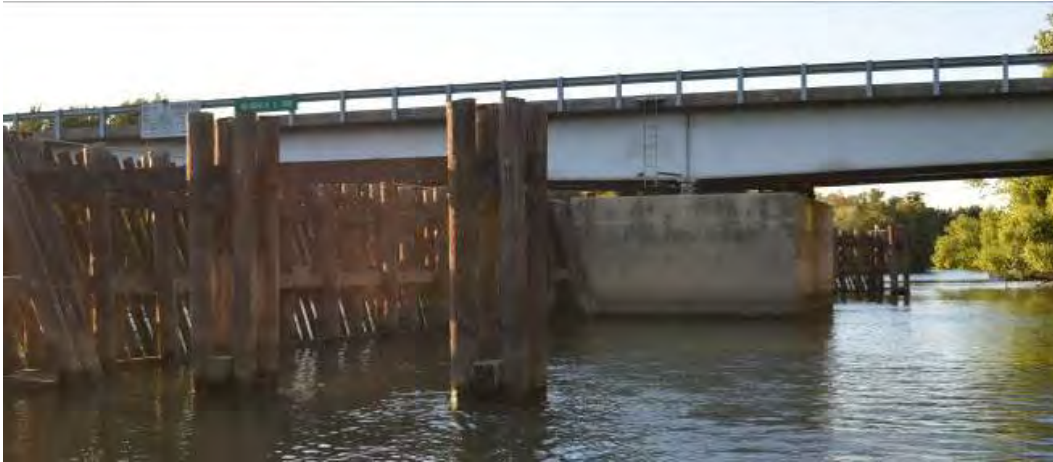
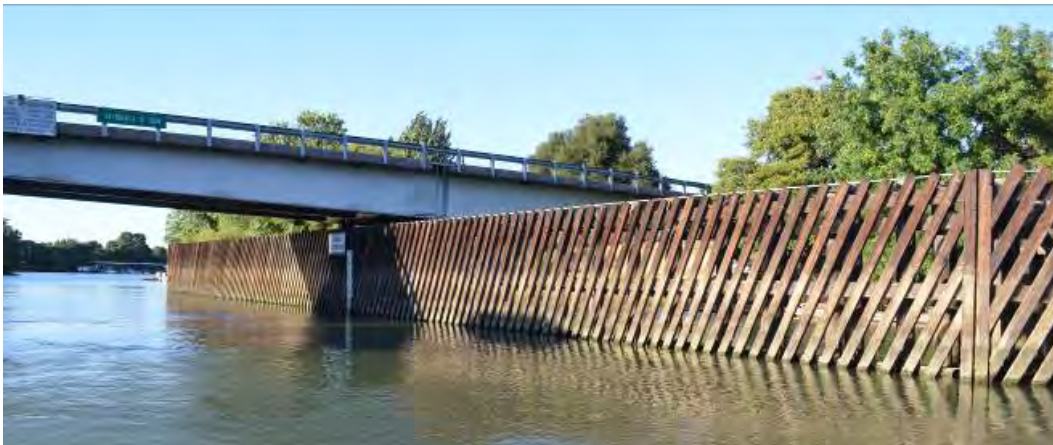
A. Looking north behind the timber fender.

B. Looking north from the main channel.

Figure 24. Photo. The Georgiana Slough Bridge.

The Georgiana Slough Bridge, shown in figure 24, is located on Isleton Road crossing Georgiana Slough near Walnut Grove, California. The main feature is a pivot pier (pier 2) supported on concrete-filled steel piles. It also features a treated timber fender system next to the pier and across the stream. An as-built drawing of the bridge is provided in figure 25. Post-test discussion with Caltrans revealed that previous inspections reported that the main pier has tilted.

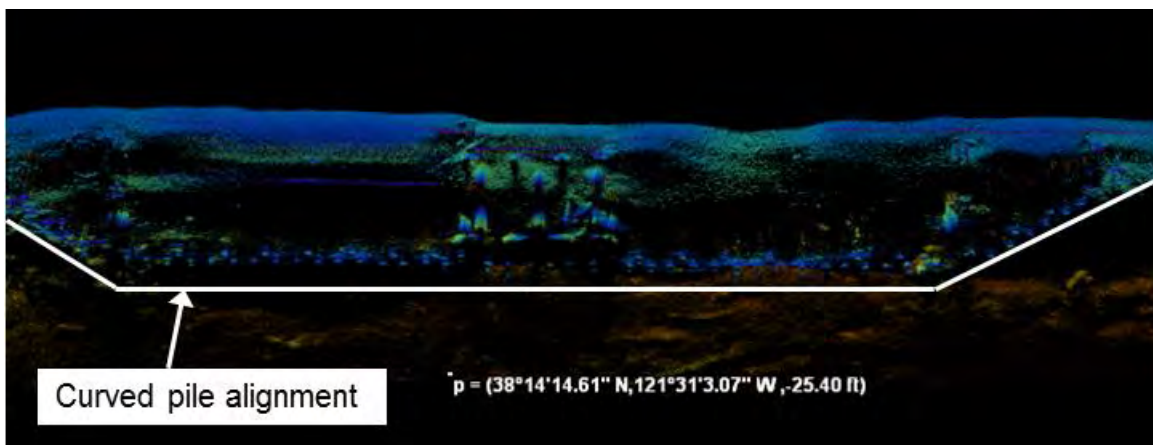
Figure 27. Image. Curved pile alignment in plan view (Georgiana Slough).

Using a real-time multibeam sonar, inspection team A collected data in the field that produced images that captured general pile features. The images in figure 26 and figure 27 reveal the piles supporting the fender in profile and plan view, respectively. In the profile view, it is evident that several piles are not aligned vertically. In the plan view, the curved alignment of the set of piles is clearly seen.

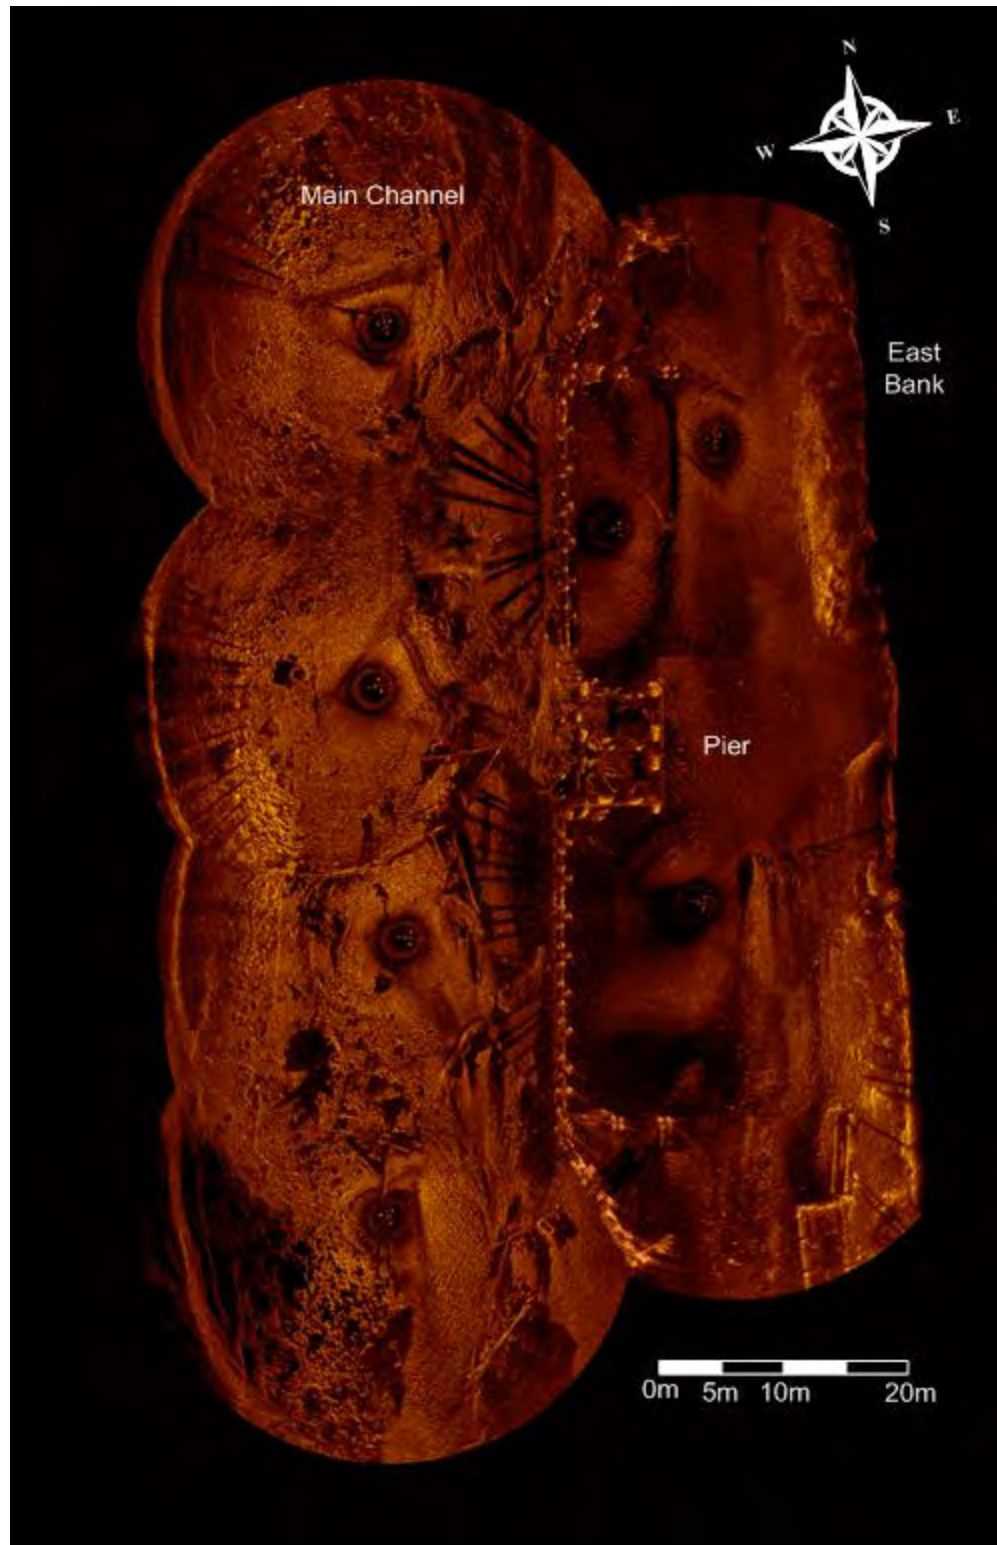
Figure 34. Image. Mosaic of bottom drop images.

Inspection team C used 2D sector-scanning sonar and 3D profiler sonar to collect riverbed and vertical visualization scans of the underwater portion of pier 2 of the Georgiana Slough Bridge. Bottom scans, taken with the sonar head fitted onto a tripod, were collected adjacent to the structure. The bottom scan locations are shown in figure 33 with a resulting mosaic of the drop images shown in figure 34. The bridge pier, piling, bathymetry, and some debris are visible.

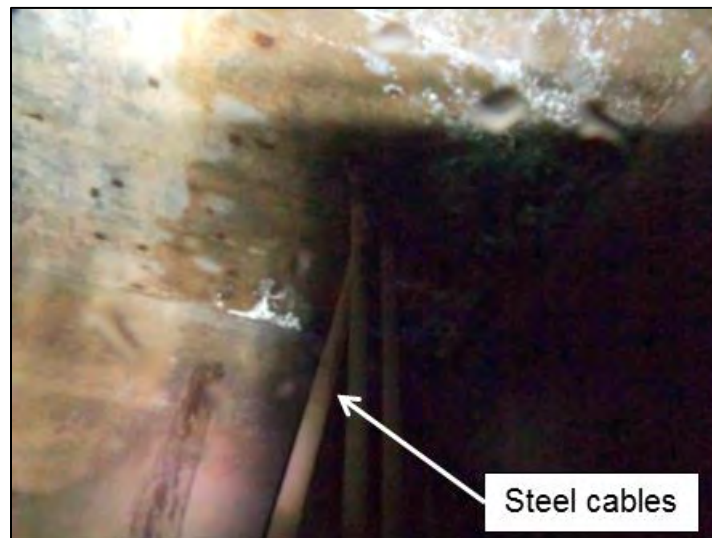
Figure 37. Photo. Above water view of steel cables.

- Three 4-inch (100 mm) diameter steel cables were observed extending vertically from the northwest quadrant of the south bay to the channel bottom as shown in figure 37.

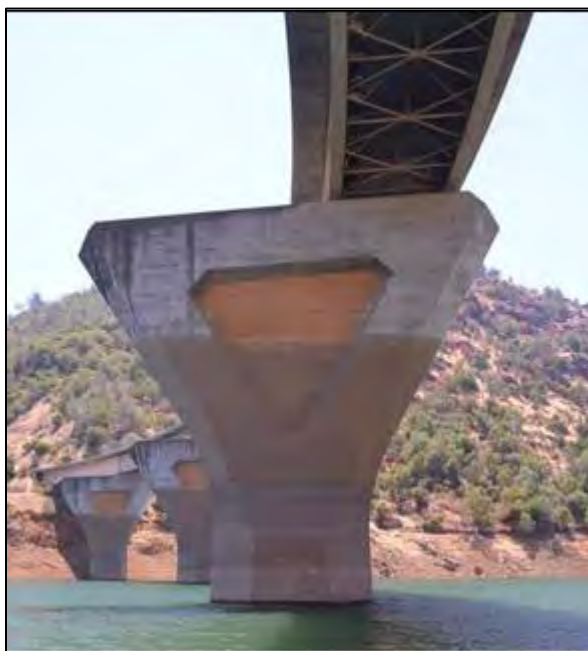
Figure 38. Photo. Northwest face of bent 4.

girder superstructure. Bent 4, shown in figure 38, was selected for inspection. Figure 39 provides an as-built drawing of bent 4. This bent has the greatest height among the 5 bents at 229 ft (70 m). While the water surface varies with season, the depth of water at the bent on the day of testing was approximately 150 ft (46 m).

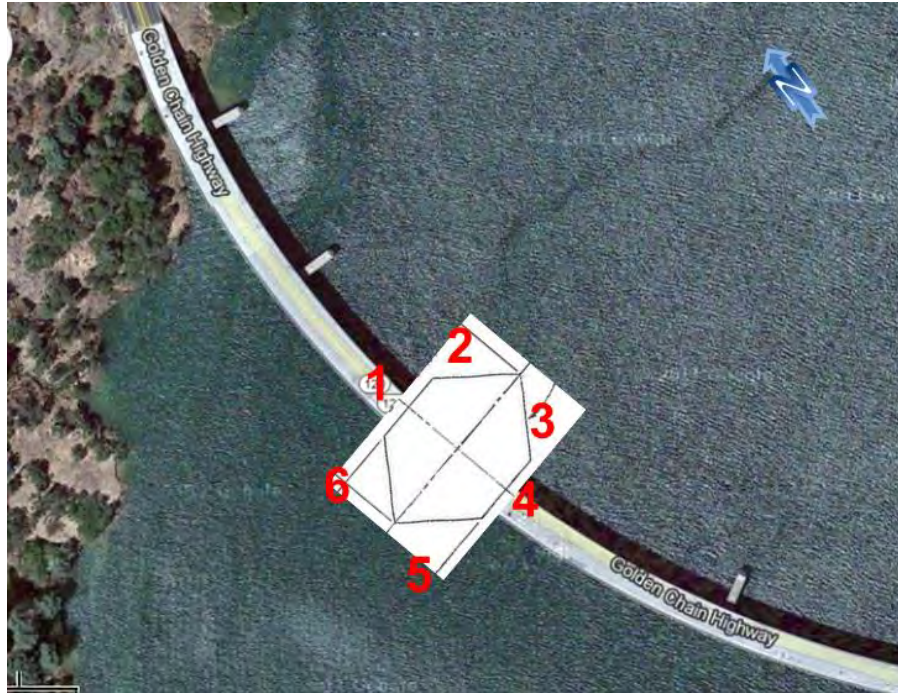
Figure 43. Image. Bent 4 face naming convention.

Figure 43 displays a plan view of the James E. Roberts Bridge with the naming convention used by inspection team B to label data and images on bent 4. Figure 44 is a sonar wing close-up of the base of face 3 that reveals evidence of an anomaly on the surface.

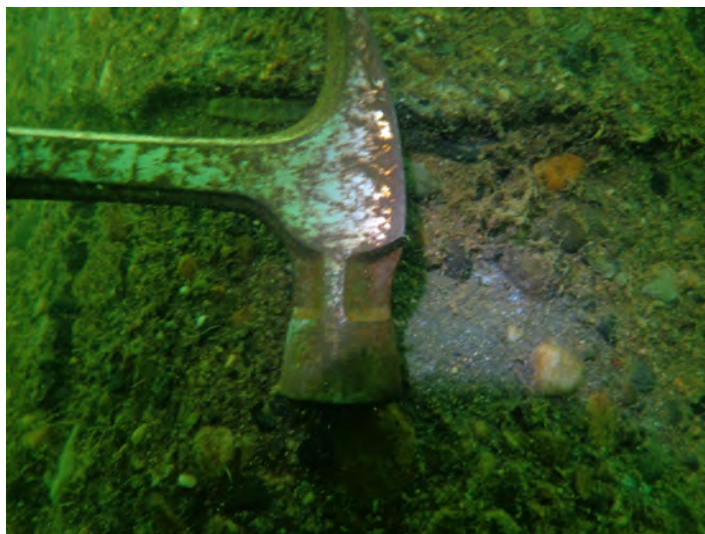
Figure 50. Photo. Typical cold joint after cleaning.

- Horizontal cold joints in the concrete surface were noted at 8, 23, 42, 66, 85, and 110 ft (2.4, 7.0, 12.8, 20.1, 25.9, and 33.5 m) below the waterline. Joints were created during original construction and did not exhibit any major deterioration. Figure 50 shows an example of a joint after level II cleaning at a depth of 23 ft (7.0 m).

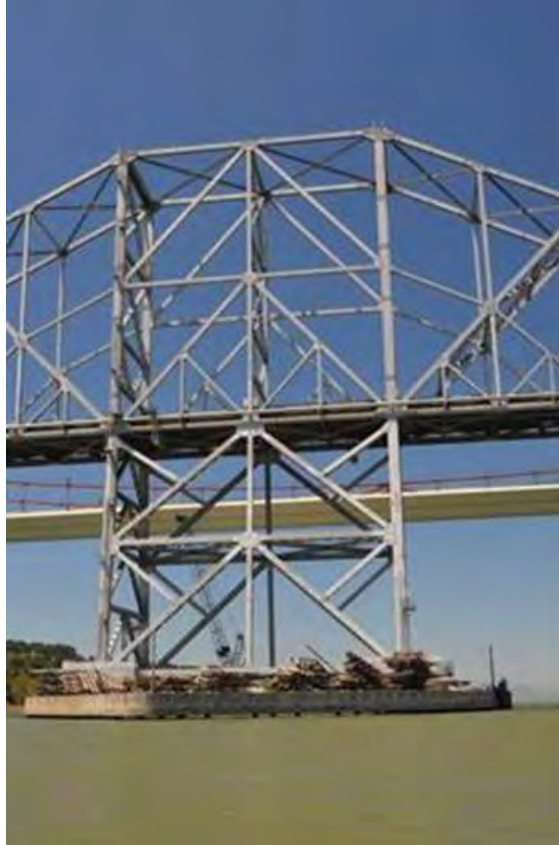
Figure 51. Photo. Pier 3 of the 1958 Carquinez Bridge (2003 bridge in background).

The Carquinez Straight connects San Pablo Bay and Grizzly Bay/Suisun Bay. The older of two parallel spans was built in 1958. The truss bridge is supported at bent 3 on two large concrete footings as shown in figure 51 with a plan view displayed in figure 52. A large concrete fender system surrounds the foundations of the 1958 bridge and a demolished 1927 bridge. The timber fascia of the fender has been removed and part of the fender near the 1927 bridge foundation has been demolished. Swift current and turbid water conditions are common. Figure 53 provides an as-built drawing for bent 3.

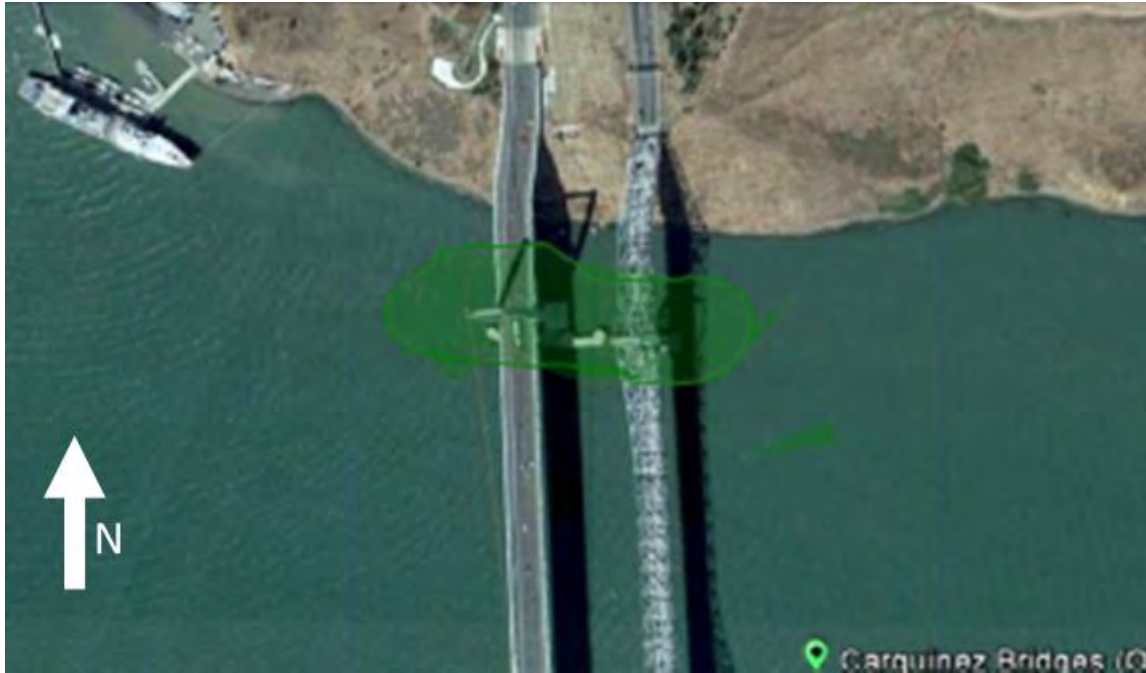
Figure 60. Photo. Aerial view of tower 3 (2003 bridge on the left).

A second span crossing of the Carquinez Straight parallel to the 1958 span was built in 2003 and is shown in figure 60. Tower 3 of the 2003 Carquinez Bridge, shown in figure 61, is founded on two prestressed concrete pile caps, each supported on six 10-foot (3.05 m) piles, and linked by a bridging element. Figure 62 shows the pier at the water level. Figure 63 provides the as-built drawing for this location.

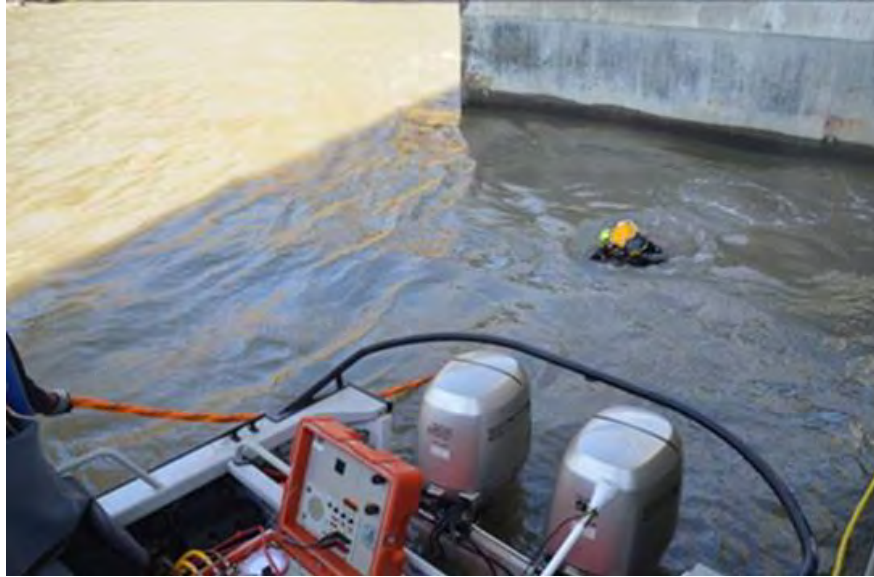
Figure 69. Photos. Wave and current condition during the diving operation.

With respect to the diving team at the Carquinez Bridge, the first dive was timed close to a slack tide. Overall, the current was manageable, but challenging for the divers. Examples of the water surface conditions are shown in figure 69. In addition, the depth was approximately 90 ft (27 m). The diver used the maximum amount of time allowed for the depth (30 min) to inspect one pile including one level II cleaning. The second dive occurred at a time between slack tide and maximum current. Inspection was nearly impossible because of the current. While the estimated current was likely between 2 ft/s (0.6 m/s) and 3 ft/s (0.9 m/s), the diver reported experiencing an approximately 4 ft/s (1.2 m/s) equivalent current. Based on the post-dive description and observation of the flow condition, it was hypothesized that the blockage caused by the massive pile cap might have produced a high velocity area some distance below the bottom face of the pile cap. This condition was hazardous for the diver.

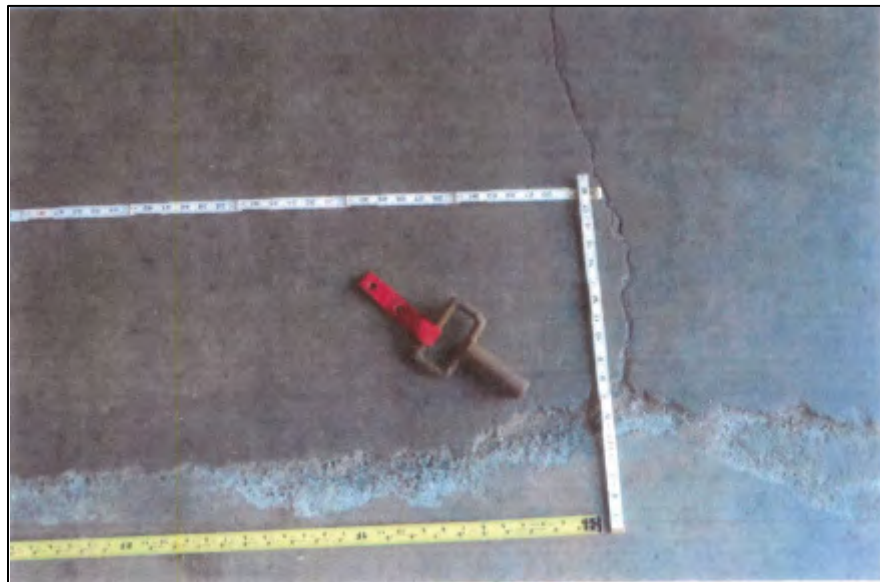
Figure 75. Photo. Target number 4: a steel pin with handle.

- Target 4: A steel pin with handle, 6 inches (150 mm) overall with 3.5-inch (90 mm) by 1.25-inch (32 mm) pin and a 4-inch (102 mm) by 2.5-inch (63 mm) handle (see figure 75). This target was bolted to W6 west face (15 ft (4.6 m) from the north corner and 15 ft (4.6 m) below the smooth concrete/formwork interface).

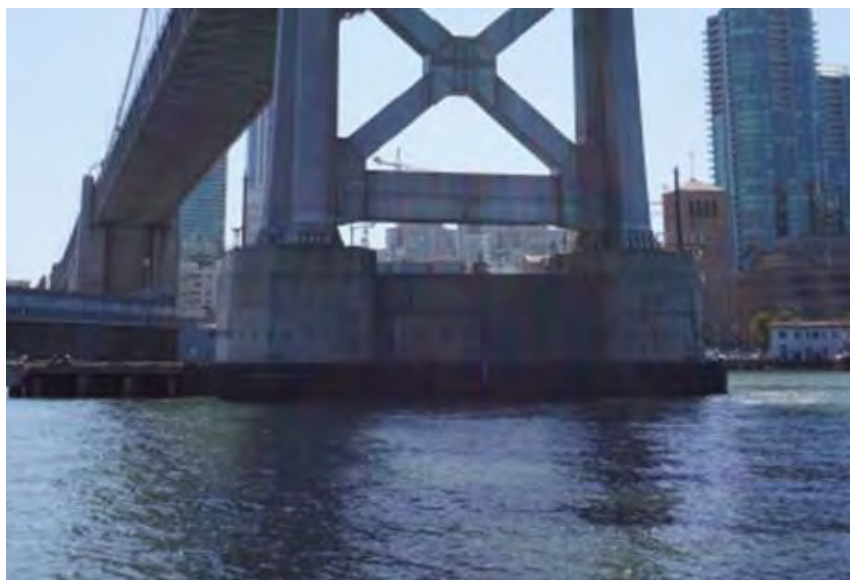
Figure 76. Photo. Pier W2 viewed from the east.

The SF–OBB, west span carries traffic over the San Francisco Bay between Yerba Buena Island and San Francisco. The bridge consists of six suspension spans. The superstructure is supported by two abutments and five intermediate piers. The piers consist of submerged concrete cofferdams beneath concrete pedestals that support the steel towers. The piers are numbered from west to east, with pier W2 (figure 76) adjacent to San Francisco and pier W6 (figure 77) adjacent to Yerba Buena Island.

The caisson on pier W2 includes remnants of sheet pile, probably from the construction of the coffer dam. Also contained within close proximity to the west side of pier W2 are piles supporting a remnant of the old Wharf Pier 24, which had been truncated during the construction of the west span of the SF-OBB.

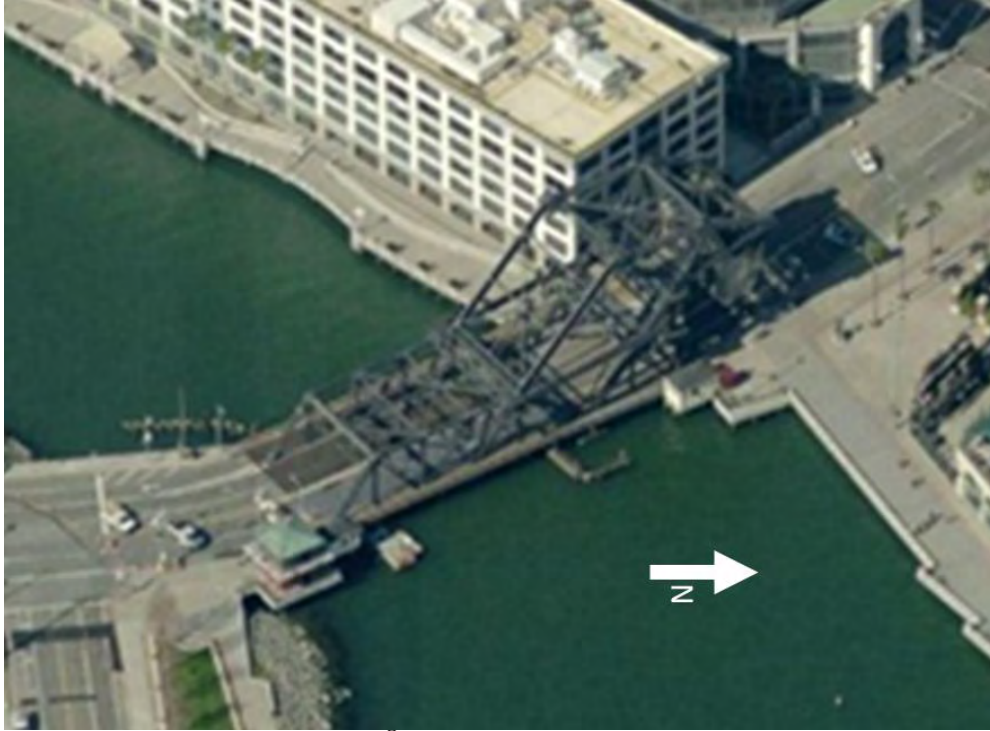
Figure 91. Photo. Third Street Bridge in San Francisco.

The Third Street bascule bridge, shown in figure 91, carries traffic over China Basin in downtown San Francisco. The bascule bridge has less than 3 ft (0.9 m) of vertical clearance at high tide and lifts from the north end when additional clearance is needed. The inspections focused on the piers adjacent to the main channel: pier 2 (the north channel pier) and pier 3 (the south channel pier). The south channel pier consists of two rectangular concrete supports founded on timber piles with a third concrete box between the two supports. The north channel pier consists of two rectangular concrete supports founded on timber piles connected by a concrete buttress wall.
