Earthquakes, Structural Defects, Structural Damages, and Possible Solutions

Course No: S02-038 Credit: 2 PDH

Ibrahim M. Metwally, Ph.D., P.E.

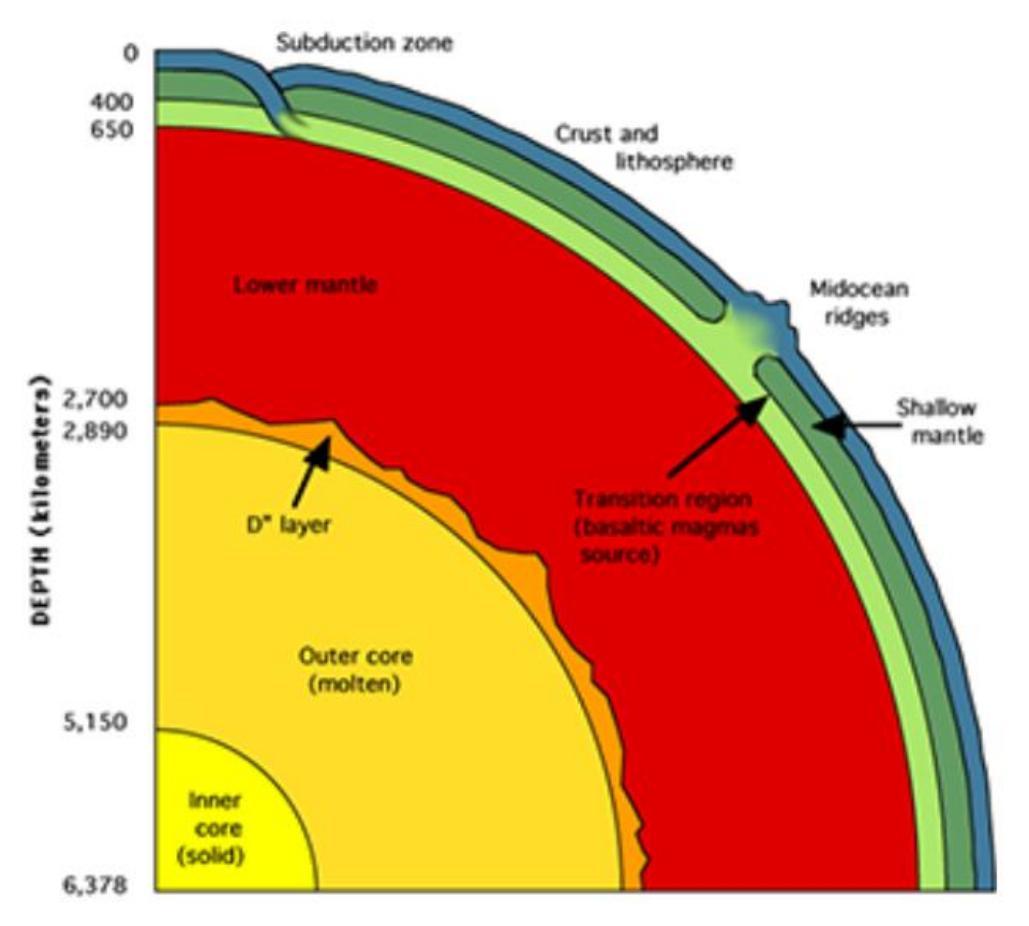
Figure 1. Earth Internal Structure.

The earth consists of layers which have different properties. The outer layer of the earth is called as "crust." The thickness of this layer is between 35 and 70 km for continents, and this thickness varies between 5 and 10 km thickness for ocean floor. Mantle layer, existed under the crust, is divided as lower mantle and outer mantle. This layer is approximately 2900 km thickness. Convection current occurred in the mantle causes plate tectonics in the crust. Core is the innermost layer and divides into two parts as fluid outer core and solid inner core. The outer layer is 2300 km, and inner layer is 1200 km thickness. The internal structure of the earth is shown in the Figure 1.

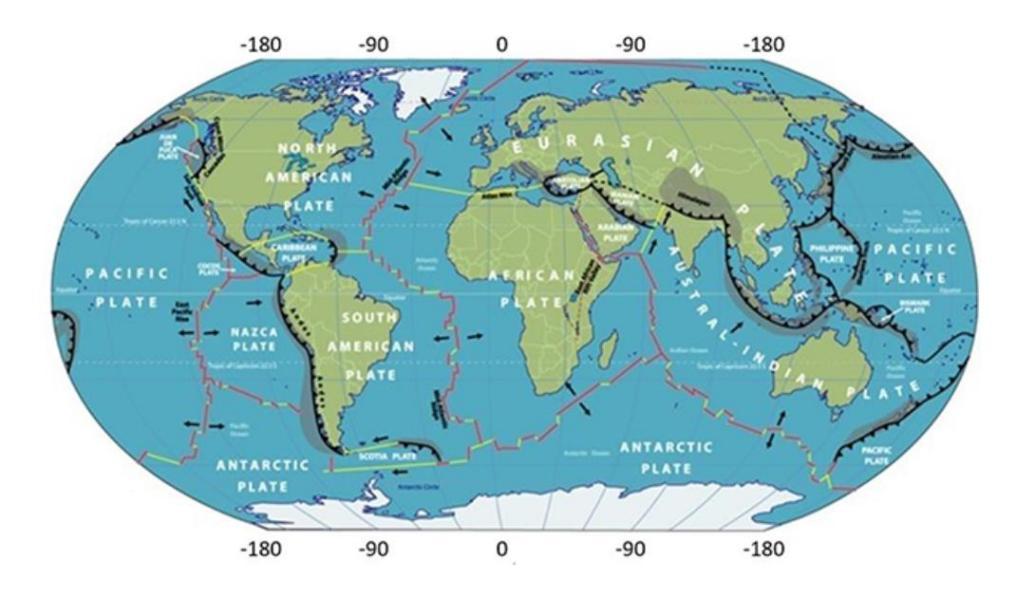
Figure 2. Tectonic plates.

Plate tectonic deals with movement and strain of earth crust. According to the state of the art of Plate tectonic, the earthquake occurs in some parts of the plate and these parts act relative to each other. Pressure shift arose from these action and cooling stages in mantle causes stresses in the earth crust. When the increased stresses reached to bearing capacity of the crust on faults, this event causes sliding (breakthrough). Sliding movement spreads outward starting from hypocenter. Strain energy, which cumulated for a long time, discharges with sliding and causes earthquake shaking. Propagation of wave from hypocenter that results surface sliding is perceived as earthquake. Figures 2 and 3 show the tectonic plates and worldwide earthquake distribution, respectively.

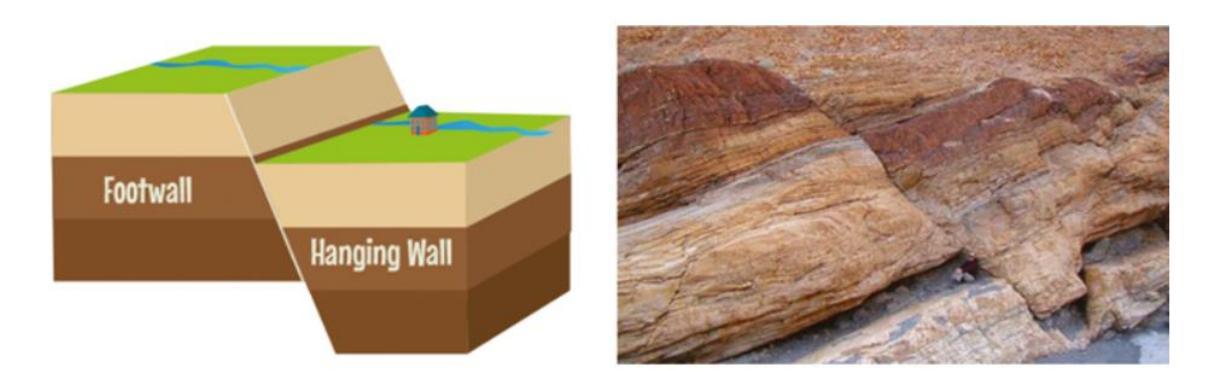
Figure 4- Normal fault graphical presentation and mechanism.

When two plates move with respect to each other, elastic strain energy is accumulated in results of tectonic processes. Thus, these two plates are released through the rupture of the interface zone. The shapeless blocks show immediate reaction towards equilibrium. As a result of this reaction, a seismic motion is produced. This process is called as "elastic rebound" theory. The resulting fracture in the crust of earthquake is defined as "fault". Figures 4–6 show fault mechanisms.

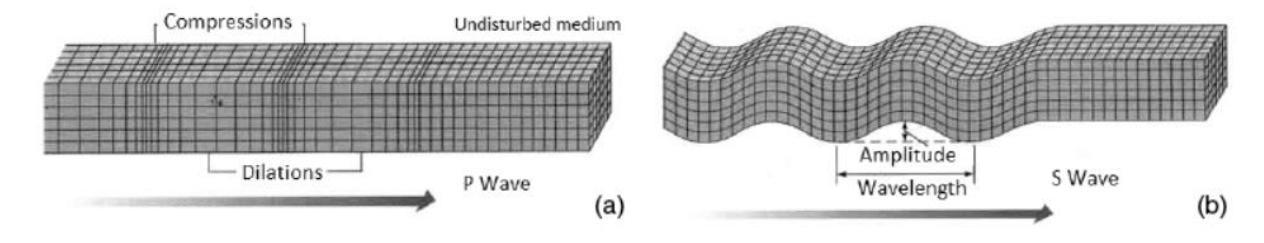
Figure 6. (a) Primary (P) wave and (b) Secondary (S) wave

Seismic activity that results in earthquake generates two types of seismic waves: body and surface. Body waves move through the interior layers of earth. Body waves include primary waves (known as P-waves) and secondary waves (also called as S-waves). P-waves generate sequential push (or compression) and pull (or tension) in soil as shown in below Figure 7a. P waves have relatively little damage potential. On the contrary, S-wave propagates horizontal and vertical motion. S-waves produce shear stresses in the soil along their paths as shown in Figure 7b.

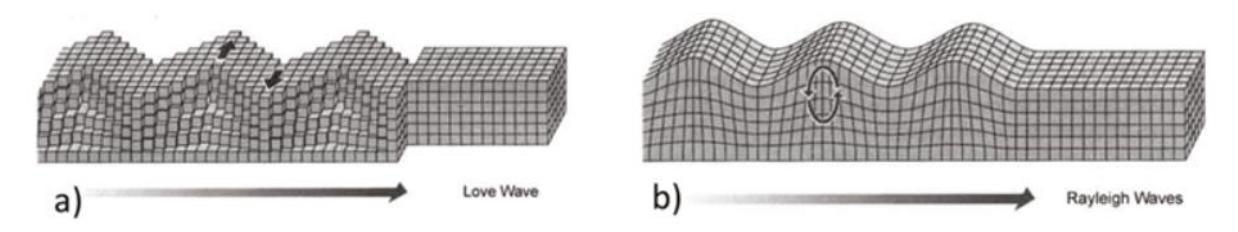
Figure 7. (a) Love (L) wave and (b) Rayleigh (R) wave.

Surface waves include Love (L) and Rayleigh (R) waves that propagate through the outer layers of the crust. These waves are generated by body waves move through parallel to the ground surface and various underpass the layer boundaries. These waves cause large displacements. These types of waves take various forms at a further distance away from the earthquake source. Surface waves are occurred during shallow earthquakes; on the other hand, body waves take place at all depths. Surface waves cause serious damage to structures due to their long duration. Figure 8a and b shows these types of waves.

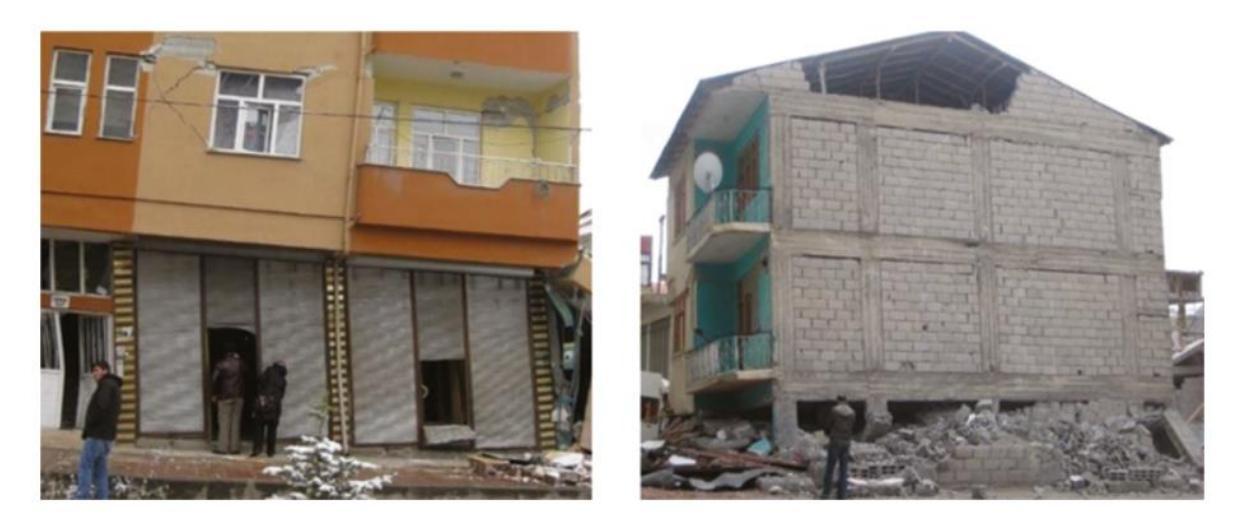
Figure 8. Unexpected inter-story drift due to soft story during the Van earthquake.

In some R/C buildings, especially at the ground floor, walls may not be continuous along to height of building for architectural, functional, and commercial reasons. While ground floor generally encloses with glass window instead of brick infill walls, partition walls are constructed above from this story for separating rooms for the residential usage. This situation causes brittle failures at the end of the columns. In mid-rise reinforced concrete buildings, the most common failure mode is soft-story mechanism, particularly at the first story. Failures can be concentrated at any story called as weak story in which the lateral strength changes suddenly between adjacent stories due to lack of or removing of partition walls or decreasing of cross section of columns. Thus, during an earthquake, partial and total collapses occur in these stories. These types of damages can be seen in Figures 9 and 10.

- The reason for soft story collapse is occurred due to the low rigidity of reinforced concrete structural members on the ground floor. In case of the absence of the infill wall, the rigidity of the ground floor is lower than the upper stories. Thus, this failure mechanism is triggered by the earthquake. This type of failure is prevented during the design phase by designing with more detail.

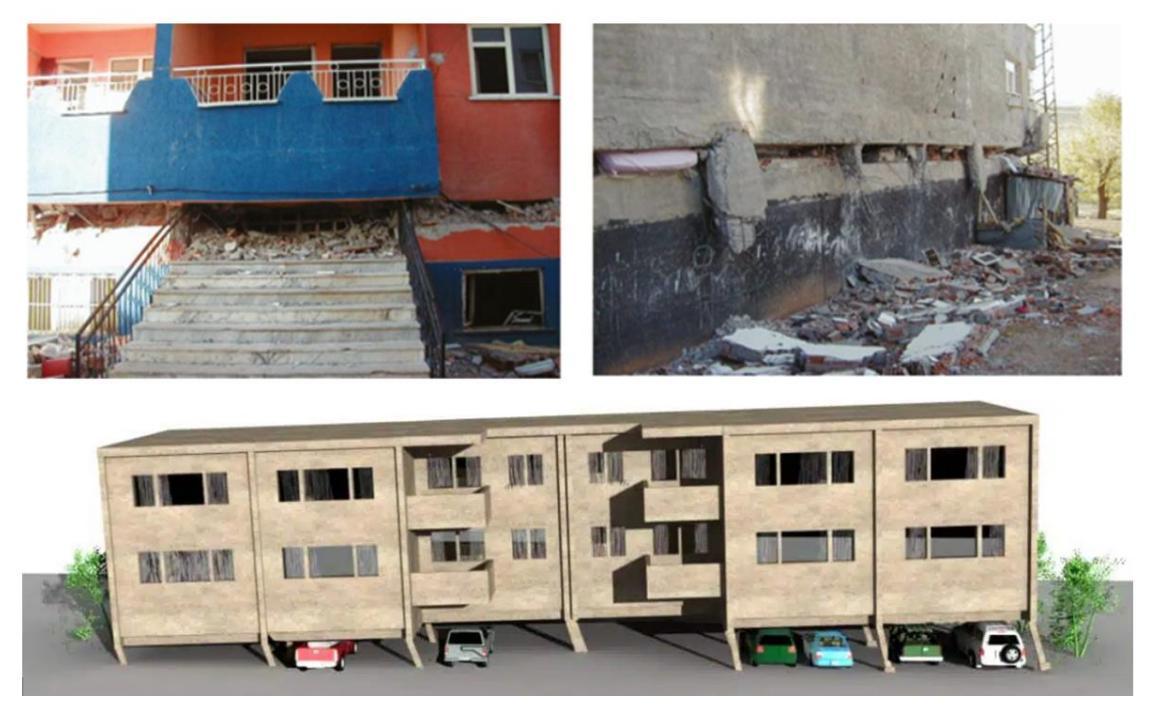
Figure 9. Weak story mechanism during the Bingöl earthquake.

When the lateral loads from the earthquakes are applied, floors with high lateral safeness will be able the bear the forces and control the lateral deflections. However, soft story will have excessive lateral deformation leading the failure of the floor. <u>These kinds of failures result in collapse of the structures.</u>

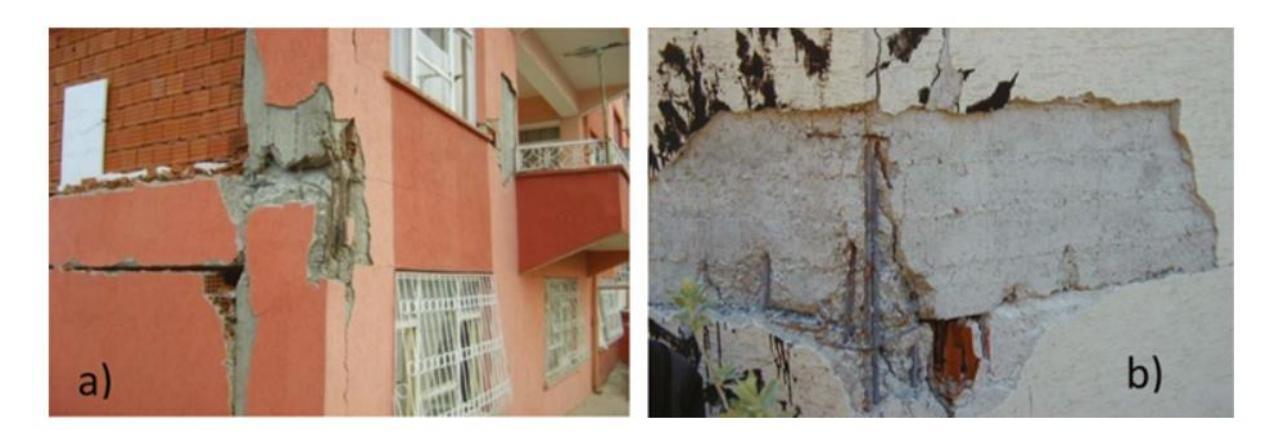
Figure 10. Damaged structure due to inadequate spacing between shear reinforcements during (a) Van earthquake and (b) Bingöl earthquake.

Shear forces increase during an earthquake especially at columns and beam–column joints. Consequently, special attention should be paid to construction and design of beam–column joints and columns. Seismic design requires increasing of ductility of structures for performance-based design approach. In particular, columns of buildings can be having insufficient transverse reinforcement in the plastic hinge region. Therefore, structural elements which have such details show low performance against to dynamic loads and lost their shear and axial load carrying capacity. Figure 11 shows this failure below.

- Inadequate transverse reinforcement and no bending of hooks or ties in structural elements cause damage. This problem can be solved by using close-spaced stirrups and 1350 bent hooks to increase the shear resistance of structural elements.

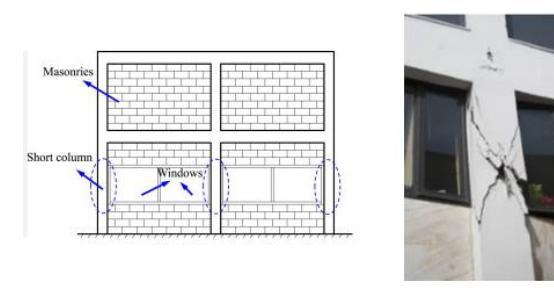
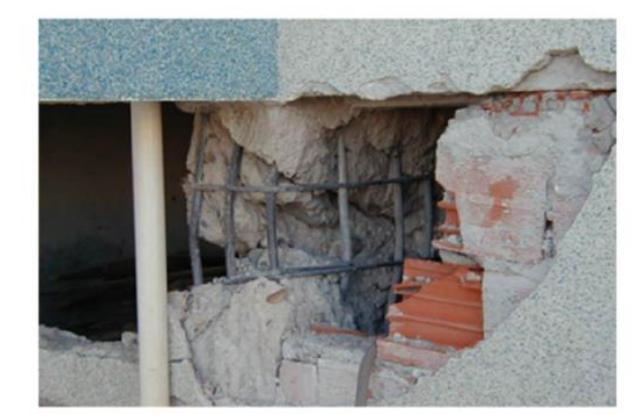
Figure 11. Short column damages during the 2003 Bingöl earthquake.

This type of mechanism can be developed due to structural adjustments and/or to continuous openings at the top of infill walls between columns. Lateral forces that occurred by an earthquake are carried by columns and shear walls. Length of column is an important factor for dissipation of these loads. When the length of column decreases, the column becomes stiffer and brittle than the other columns and this column attracts more shear forces. Thus, shear failure which is a critical type of concrete column damage occurs at these columns.

Special attention is required for short columns and hence recommended to avoid in building design especially for earthquake-prone areas. The effect of a short column is disastrous as they undergo brittle shear failure. Short column failure is given in Figure 12.

- 1) The first possible solution is to avoid the use of a short column in the architectural design stage itself.
- 2) If short columns cannot be ignored, special design requirements are followed. As per ACI 318 code, for those columns that have chances to undergo short column effect will require special confining reinforcement called the ductile reinforcement. The reinforcement provided must extend to the columns below and above by a certain amount as stated in standards.
- 3) In order to reduce the short-column effect on an existing building. The openings are closed by constructing a full-height wall.

4) If wall building is not possible, the short columns have to be retrofitted by any existing methods. A quality structural engineer who has sufficient experience in this area have to implement this.

- Failures reason of short columns especially occurred due to partially filled infill walls in R/C frame system. These failures can be prevented by increasing of shear strength of this part of the column.

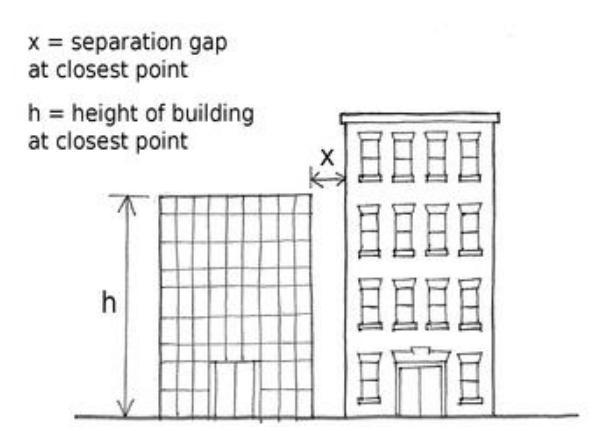
Insufficient or no seismic separation gap between buildings thus allowing them to pound and damage each other. A building can have pounding potential if the gap between buildings is less than 4% of the height (h) of the lower building see to figure below.

If x is less than 4% of h, the buildings can have pounding potential.

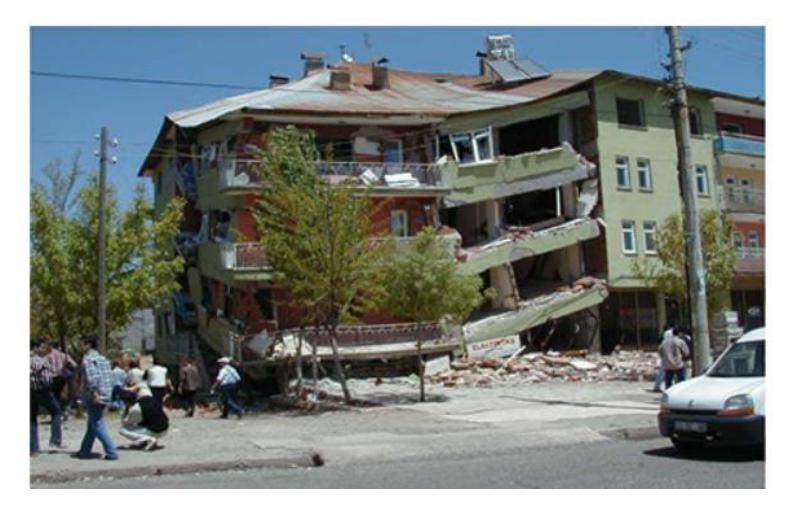
Figure 12. Collapse of adjacent buildings during the Bingöl earthquake.

Buildings are sometimes constructed adjacent because of the lack of building lots. In this layout plan, one or two faces of two buildings are in contact to each other. Consequently, the buildings that have not adequate gaps pound to each other during the earthquake. If the floors of the

buildings are not at the same level, pounding effect of the buildings becomes more dangerous. Figure 13 shows this type of damage during the 2003 Bingöl earthquakes.

- During the earthquake, after the first shake, different natural vibration periods cause a hammer effect and then result in total collapse. To prevent this problem, adequate gaps according to current codes should be left between the adjacent buildings.

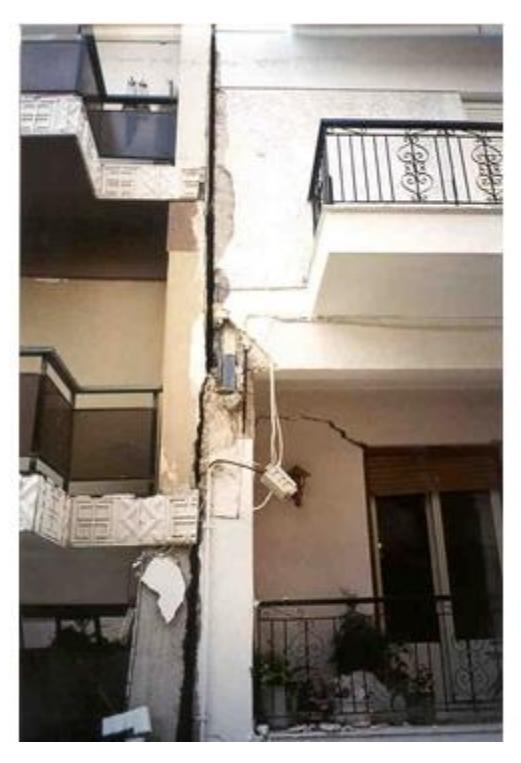
Damage due to pounding in reinforced concrete buildings with floors at different elevations in the 1999 Athens earthquake.

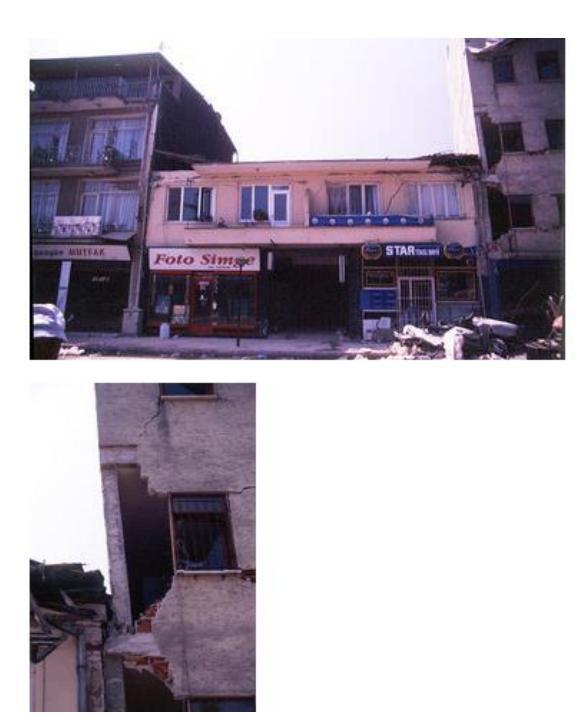
Pounding damage in adjacent buildings of different heights affected by the 1999 Turkey earthquakes

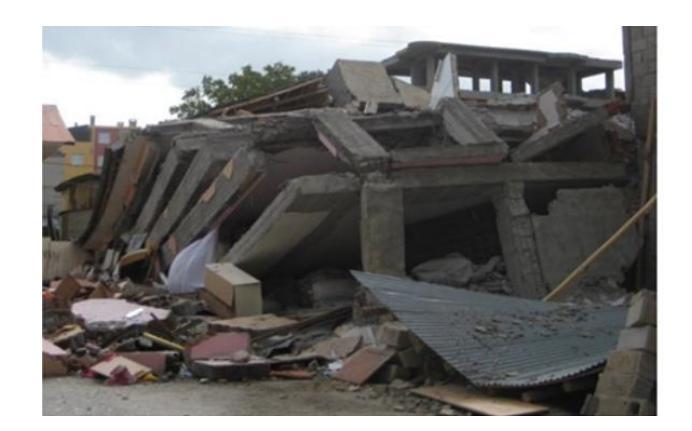
Figure 13. Failure of a building due to strong beam-weak column effect during the Van earthquake.

Deep and rigid beams are used with flexible columns in type of buildings. Therefore, these beams resist more moments, occurred by dynamic loads, than weak columns. In such a design during an earthquake while deep and rigid beams show elastic behavior, shear failure or compression crushing causes plastic hinges at flexible columns. Failure mechanism of strong beam–weak column can be seen in Figure 14.

- When deep and rigid beams are used with flexible columns, a weak column-strong beam failure mechanism is developed. To refrain this type of problem, the sum of moments at the column connected to any of the joints should be bigger than the sum of moments at the beam connected to the same joint.

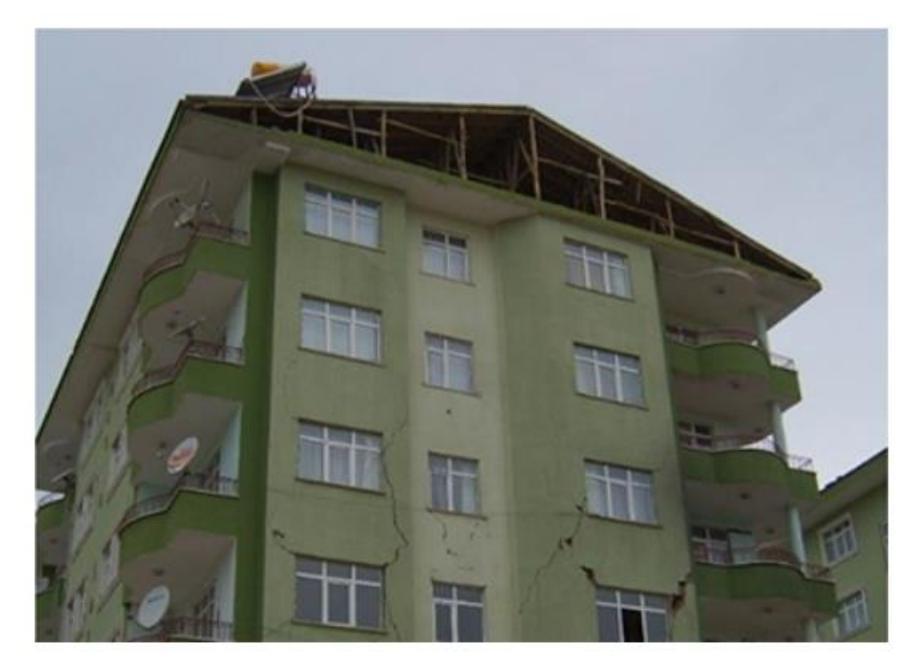
Figure 14. Failure of gabble walls on top of the building during the Van earthquake.

The most common failure mode at gable walls is out-of-plane collapse in the earthquakes. Although failures of gable walls are not structural damages, these damages may be causing loss of lives and properties. Stability problems and large unsupported wall lengths cause damages at these walls. Failure of gabble wall is presented in Figure 15.

- The reason for in-plane, out-of-plane, and gabble wall failures is the lower strength of infill materials than the reinforced concrete frames. To prevent this type of failure,

adequate connection and high-strength mortar between the wall and reinforced concrete frame should be used.

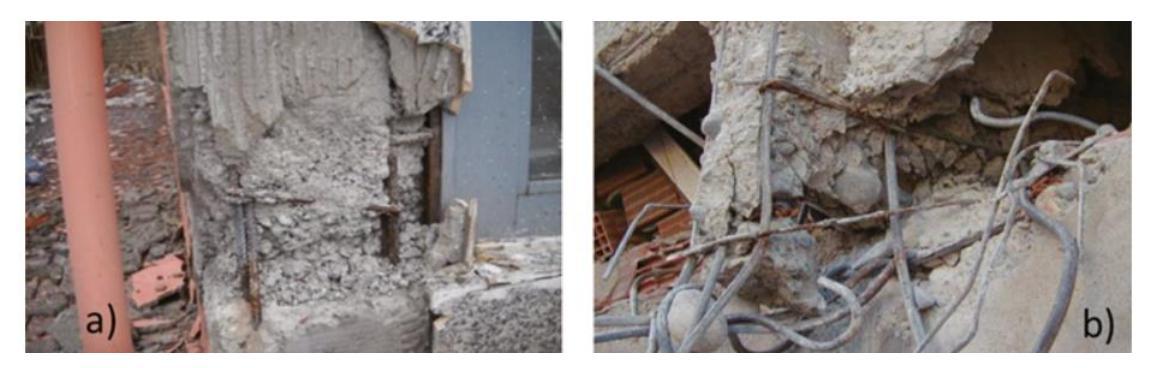
Figure 15. Failure of column due to poor concrete quality during; (a) Van earthquake and (b) Bingöl earthquake.

The other main reasons of damages are low concrete strength and workmanship. Concrete quality is an important factor for building performance against to earthquakes. Handmade concrete is used to without using vibrator in construction of old buildings. Thus, homogeny mixing was not obtained and expected compressive strength was not provided in these buildings. In addition to this, using aggregates that have improper granulometry, corrosion which decreases reinforcement bar area, and using smooth steel reinforcement affected the strength of concrete. This type of damages is given in Figure 16.

- Low concrete strength, workmanship, and corrosion of steel bars decrease the lateral stiffness of the structural system. This important reason can be eliminated by inspecting concrete and workmanship.

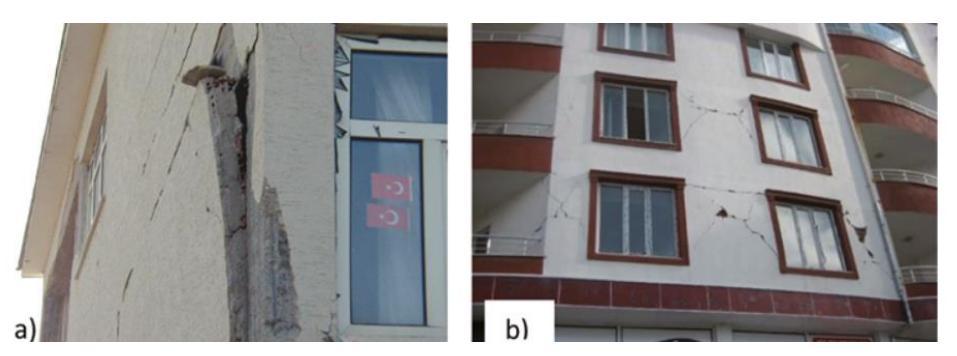
Figure 16. (a) Detachment of infill wall during the Bingöl earthquake and (b) In-plane damage of during the Van earthquake

One of the most important reasons for life and economic loss during the earthquake is the combined effect of in-plane and out-of-plane movement of the wall. In-plane and out-of-plane interaction is very complicated and should be analyzed well for this phenomenon. For low-rise and mid-rise unreinforced masonry (URM) infilled R/C frames, ground story infill walls are expected to be damaged firstly, because they are subjected to the highest in-plane demands. However, under the effect of bidirectional loading, where the two components of a ground motion are equally significant, infill walls of the upper stories may fail under the combination of in-plane and out-of-plane effects. The in-plane demand reduces at the upper stories, while that of out-of-plane forces increases due to the increase in accelerations. To prevent this problem, the in-plane carrying capacity of the wall should increase, and out-of-plane ductility should increase with possible and applicable developments like bed-joint reinforcements and wire mesh. These listed applications will prevent the detachment of infill walls from reinforced concrete elements and will increase the stiffness of the total structural system. Figure 17 shows out-of-plane and in-plane damages.

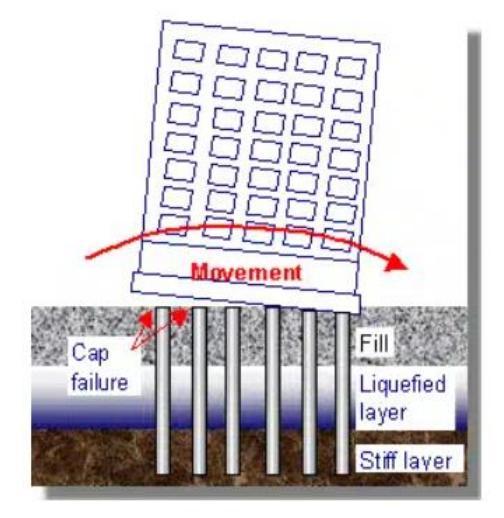
When buildings are overturned due to the lateral loads applied from earthquakes, failure of the pile caps could occur in addition to other structural damages to the superstructure (see figure below).

At the connection of the pile cap, the failure may occur with excessive loads applied. Since the pile cap together with the ground beams has very high stiffness, the connection of the pile and pile cap would become a weak location to fail. In addition, the interaction of the soil and structure would worsen the situation further.

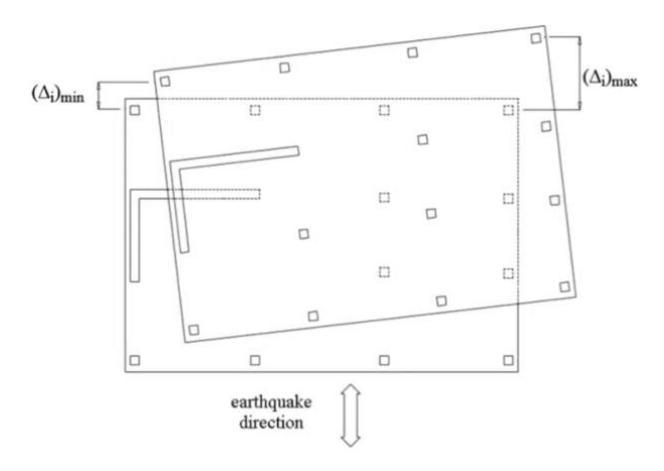
The torsional behavior of a structure in an earthquake would cause severe damage to the structure if it is not considered during the structural design. <u>The most common practice is to</u> modify the stiffness of the structure to avoid the torsional modes becoming dominant.

As indicated in the above figure lateral deformation of the area having low stiffness has higher lateral deflection when compart to the shear wall area. The geometric center and the center of the stiffness are not coinciding.

The columns in an area subjected to higher lateral deflection could develop high bending movement and shear forces. If the structural capacity of the columns is not adequate to bear these forces, the column could fail leading to the collapse of part of the structure or whole structures.

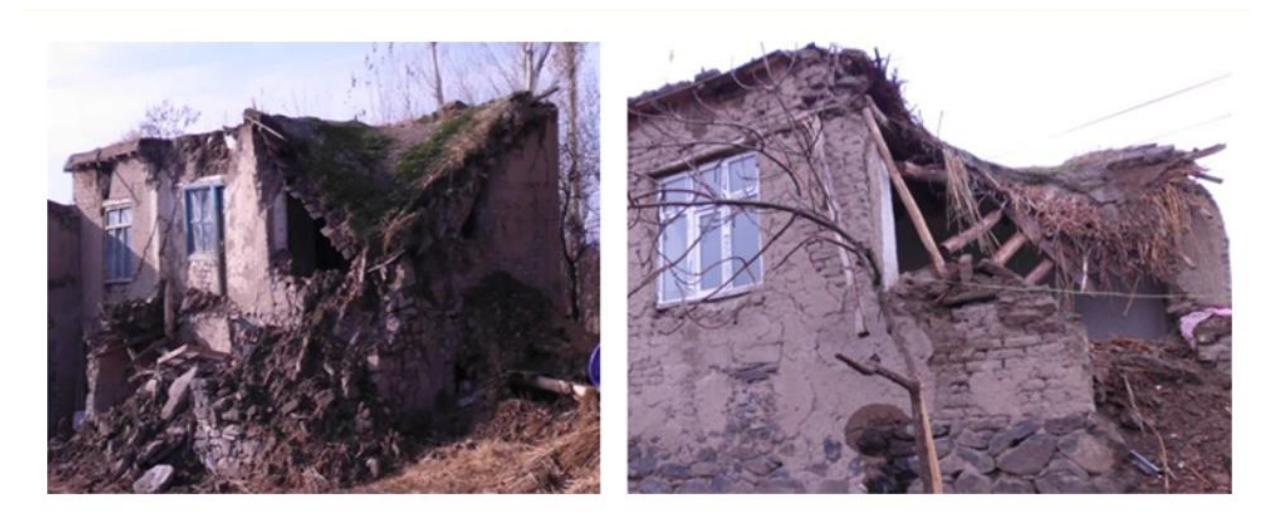
Figure 17. Damage to adobe structures due to the heavy earthen roof during the Van earthquake

Generally, earthen roofs are constructed over wooden logs supported by two main walls of the buildings to provide thermal and water insulation. Also, heavy earthen roofs are constructed by the residents because a thick roof keeps the house cool or warm according to the seasons. However, these roofs lose their effectiveness because of weather conditions, such as rain and snow. Therefore, the residents place a new earthen cover on top of the existing roof to repair these roofs. Thus, the weight and thickness of the roof increase over time. As a result of these heavy roofs, the structures are subjected to larger inertia forces during earthquakes. During horizontal displacements, these heavy roofs are very vulnerable since they can easily slide over the walls. Figure 18 shows the damaged masonry buildings arising from heavy earthen roofs at various earthquakes.

- Thick and heavy earthen roofs are one of the reasons for the damage. The walls of the buildings could not support heavy mass during an earthquake, and the heavy roof partially or completely collapsed. This type of application should be refrained.

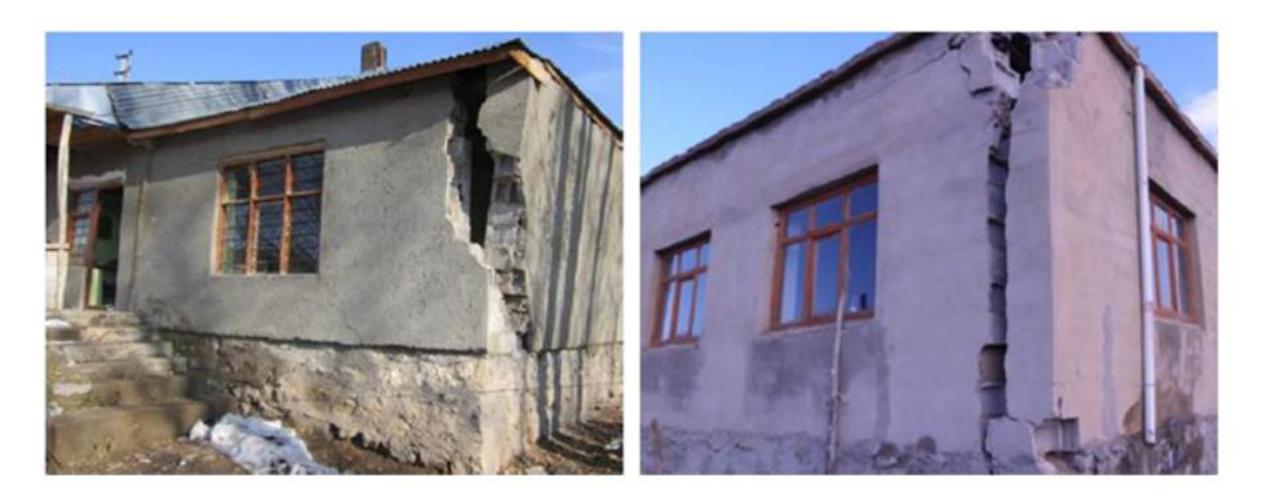
Figure 18. Corner damage of briquette masonry buildings

Corner damages are common in adobe and masonry buildings. This type of mechanism generally occurs at wall-to-wall and wall-to-roof connections when subjected to out-of-plane displacements. During an earthquake, the stress concentrations increase at the intersection of the walls. In this way, vertical or inclined cracks appear in the corners of masonry buildings. If bond beams are not used in the corners or connection, two walls are not properly anchored to each other, the intensity of the cracks increases and these cracks spread along the height of the wall. Similar cracking may have been observed at adobe buildings. Poor connections between adjacent walls and the absence of bond beams cause serious damage. In addition, there are no appropriate connections at the corner of the walls in damaged buildings. This type of damage for adobe and masonry buildings is shown in Figure 19. Due to reduced compression stress and increased seismic acceleration at upper stories, the common failures are seen at the corners of the roof level. When there is no slab with some in-plane rigidity at the roof level, top corners are more sensitive to failure because of cantilever-like behavior.

- Corner damages are developed due to insufficient wall-to-wall connections and a lack of horizontal and vertical bond beams. This problem can be eliminated by using the proper connection defined in current codes. Moreover, bond beams should be used.

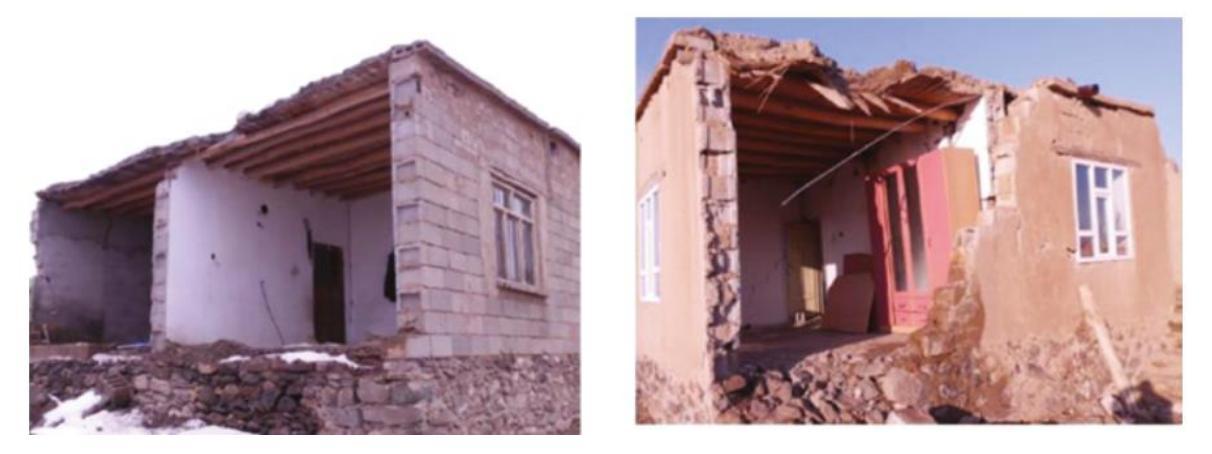
Figure 19. Out-of-plane mechanism of the briquette buildings

Out-of-plane mechanisms may appear from the combination of several deficiencies. A lack of bond beams, poor connections among the walls and the roofs, and large unsupported wall lengths cause the separation of walls and cause damage to occur via the of out-of-plane mechanism. Thus, the whole or the significant parts of the wall fall down during the earthquake. Wooden logs that bear the weight of the floor of the building are generally placed on load-bearing walls in only one direction. Thus, earthquake loads are transferred to

perpendicular walls by wooden logs. Therefore, the walls that are not supported by the wooden logs may easily overturn to out-of-plane direction during the earthquake. This failure mechanism can be commonly observed in the earthquake region. Figure 20 shows the out-of-plane mechanism of the adobe and briquette masonry buildings, respectively.

- Another reason for the damage is the out-of-plane mechanism. The main reasons for this mechanism are the lack of bond beams, poor connections among the walls and roofs, and large unsupported wall lengths. Also, the gable walls of some masonry buildings are affected negatively by the out-of-plane mechanism. This problem can be eliminated by using the proper connection defined in current codes. Constructing long and unsupported walls should be refrained. In addition to this, vertical and horizontal bond beams should be used.

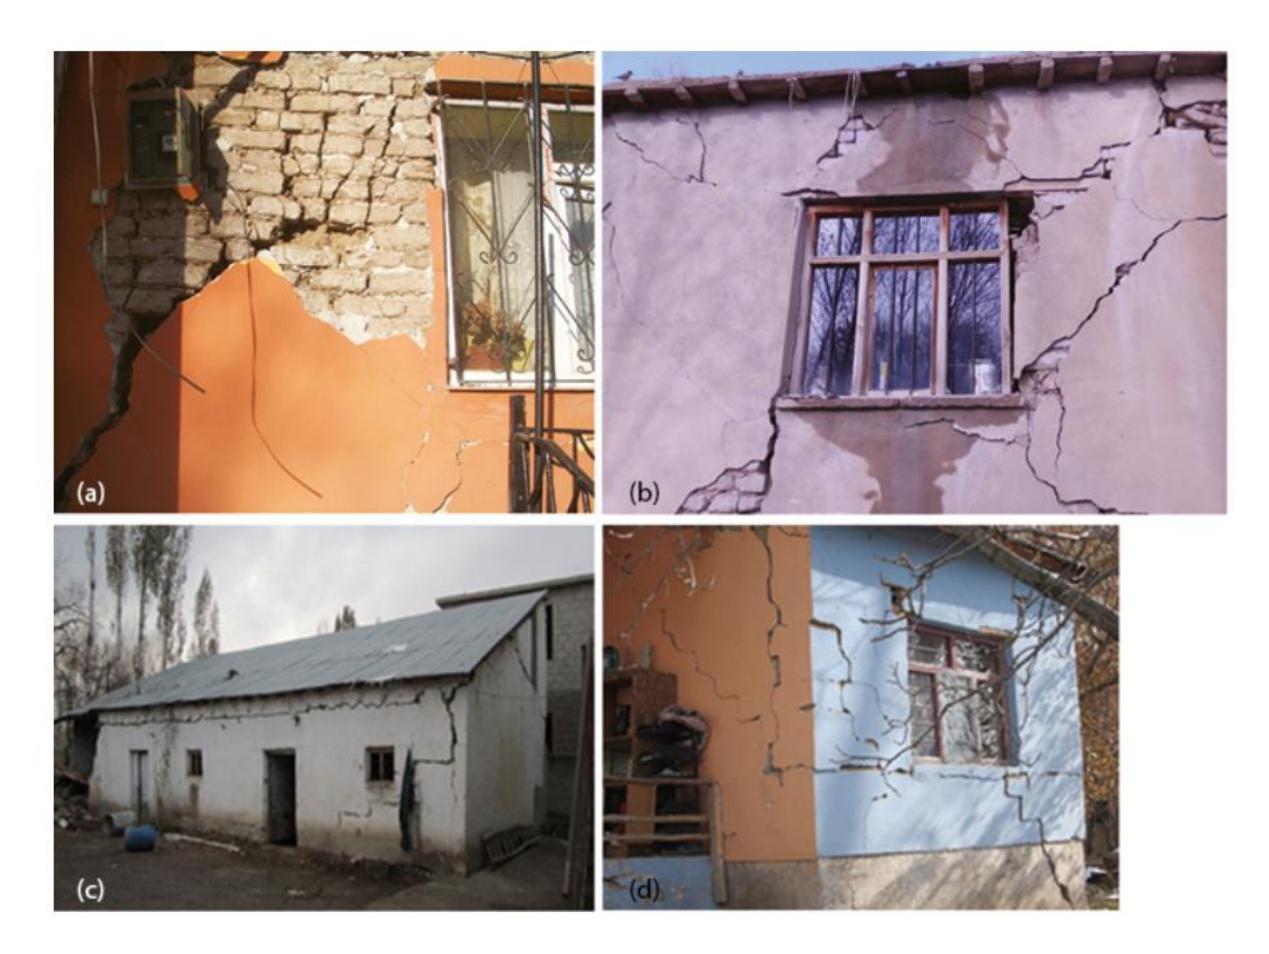
Figure 20. Diagonal shear (a-b), horizontal (c) and stepped (d) failures wall

The seismic performance of the masonry buildings relates to the in-plane stiffness of the walls. The in-plane mechanism is generally observed in most of the masonry buildings that are affected by shear cracking. Earthquake loads increase the shear force. It can damage walls and their connections. These damages generally occur near openings, because most of the masonry buildings don't have sufficient and proper bond beams that distribute the lateral forces uniformly and enhance the lateral strength of the walls. During earthquakes, excessive bending and shear can produce in-plane failures depending on the aspect ratio of the unreinforced masonry elements. In the areas struck by earthquake, three failure modes of the shear damages in masonry buildings are generally observed, namely diagonal shear failures that proceed through masonry units and mortar (Figure 21a–b), sliding consisting of straight failure at the horizontal bed joints (Figure 21c), and stepped failures from the head to bed or bed to head joints (Figure 21d).

- However, a lack of bond beams and large openings that decrease the stiffness of the walls increases the shear effects and cause in-plane failures, such as diagonal shear failures, sliding consisting of straight cracks, and stepped failures. It should be refrained to construct large window and door openings. In addition to this measure, vertical bond beams should be constructed near the openings.

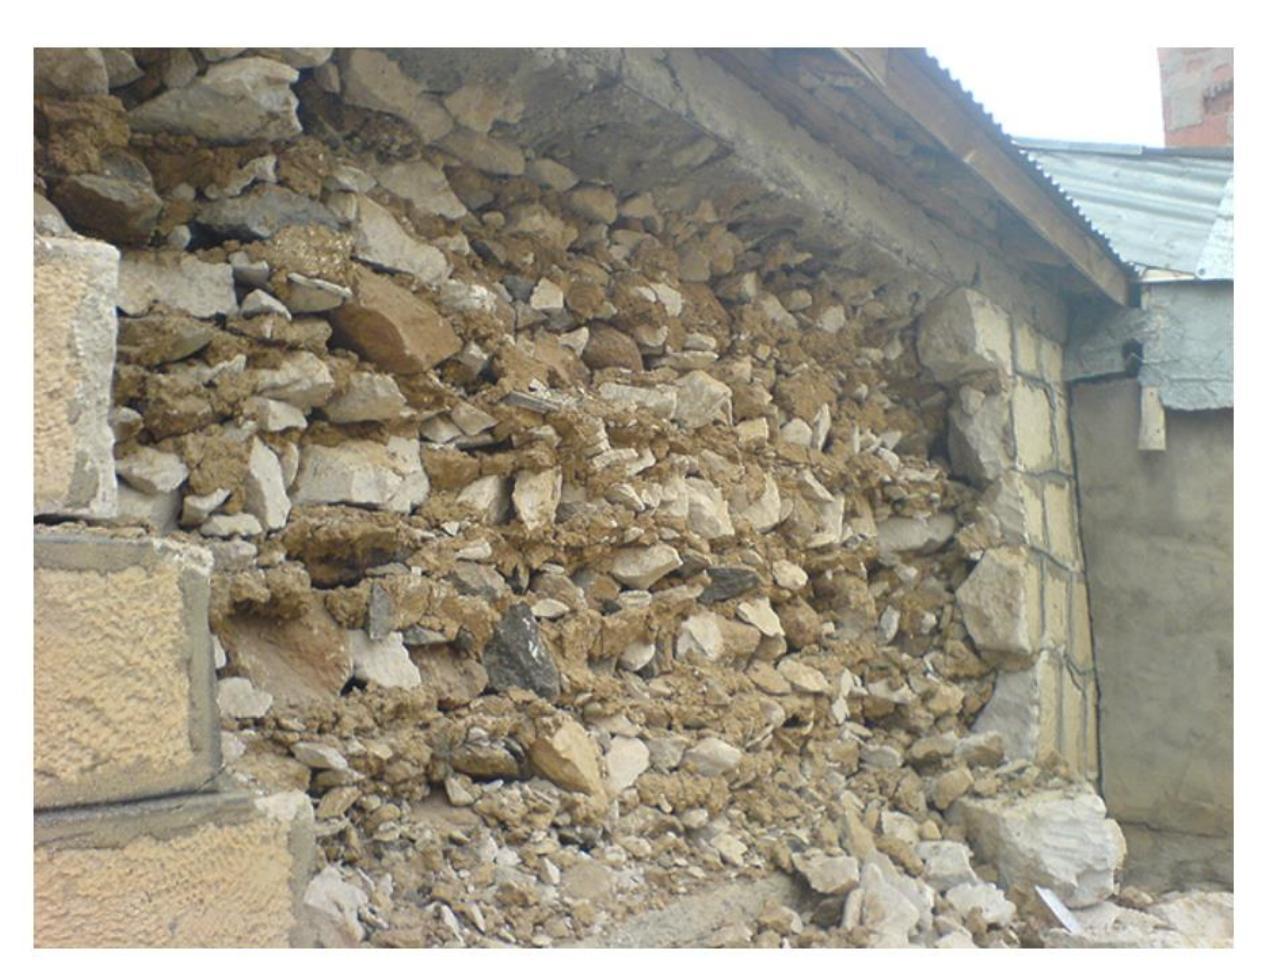
Figure 21. Disintegration in stone masonry buildings

Most of the masonry buildings are constructed with thick stone walls. As the thickness of the walls is relatively large, these stone walls are constructed by using more than one stone along the thickness direction. In these walls, stones are placed in a random order. These walls have two exteriors vertical wythes of large coarse stones. However, smaller rubble stones with mud mortar are used between two exterior layers. Using mud mortar instead of cement mortar causes insufficient adherence between the layers. Thus, the interior and exterior layers of the wall behaved independently and separated each other during the earthquake. Some reasons such as the quality of construction, poor workmanship, and the use of improper materials increase the intensity of the disintegration. Figure 22 presents this failure in stone masonry buildings.

- The construction of multilayer walls with inadequate connections causes the disintegration of stone masonry buildings along the wall thickness. This application should be prevented while constructing stone masonry walls.
