Bridge Materials Inspection: Timber (BIRM)

Course No: S03-010

Chapter 2 Bridge Materials

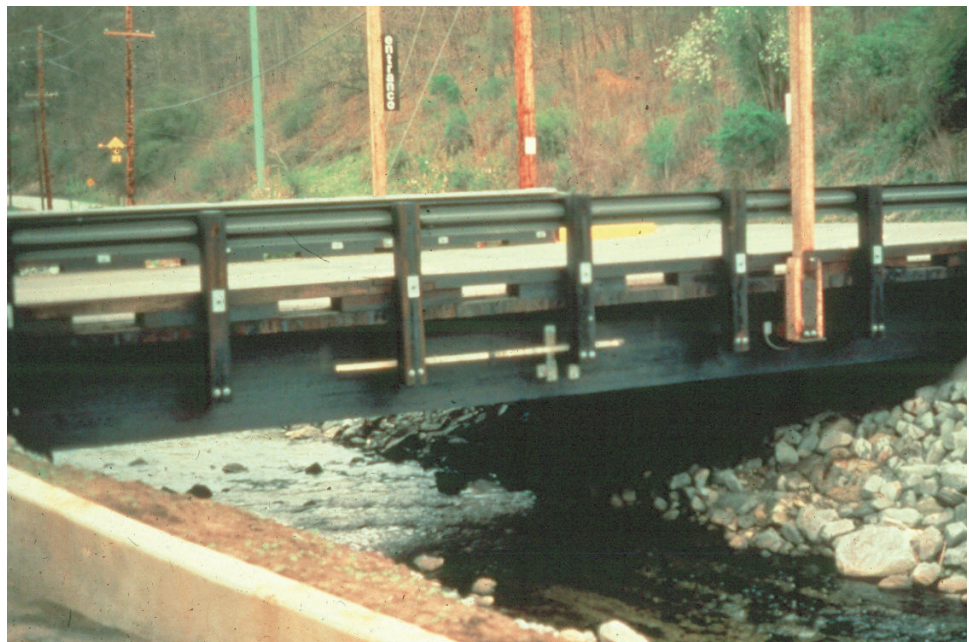
Figure 2.1.1 Glued-laminated Modern Timber Bridge

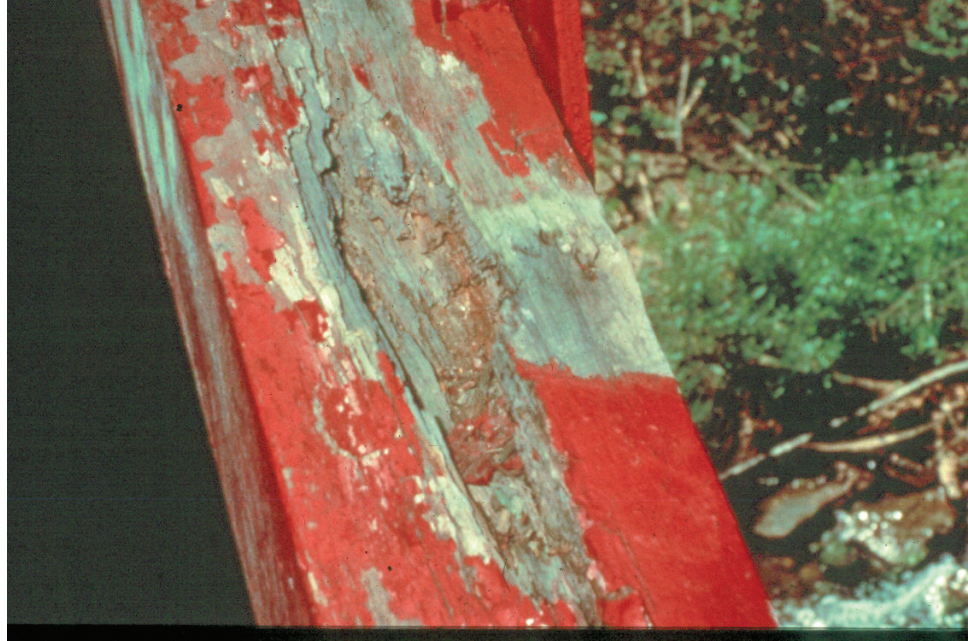
Decay is the primary cause of timber bridge replacement. Decay is the process of living fungi, which are plants feeding on the cell walls of wood (see Figure 2.1.7). The initial process is started by the deposition of spores or microscopic seeds. Fruiting bodies (e.g., mushrooms and conks) produce these spores by the billions. The spores are distributed by wind, water, or insects.

Figure 2.1.7 Decay of Wood by Fungi

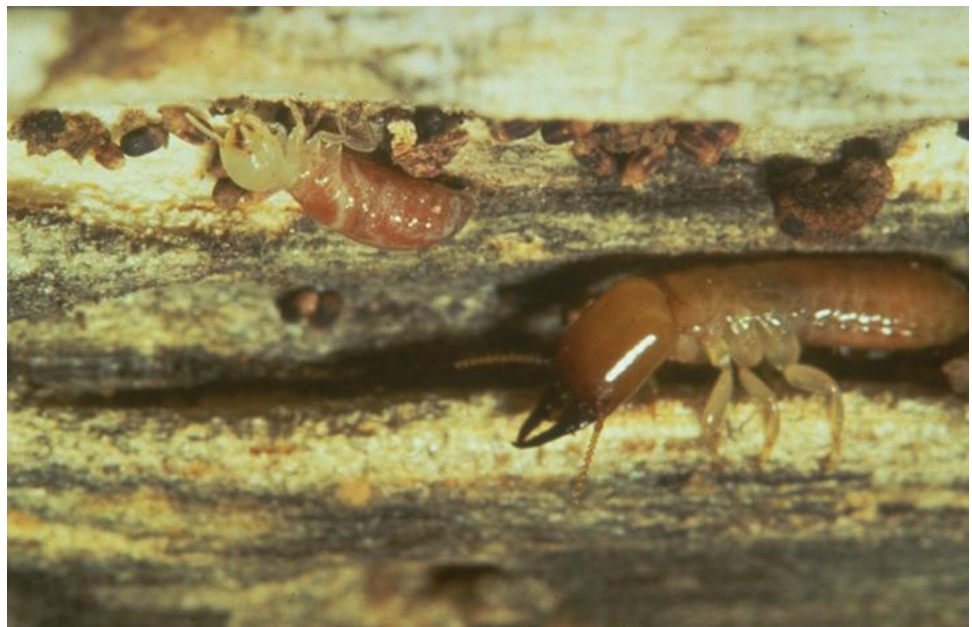
Termites are pale-colored, soft-bodied insects that feed on wood (see Figure 2.1.10). All damage is inside the surface of the wood; hence, it is not visible. The only visible signs of infestation are white mud shelter tubes or runways extending up from the earth to the wood and on the sides of masonry substructures. Termite attack of bridge members, however, is rare or nonexistent in bridges throughout most of the country due to the constant vibration caused by traffic travelling over timber bridges.

Figure 2.1.10 Termites

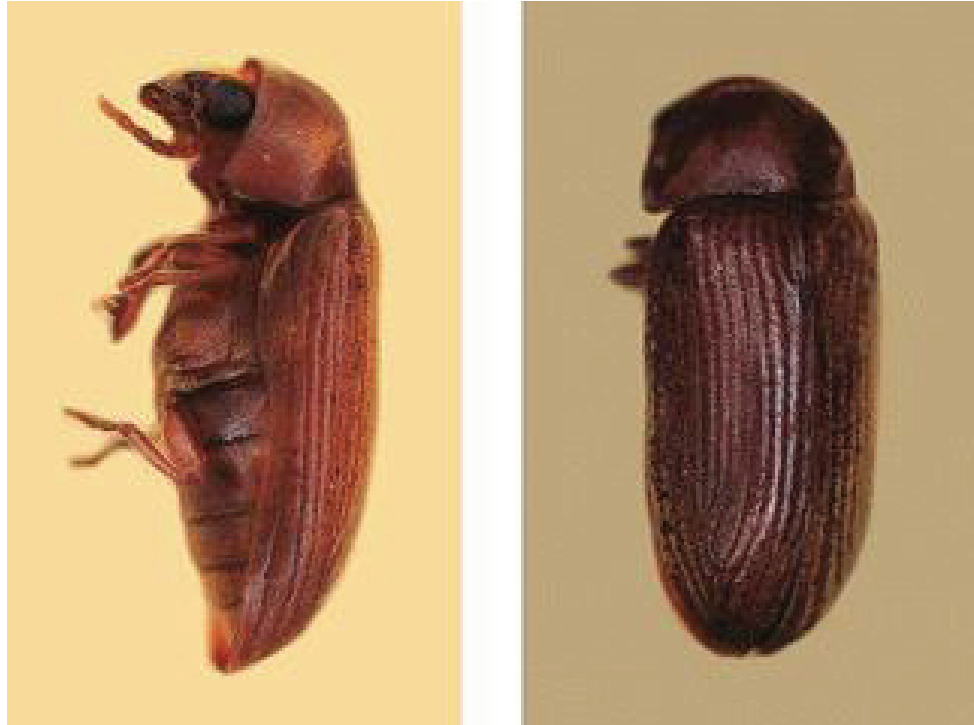
Powder-post beetle larvae also hollow out the insides of timber members and leave the outer surface pocked with small holes (see Figure 2.1.11). Often a powdery dust is dislodged from the holes. The inside may be completely excavated as the larvae of these beetles bore through the wood for food and shelter.

Figure 2.1.11 Powder Post Beetle

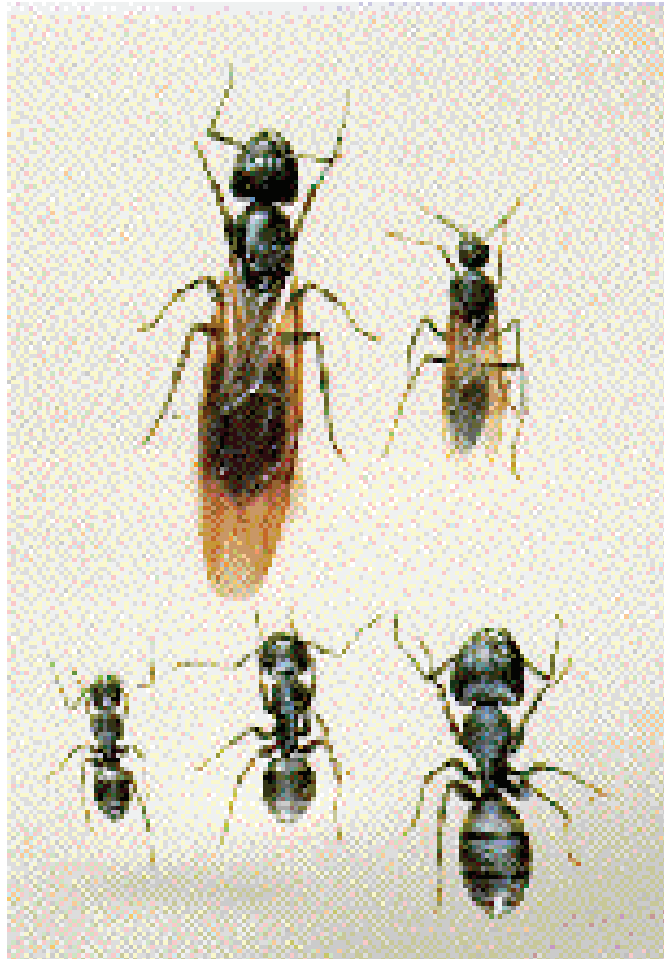
Carpenter ants are large, black ants up to 19 mm (3/4 inches) long that gnaw galleries in soft or decayed wood (see Figure 2.1.12). The ants may be seen in the vicinity of the infested wood, but the accumulation of sawdust on the ground at the base of the timber is also an indicator of their presence. The ants do not use the wood for food but build their galleries in the moist and soft or partially decayed wood.

Figure 2.1.12 Carpenter Ants

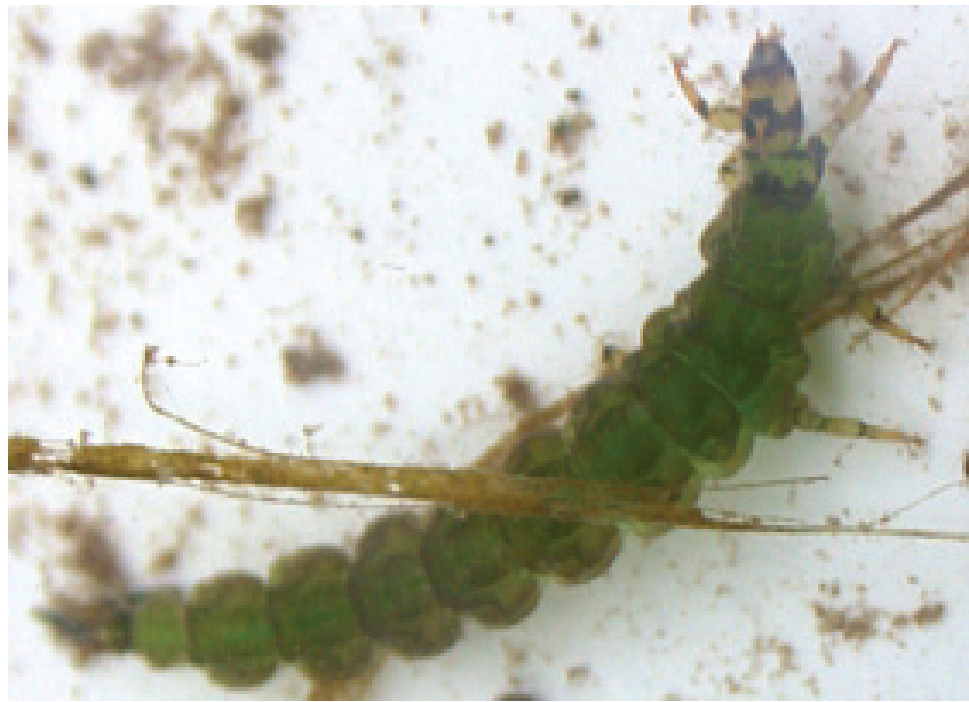
The caddisfly is an aquatic insect that is closely related to the moth and butterfly (see Figure 2.1.13). During the larva and pupa stage of their life cycle, they can dig small holes in the timber for protection. The larvae do not feed on the timber, but rather use it as a foundation for their silken shelters. This explains why caddisfly larvae have been known to exist on creosote treated timber.

Figure 2.1.13 Caddisfly Larva

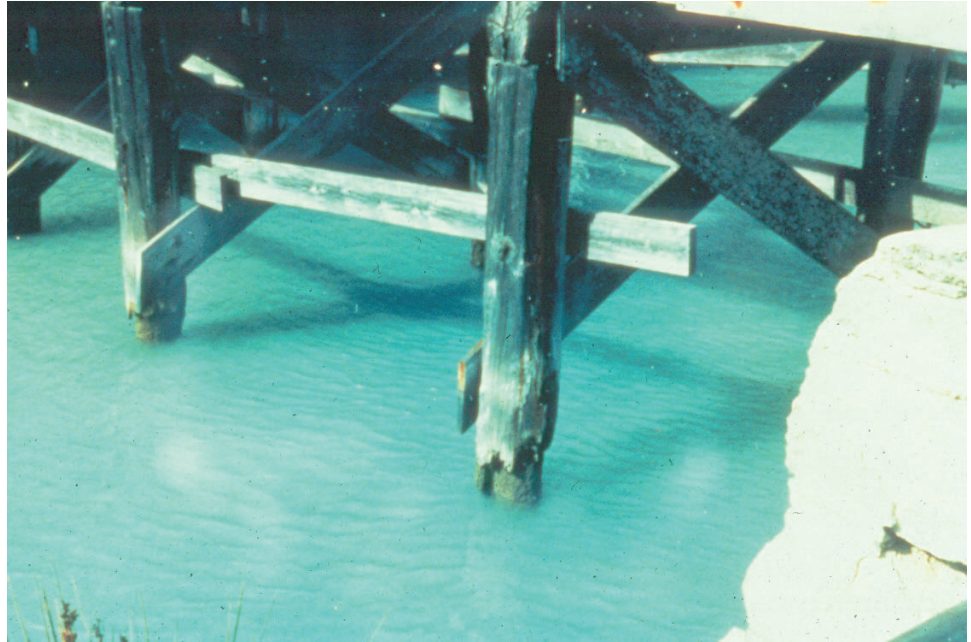
Marine borers are found in sea water and brackish water only and cause severe damage to timber members in the area between high and low water, although damage may extend to the mud line (see Figure 2.1.14). They can be very destructive to wood and have been known to consume piles and framing in just a few months.

Figure 2.1.14 Marine Borer Damage to Wood Piling

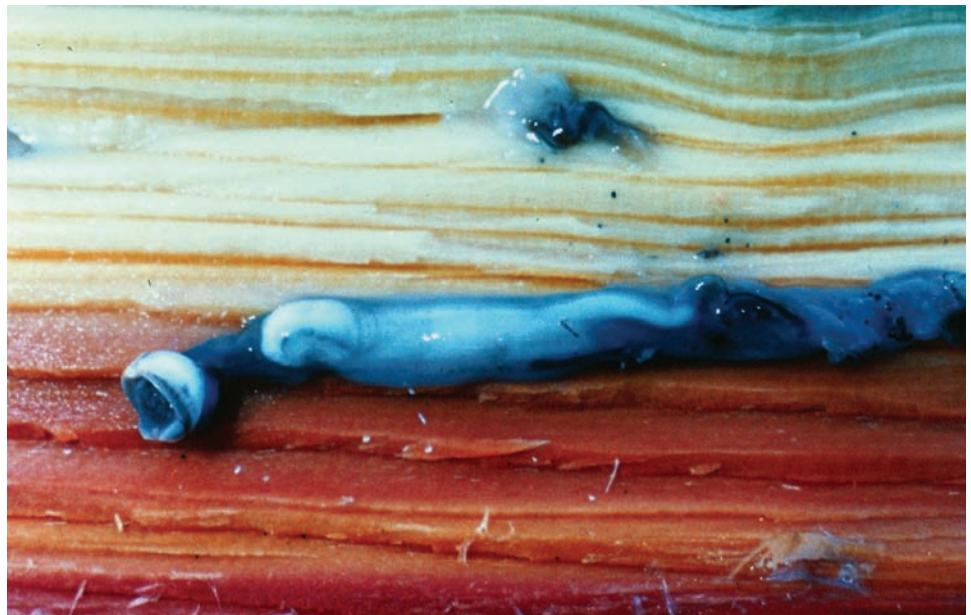
One type of marine borer is the mollusk borer, or shipworm (see Figure 2.1.15). The shipworm is one of the most serious enemies of marine timber installations. The most common species of shipworm is the teredo. This shipworm enters the timber in an early stage of life and remains there for the rest of its life. Teredos are gray and slimy and can typically reach a length of 380 mm (15 inches) and a diameter of 10 mm (3/8 inch). Some species of shipworm have been known to grow to a length of 1.8 m (6 feet) and up to 25 mm (1 inch) in diameter. The teredo maintains a small opening in the surface of the wood to obtain nourishment from the sea water.

Figure 2.1.15 Shipworms (Mollusks)

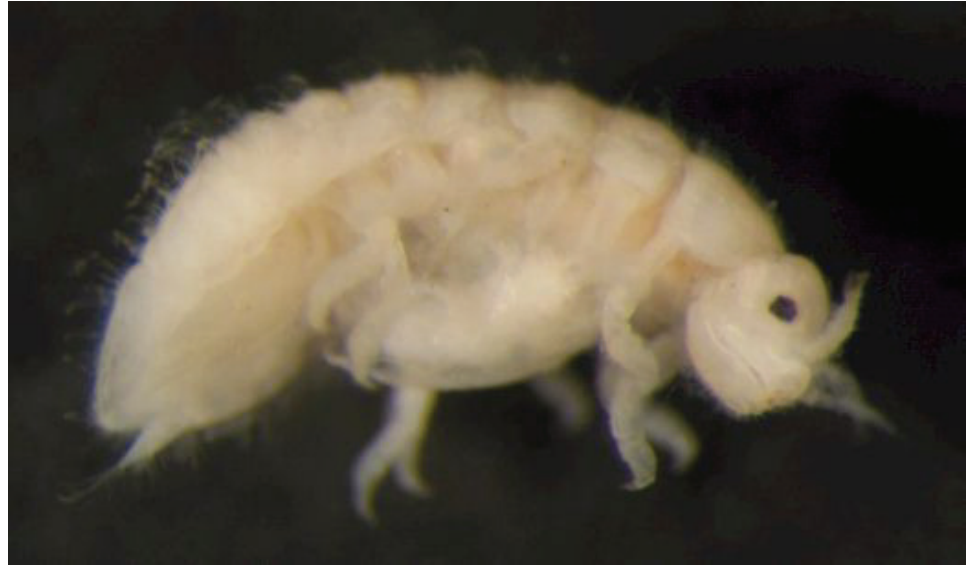
Another type of marine borer is the crustacean borer. The most commonly encountered crustacean borer is the limnoria or wood louse (see Figure 2.1.16). It bores into the surface of the wood to a shallow depth. Wave action or floating debris breaks down the thin shell of timber outside the borers' burrows, causing the limnoria to burrow deeper. The continuous burrowing results in a progressive deterioration of the timber pile cross section, which will be noticeable by an hourglass shape developed between the tide levels. These borers are about 3 to 6 mm (1/8 to 1/4 inches) long and 2 to 3 mm (1/16 to 1/8 inches) wide.

Figure 2.1.16 Limnoria (Wood Louse)

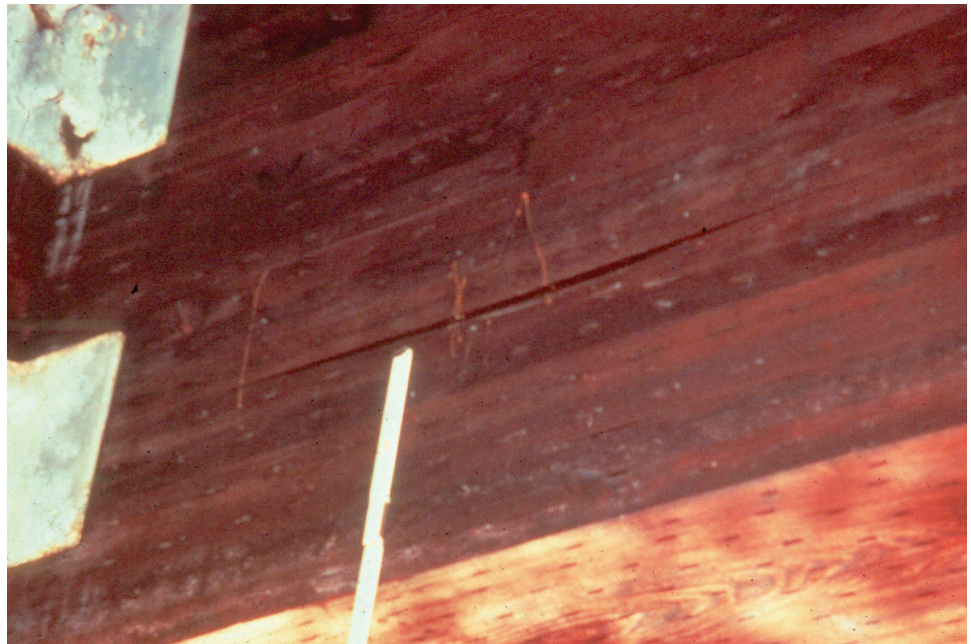
Delaminations occur in glued-laminated members when the layers separate due to failure within the adhesive or at the bond between the adhesive and the laminate. They provide openings for decay to begin and may cause a reduction in strength (see Figure 2.1.17).

Figure 2.1.17 Delamination in a Glue Laminated Timber Member

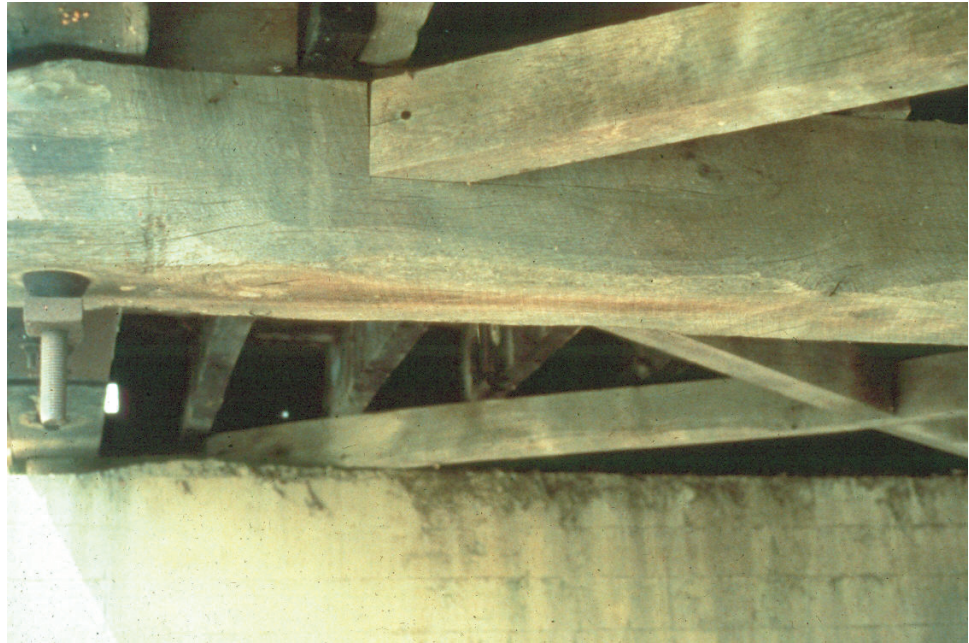
Loose connections may be due to shrinkage of the wood, crushing of the wood around the fastener, or from repetitive impact loading (working) of the connection. Loose connections can reduce the bridge's load-carrying capacity (see Figure

Figure 2.1.18 Loose Hanger Connection Between the Timber Truss and Floorbeam

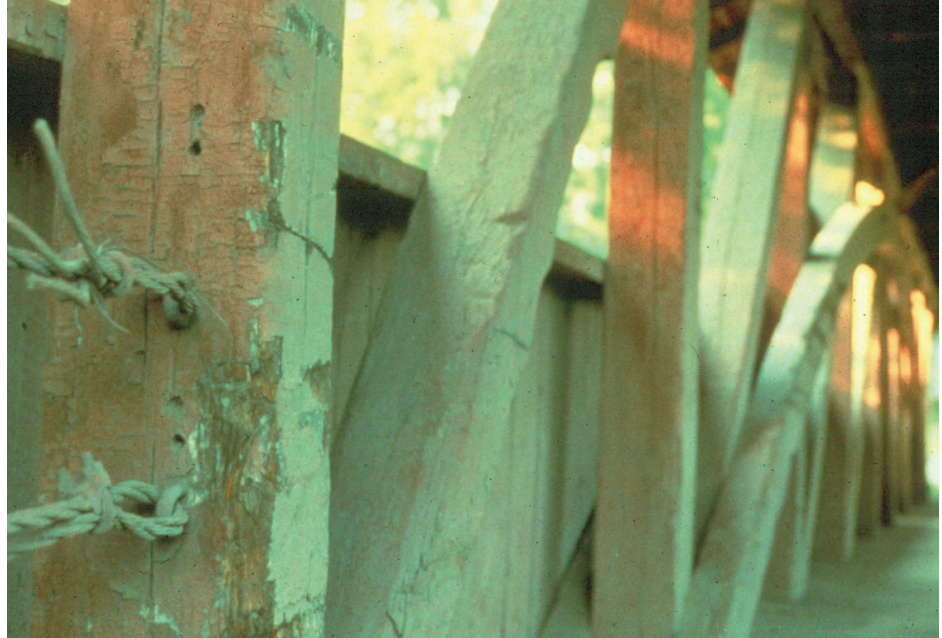
Severe damage can occur to truss members, railings, and columns when an errant vehicle strikes them (see Figure 2.1.20).

Figure 2.1.20 Impact/Collision Damage to a Timber Member

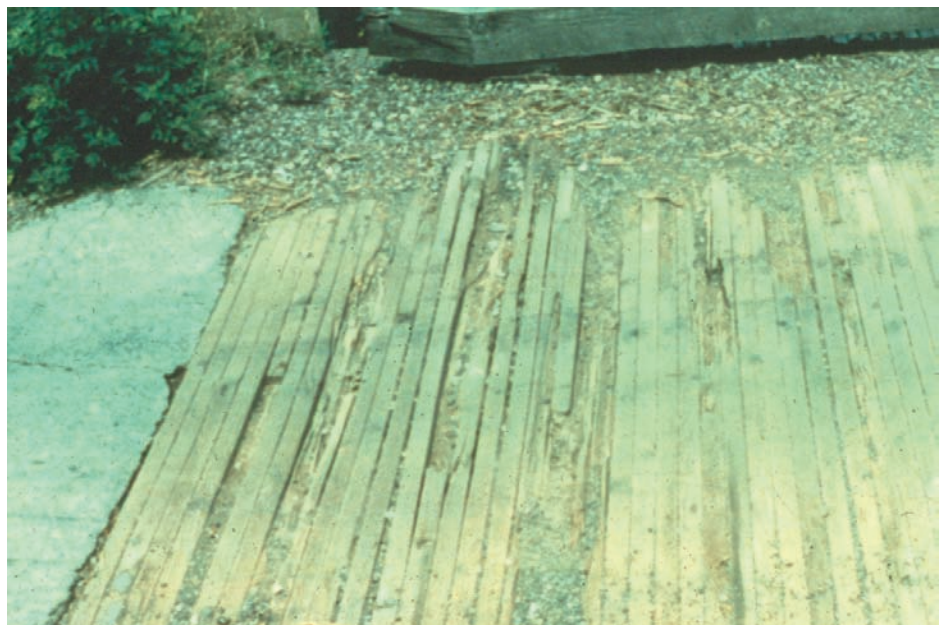
Vehicular traffic is the main source of wear on timber decks (see Figure 2.1.21). Abrasion occurs on timber piles that are subjected to tidal flows. Mechanical wear of timber members sometimes occurs due to movement of the fasteners against their holes when connections become loose.

Figure 2.1.21 Wear of a Timber Deck

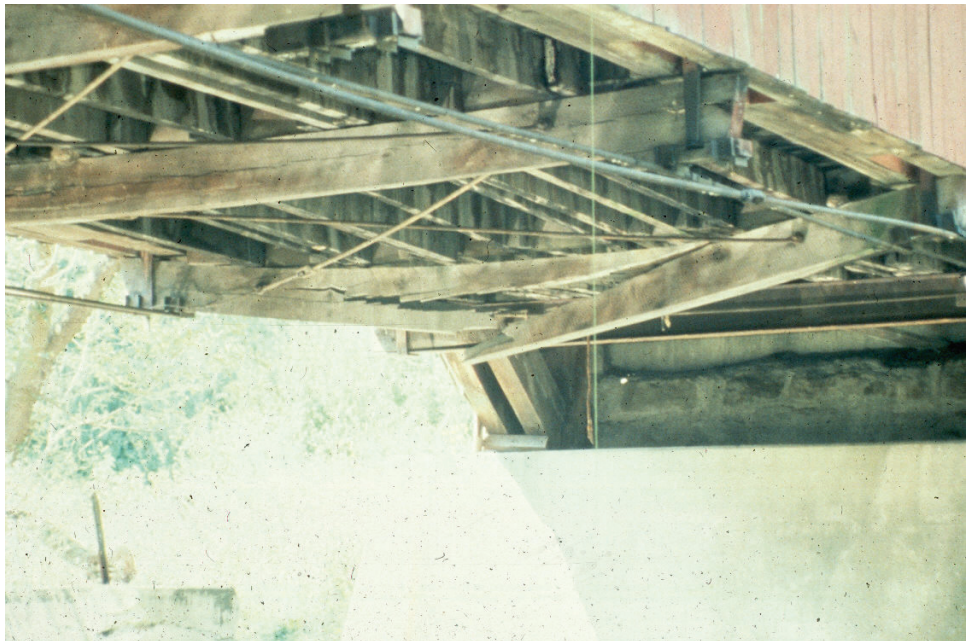
Each timber member has a certain ultimate load capacity. If this load capacity is exceeded, the member will fail (see Figures 2.1.22 and 2.1.23).

Figure 2.1.23 Failed Timber Floor Beam due to Excessive Bending Moment

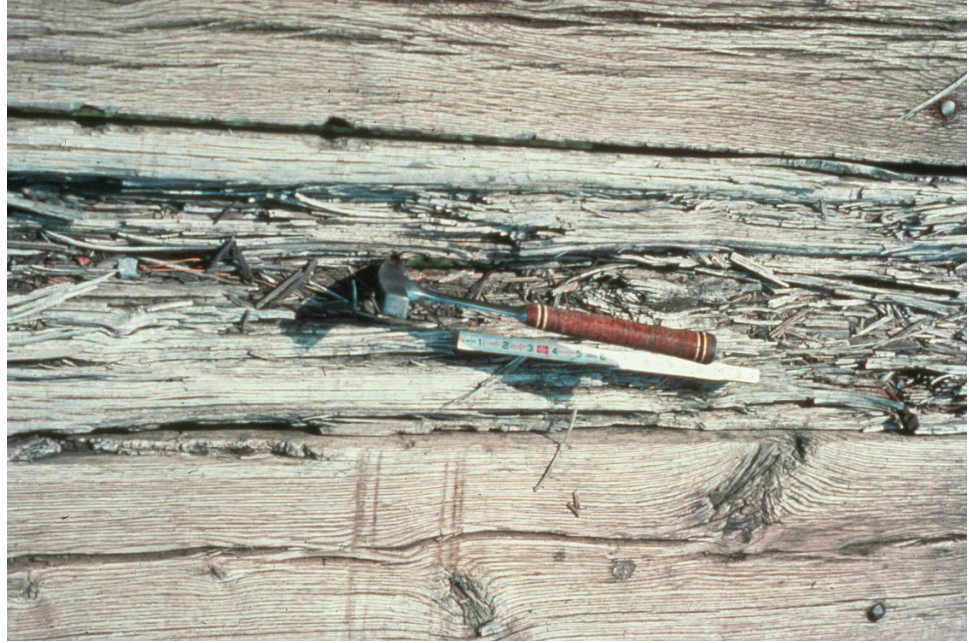
equilibrium moisture content in the wood in a non-uniform fashion, thereby resulting in changes in the strength and dimensions of the wood. Uneven reduction in moisture content causes localized shrinkage, which can lead to warping, checking, splitting, or loosening of connectors (see Figure 2.1.24).

Figure 2.1.24 Weathering on Timber Deck

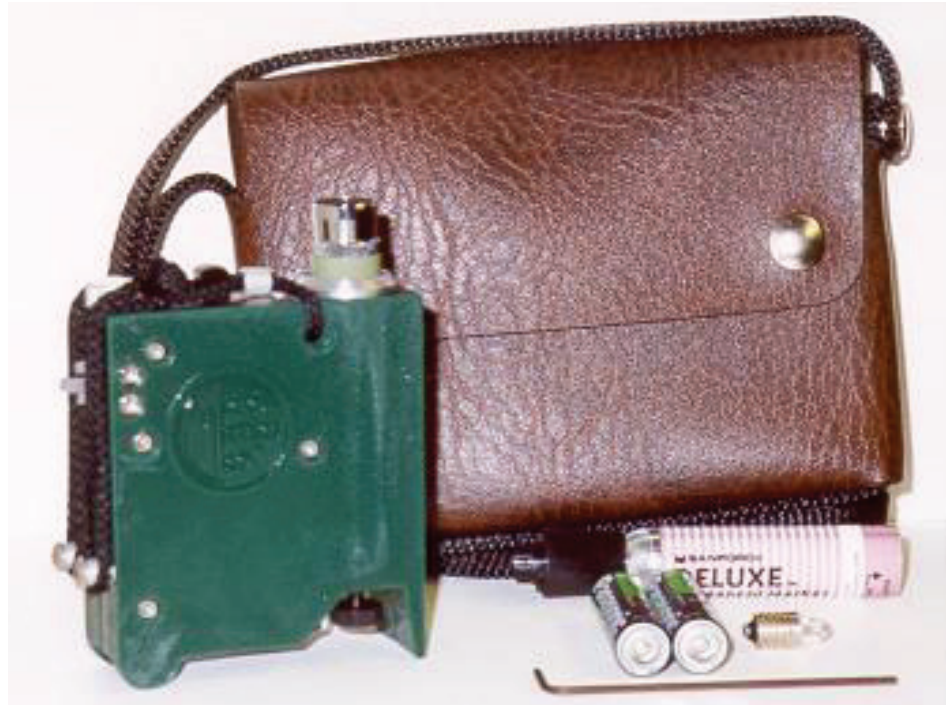
Paint dry film thickness is measured with a Tooke Gage (see Figure 2.1.29). With this instrument, a groove is cut at a known angle with the grain through the paint to expose the wood substrate. The thickness of each layer of paint is measured through a 50-power microscope built into the gage.

Figure 2.1.29 Tooke Gage Used to Measure Coating Dry Film Thickness
