Common ADA Errors in Facilities Design

Course No: A03-003

Common ADA Errors and Omissions in New Construction and Alterations

Common ADA Problems at Newly Constructed Lodging Facilities

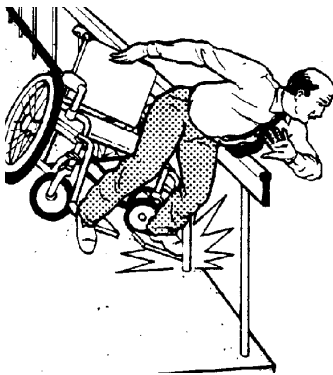
Parts of an accessible route with slopes that exceed 1:20 lack required features including handrails and edge protection.

4.8.1* General. Any part of an accessible route with a slope greater than 1:20 shall be considered a ramp and shall comply with 4.8.

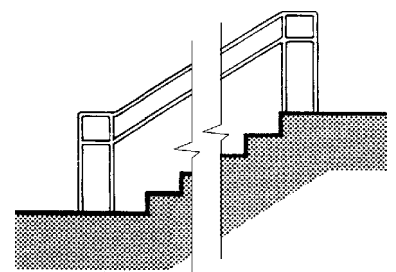
Handrail extensions are not provided at the top and bottom risers.

4.9.4(2) If handrails are not continuous, they shall extend at least 12 in (305 mm) beyond the top riser and at least 12 in (305

mm) plus the width of one tread beyond the bottom riser. At the top, the extension shall be parallel with the floor or ground surface. At the bottom, the handrail shall continue to slope for a distance of the width of one tread from the bottom riser; the remainder of the extension shall be horizontal (see Fig. 19(c) and (d)). Handrail extensions shall comply with 4.4.

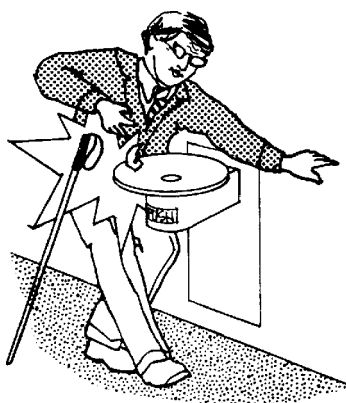
Objects protrude into circulation paths from the side or from posts.

Objects that overhang circulation paths do not provide clear headroom.

4.4.1* General. Objects projecting from walls (for example, telephones) with their leading edges between 27 in and 80 in (685mm and 2030 mm) above the finished floor shall protrude no more than 4 in (100 mm) into walks, halls, corridors, passageways, or aisles (see Fig. 8(a)). Objects mounted with their leading edges at or below 27 in (685 mm) above the finished floor may protrude any amount (see Fig. 8(a) and (b)). Free-standing objects mounted on posts or pylons may overhang 12 in (305 mm) maximum from 27 in to 80 in (685 mm to 2030 mm) above the ground or finished floor (see Fig. 8(c) and (d)). Protruding objects shall not reduce the clear width of an accessible route or maneuvering space (see Fig.8(e)).

4.4.2 Head Room. Walks, halls, corridors, passageways, aisles, or other circulation spaces shall have 80 in (2030 mm) minimum clear head room (see Fig. 8(a)). If vertical clearance of an area adjoining an accessible route is reduced to less than 80 in (nominal dimension), a barrier to warn blind or visually-impaired persons shall be provided (see Fig. 8(c-1)).

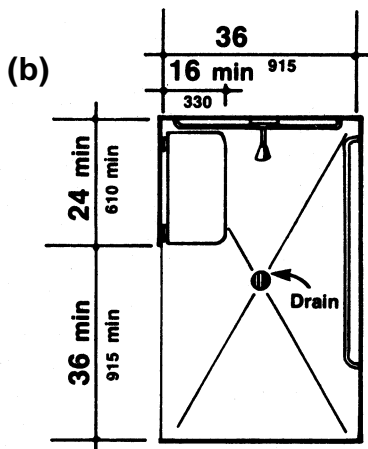
Fig. 57
Roll-in Shower
with Folding Seat

Lodging facilities must provide a specific number of accessible guest rooms based on the table provided below. Bathing facilities in these rooms must comply with the Standards. In addition, in lodging facilities with more than 50 guestrooms or suites, the facility must provide a specified number of accessible guestrooms that have a roll-in shower with a permanently attached fold-down seat. The roll-in shower in these rooms must comply with specific requirements contained in Figure 57 of the Standards, shown on this page.

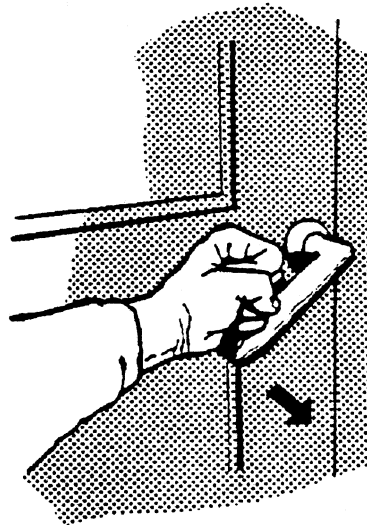
Handles, pulls, latches, locks, and other operating devices on accessible doors; faucets; fixed lamps; and drapery, heating, and air conditioning controls shall have a shape that is easy to grasp with one hand and does not require tight grasping, tight pinching, or twisting of the wrist to operate. Lever-operated mechanisms, push-type mechanisms, and U-shaped handles are acceptable designs. ADA Standards 4.13.9; 9.2.2(3); 9.2.2(5).

single-lever handle that is easy to reach and operable with one hand

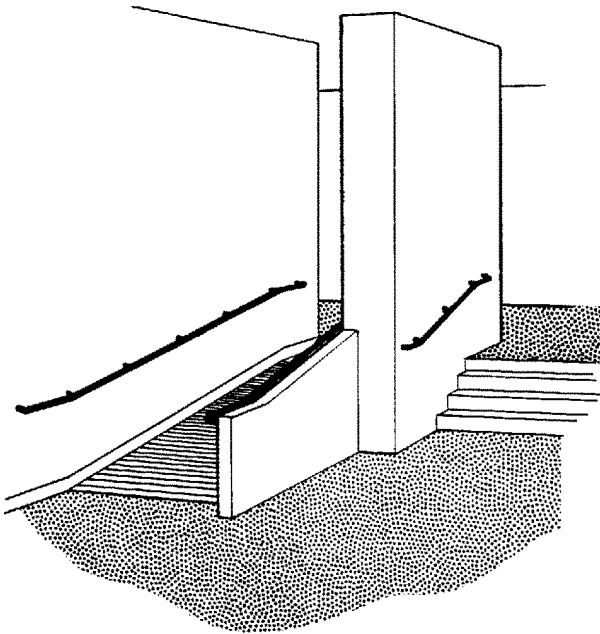
At least one route that is a minimum of 36 inches wide without steps, stairs, or other abrupt level changes must be provided within the boundary of the lodging facility's property from an accessible entrance to the building to public transportation stops, accessible parking spaces, accessible passenger pick-up/drop-off areas, if provided, and public streets or sidewalks. Once inside the facility, an accessible route must be provided between an accessible entrance, lobby and the various accessible elements and spaces in the lodging facility. ADA Standards 4.1.2 (1); 4.1.3(1); 4.3.
