# **Membrane Bioreactors (MBR) for Water Reclamation**

*This course was adapted from the Department of Interior, Publication Named, “Optimization of Various MBR Systems for Water Reclamation, Phase III, Final Technical Report”, which is in the public domain.*

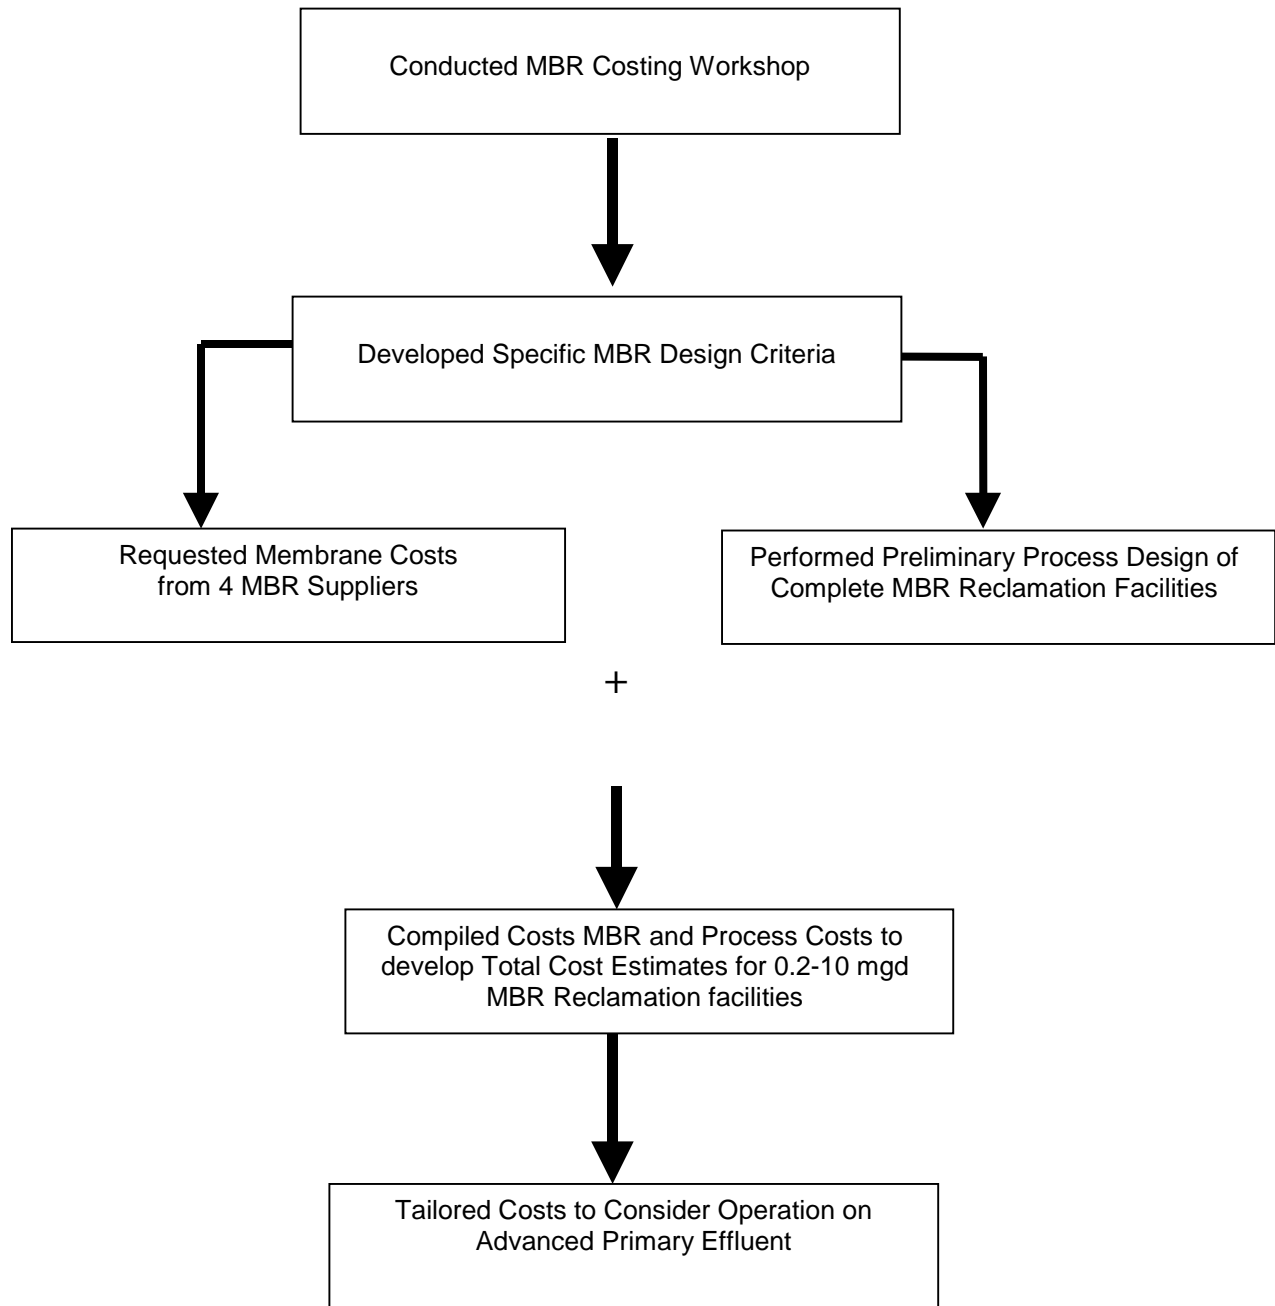
**Figure 9-1 Outline of Costing Approach**

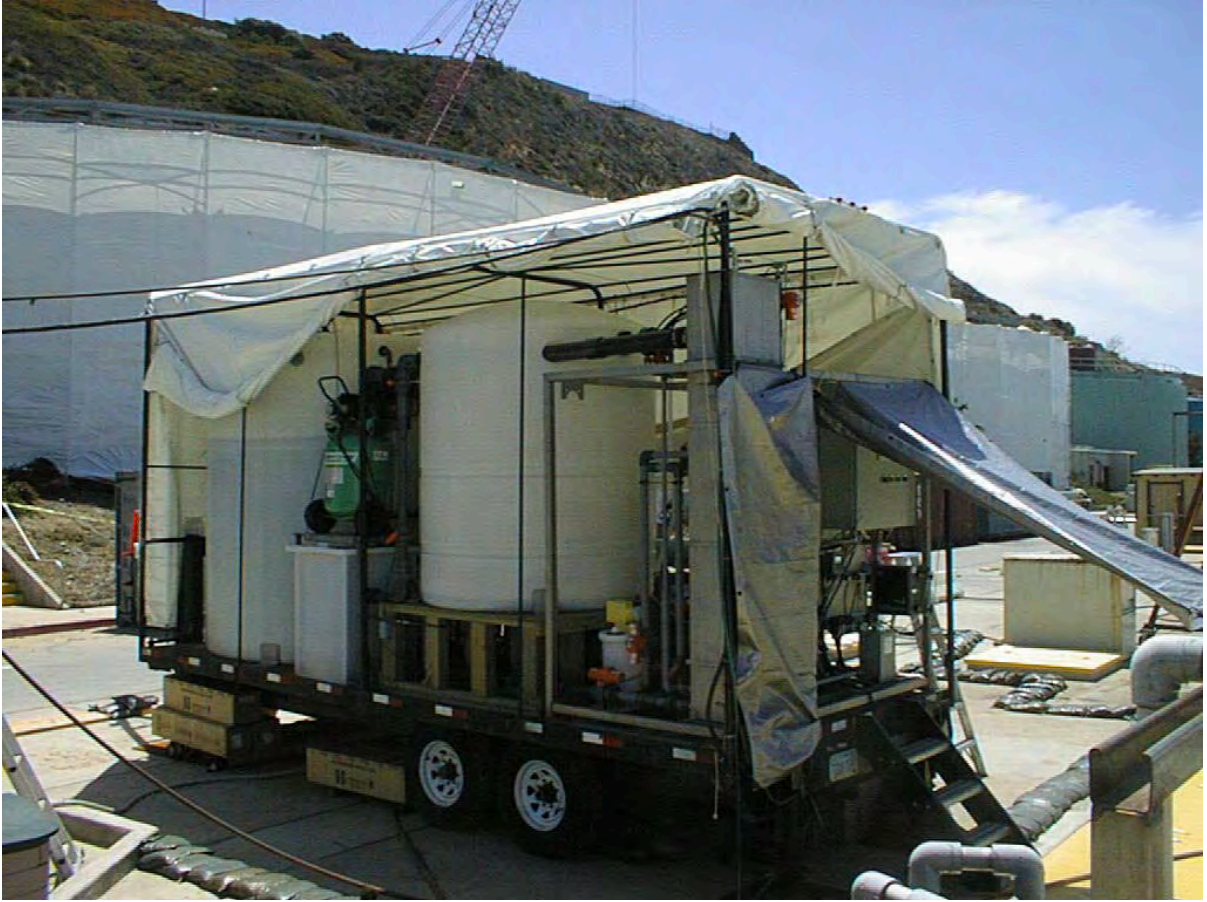
**US Filter MBR Pilot Unit**

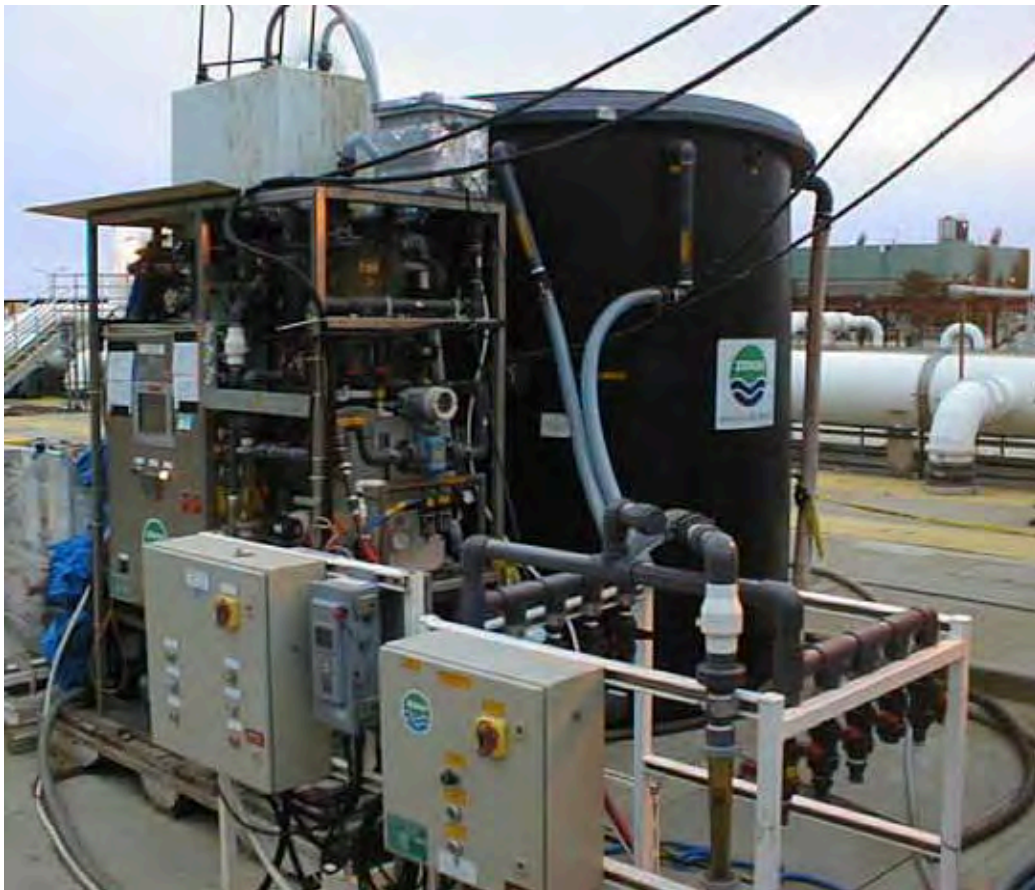
**Zenon MBR Pilot Unit**

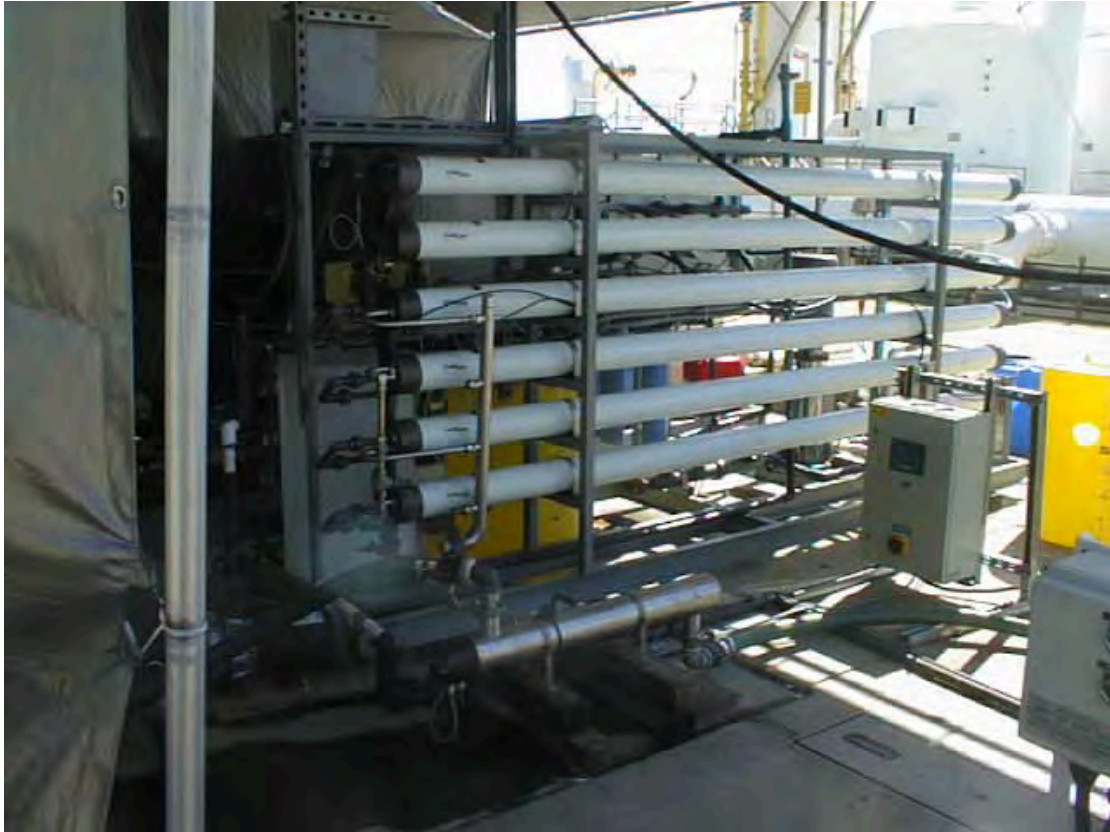
**RO Pilot Skid**

Both RO membrane trains were operated simultaneously on identical source waters at a constant flux of 10 gfd (17 L/hr-m<sup>2</sup>) and feed water recovery of 50 percent. The source water for Part 1 and Part 2 testing was raw wastewater and advanced primary effluent treated by MBR, respectively. Per the manufacturer's recommendation, the RO influent was dosed with 2 mg/L antiscalant to slow the precipitation of sparingly soluble salts. The antiscalant used was Pre-treat Plus (King Lee Technologies, San Diego, CA). Next, feedwater passed through a 5- $\mu$ m cartridge filter before being pressurized and introduced into the RO membranes. Two different methods of pre-treatment were tested during the study to mitigate biofouling of the RO membranes. During the first part of testing, RO feed water was dosed with low pressure UV. However, for the remainder of testing, chloramine was dosed to the RO feed water to maintain a 1-2 mg/L total chlorine residual concentration; no free chlorine was allowed onto the RO units. See Section 4.3.7 for specific details of the UV pilot system.
