Ethical Issues from the St. Francis Dam Failure

Course No: LE2-004

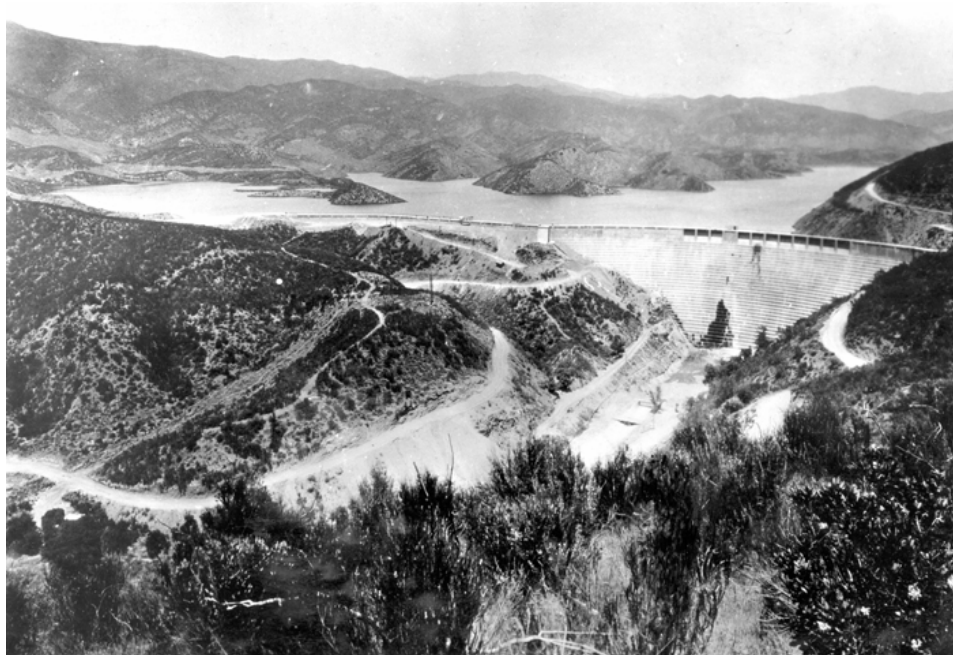
Figure 1

St. Francis Dam

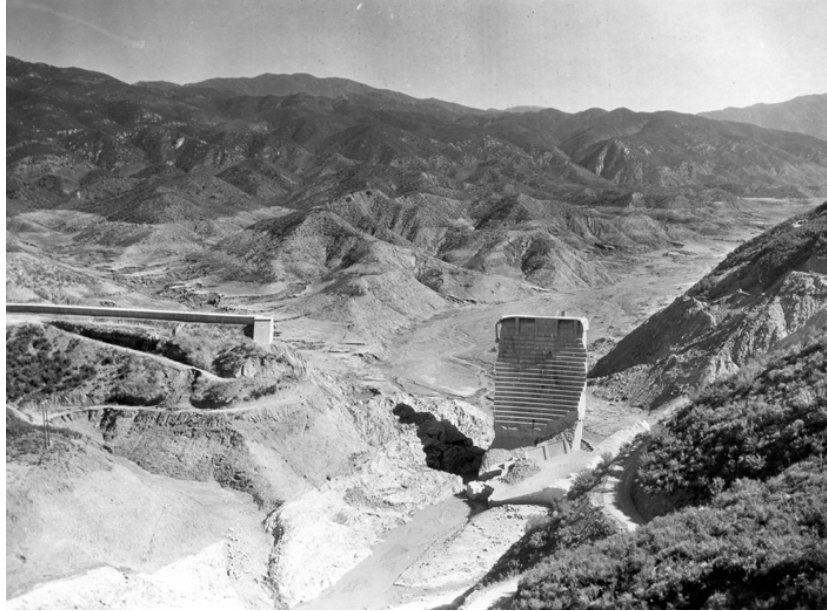
St. Francis Dam, March 17, 1928
(Attribution: U.S. Geological Survey Photographic Library)
Figure 3

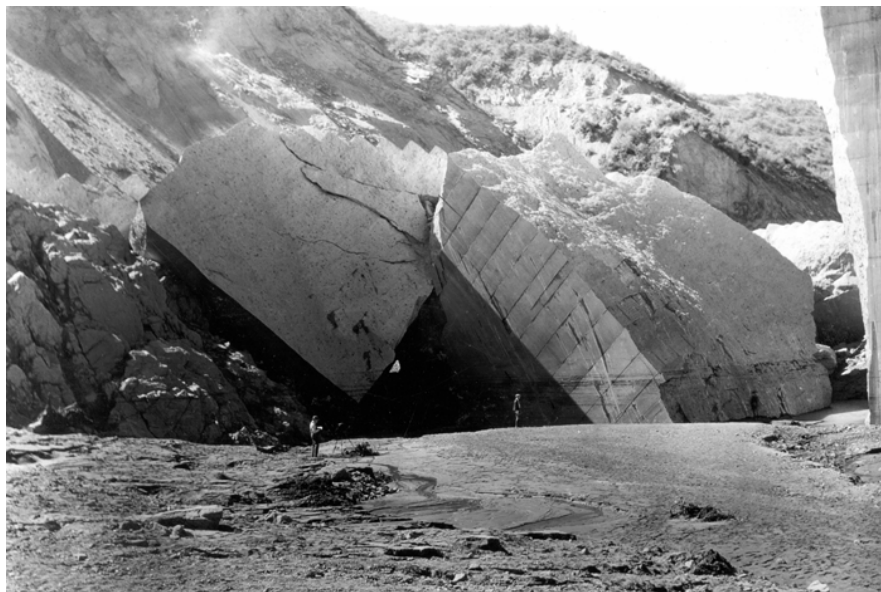
St. Francis Dam, Concrete Debris Blocks
(Attribution: U.S. Geological Survey Photographic Library)
Figure 5

The dam broke into several large concrete blocks, some of which were carried almost 1/2 mile downstream, while the center section of the dam remained standing. The upright center section was subsequently demolished. The St. Francis Dam was not rebuilt, although Bouquet Reservoir in nearby Bouquet Canyon and Castaic Dam in the town of Castaic were subsequently built as replacements for the St. Francis Dam.

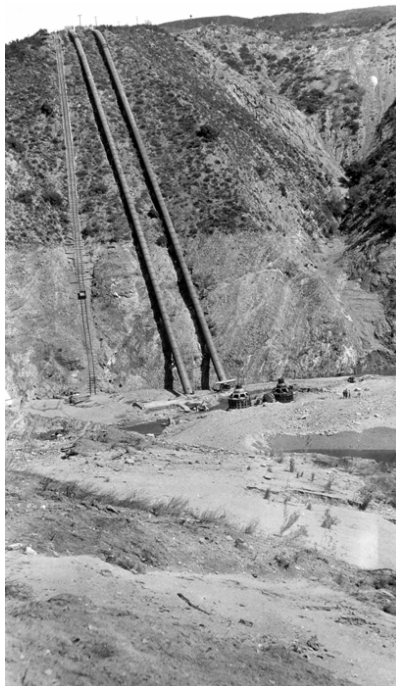
Remains of downstream powerhouse
(Attribution: U.S. Geological Survey Photographic Library)
Figure 7

Studies concluded that water behind the dam took about five minutes to travel 1.5 miles to Powerhouse No. 2 located below the dam. The height of the wall of water for the first few miles was 100 to 140 feet, and huge pieces of the dam, some weighing ten thousand tons, were washed one-half mile or more down the canyon.

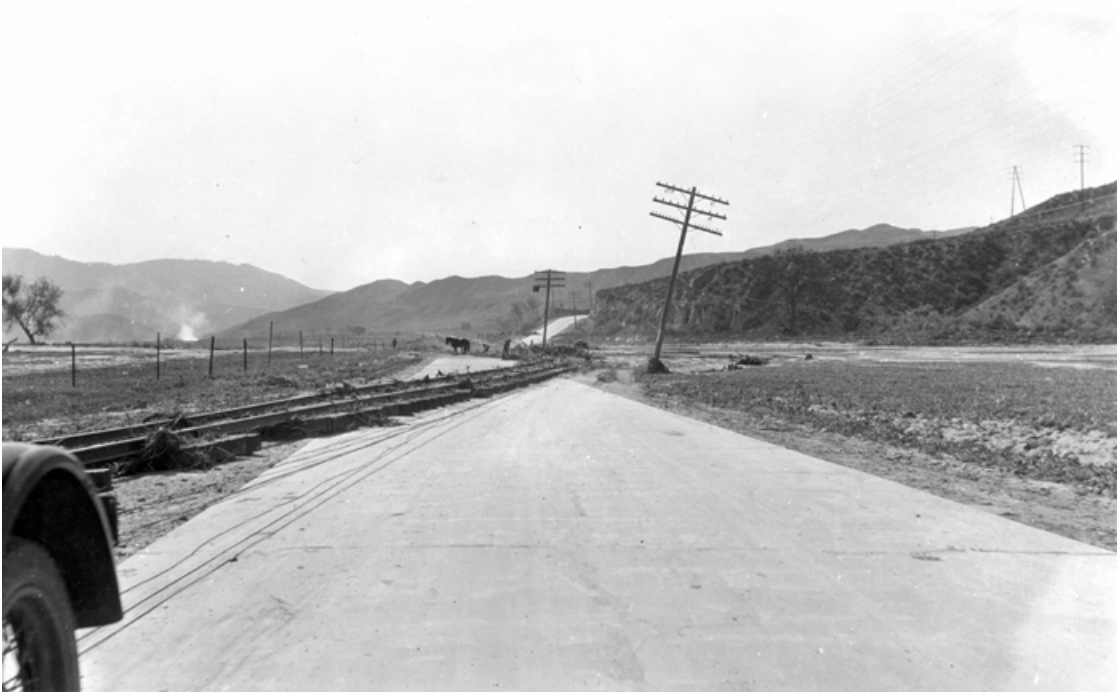
Dislocated railroad tracks
(Attribution: U.S. Geological Survey Photographic Library)
Figure 9

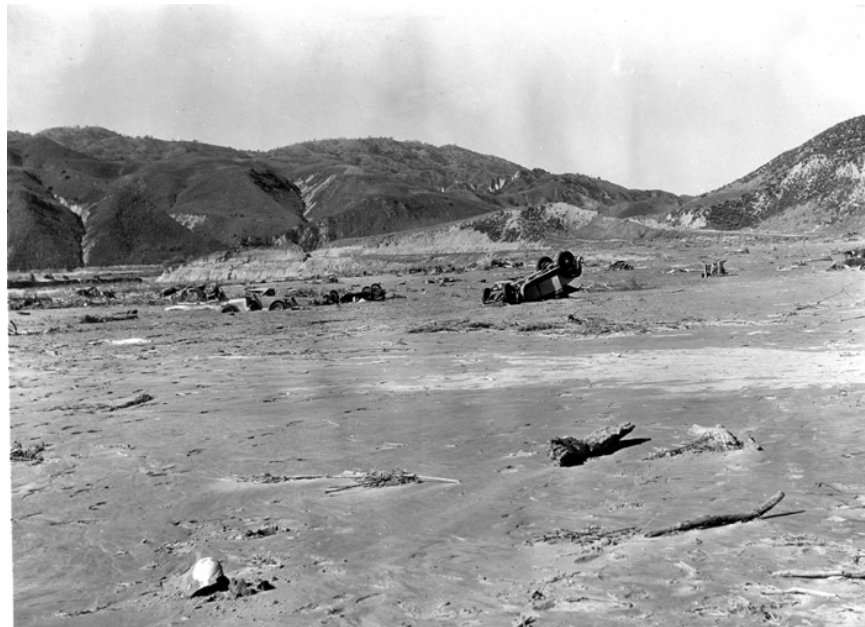
Flood damage
(Attribution: U.S. Geological Survey Photographic Library)
Figure 11
