Mine Subsidence and Damage to Residential Structures

Mine Subsidence in Illinois: Facts for Homeowners

Circular 569 2006

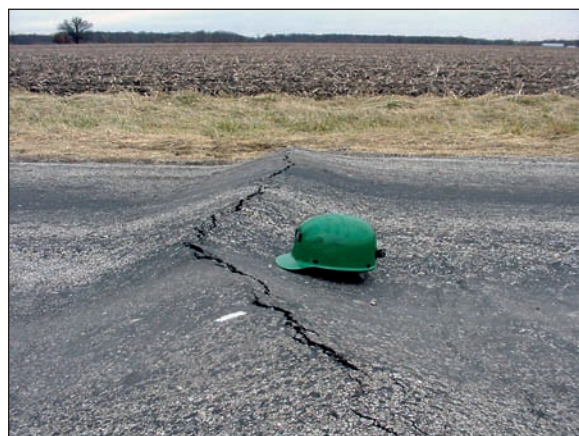
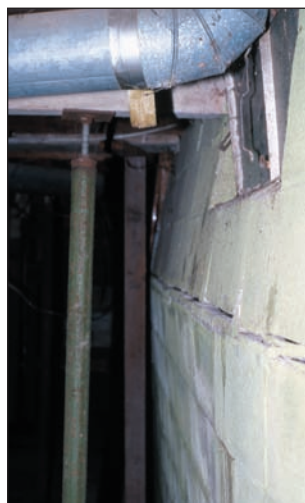
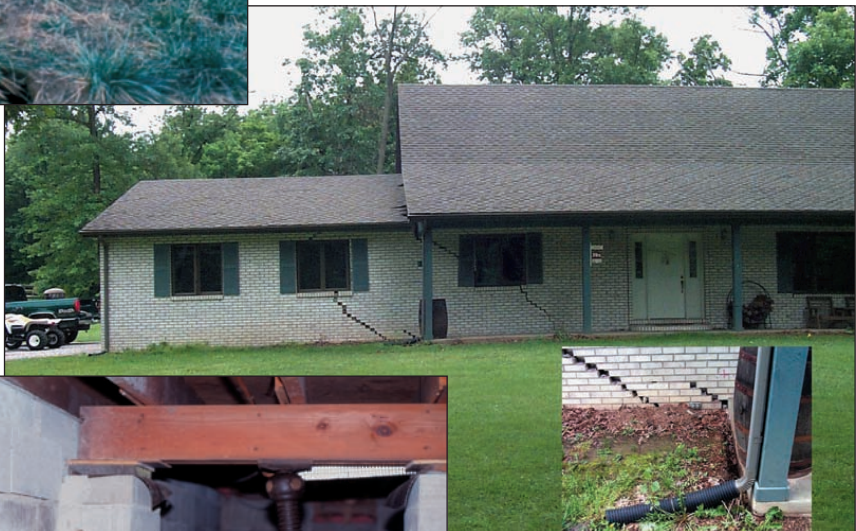
Front Cover: (a) Tension cracks formed in the ground surface extending through a home; the foundation has settled at the house corner closer to center of sag. (b) Compression ridges formed in a road as the result of ground movement (compression) associated with coal mine subsidence. (c) The brick-sided house in the tension zone shows downward bending (compare roof lines). The left side of the home is closest to the sag center and has dropped down. Insert: ground has pulled away from the porch toward the sag center (left). (d) Settlement of main beam caused by construction problems. (e) This basement damage was unrelated to mine subsidence. It was caused from decades of seasonal wetting and drying of soils, which built up pressure against the basement foundation walls. With each cycle, dryness allows fine grains of soil to fall into the gap between the soil and the foundation wall. When moisture returns, the soil expands, increasing pressure until the wall fails and is pushed inward.

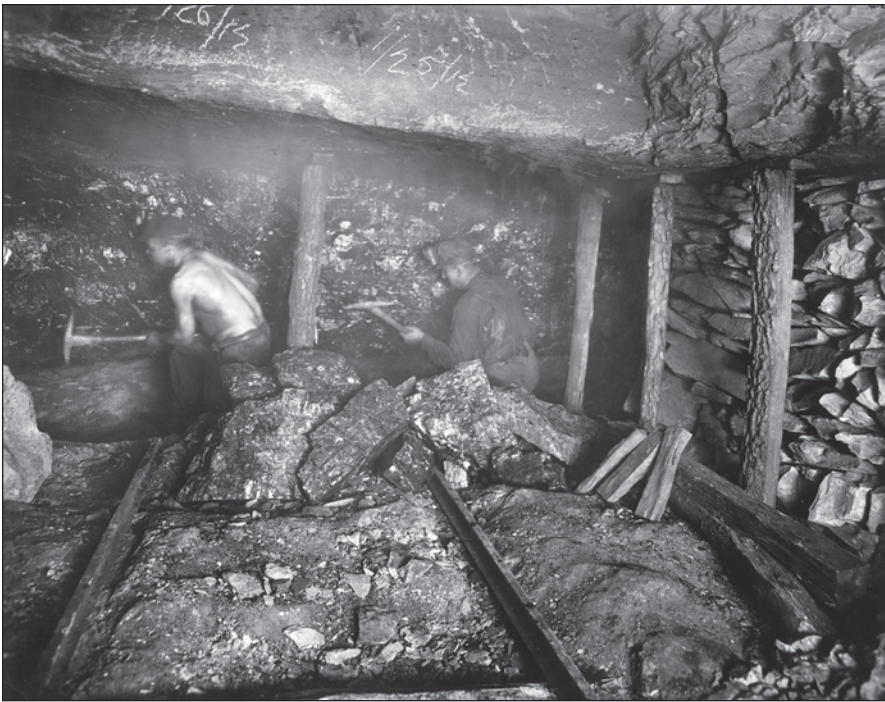
Figure 5 Photograph of mining at the face in an early longwall mine. Note the rock support on the right side of photograph. These mines operated from the 1870s to 1951 in fifteen counties. Most were located in the northern counties from Bureau through Will (fig. 2).

In the late 1800s and early 1900s, longwall mines (figs. 5 and 6a) were excavated by hand, and workers maintained the haulageways (entryways) by placing stacked rock, wooden props, and rock-filled wooden structures to replace the support lost by the removal of coal. The mine roof and the rest of the overburden’s weight settled onto the stacks of rock and compressed them. When this occurred, a few feet of subsidence resulted at the ground surface over the entire mined area.

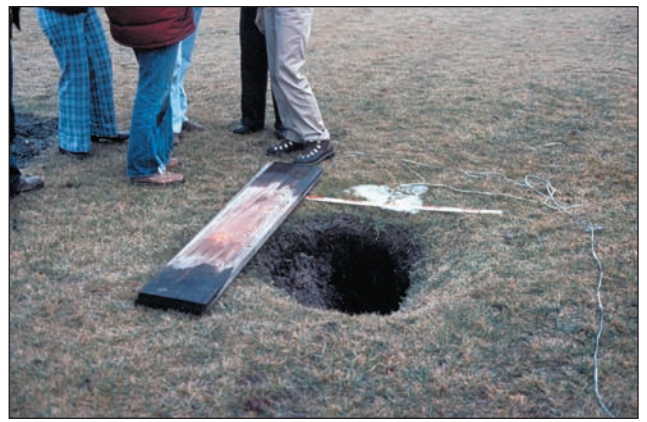
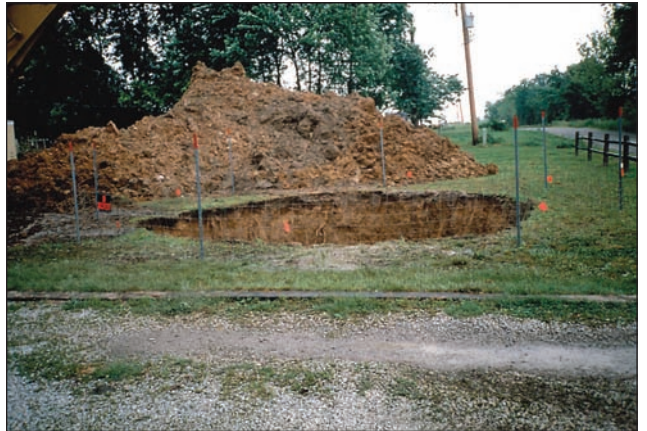
Figure 8 Diagram (Wildanger et al. 1980) and photographs of typical pit subsidence events.

layers to the ground surface. Pit subsidence forms very quickly. If the bedrock is only a few feet thick and the surficial deposits are loose, these materials may wash into adjacent mine voids, producing a surface hole deeper than the height of the collapsed mine void.

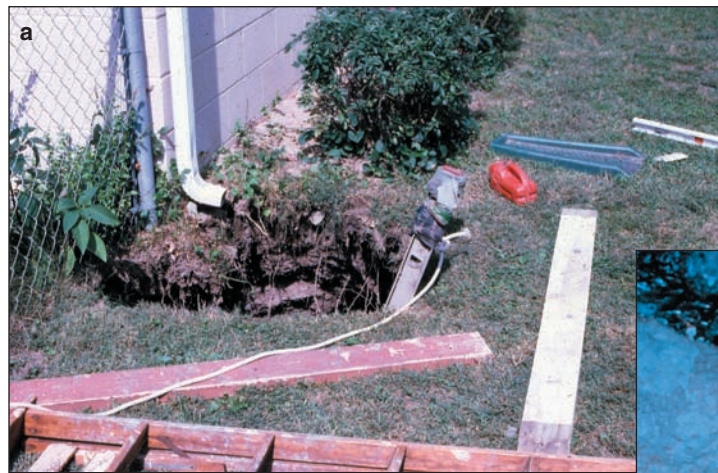
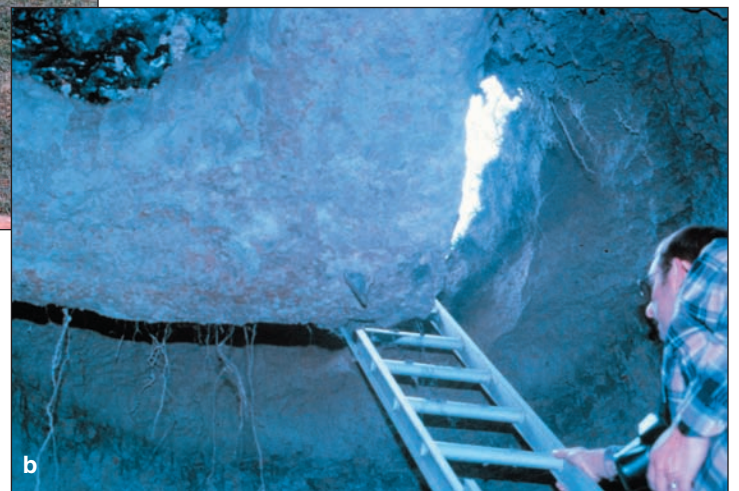
Figure 9 Pit subsidence under the corner of a house from (a) above and (b) below ground.

Structures can be damaged if pit subsidence develops under the corner of a building, the support posts of a foundation, or another critical spot. Otherwise, the probability of a structure being damaged by pit subsidence is low because most pits are relatively small—only a few feet across. If pit subsidence develops under foundation walls, the house may not be affected immediately because the foundation may temporarily bridge the pit (figs. 8 and 9). Left unfilled, the structure (bridge) may become damaged from lack of support.

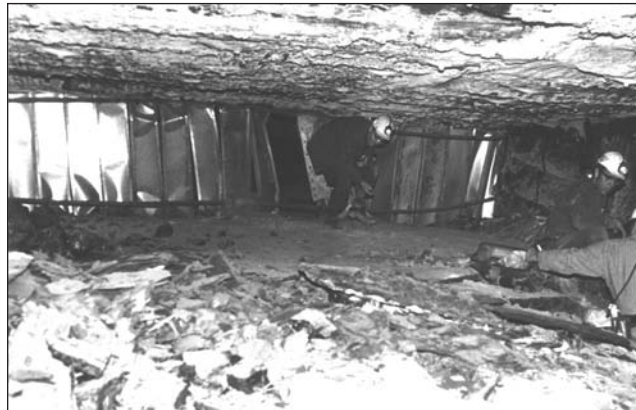
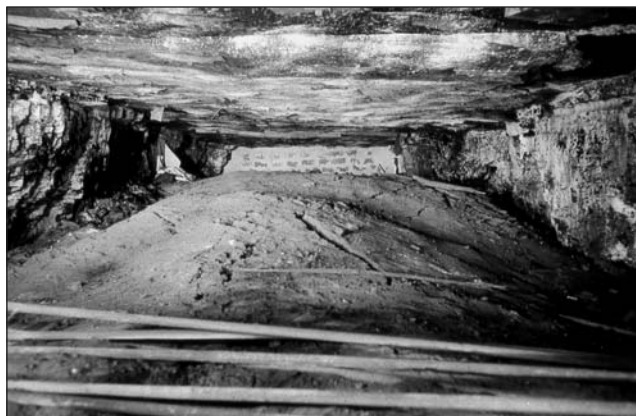
Figure 12 Diagram and photographs of coal pillars being pushed into a soft floor. The claystone material is being squeezed out from under the pillar up into the entryway.

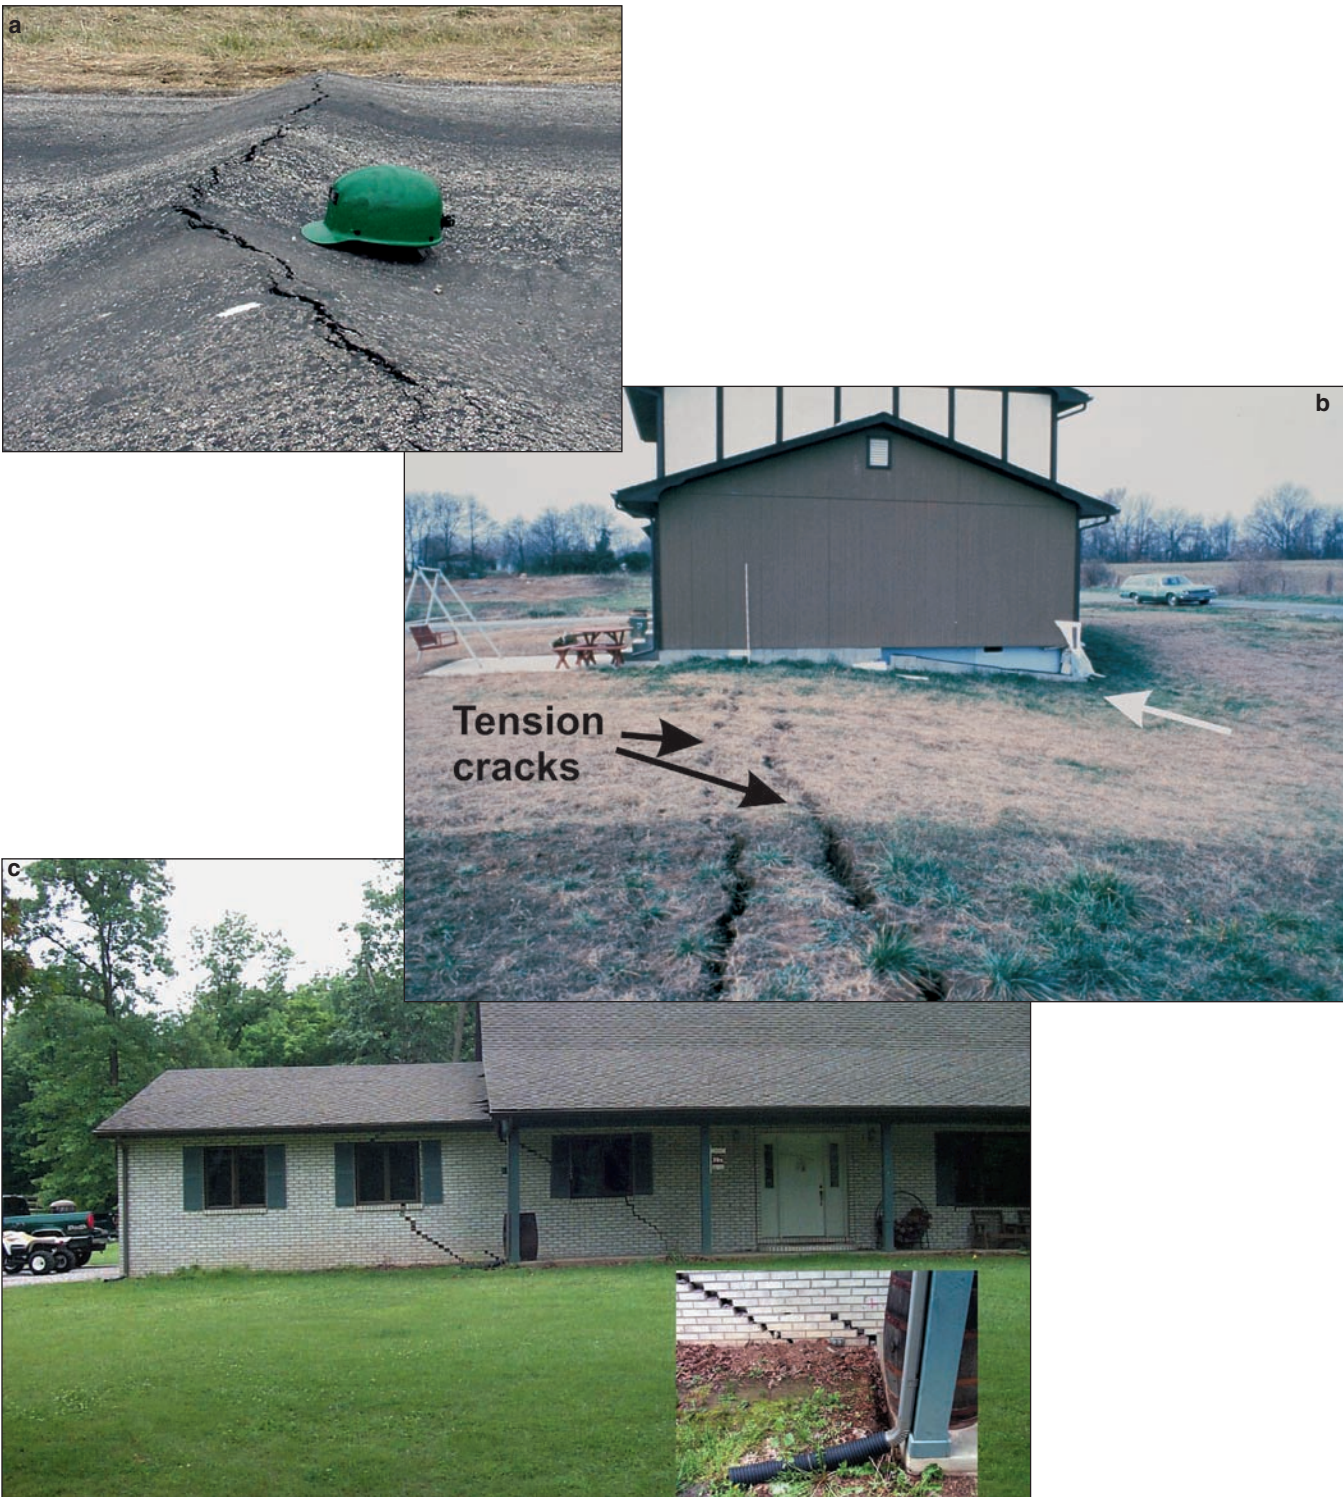
Figure 14 Photographs illustrating the sag subsidence event and features shown in figure 13. (a) Compression ridges formed in the road (feature R) as the result of ground movement (compression) associated with coal mine subsidence. (b) Tension cracks form in the ground surface extending through a home (feature H1); the foundation has settled at the house corner close to the center of the sag. (c) The brick-sided house (feature H2) in the tension zone shows downward bending (compare roof lines). The left side of the home is closest to the sag center and has dropped down. Insert: Ground has pulled away from the porch toward the sag center (left).

The ground moves in two directions during sag subsidence (figs. 13 and 14). The ground drops vertically and moves horizontally toward the center of the sag. At the surface, the sag may be much broader than the collapsed part of the mine. For example, a failure in a mine 160 feet deep could cause minor surface subsidence more than 70 feet beyond the edge of the collapsed area underground (edge of panel). The deeper the mine, the larger the area affected out over the unmined area. Collapsed areas in abandoned underground mines may occur in only part of a panel or mined-out area (fig. 15).

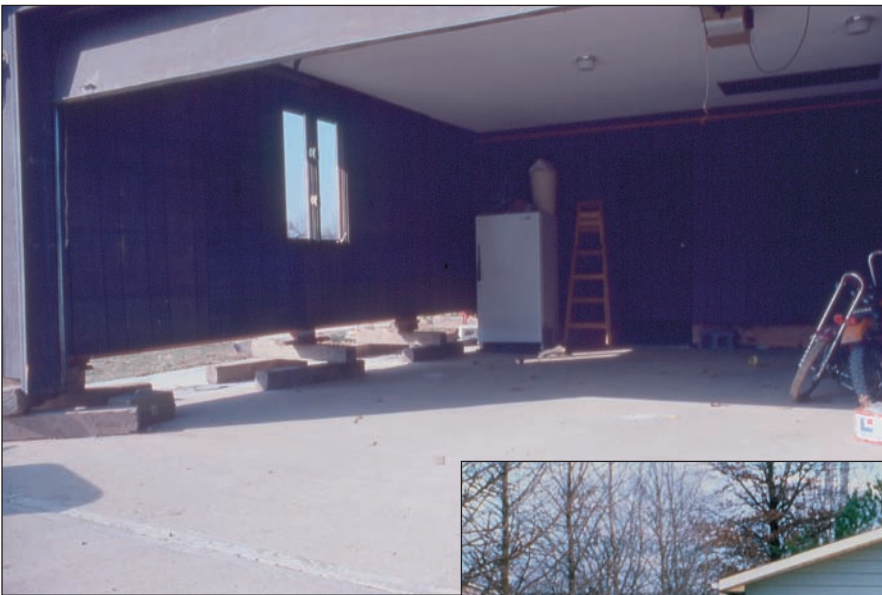
Figure 16 Load-bearing walls of a garage on a slab. The entire superstructure (frame) has been raised to a level position, exposing the interior of the garage. This re-leveling eliminates damaging stresses from differential movements of the foundation and maintains the superstructure level throughout the life of the event.

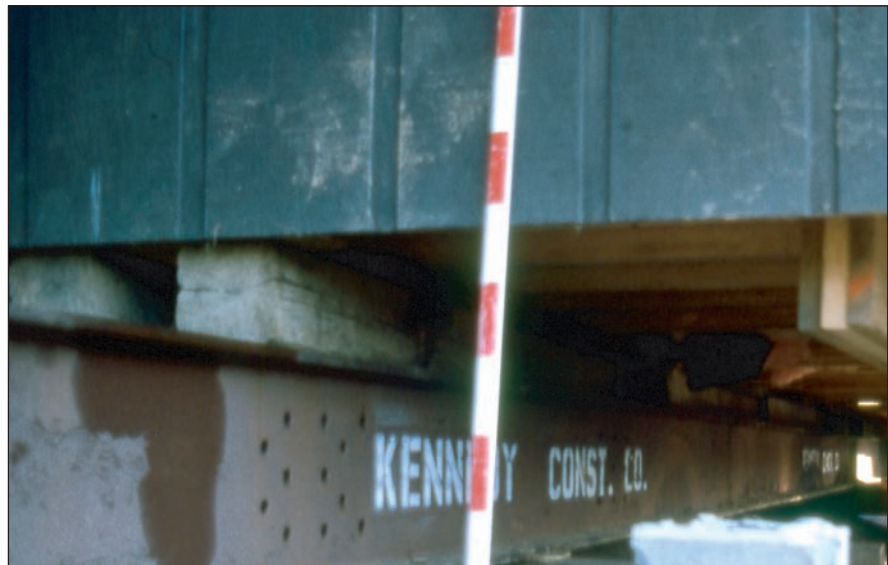
Figure 17 Concrete blocks of a crawl space have been removed to make room to jack the house to a level position. I-beams support the re-leveled house.

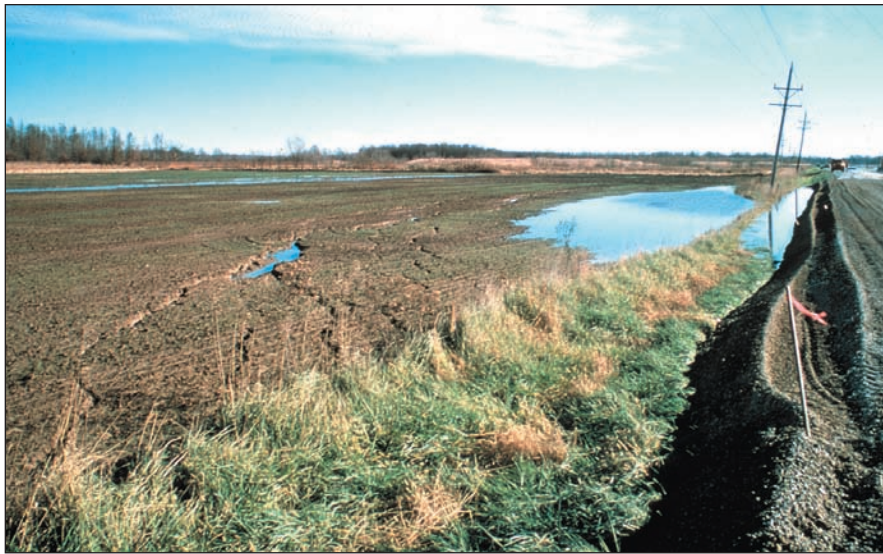
Figure 18 Ponding created by sag subsidence. Note the tension cracks around the edge of the depression.

Water can also pond in a sag subsidence event (fig. 18). If any part of a house is in a sag, an attempt should be made to keep water from accumulating around and under it. The ground surrounding the foundation must be kept

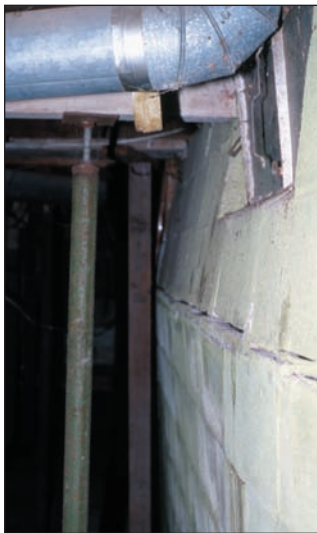
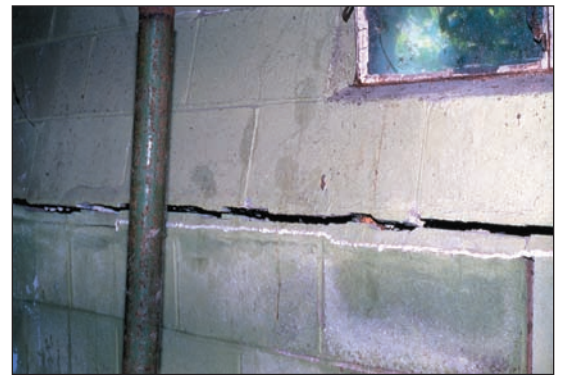
Figure 19 Basement damage unrelated to mine subsidence. Damage was caused from decades of seasonal wetting and drying of soils, which built up pressure against the basement foundation walls. With each cycle, dryness allows fine grains of soil to fall into the gap between the soil and the foundation wall. When moisture returns, the soil expands, increasing pressure until the wall fails and is pushed inward.

Shrinking and swelling Moisture-sensitive soils expand when wet and shrink when dry. Many decades of cyclic wetting and drying build up pressure against basement foundation walls as soil and other debris fall into the space between the foundation wall and the dry, shrunken soil. Pressures build until basement walls are pushed inward, forming horizontal cracks that continue across the length of the wall until they propagate downward in a stair-step pattern near the corners. Often these cracks form on all walls but tend to be more severe along the longer, load-bearing walls of rectangular-shaped homes. Typically, these horizontal cracks form a foot or more below the ground surface. If the walls move inward an excessive amount, the floor of the house may drop and tilt (fig. 19).

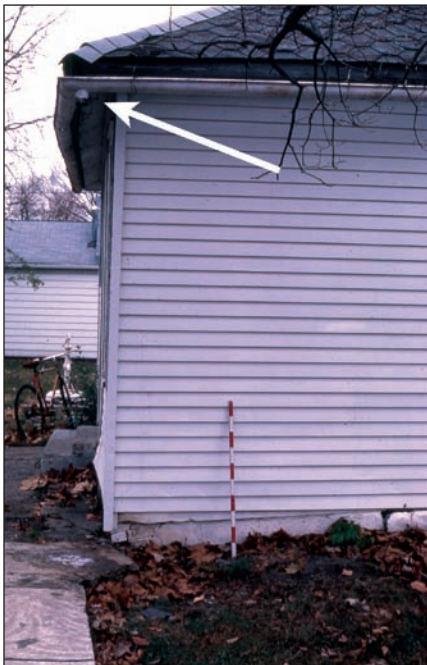
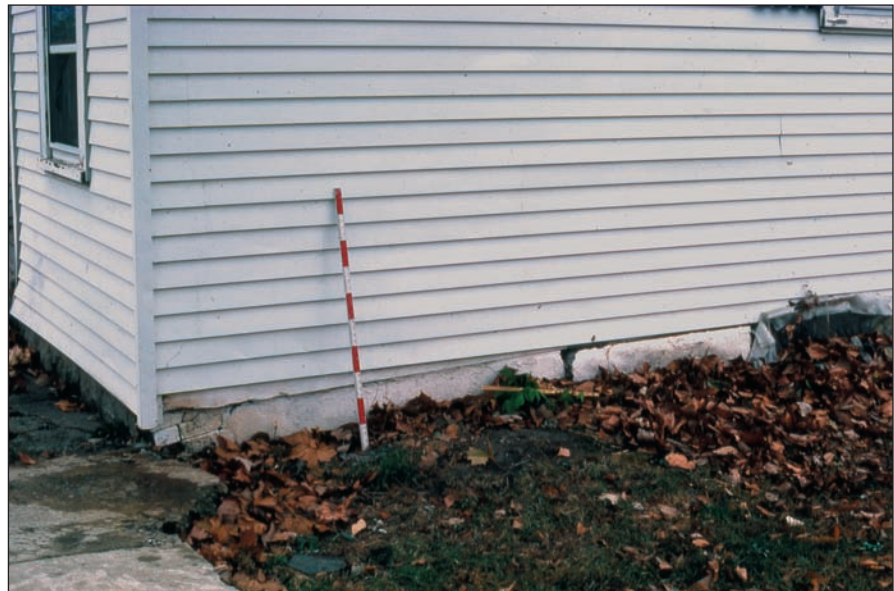
Figure 20 Foundation sinking at the corner of building due to reduced support caused by excessive, repeated moisture changes. Note gutter drainage (arrow) and lack of downspout to channel drainage away from foundation.

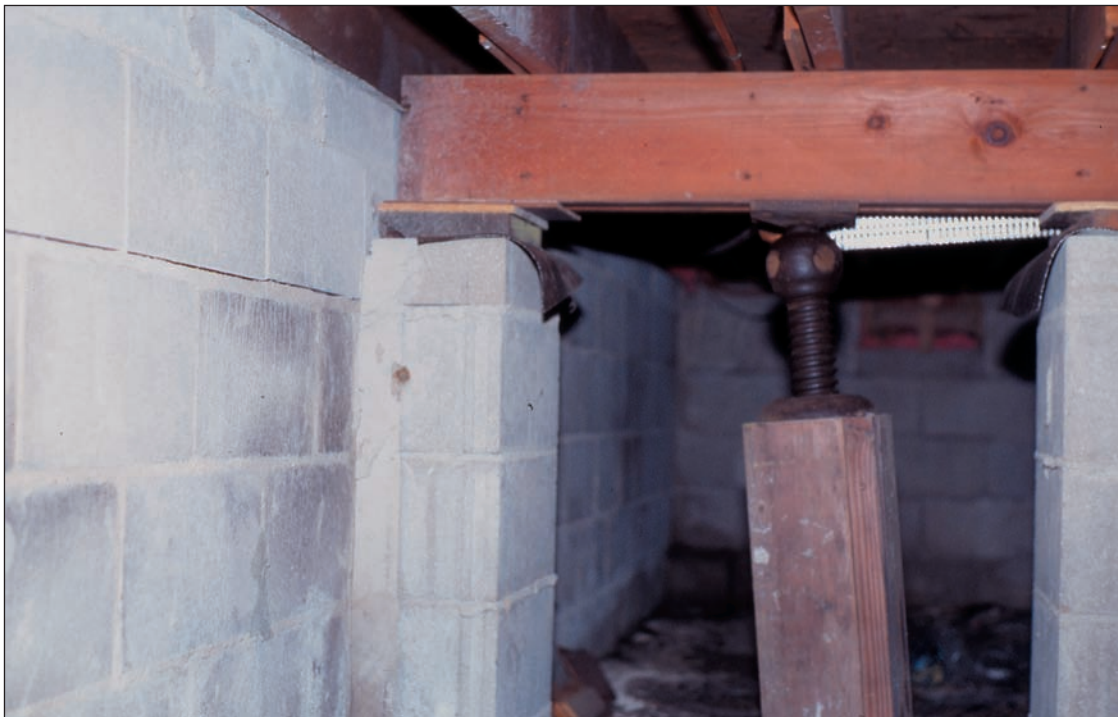
Figure 25 This main beam is not attached directly to the foundation wall. Because the beam is settling a different amount than the foundation and because some of the thick layers of shims are compressing, cracks have developed in the house above the beam.

Vertical intermediate supports for the main beam of a house may sink if they do not rest on properly sized concrete footings. Many times concrete blocks are used in crawl spaces to support the main beam running down the center of the house. Sometimes these blocks are resting directly on the soil, and, because they do not provide enough bearing area, they will sink into the soil. If there is inadequate contact area between a beam and a vertical support, enough weight can be concentrated onto the beam to crush it, thus lowering the floor. Also, if a thick stack of shims has been used between the beam and the vertical support, the shims may compress, lowering the beam (fig. 25). The ends of the main beam should rest on the foundation walls to reduce the likelihood of

the beam moving a different amount than the foundation and causing cracks to develop in the walls above this location. Insufficient spacing and floor joist size can result in sagging floors, a condition sometimes mistaken for subsidence.

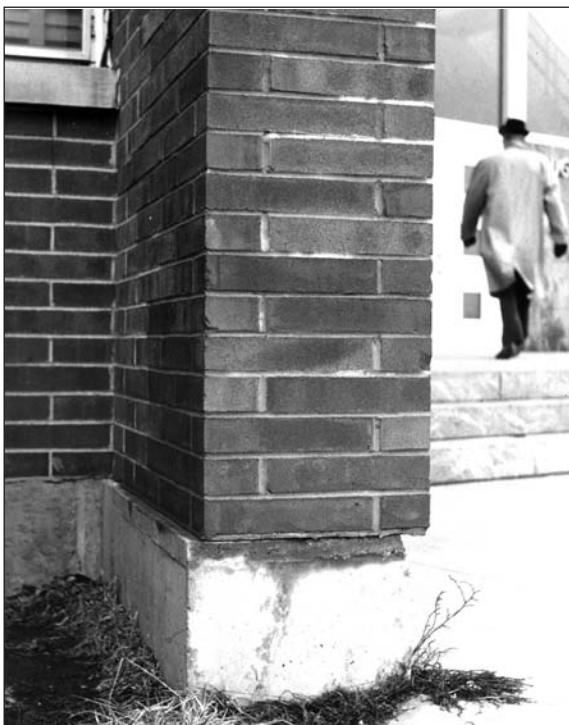
Figure 28 The largest movements are at the edges of the long continuous wall. At this point, the brick wall is being pushed off the foundation.

(fig 28); weaker materials in the wall, such as glass blocks, may be crushed (fig. 29), and the sliding wall may become separated from the interior floor slab. To minimize this type of problem, functioning expansion joints should be incorporated into the construction. Expansion joints should be clear of any hard materials that may have fallen in during construction, and pliable caulk should be used to seal the gap.

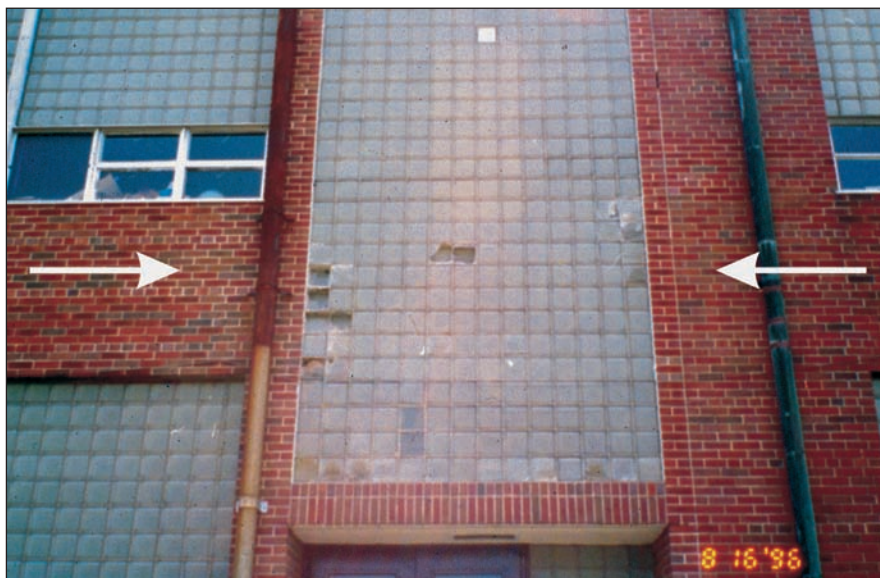
Figure 29 The long, continuous brickwork intersects the vertical glass block wall. Pressures have broken the glass blocks in line with the long continuous expanse of brick work.
