Ethical Issues from the St. Francis Dam Failure

Course No: LE2-004

J. Paul Guyer, P.E., R.A., Fellow ASCE, Fellow AEI

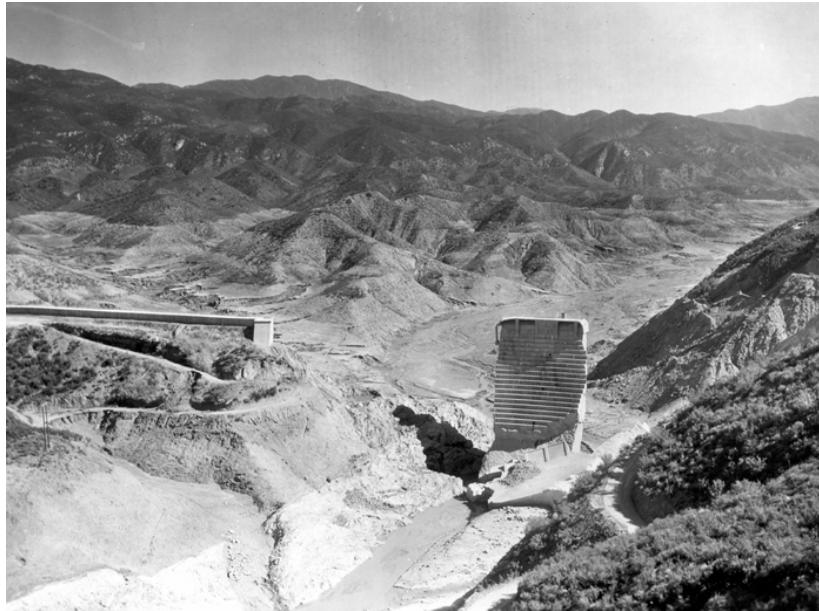
St. Francis Dam, March 17, 1928
(Attribution: U.S. Geological Survey Photographic Library)
Figure 3

The dam broke into several large concrete blocks, some of which were carried almost 1/2 mile downstream, while the center section of the dam remained standing. The upright center section was subsequently demolished. The St. Francis Dam was not rebuilt, although Bouquet Reservoir in nearby Bouquet Canyon and Castaic Dam in the town of Castaic were subsequently built as replacements for the St. Francis Dam.

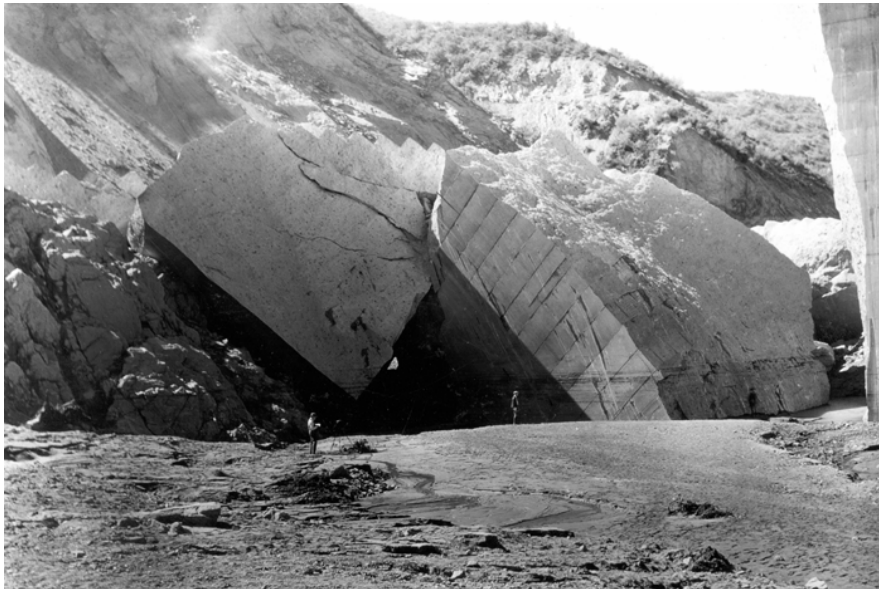
St. Francis Dam, Concrete Debris Blocks
(Attribution: U.S. Geological Survey Photographic Library)
Figure 5

Studies concluded that water behind the dam took about five minutes to travel 1.5 miles to Powerhouse No. 2 located below the dam. The height of the wall of water for the first few miles was 100 to 140 feet, and huge pieces of the dam, some weighing ten thousand tons, were washed one-half mile or more down the canyon.
