Mine Subsidence and Damage to Residential Structures

Course No: G01-004

Mine Subsidence in Illinois: Facts for Homeowners

Circular 569 2006

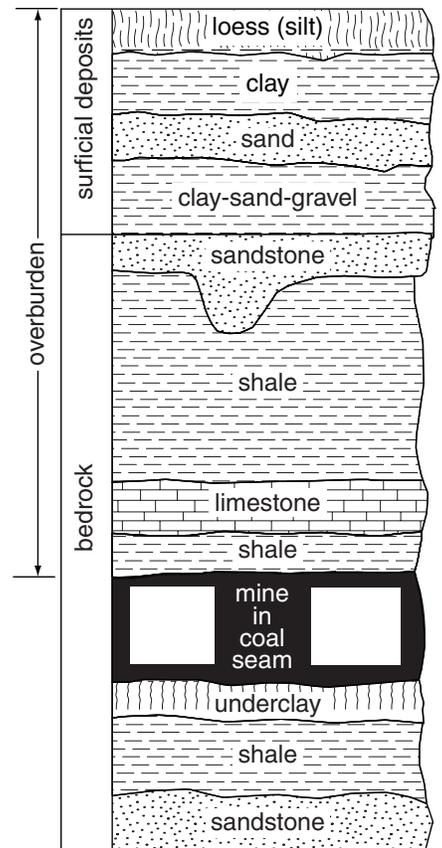
Figure 4 Generalized geologic column showing layers of surficial materials and underlying bedrock layers that are typical of the overburden of many coal mining areas.

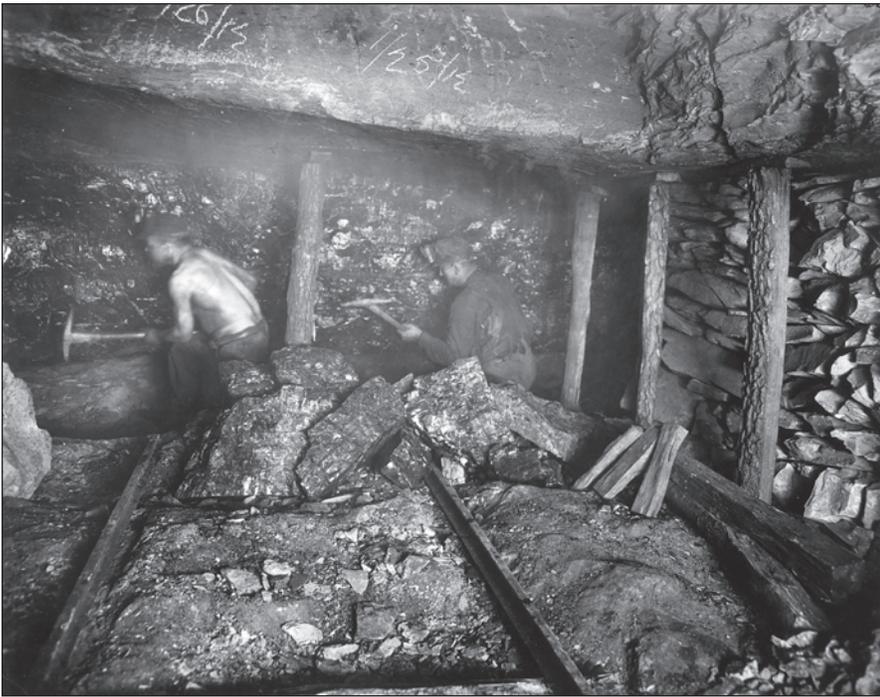
Figure 5 Photograph of mining at the face in an early longwall mine. Note the rock support on the right side of photograph. These mines operated from the 1870s to 1951 in fifteen counties. Most were located in the northern counties from Bureau through Will (fig. 2).

In the late 1800s and early 1900s, longwall mines (figs. 5 and 6a) were excavated by hand, and workers maintained the haulageways (entryways) by placing stacked rock, wooden props, and rock-filled wooden structures to replace the support lost by the removal of coal. The mine roof and the rest of the overburden’s weight settled onto the stacks of rock and compressed them. When this occurred, a few feet of subsidence resulted at the ground surface over the entire mined area.

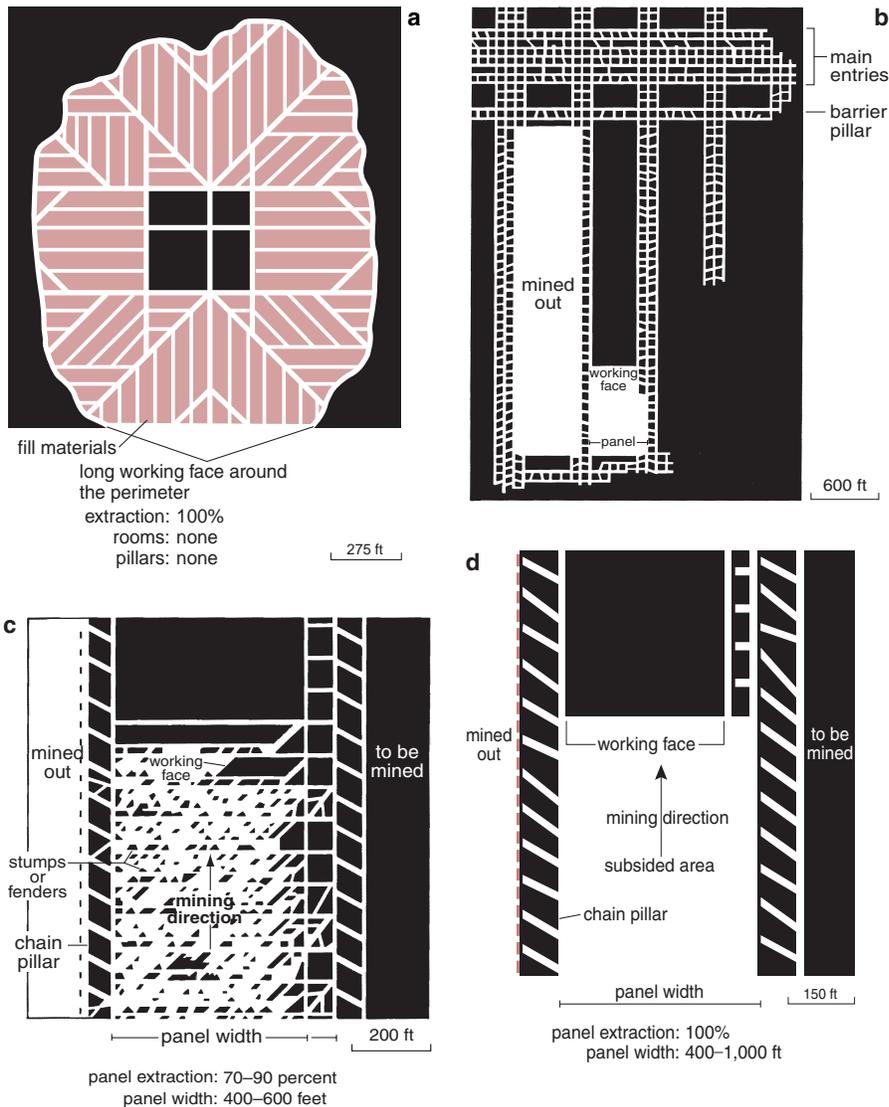
Figure 6 (a) Diagram of an early longwall mine design. Coal was removed starting from the center of the mine (shaft-entrance to mine level) outward along a continuous outside perimeter of the mine. Areas where the coal was removed were backfilled with rock support (see fig. 5) (after Andros 1914a). (b) Diagram of general development plan for modern high-extraction retreat and longwall mine (Hunt 1980). (c) Modern high-extraction retreat method: small stumps of pillars are crushed when roof collapses. Chain pillars may be mined to increase panel width (Hunt 1980). (d) Modern longwall method whereby all coal is removed along a straight mining face, forming a sharply defined panel with no remaining coal support except a row of pillars between panels (after Hunt 1980).

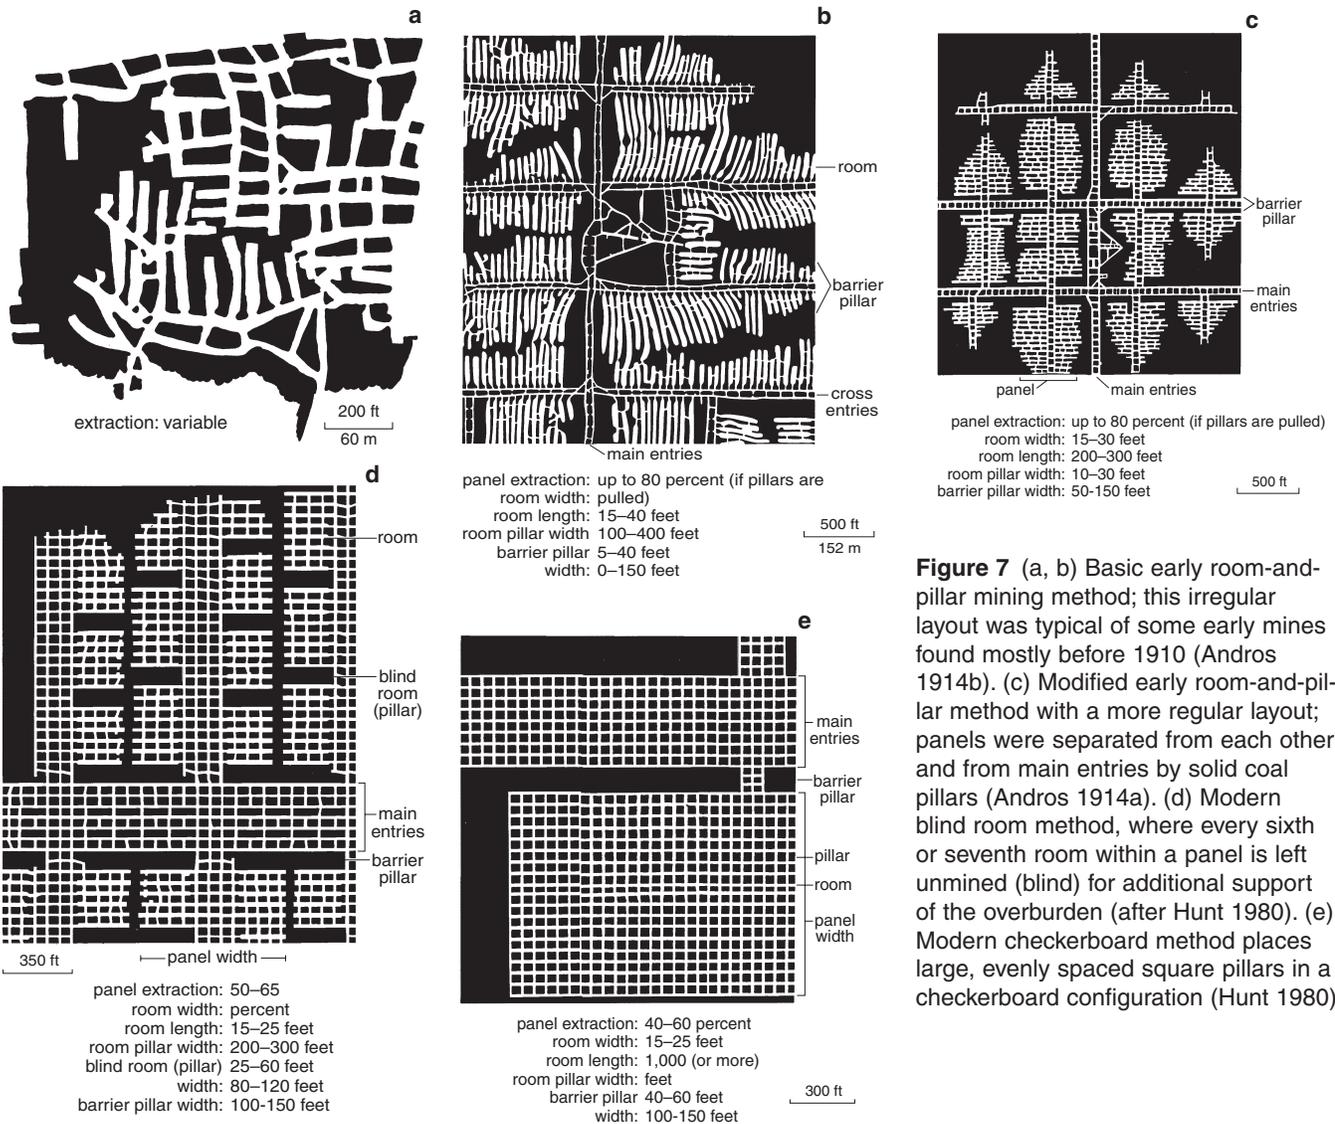
Figure 7 (a, b) Basic early room-and-pillar mining method; this irregular layout was typical of some early mines found mostly before 1910 (Andros 1914b). (c) Modified early room-and-pillar method with a more regular layout; panels were separated from each other and from main entries by solid coal pillars (Andros 1914a). (d) Modern blind room method, where every sixth or seventh room within a panel is left unmined (blind) for additional support of the overburden (after Hunt 1980). (e) Modern checkerboard method places large, evenly spaced square pillars in a checkerboard configuration (Hunt 1980).

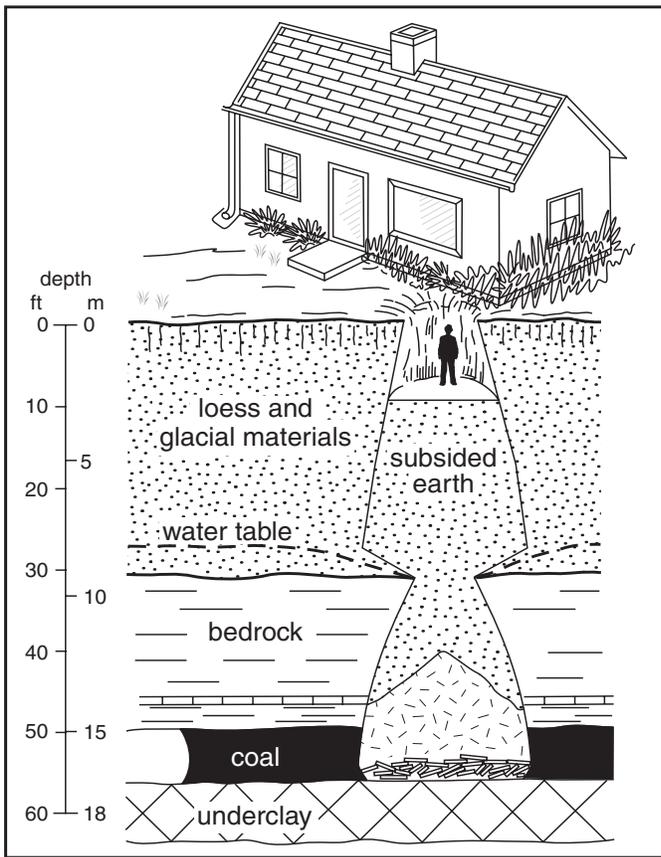
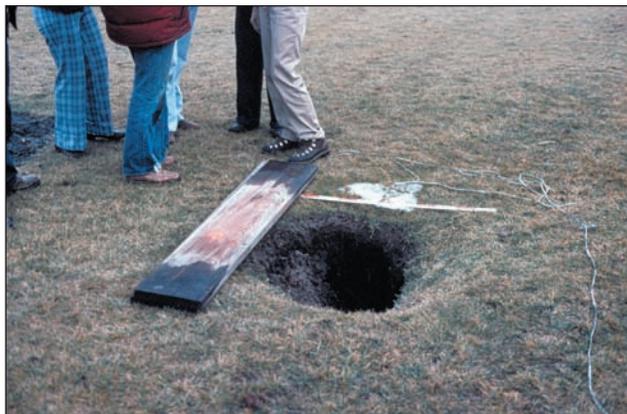
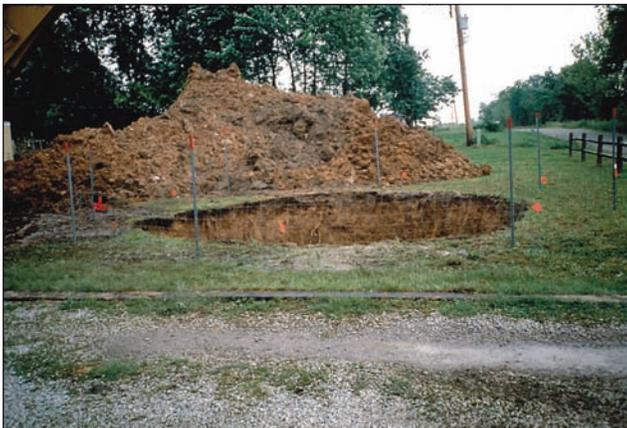
Figure 8 Diagram (Wildanger et al. 1980) and photographs of typical pit subsidence events.

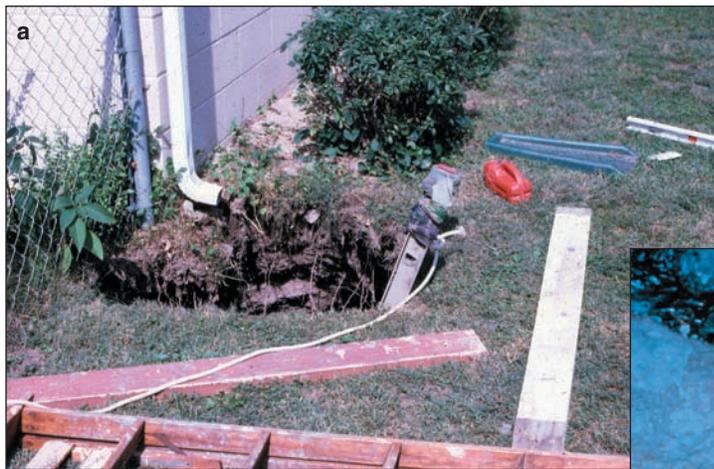
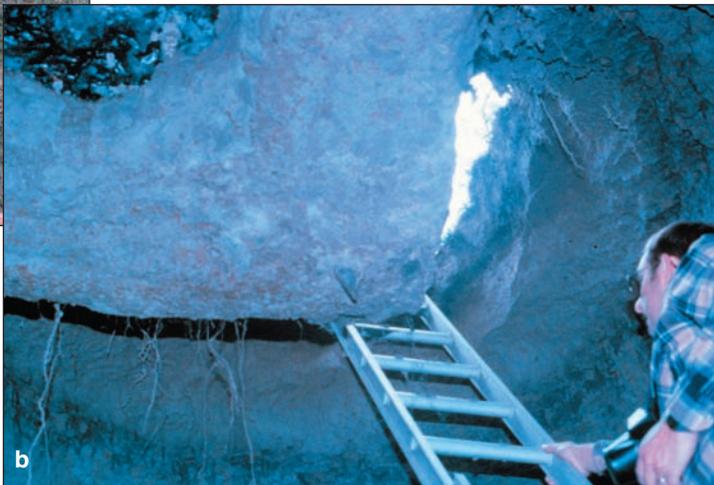
Figure 9 Pit subsidence under the corner of a house from (a) above and (b) below ground.

Structures can be damaged if pit subsidence develops under the corner of a building, the support posts of a foundation, or another critical spot. Otherwise, the probability of a structure being damaged by pit subsidence is low because most pits are relatively small—only a few feet across. If pit subsidence develops under foundation walls, the house may not be affected immediately because the foundation may temporarily bridge the pit (figs. 8 and 9). Left unfilled, the structure (bridge) may become damaged from lack of support.

Homeowners living where pit subsidence is common should periodically inspect crawl spaces and other hidden areas of their homes. When a pit is discovered below a foundation, the pit should be carefully filled so that proper support is again established.

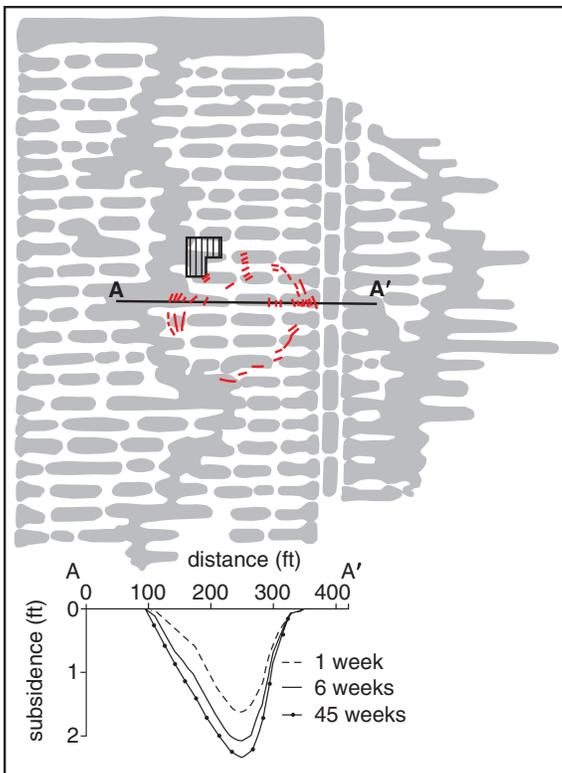
Figure 10 Sag subsidence shown on a map of the underlying mine. Profile A–A' shows the sag developing. Compression ridges formed near the deepest part of the sag, and tension cracks (red lines) formed around the perimeter. (Data are from Dave Kiesling, Department of Civil Engineering, University of Illinois, personal communication 1981.)

Sag subsidence forms a gentle depression over a broad area. Some sags may be as large as a whole mine panel—several hundred feet long and a few hundred feet wide (fig. 10). Several acres of land may be affected. The maximum vertical settlement is gener-

ally near the center of the depression and is 2 to 4 feet deep (fig. 10).

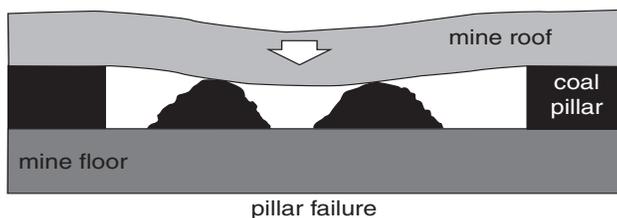
Figure 11 Diagram of a failure of pillars that results in lowering of the ground surface.

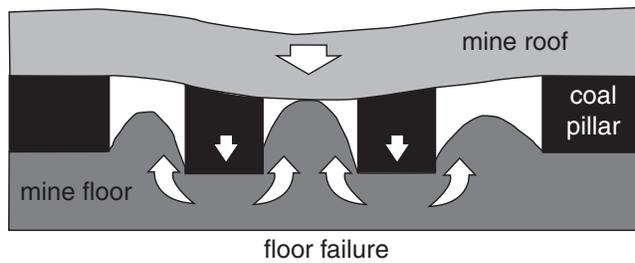
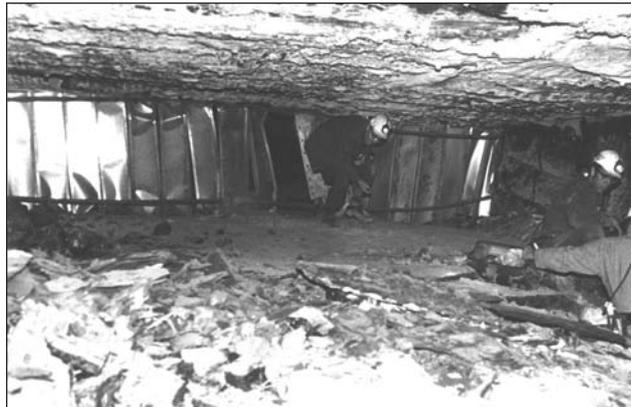
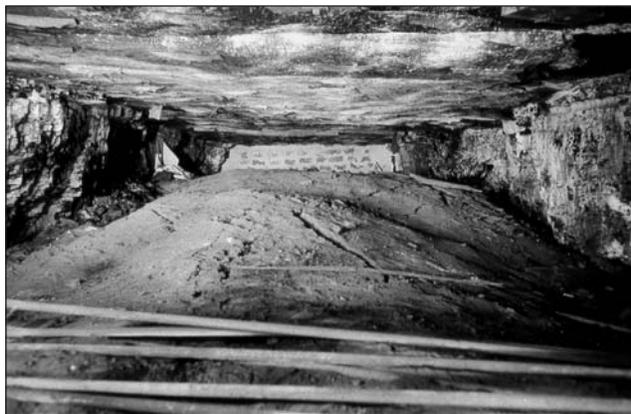
Figure 12 Diagram and photographs of coal pillars being pushed into a soft floor. The claystone material is being squeezed out from under the pillar up into the entryway.

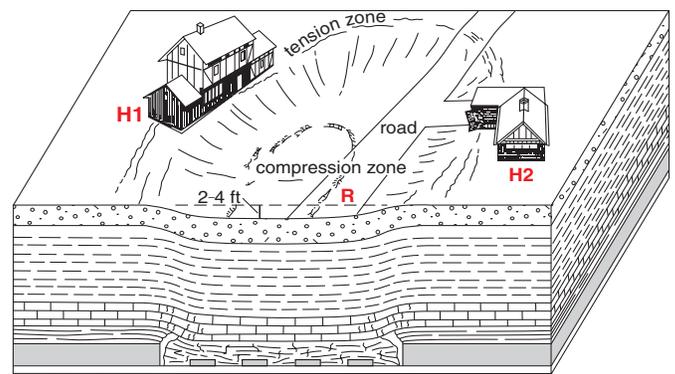
Figure 13 Block diagram of a typical sag subsidence event. The road is in the compression zone (located at R), and asphalt has buckled. The wood frame house (H1) is in the tension zone; the house's foundation has pulled apart and dropped away from the superstructure in one corner. A brick house (H2) in the tension zone shows cracks in walls, ceilings, and floors.

The ground moves in two directions during sag subsidence (figs. 13 and 14). The ground drops vertically and moves horizontally toward the center of the sag. At the surface, the sag may be much broader than the collapsed part of the mine. For example, a failure in a mine 160 feet deep could cause minor surface subsidence more than 70 feet beyond the edge of the collapsed area underground (edge of panel). The deeper the mine, the larger the area affected out over the unmined area. Collapsed areas in abandoned underground mines may occur in only part of a panel or mined-out area (fig. 15).

can be made, house H1 needs to be entirely supported. Damage in house H2 will be restricted mostly to the lowered side, so that only this side may need support.

In the comparatively smaller compression zone, roads (fig. 13, R) may buckle, and foundation walls may be pushed inward. The foundation of any house in the center of the sag would be subjected to horizontal compression. Buildings damaged by compression

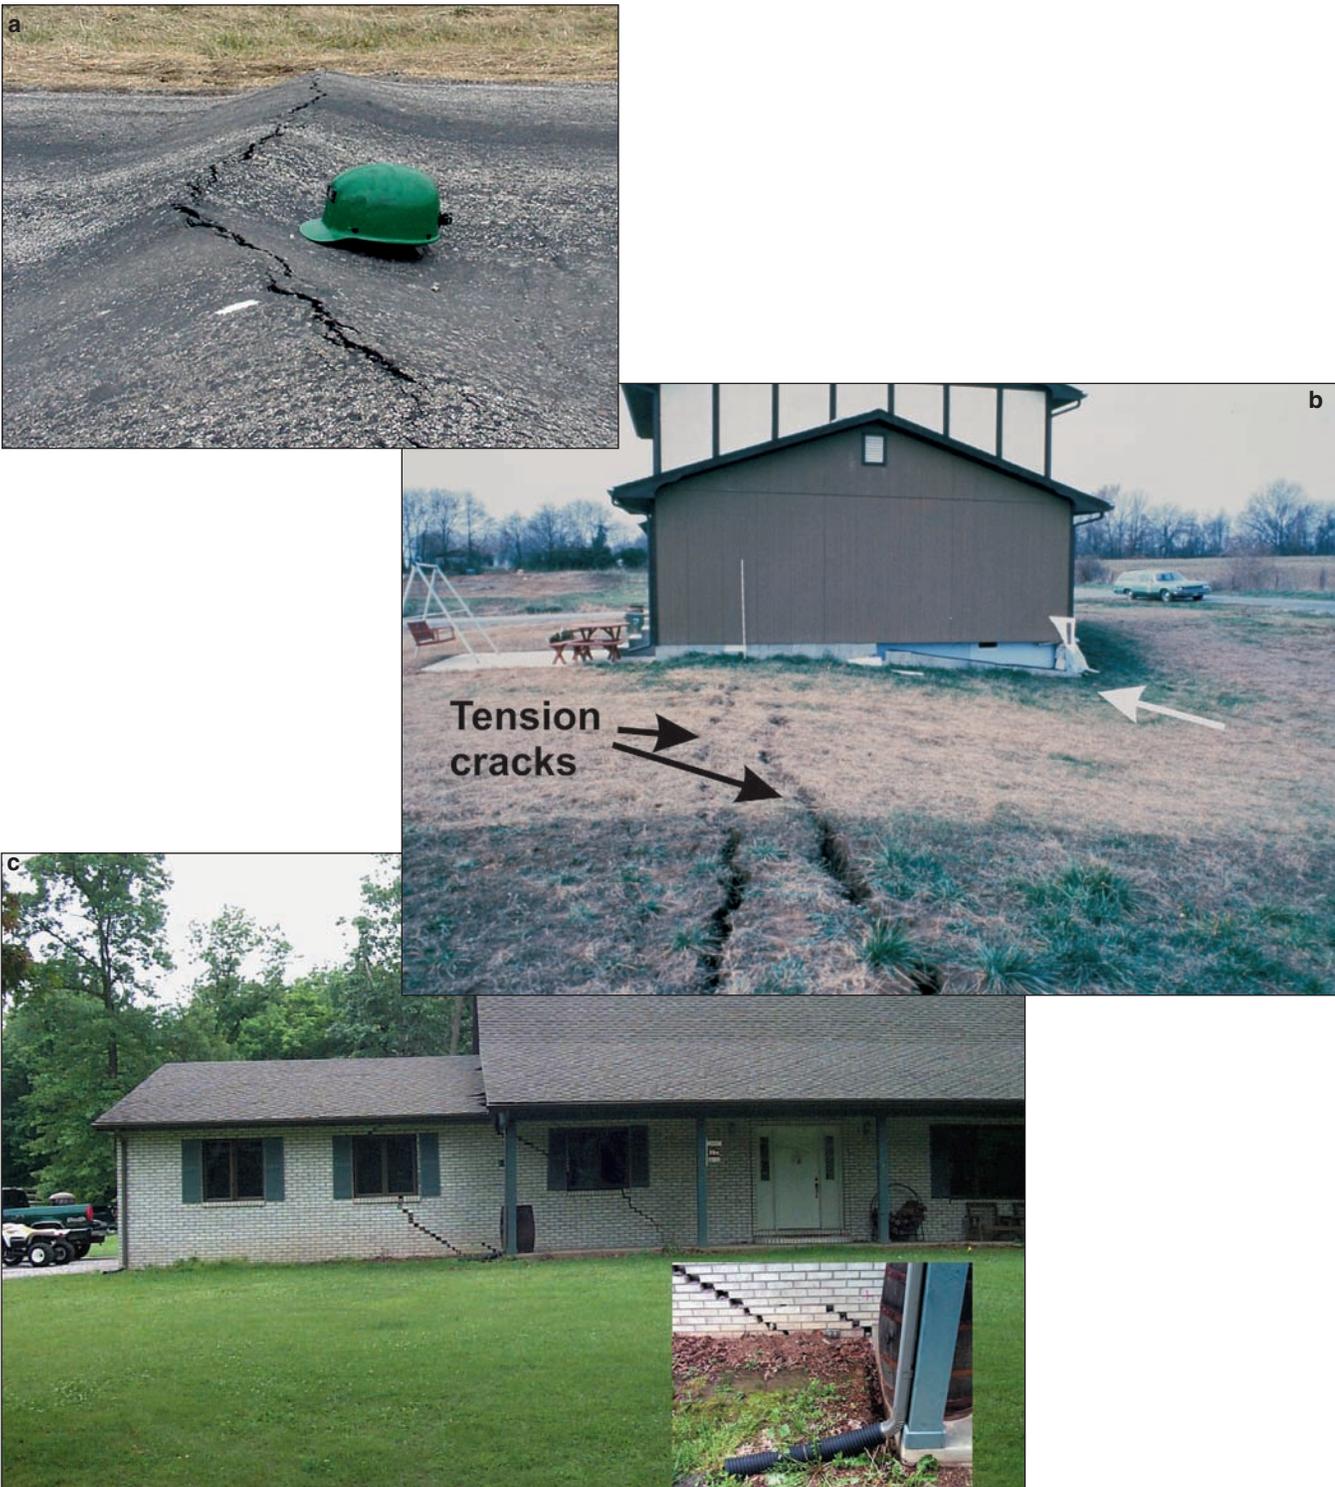
Figure 14 Photographs illustrating the sag subsidence event and features shown in figure 13. (a) Compression ridges formed in the road (feature R) as the result of ground movement (compression) associated with coal mine subsidence. (b) Tension cracks form in the ground surface extending through a home (feature H1); the foundation has settled at the house corner close to the center of the sag. (c) The brick-sided house (feature H2) in the tension zone shows downward bending (compare roof lines). The left side of the home is closest to the sag center and has dropped down. Insert: Ground has pulled away from the porch toward the sag center (left).

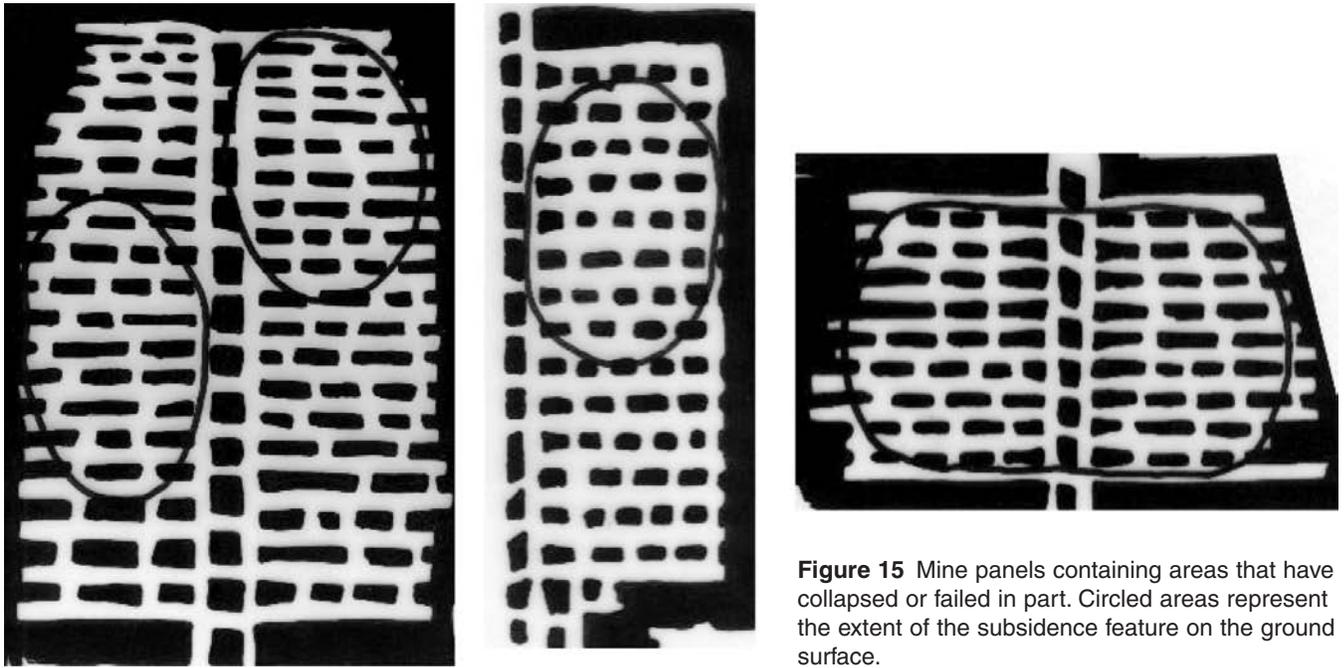
Figure 15 Mine panels containing areas that have collapsed or failed in part. Circled areas represent the extent of the subsidence feature on the ground surface.

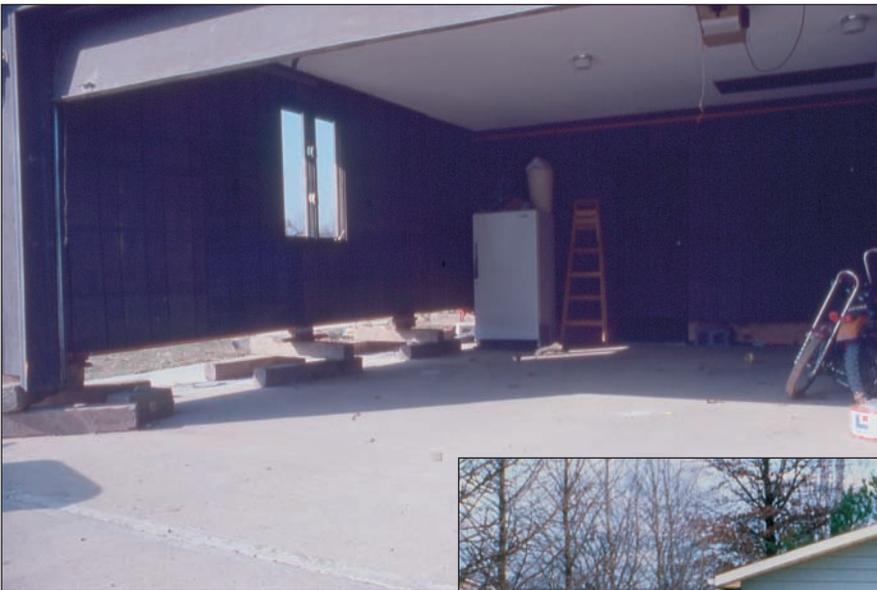
Figure 16 Load-bearing walls of a garage on a slab. The entire superstructure (frame) has been raised to a level position, exposing the interior of the garage. This re-leveling eliminates damaging stresses from differential movements of the foundation and maintains the superstructure level throughout the life of the event.

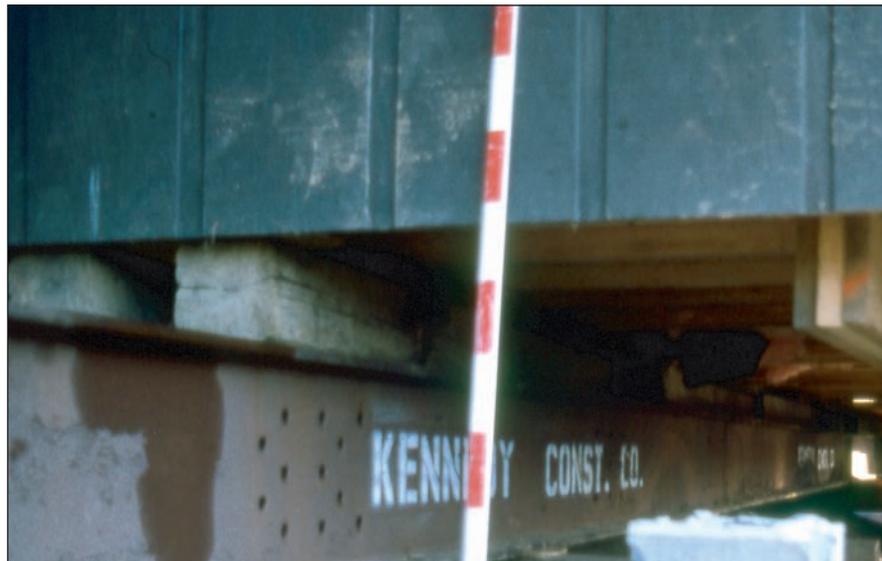
Figure 17 Concrete blocks of a crawl space have been removed to make room to jack the house to a level position. I-beams support the re-leveled house.

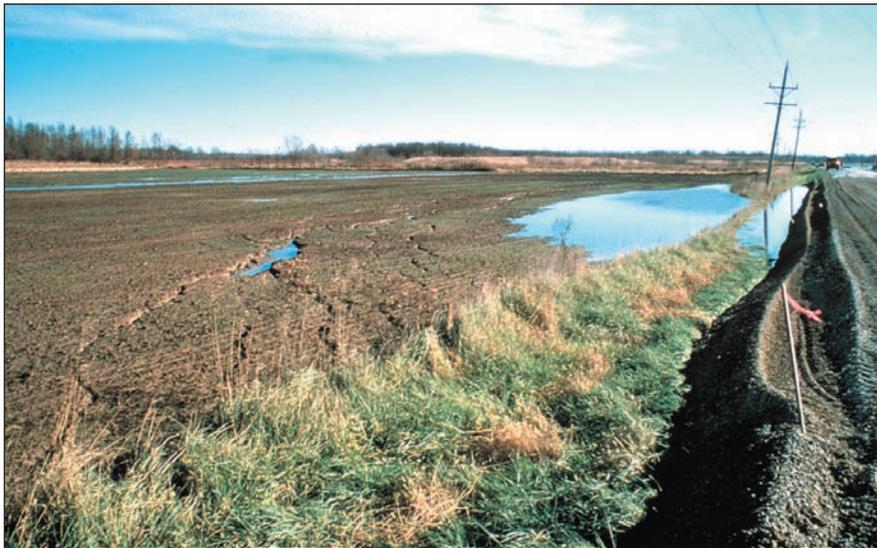
Figure 18 Ponding created by sag subsidence. Note the tension cracks around the edge of the depression.

Water can also pond in a sag subsidence event (fig. 18). If any part of a house is in a sag, an attempt should be made to keep water from accumulating around and under it. The ground surrounding the foundation must be kept

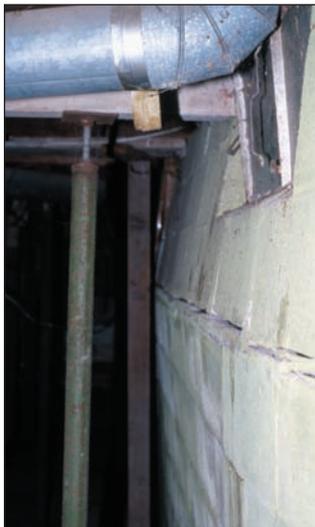
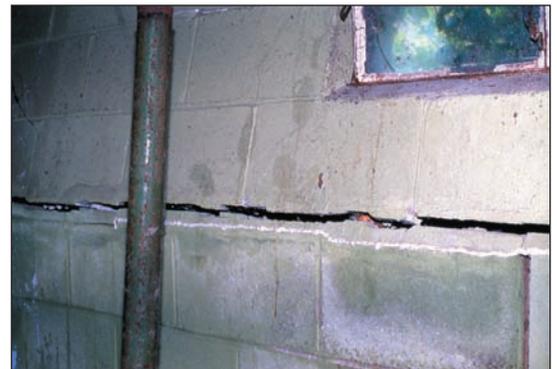
Figure 19 Basement damage unrelated to mine subsidence. Damage was caused from decades of seasonal wetting and drying of soils, which built up pressure against the basement foundation walls. With each cycle, dryness allows fine grains of soil to fall into the gap between the soil and the foundation wall. When moisture returns, the soil expands, increasing pressure until the wall fails and is pushed inward.

Shrinking and swelling Moisture-sensitive soils expand when wet and shrink when dry. Many decades of cyclic wetting and drying build up pressure against basement foundation walls as soil and other debris fall into the space between the foundation wall and the dry, shrunken soil. Pressures build until basement walls are pushed inward, forming horizontal cracks that continue across the length of the wall until they propagate downward in a stair-step pattern near the corners. Often these cracks form on all walls but tend to be more severe along the longer, load-bearing walls of rectangular-shaped homes. Typically, these horizontal cracks form a foot or more below the ground surface. If the walls move inward an excessive amount, the floor of the house may drop and tilt (fig. 19).

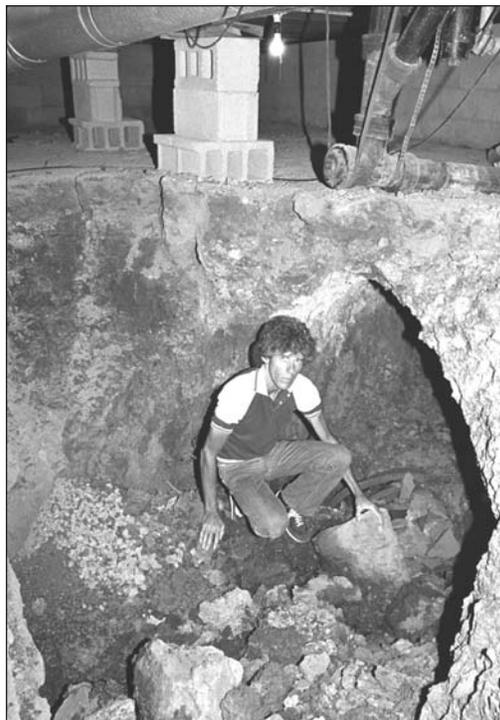
Figure 22 An extreme example of soil piping in a home crawl space. Soil was removed by moving water associated with farm drainage tile. Reproduced by permission of The News-Gazette, Inc. Permission does not imply endorsement by the newspaper. Originally published September 11, 1983.

Piping Piping, or subsurface erosion from water washing away fine-grained soil, can occur along broken or separated sewer lines, water lines, old farm tile, and buried downspout extensions (fig. 22). Older drainage systems around the outside base of the foundation—the peripheral drainage system—slowly remove soil particles and lower the ground surface around the house (fig. 23). This removal causes sidewalks, stairs, and patio slabs located along the foundation to drop and tilt toward the house (fig. 24).

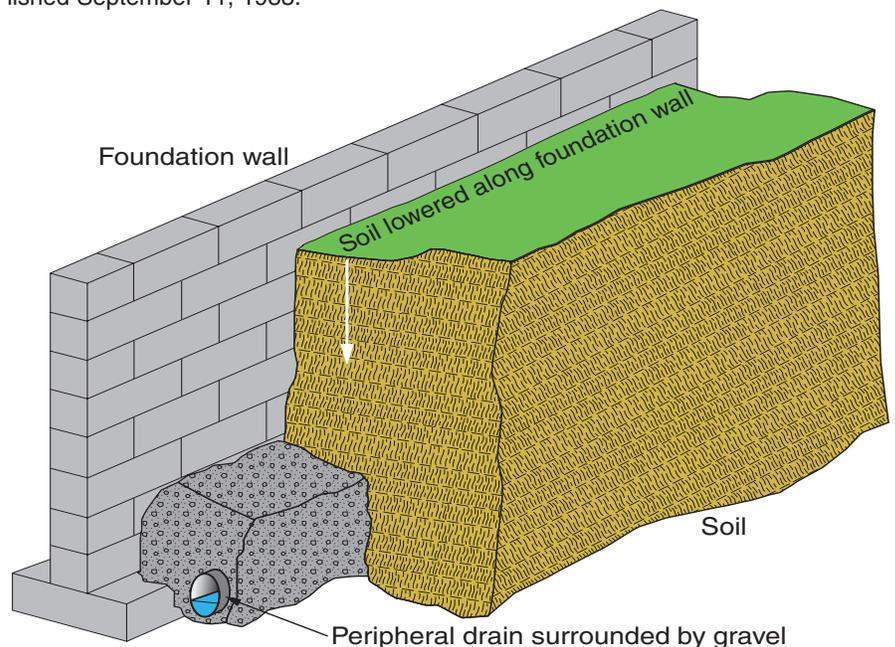
Figure 23 Diagram of a peripheral drainage system around some exterior foundation walls. Over time, the drainage system removes small amounts of soil and lowers the ground surface along the foundation.

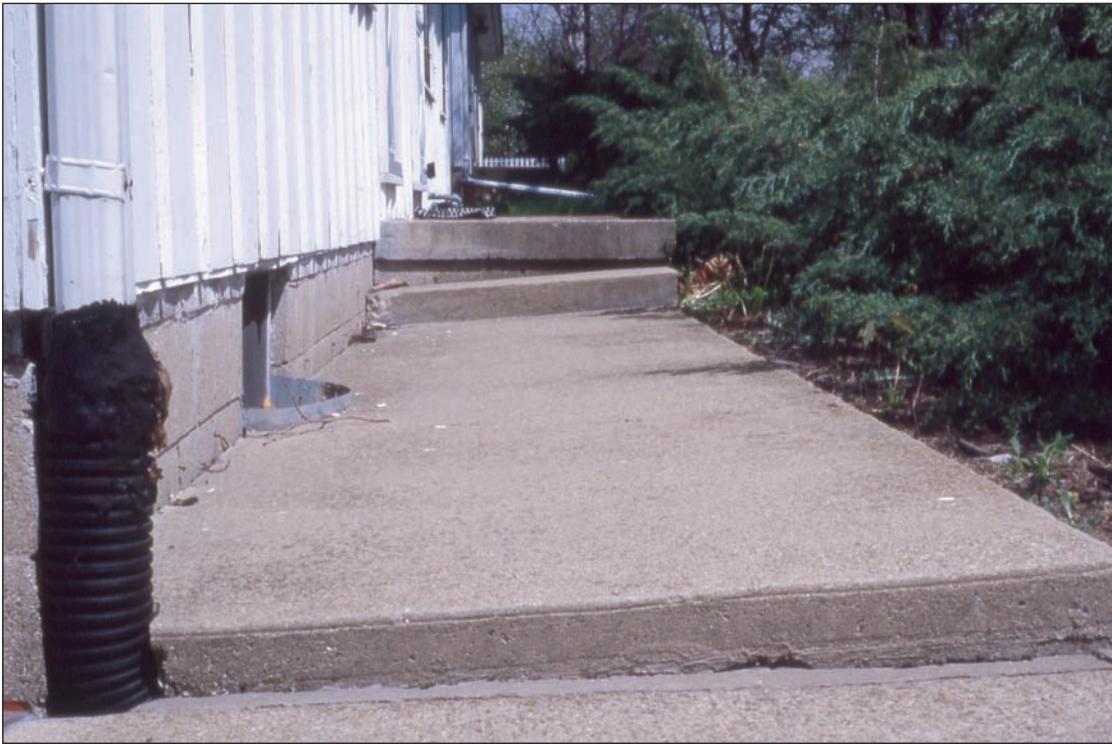
Figure 24 A moat-type depression along the foundation wall and lowered sidewalk and patio slabs caused by the kind of peripheral drainage system shown in figure 23.

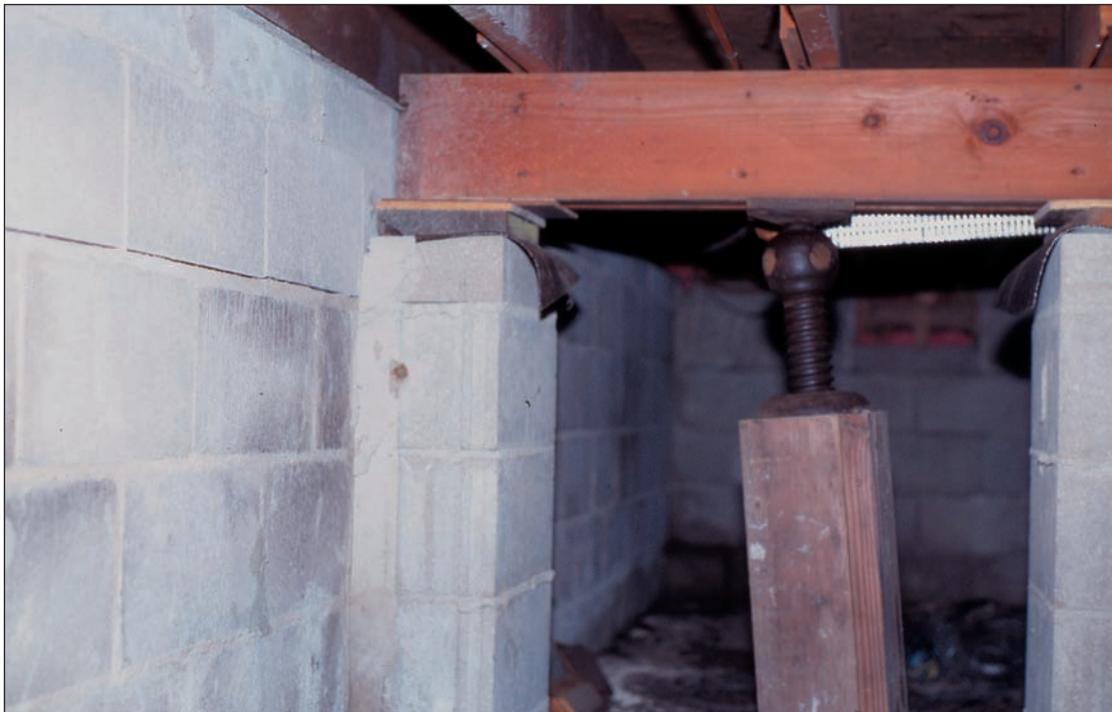
Figure 25 This main beam is not attached directly to the foundation wall. Because the beam is settling a different amount than the foundation and because some of the thick layers of shims are compressing, cracks have developed in the house above the beam.

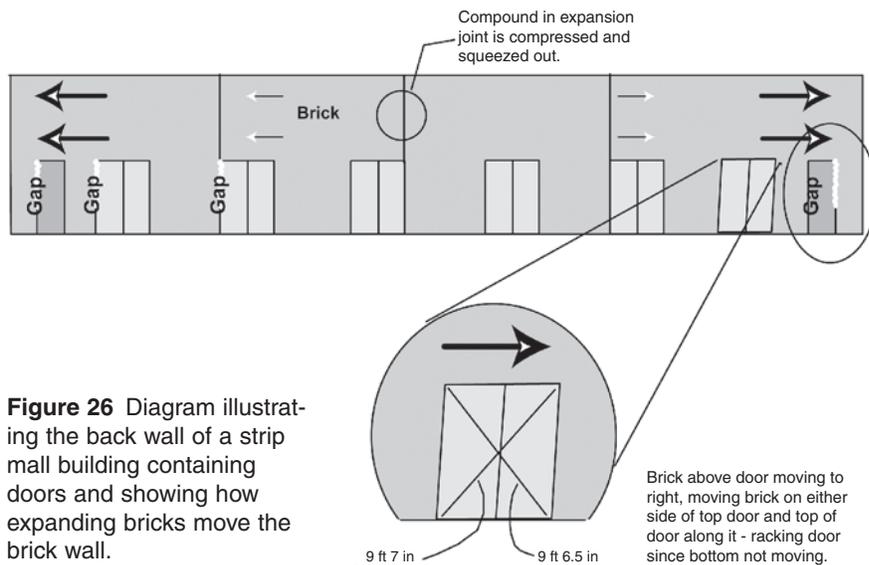
Figure 26 Diagram illustrating the back wall of a strip mall building containing doors and showing how expanding bricks move the brick wall.

This type of damage is commonly associated with long continuous expanses of brick usually found above or below windows or above doors of buildings. Movement increases from none near the center of the brick expanse to the greatest at the edges of the length of the wall (fig. 26). This movement difference occurs because small changes in

each brick push adjacent bricks toward the unconfined edge of the wall. Damage is usually at the top of door frames, which move horizontally with the expanding wall in one direction in relation to the bottom of the door frame (fig. 27). This type of movement may result in the brick wall sliding slightly off the foundation at a corner

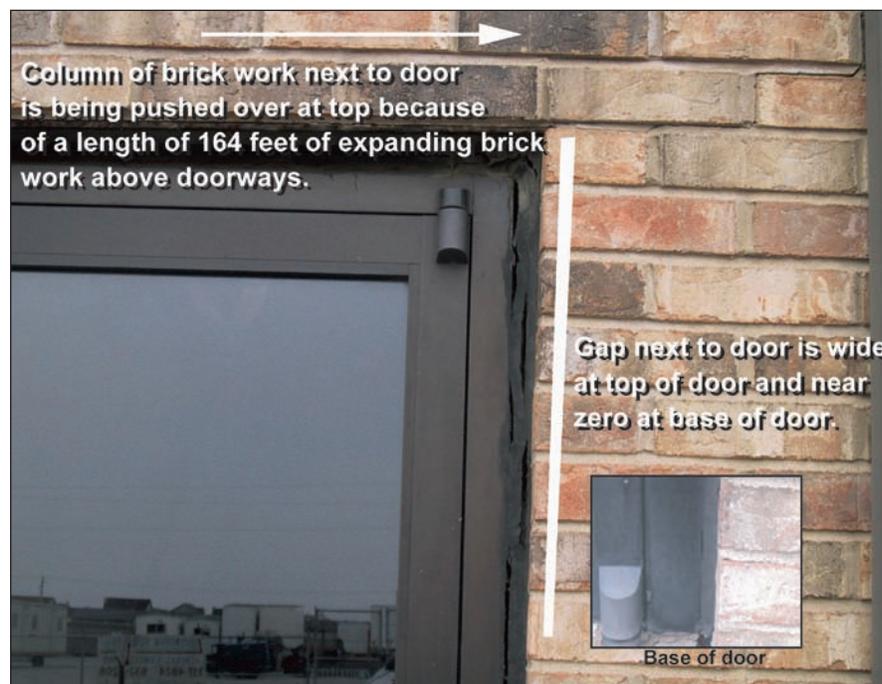
Figure 27 The long continuous length of brickwork above the door is expanding, pushing the top of the door frame to the right while the base of the door remains stationary. This movement creates the gap and causes the door to stick while opening and closing.

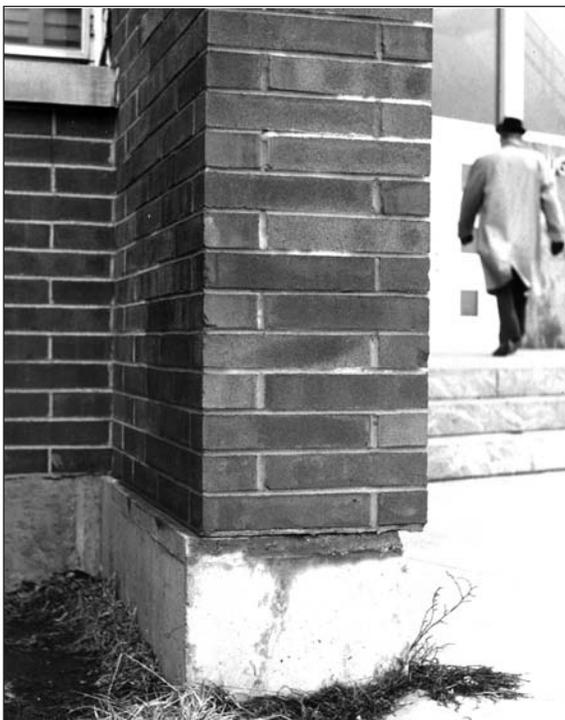
Figure 28 The largest movements are at the edges of the long continuous wall. At this point, the brick wall is being pushed off the foundation.

(fig 28); weaker materials in the wall, such as glass blocks, may be crushed (fig. 29), and the sliding wall may become separated from the interior floor slab. To minimize this type of problem, functioning expansion joints should be incorporated into the construction. Expansion joints should be clear of any hard materials that may have fallen in during construction, and pliable caulk should be used to seal the gap.

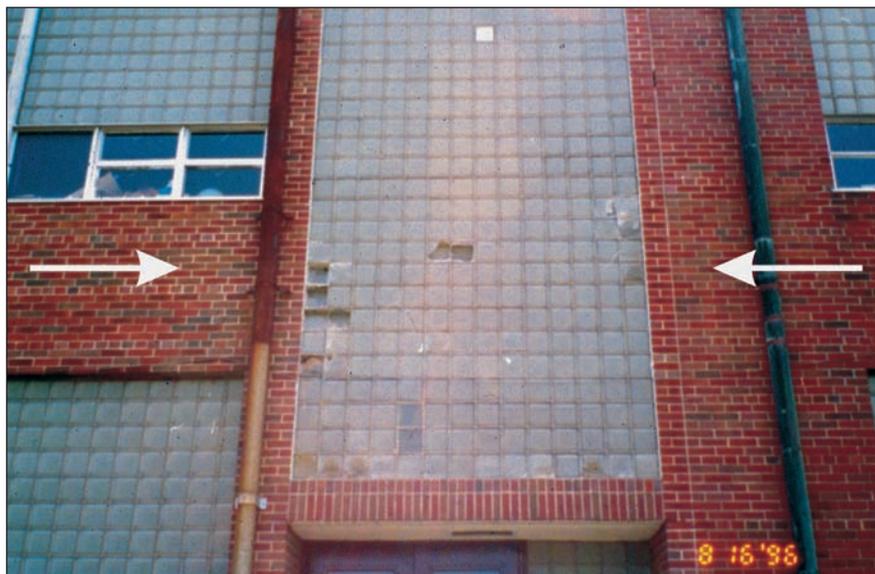
Figure 29 The long, continuous brickwork intersects the vertical glass block wall. Pressures have broken the glass blocks in line with the long continuous expanse of brick work.
