Performance-Based Earthquake Design of Buildings and Structures

Course No: S02-013

Communicating with Owners and Managers of New Buildings on Earthquake Risk

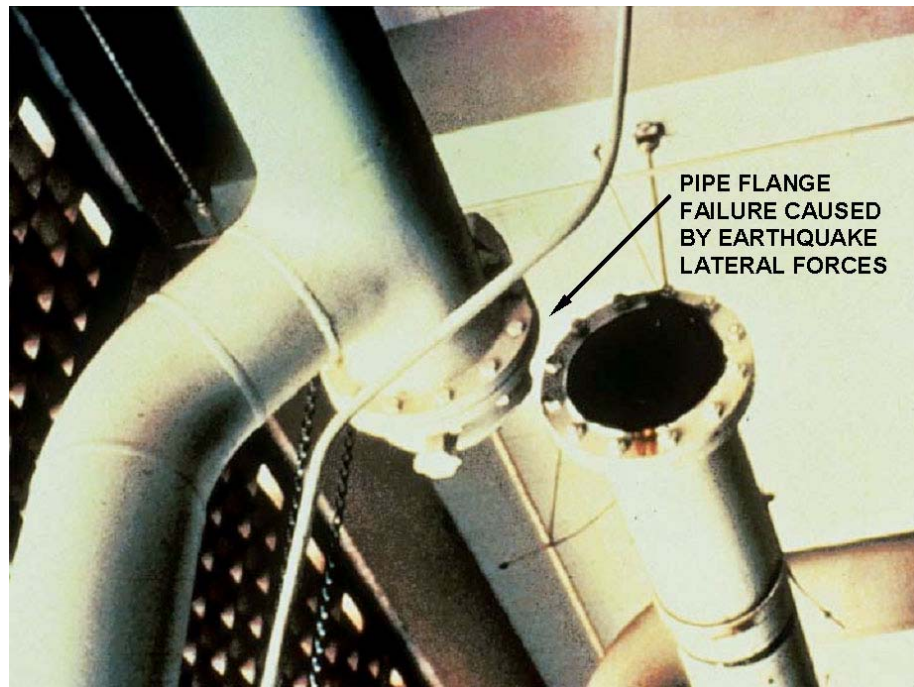
Figure 4-2 Photo of pipe flange failure caused by earthquake lateral forces. (ATC-20 Training Slide Set photo)

flow lines (see Figure 4-2), or non-functioning heating or air conditioning will render a building unusable by tenants. Breaks in fire sprinklers will cause flooding within all or part of a building, soaked carpets and walls, inundated files and records, and electrical shorts or failures in electrical equipment and computers. Other examples of nonstructural damage that can be expected in a code-compliant building subjected to strong ground shaking include extensive cracking in cladding, glazing, partitions, and chimneys; broken light fixtures; racked doors; and dropped ceiling tiles. Section 4.3 includes further discussion of the seismic behavior of specific nonstructural systems in the context of describing performance-based design objectives.
